Expansion of Hong Kong International Airport into a Three-Runway System

Pilot Test Report on Silt Curtain Efficiency

August 2017

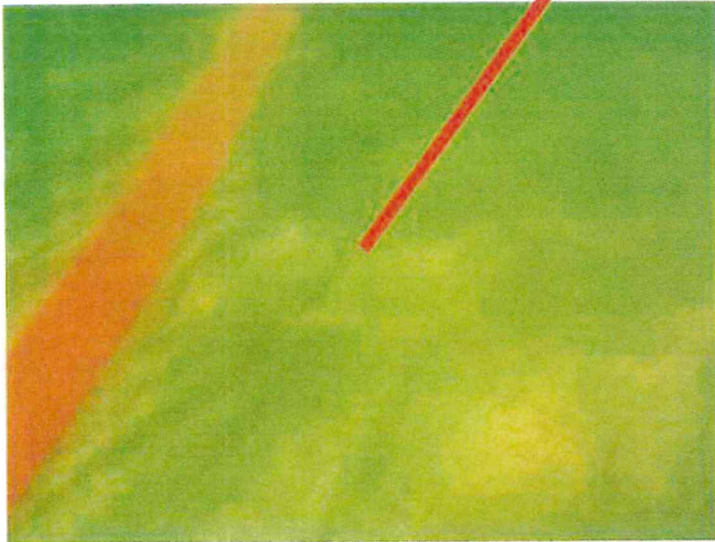
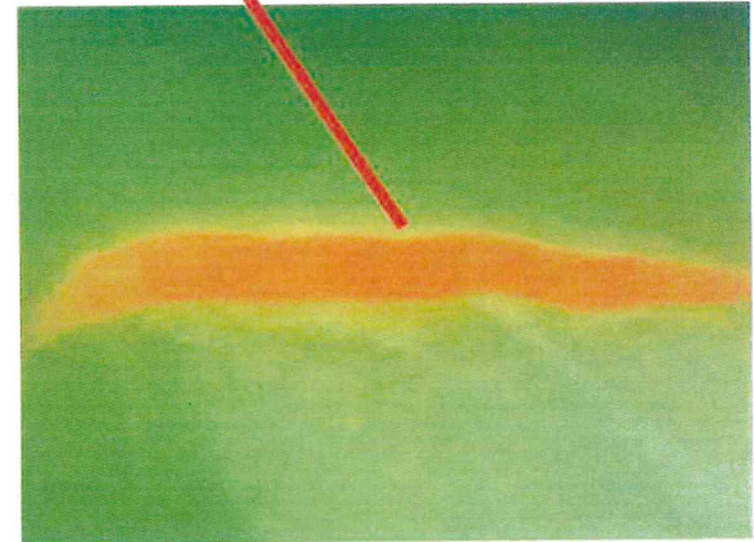
Silt Curtain for Pilot Test

The silt curtain condition is ~~*satisfactory/unsatisfactory/damaged~~ according to the diver inspection.

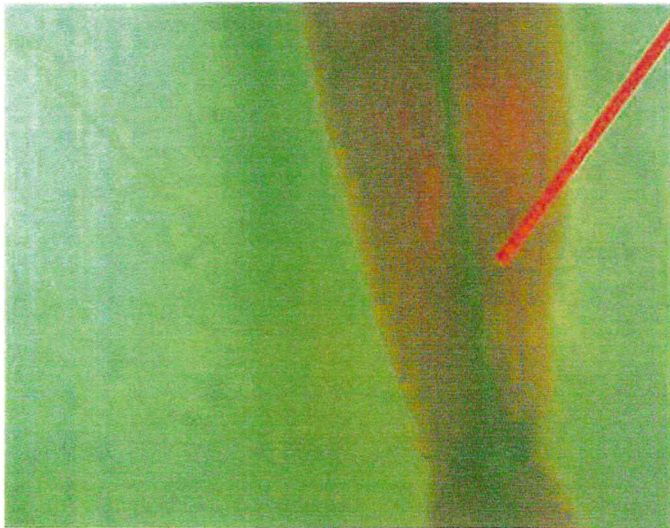
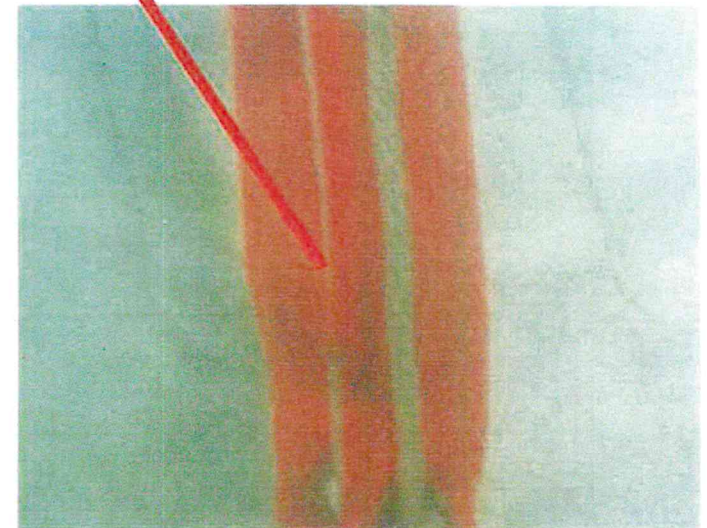
Silt Curtain for Pilot Test

The silt curtain condition is *satisfactory/~~unsatisfactory~~/~~damage~~ according to the diver inspection.

Inspection Items	Result	If Unsatisfactory, provide details on the following				
		Coordinate / Locations of Affected Section(s)	Description of Unsatisfactory Item	Proposed Action	Date of Completion of Action	Confirmed / Completed By (name and signature)
Geotextile						
Curtain remains intact and without gap	<input checked="" type="checkbox"/> Satisfactory <input type="checkbox"/> Unsatisfactory					
Curtain in upright position	<input checked="" type="checkbox"/> Satisfactory <input type="checkbox"/> Unsatisfactory					
Curtain has no loose / flapping parts	<input type="checkbox"/> Satisfactory <input checked="" type="checkbox"/> Unsatisfactory	Middle Section of floater	Loose	Repair completely before starting of test	2/6/2017

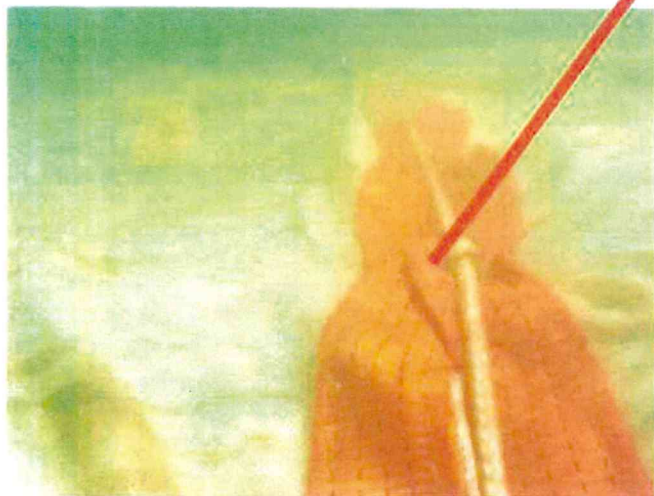
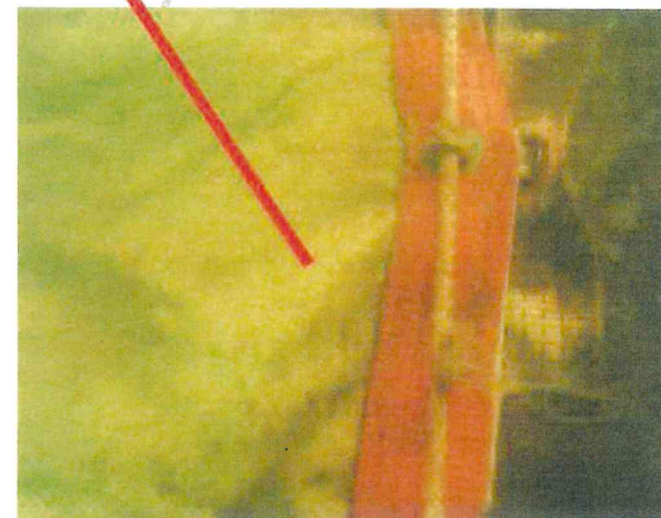
Silt Curtain for Pilot Test

The silt curtain condition is ~~unsatisfactory/damaged~~ ^{*satisfactory/} according to the diver inspection.

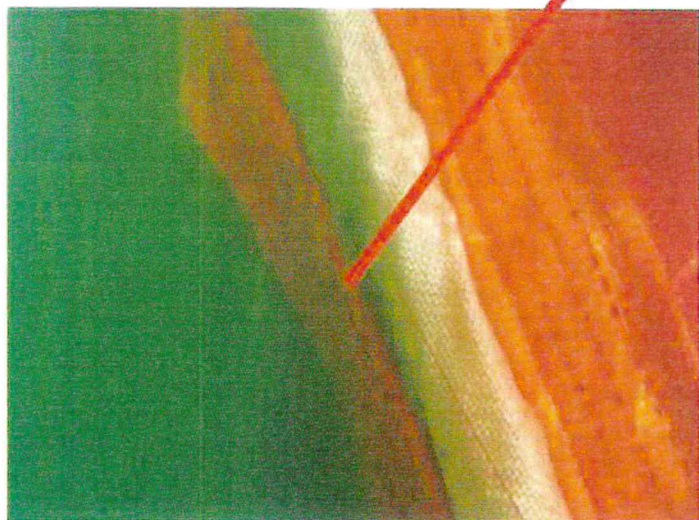
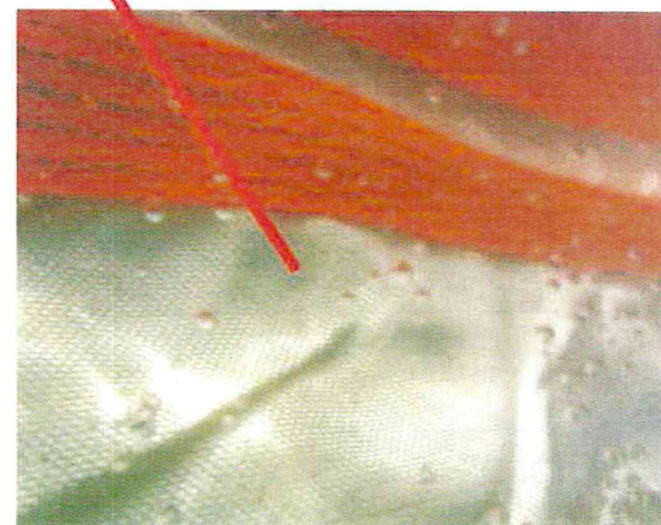
Silt Curtain for Pilot Test

The silt curtain condition is *satisfactory/~~unsatisfactory~~/~~damaged~~ according to the diver inspection.

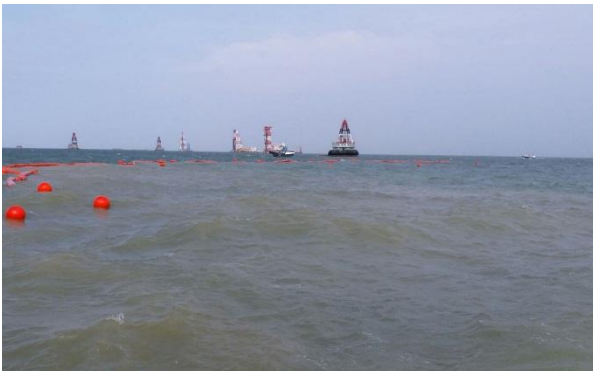
Photo 3: Sea condition inside the silt curtain during the pilot test
