Expansion of Hong Kong International Airport into a Three-Runway System

Supplementary Contamination Assessment Plan

August 2018

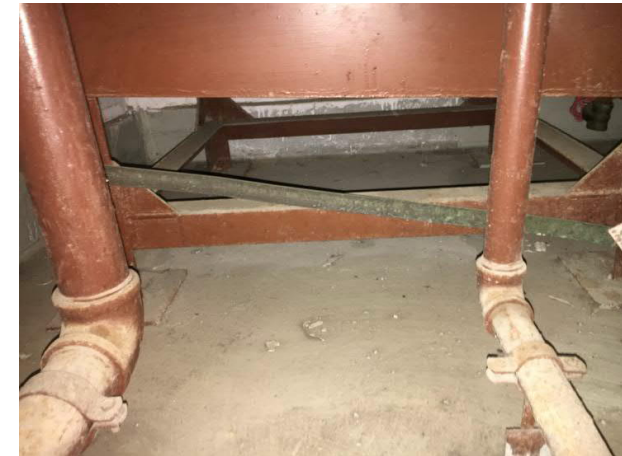
For above-ground section (i.e. BH3 and BH4), taking into account of the facilities setup and operational schedule, with no record of fuel leakage, the potential of contamination is considered to be very unlikely; therefore, SI is considered not required for the 450 L above-ground fuel tank and the emergency generator. On the contrary, final inspection and record checking should be conducted right before decommissioning/ demolition of these facilities to ensure no contaminative activities during the period from now on till the decommissioning.

BH3 View 1 – concrete floor condition underneath 450 L fuel tank

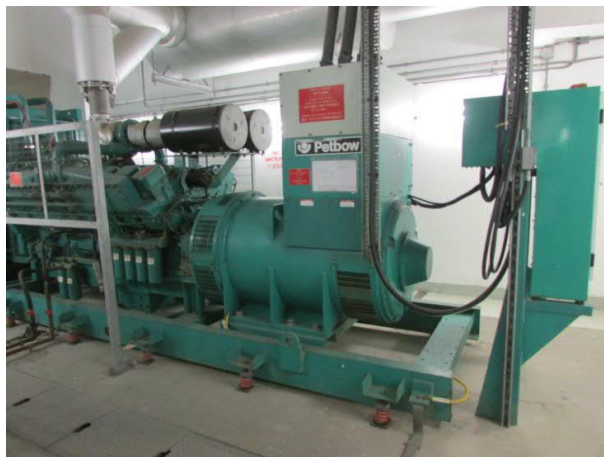
BH4 View 1 - Emergency Generator (BH4) (Mounted on 200mm-thick concrete plinth)

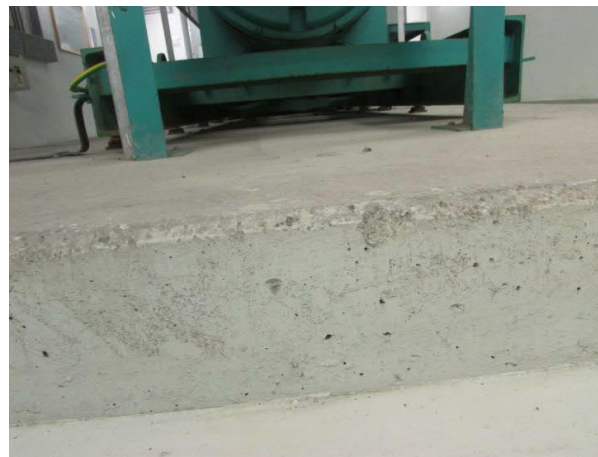
**BH4 View 2 - concrete floor condition underneath
Emergency Generator**

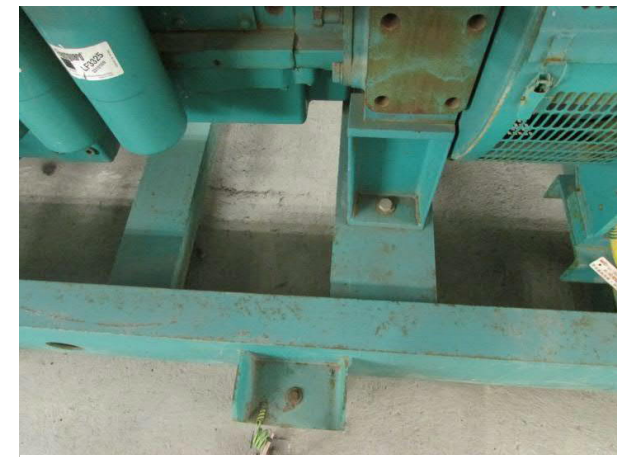
**BH4 View 3 - concrete floor condition underneath
Emergency Generator**

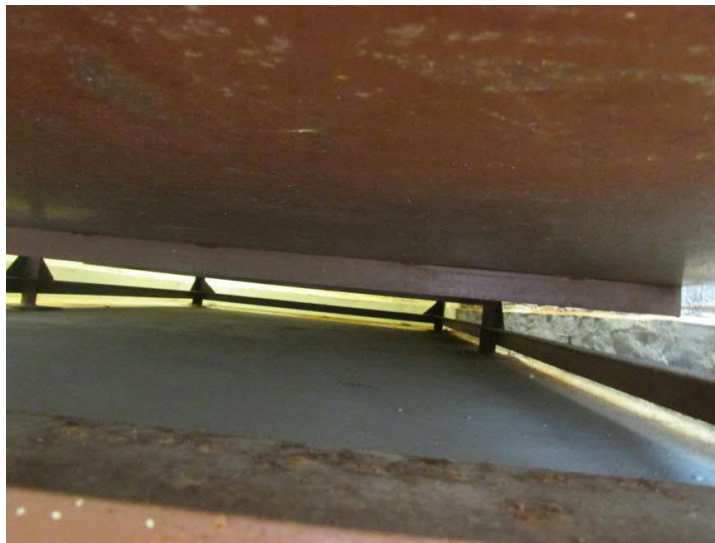
In view of facilities setup and operational schedule, with no record of fuel leakage, the potential of contamination is considered to be very unlikely; therefore, SI is considered not required for the above-ground fuel tank (i.e. BH9). For HS1, even though lubricating oil seepage during machine operation (i.e. Solely monthly test run) from engine flywheel/ engine body of one of the generators was recorded from June 2016 to March 2018 as shown in the available maintenance record, maintenance staff ensured that immediate clean-up of seepage was undertaken after every operation.

BH9 View 2 - concrete floor condition underneath 3000L Above-ground Fuel Tank

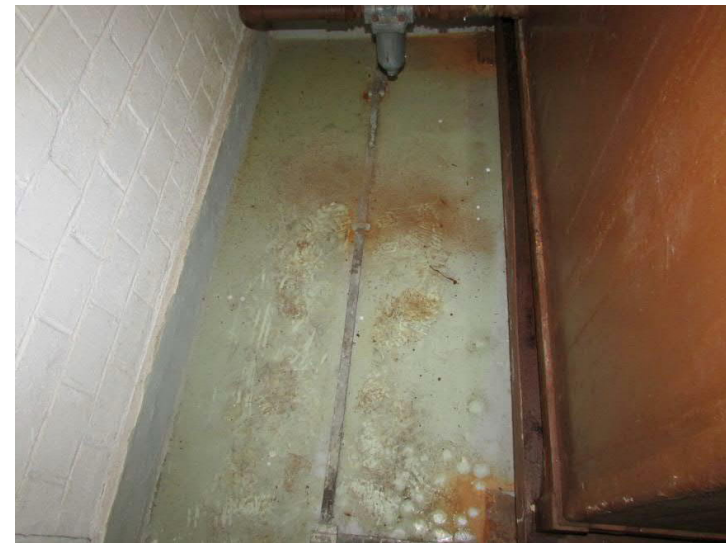
BH9 View 3 - concrete floor condition of fuel tank room with 3000L Above-ground Fuel Tank

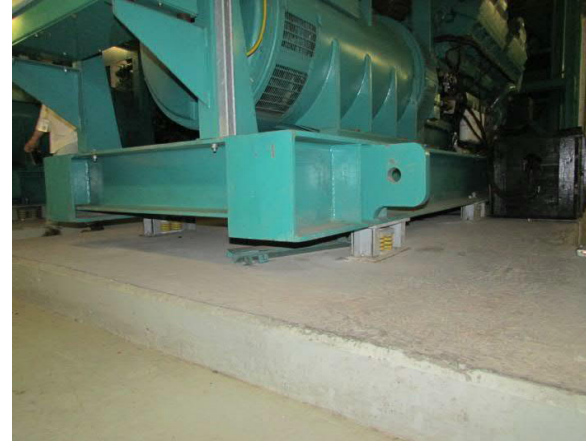
No cracks or oil stain on the intact concrete plinth underneath HS1 was observed according to site reconnaissance survey in January 2018. Based on the facility setup and site survey findings,

HS1 View 1 - concrete floor condition underneath emergency generators

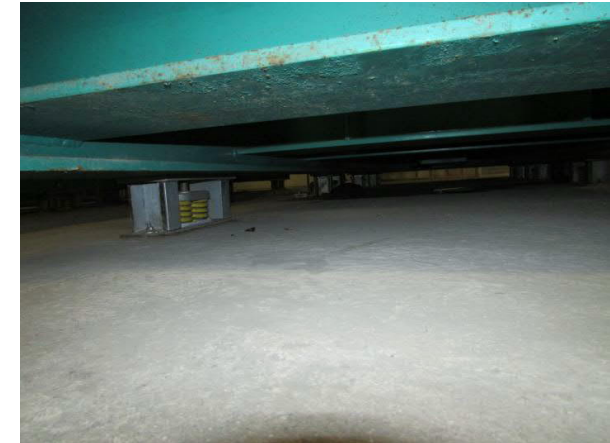
HS1 View 2 - concrete floor condition underneath emergency generators

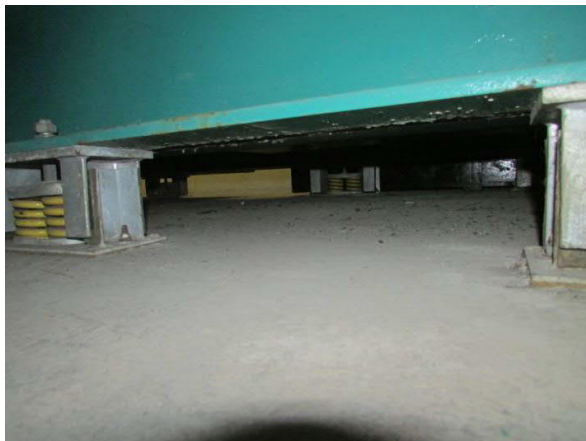
HS1 View 3 - concrete floor condition underneath emergency generators

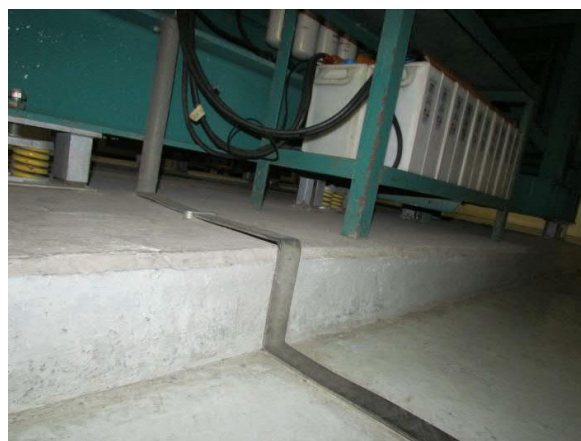
HS1 View 4 - concrete floor condition underneath emergency generators

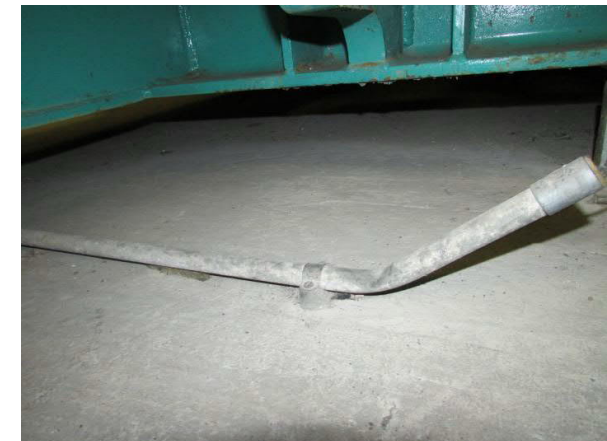
HS1 View 5 - concrete floor condition underneath emergency generators

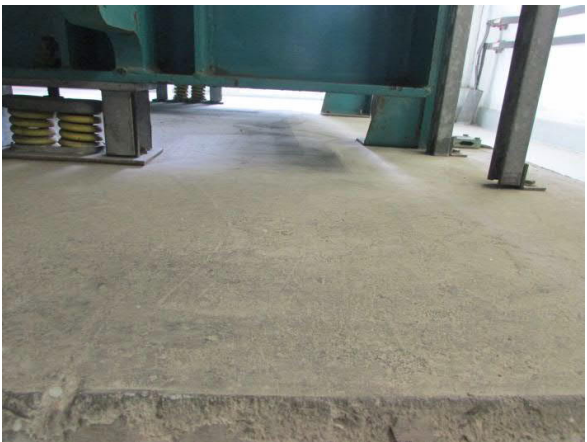
For above-ground section (i.e. BH7 and BH8), in view of the facilities setup and operational schedule, with no record of fuel leakage, the potential of contamination is considered to be very unlikely; therefore, SI is considered not required for the 450 L above-ground fuel tank and the emergency generator. On the contrary, final inspection and record checking should be conducted right before decommissioning/ demolition of these underground facilities to ensure no contaminative activities during the period from now on till the decommissioning.

BH8 View 1 - concrete floor condition underneath emergency generator

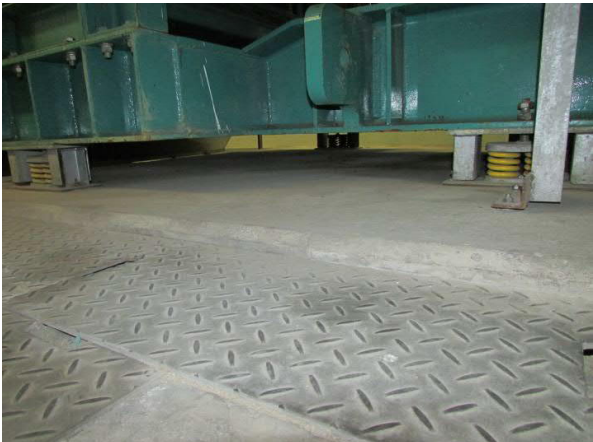
BH8 View 2 - concrete floor condition underneath emergency generator

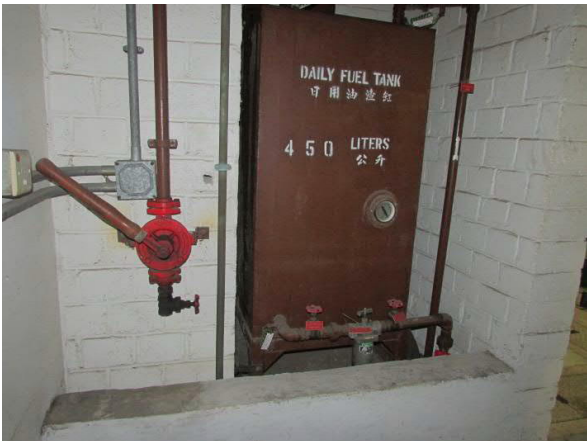
BH7 View 1 - 450 L Above-ground Fuel Tank

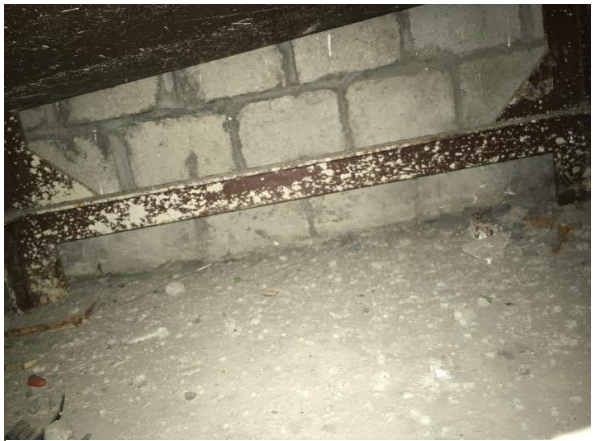
BH7 View 2 - concrete floor condition underneath 450 L Above-ground Fuel Tank

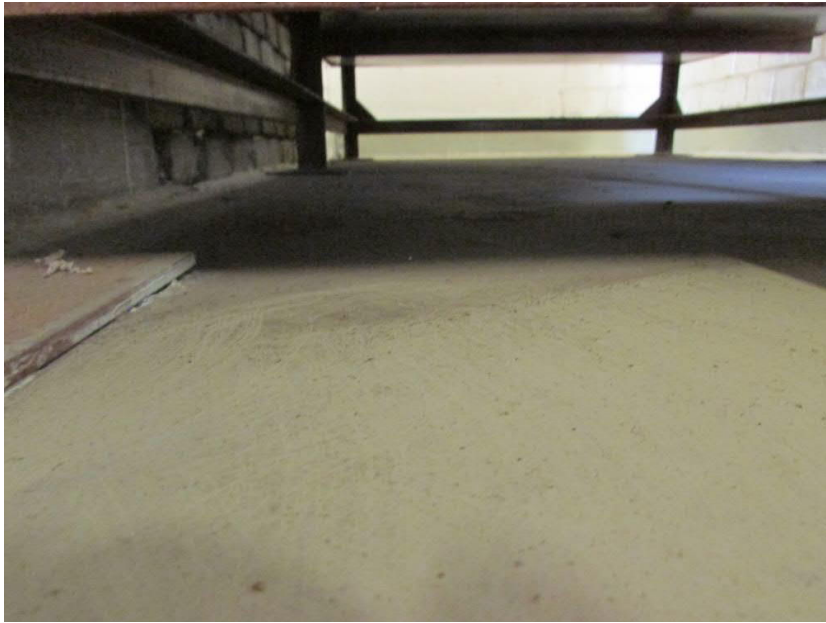
Through taking into account the facilities setup and operational means, the potential of contamination from BH10 and HS2 are therefore considered to be very unlikely. SI is considered not required for the 1,500 L above-ground fuel tank (i.e. BH10) and the emergency generator (i.e. HS2). For the underground fuel pipelines (i.e. HS3), even physical inspection is not possible, the high-standard engineering design (i.e. concrete trench filled with mass/sand), plus no record implying leakage, supported that the potential of contamination is therefore considered to be unlikely. To confirm no potential contamination taken place, an enhanced SI programme is designed for the concerned underground facilities.

BH10 View 1 - concrete floor condition underneath 1,500L Above-ground Fuel Tank

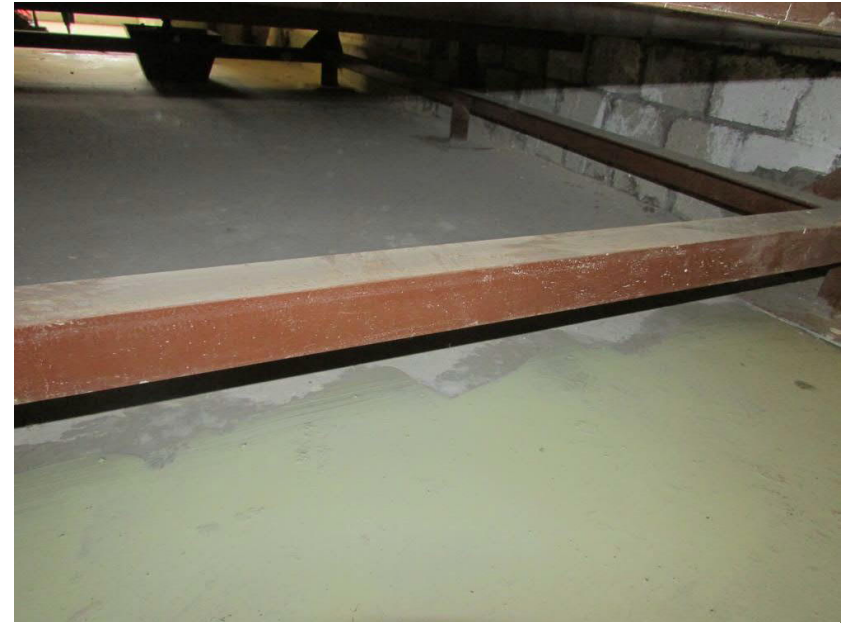
BH10 View 2 - concrete floor condition underneath 1,500L Above-ground Fuel Tank

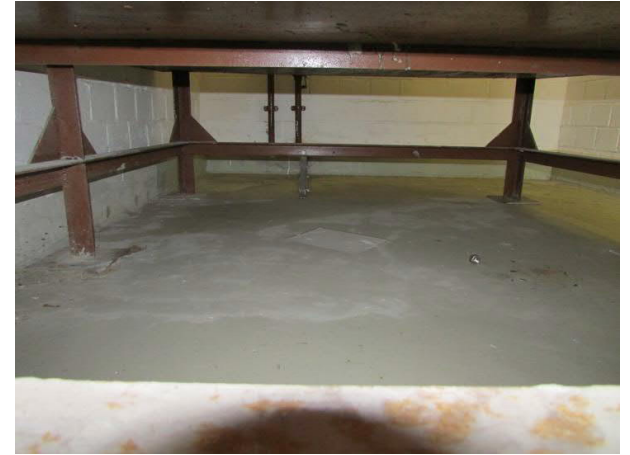
In terms of operation, this set of emergency power supply system has operated only for monthly test run (30-60 minutes for each run) since installation. The fuel tank is checked monthly and re-filled approximately every 6 months. The quantity of fuel inside the tank is monitored by level sensor while no sign of leakage being detected. Based on the facility setup and site survey observation, it is considered that the contamination potential is very unlikely. (Refer to photo record in **Appendix E.5**)

**HS4 View 1 - concrete floor condition underneath
1,500L Above-ground Fuel Tank**

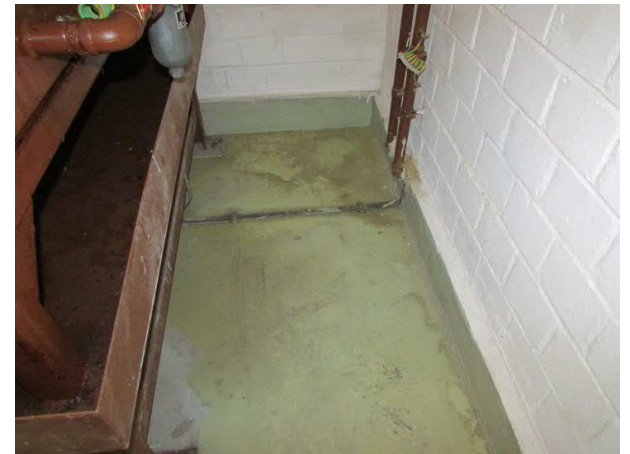
HS4 View 2 - concrete floor condition of fuel tank room with 1,500 L above-ground fuel tank

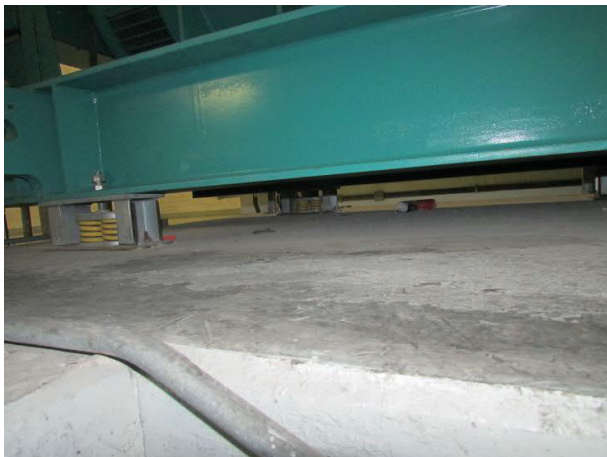
HS5 View 1 - concrete floor condition underneath emergency generator

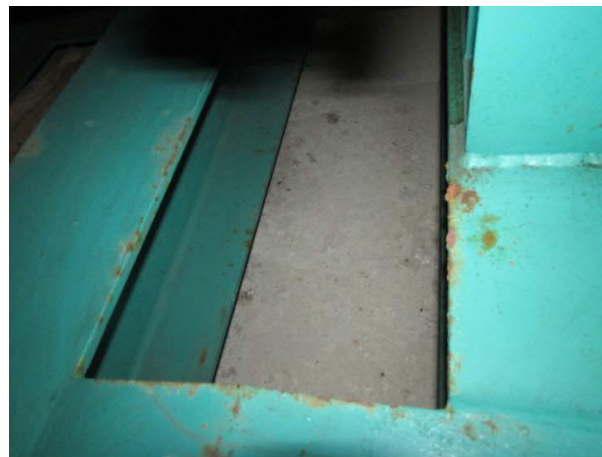
HS5 View 2 - concrete floor condition underneath emergency generator
