Expansion of Hong Kong International Airport into a Three-Runway System

Supplementary Contamination Assessment Plan

August 2018

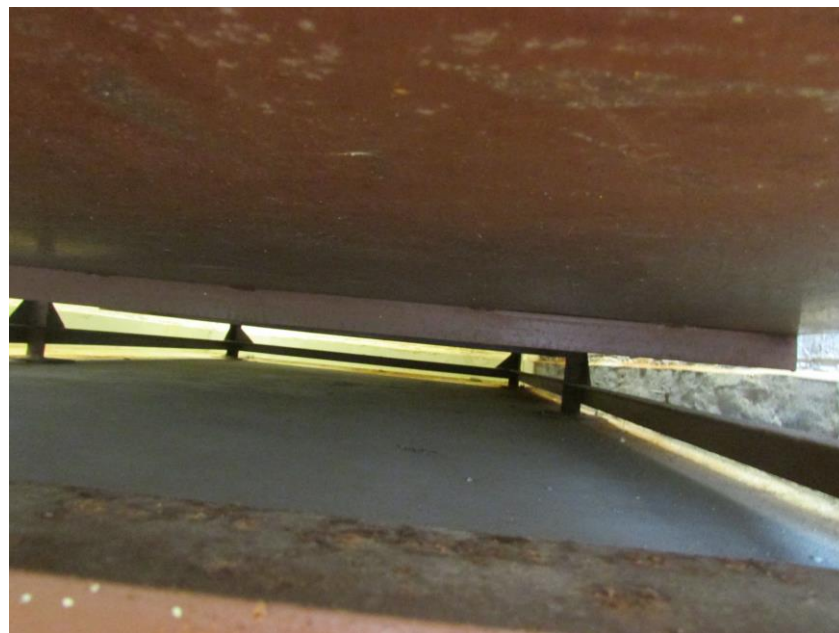
In view of facilities setup and operational schedule, with no record of fuel leakage, the potential of contamination is considered to be very unlikely; therefore, SI is considered not required for the above-ground fuel tank (i.e. BH9). For HS1, even though lubricating oil seepage during machine operation (i.e. Solely monthly test run) from engine flywheel/ engine body of one of the generators was recorded from June 2016 to March 2018 as shown in the available maintenance record, maintenance staff ensured that immediate clean-up of seepage was undertaken after every operation.

BH9 View 1 - 3000L Above-ground Fuel Tank (BH9)

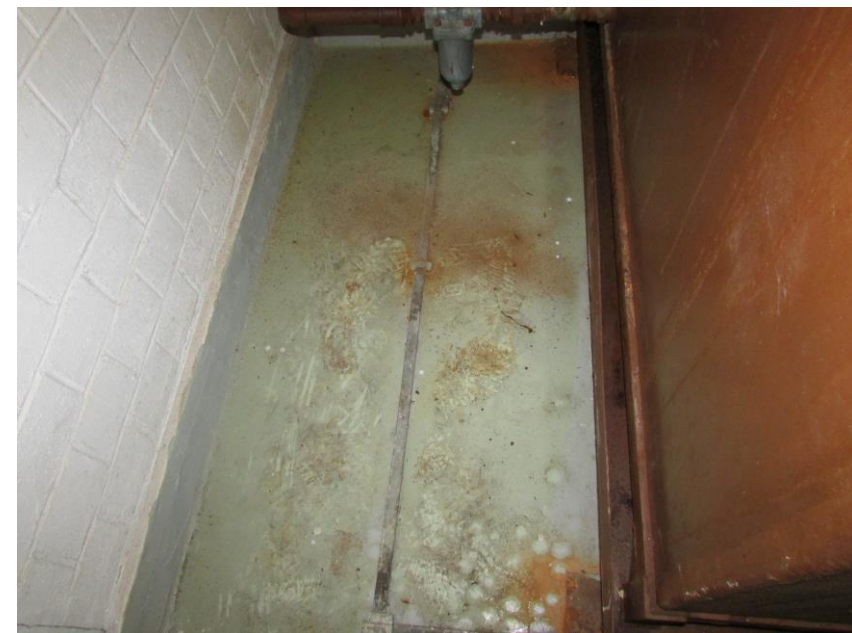
BH9 View 2 - concrete floor condition underneath 3000L Above-ground Fuel Tank

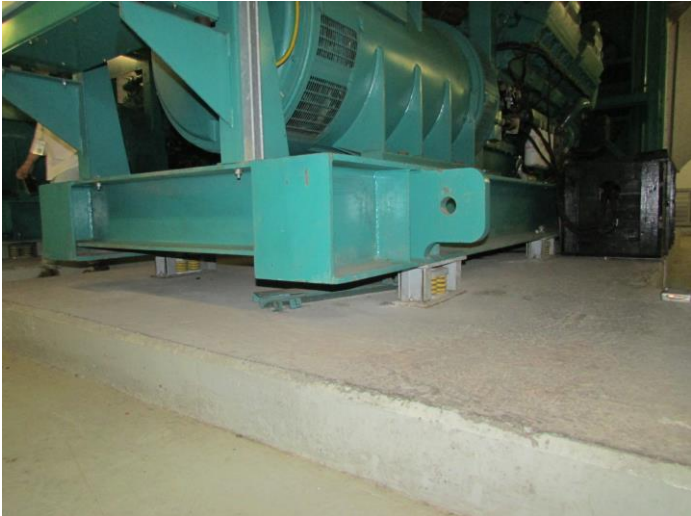
No cracks or oil stain on the intact concrete plinth underneath HS1 was observed according to site reconnaissance survey in January 2018. Based on the facility setup and site survey findings,

HS1 View 1 - concrete floor condition underneath emergency generators

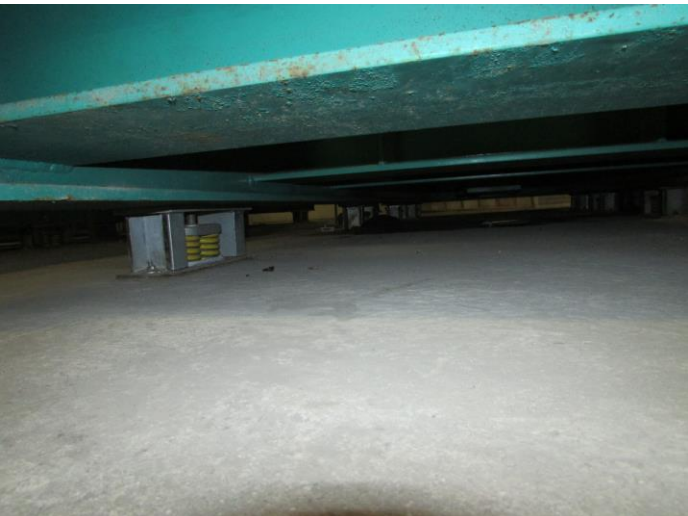
HS1 View 2 - concrete floor condition underneath emergency generators

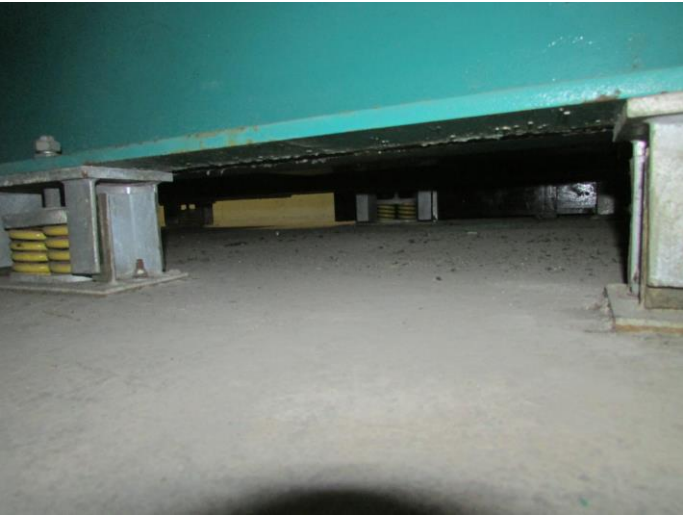
HS1 View 3 - concrete floor condition underneath emergency generators

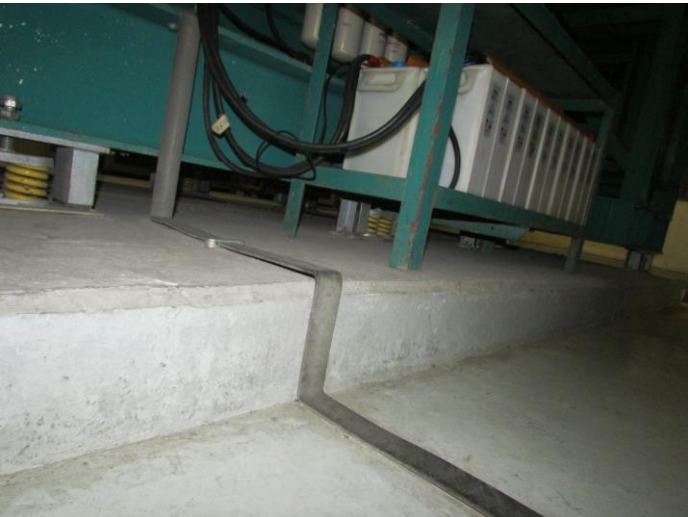
HS1 View 4 - concrete floor condition underneath emergency generators

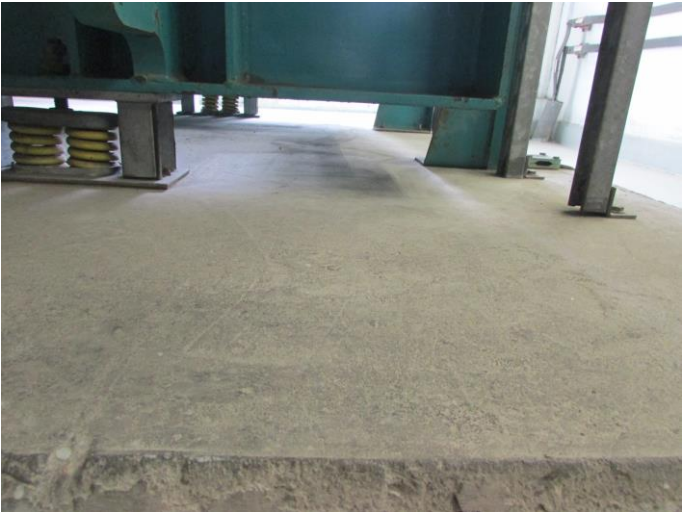
Above-ground section refers to the 450 L above-ground fuel tank containing diesel fuel equipped with drip tray (i.e. BH7) and the emergency generator (i.e. BH8) both located at an Emergency Generator Room. Both fuel tank and generator are mounted on intact concrete floor with no oil stain.

BH8 View 1 - concrete floor condition underneath emergency generator

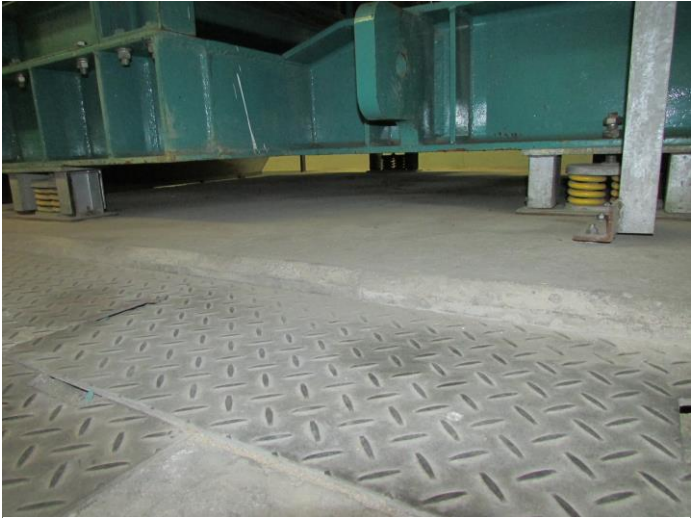
BH8 View 2 - concrete floor condition underneath emergency generator

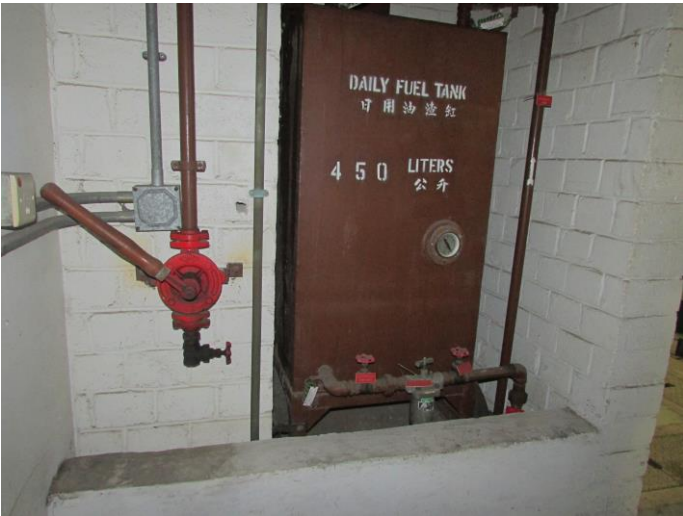
BH7 View 1 - 450 L Above-ground Fuel Tank

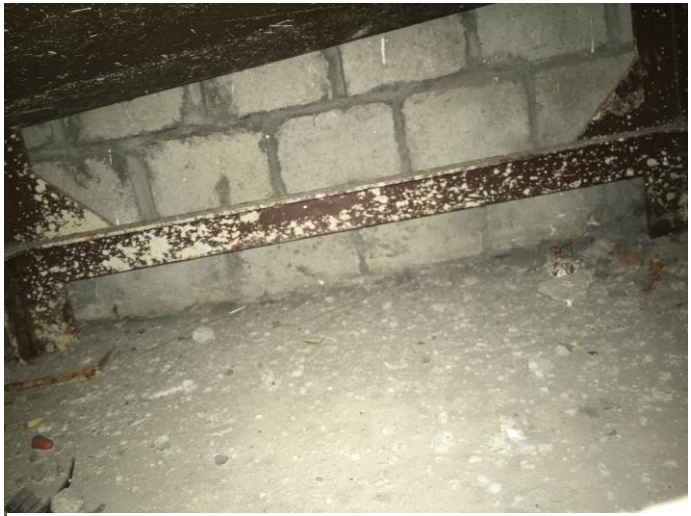
BH7 View 2 - concrete floor condition underneath 450 L Above-ground Fuel Tank

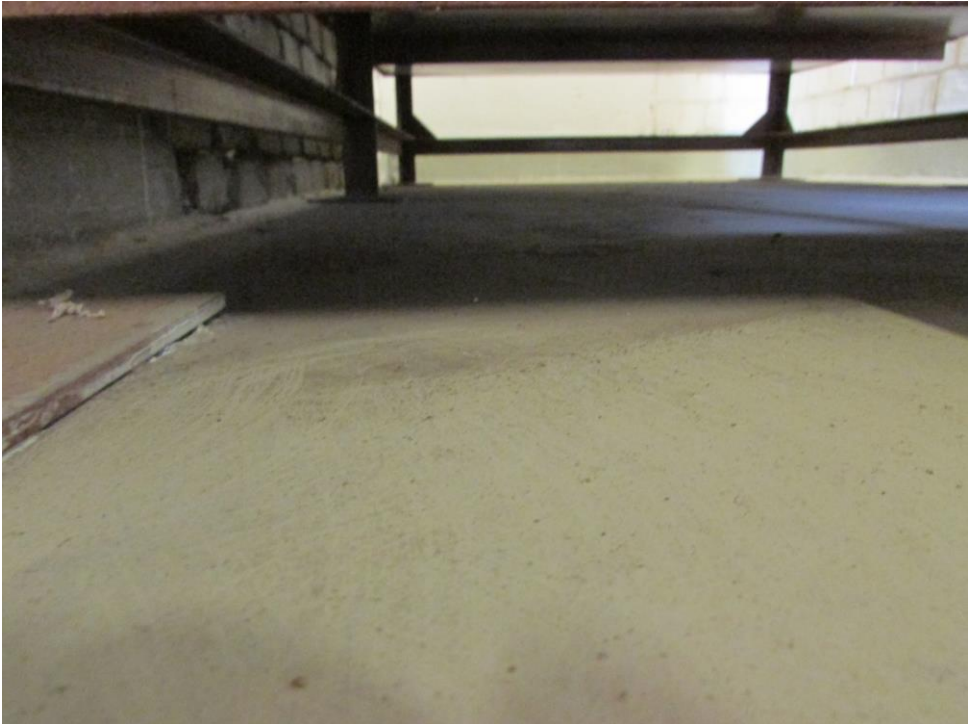
High-standard engineering design was found in facilities setup. Both above-ground facilities (i.e. BH10 and HS2) are mounted on intact concrete floor with no oil stain. Curb by builder is also provided in the Fuel Tank Room. The underground pipeline (i.e. HS3) is laid in concrete trench 1 m below ground level backfilled with mass/sand. System details are shown in drawings in **Appendix E.4**.

BH10 View 1 - concrete floor condition underneath 1,500L Above-ground Fuel Tank

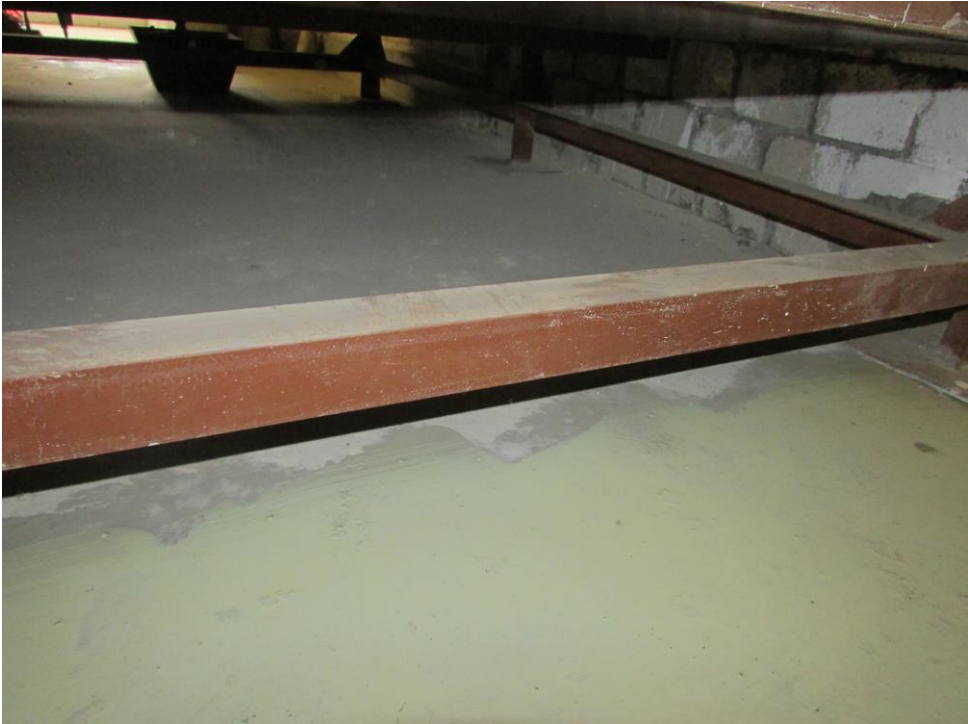
BH10 View 2 - concrete floor condition underneath 1,500L Above-ground Fuel Tank

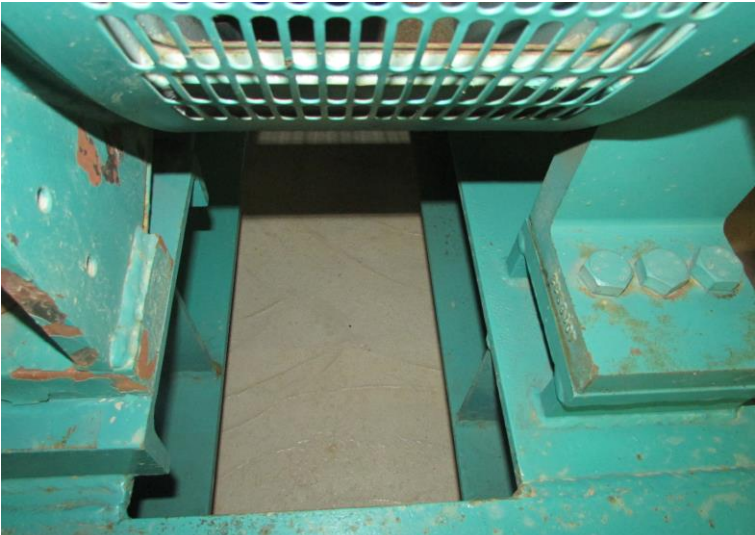
HS2 View 1 - concrete floor condition underneath emergency generator

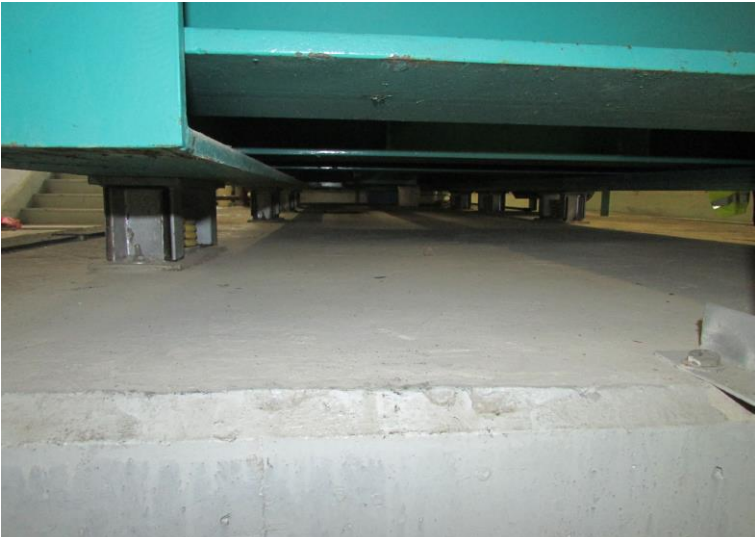
HS2 View 2 - concrete floor condition underneath emergency generator

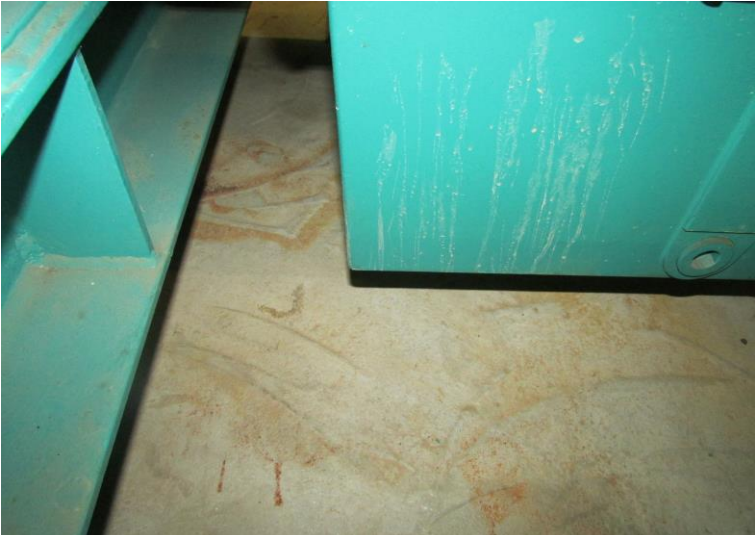
HS2 View 3 - concrete floor condition underneath emergency generator

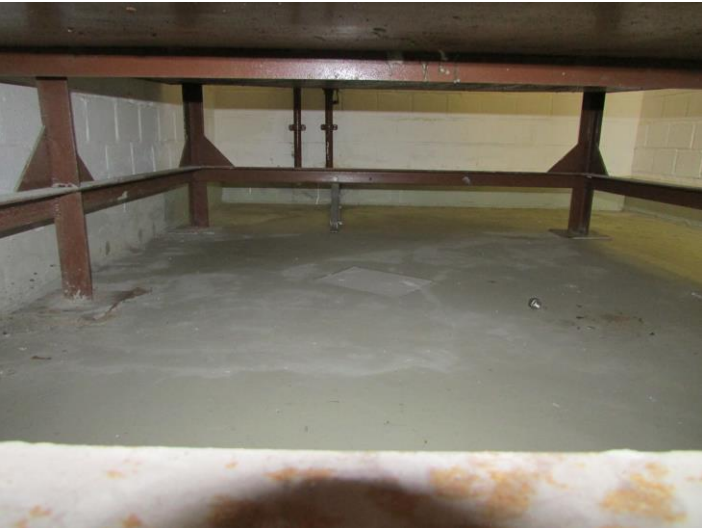
- Notes
- Both the fuel tank and generator mounted on intact concrete floor with no any oil stain.
 - Test run of emergency generator conducted monthly (for 30-60 mins)
 - Fuel tank is checked monthly and re-filled approx. every 6 months.
 - The quantity of fuel inside the tank is monitored by level sensor. No sign of leakage is detected.

HS4 View 1 - concrete floor condition underneath 1,500L Above-ground Fuel Tank

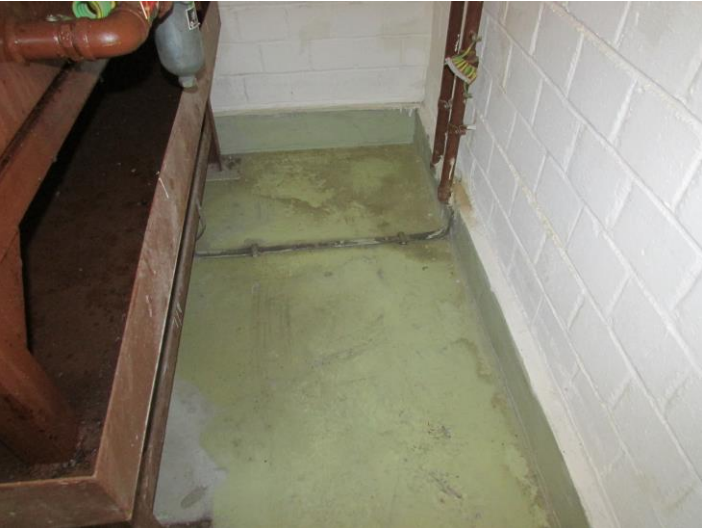
HS4 View 2 - concrete floor condition of fuel tank room with 1,500 L above-ground fuel tank

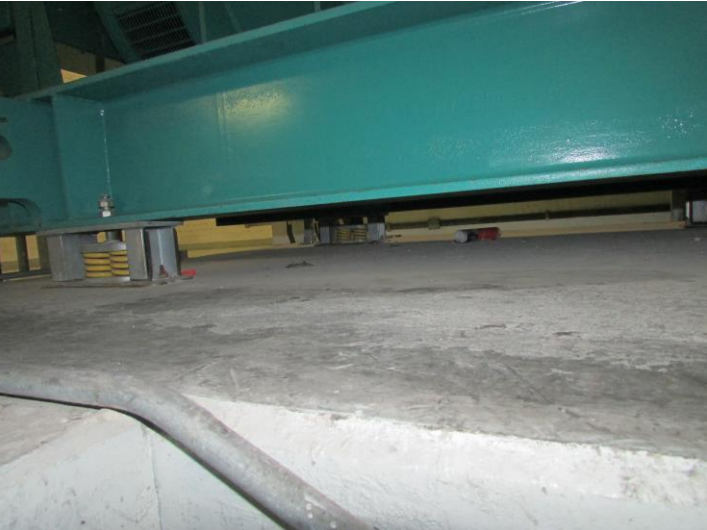
HS5 View 1 - concrete floor condition underneath emergency generator

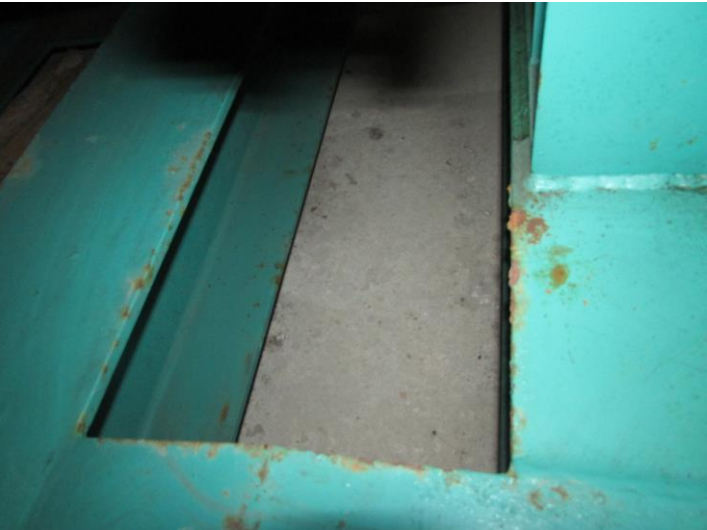
HS5 View 2 - concrete floor condition underneath emergency generator
