Appendix E.2 Emergency Power Supply System No. 2 ([BH 9](#) and [HS1](#))

Northern Section of T2 Building

Appendix E.2 Emergency Power Supply System No. 2
 Details of **BH9** (3000L **Above-ground** Fuel Tank inside T2)

Details of **HS1** (2 Newly identified above-ground Emergency generators connected with 3,000 L Above-ground Fuel Tank inside (BH9))

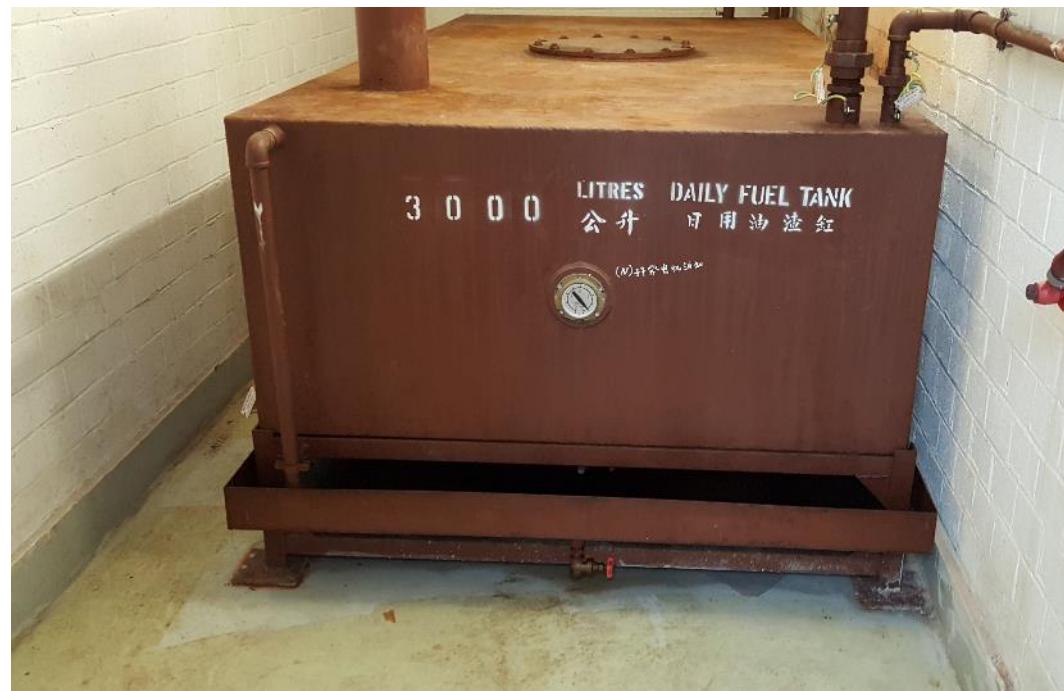
3000 L fuel tank with metal drip tray

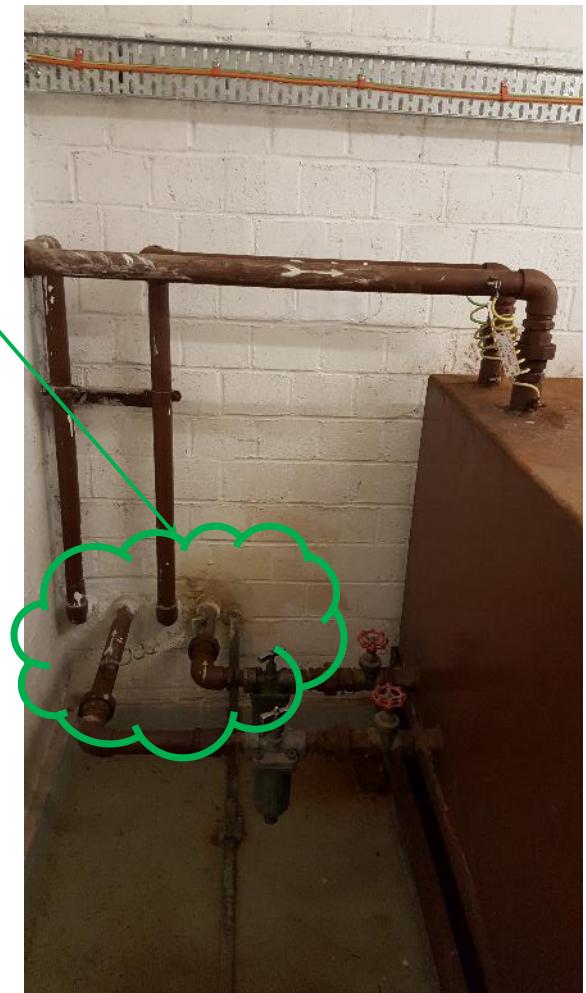
Fuel pipes penetrating the wall and connect to the generators at lower floor

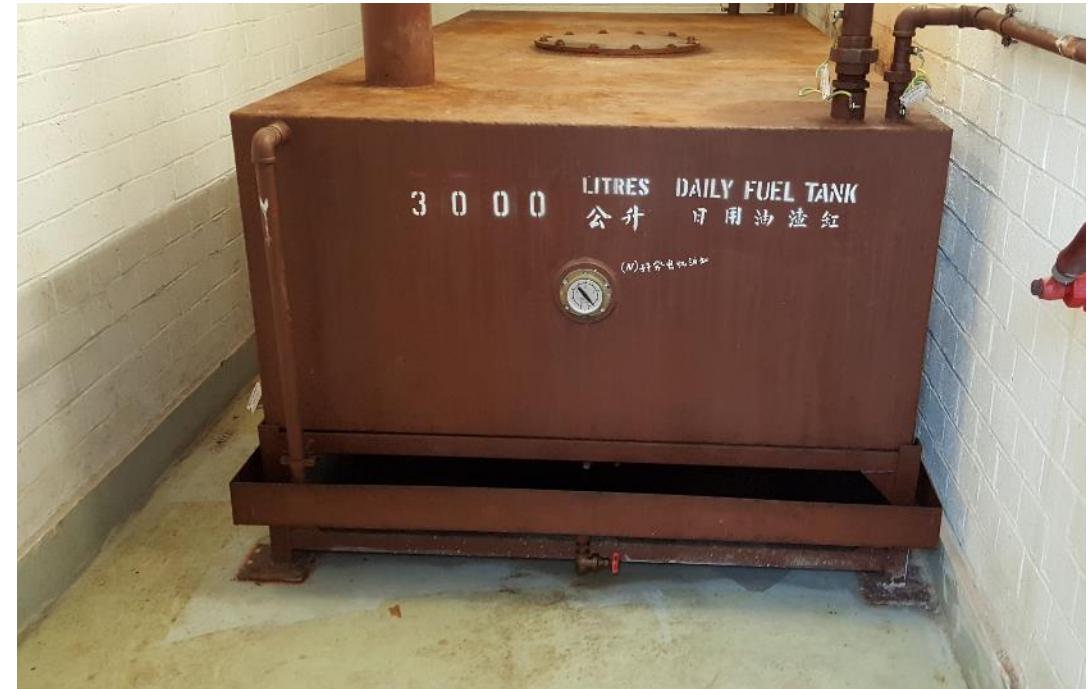
BH9 View 1 - 3000L Above-ground Fuel Tank (BH9)

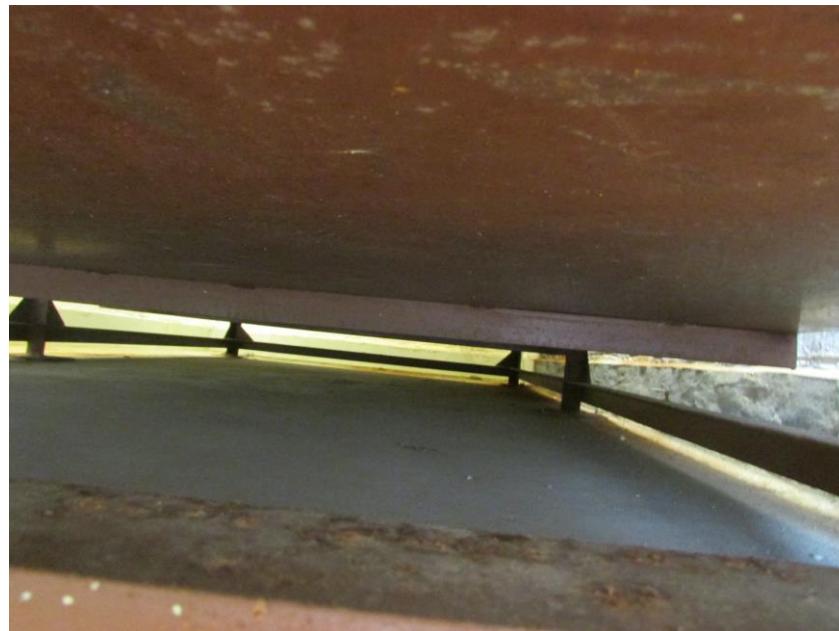
BH9 View 2 - concrete floor condition underneath 3000L Above-ground Fuel Tank

- Both the fuel tank and generator mounted on intact concrete floor with no any oil stain.
- Test run of emergency generator conducted monthly (for 30-60 mins)
- The fuel tank is checked monthly and re-filled approx. every 6 months
- The quantity of fuel inside the tank is monitored by level sensor. No sign of leakage is detected.

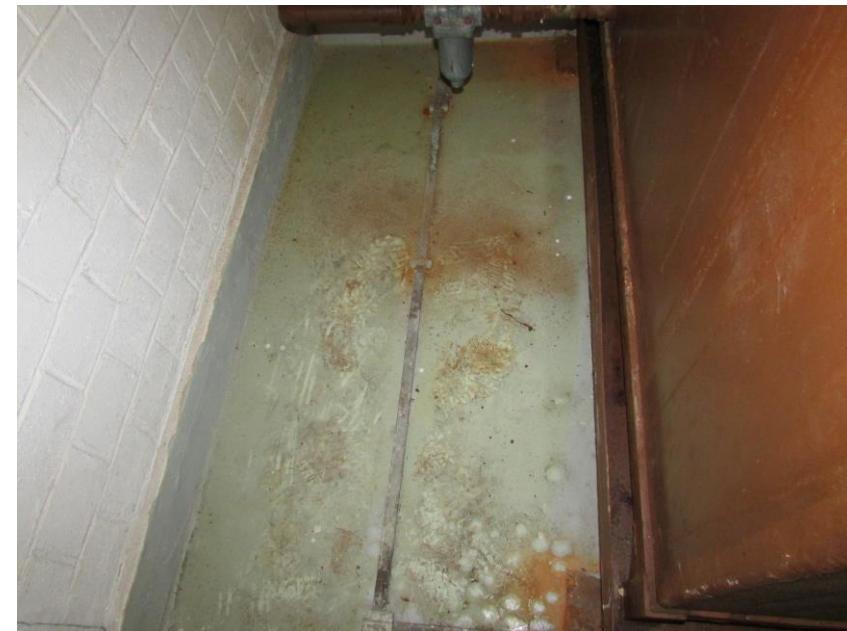
BH9 View 3 - concrete floor condition of fuel tank room with 3000L Above-ground Fuel Tank

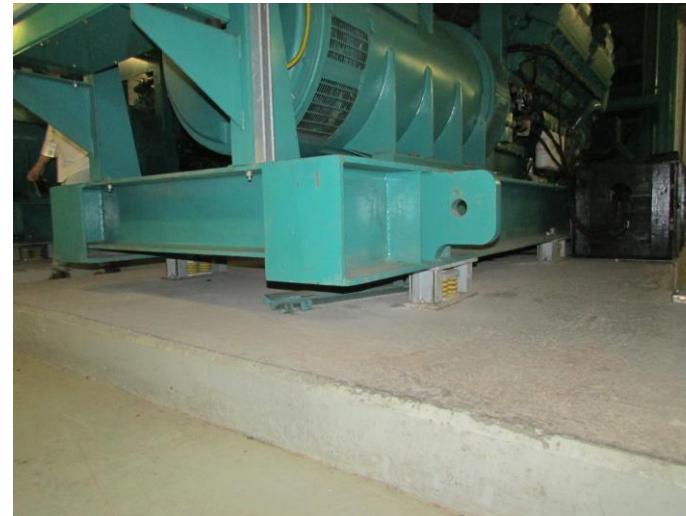
HS1 View 1 - concrete floor condition underneath emergency generators

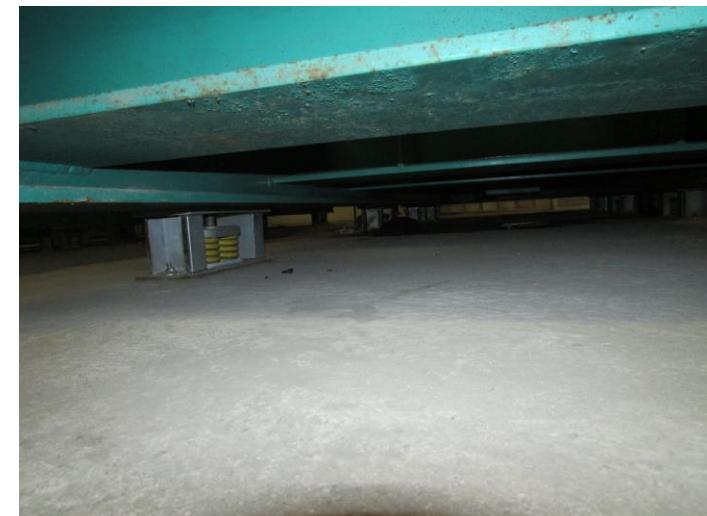
HS1 View 2 - concrete floor condition underneath emergency generators

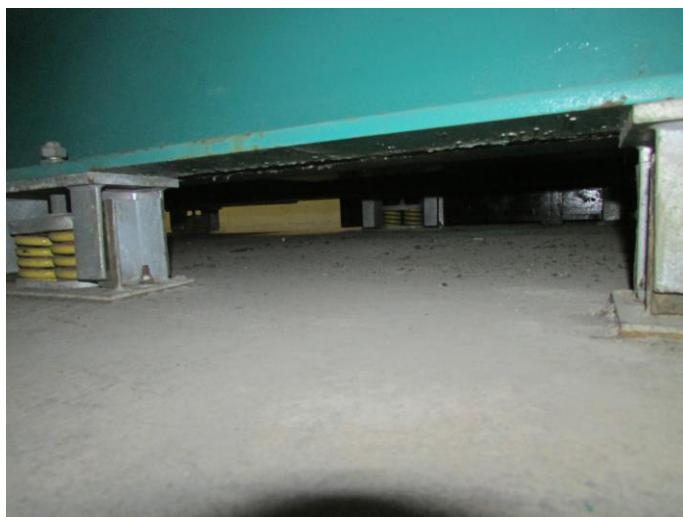
HS1 View 3 - concrete floor condition underneath emergency generators

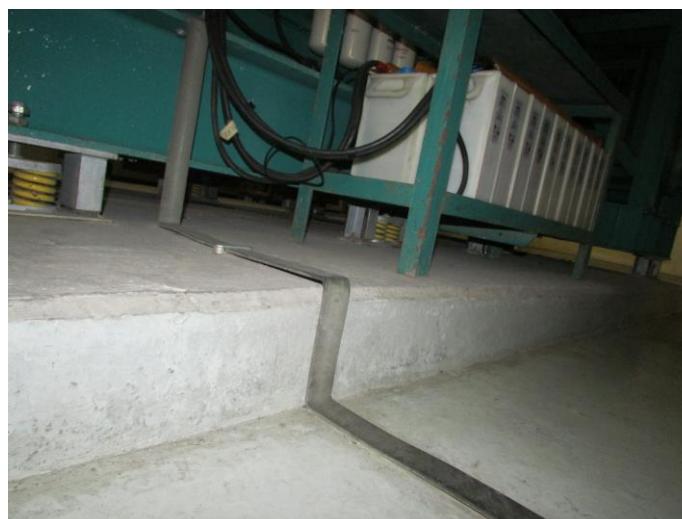
HS1 View 4 - concrete floor condition underneath emergency generators

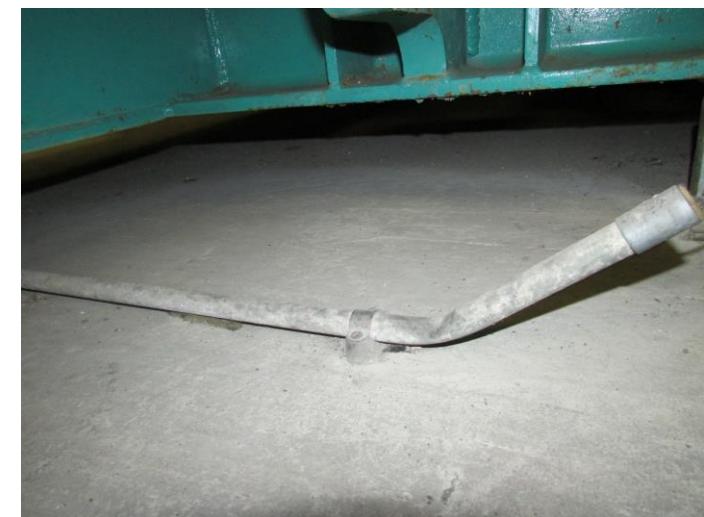
HS1 View 5 - concrete floor condition underneath emergency generators
