Appendix J1 Site Photo Record of Final Inspection for EPSS2 **BH9** (3000L **Above-ground** Fuel Tank)

Appendix J2 Site Photo Record of Final Inspection for EPSS2 **HS1** (2 **above-ground** Emergency generators connected with 3,000 L **Above-ground** Fuel Tank inside (**BH9**))

Appendix J4 Site Photo Record of Final Inspection for EPSS3 **BH8** (Above-ground Emergency Generator)

Appendix J5 Site Photo Record of Final Inspection for EPSS5 **HS4** (Above-ground Fuel Tank) and **HS5** (Above-ground Emergency Generator)

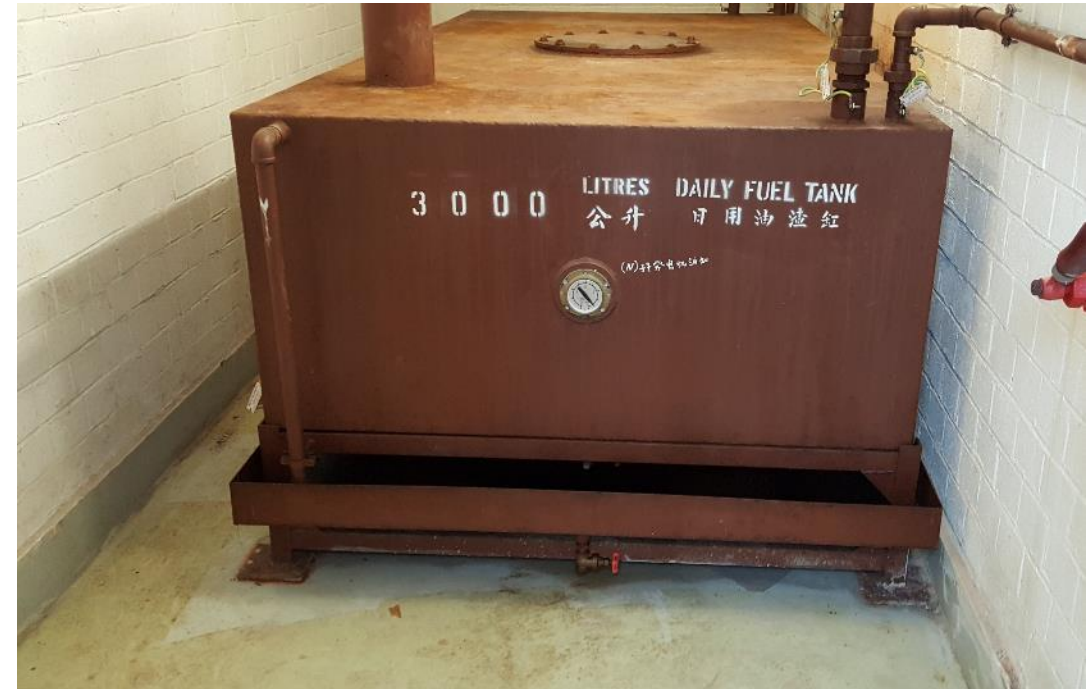
BH9 View 1 - 3000L Above-ground Fuel Tank (BH9)

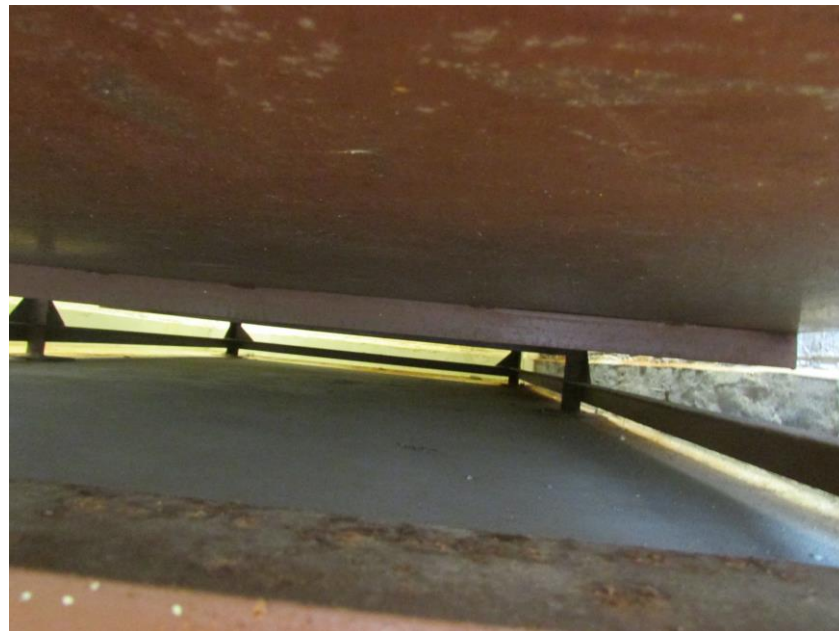
BH9 View 2 - concrete floor condition underneath 3000L Above-ground Fuel Tank

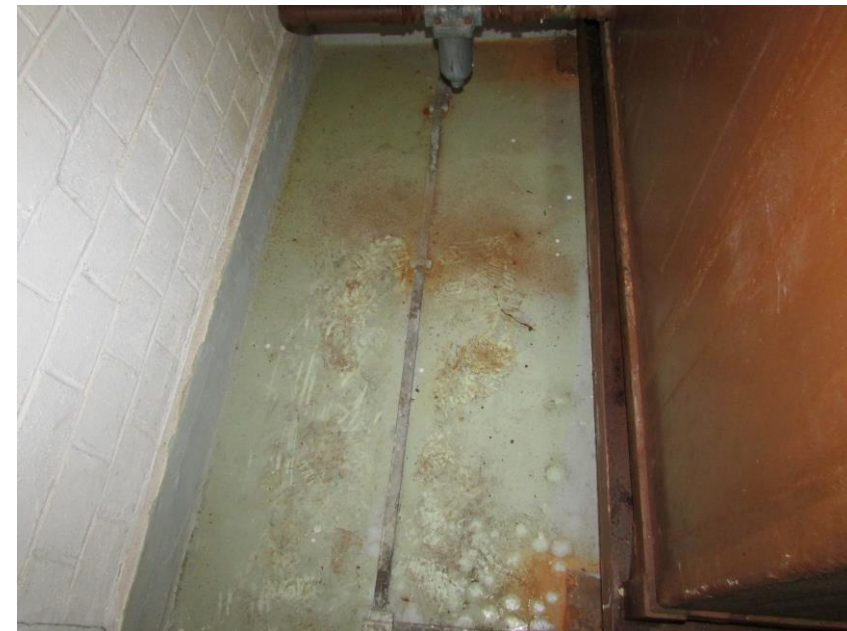
BH9 View 3 - concrete floor condition of fuel tank room with 3000L Above-ground Fuel Tank

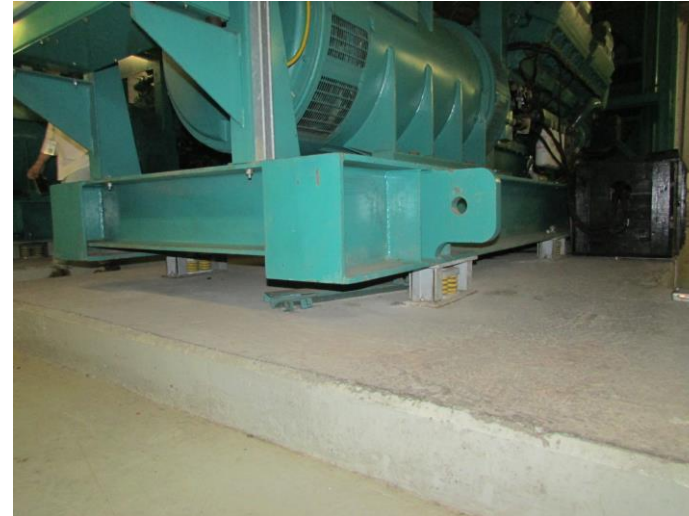
HS1 View 1 - concrete floor condition underneath emergency generators

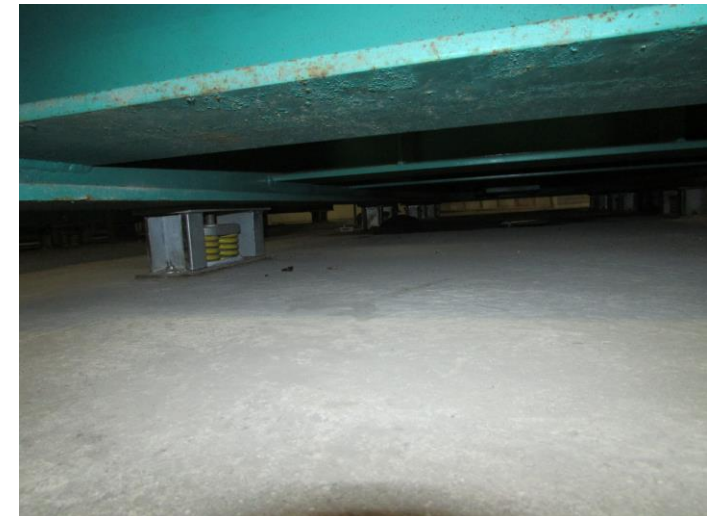
HS1 View 2 - concrete floor condition underneath emergency generators

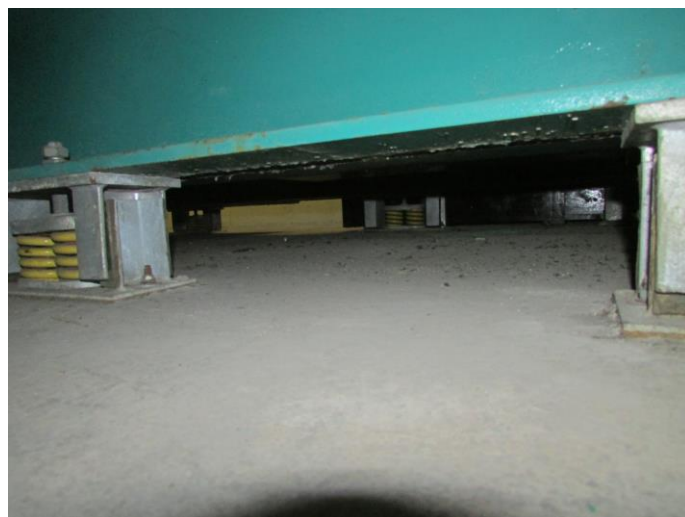
HS1 View 3 - concrete floor condition underneath emergency generators

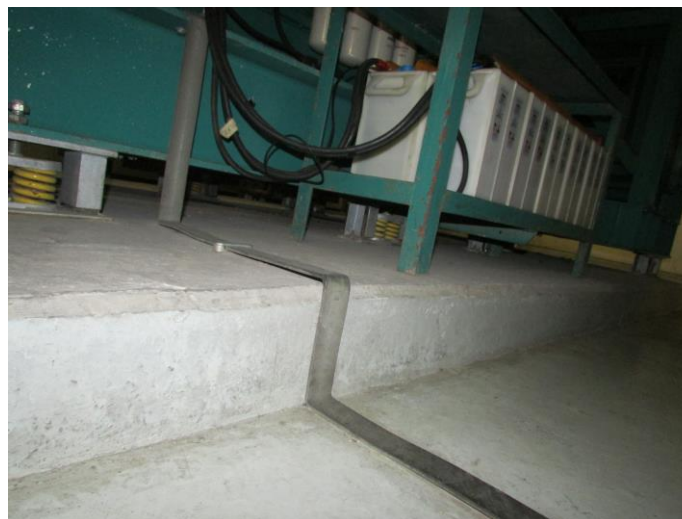
HS1 View 4 - concrete floor condition underneath emergency generators

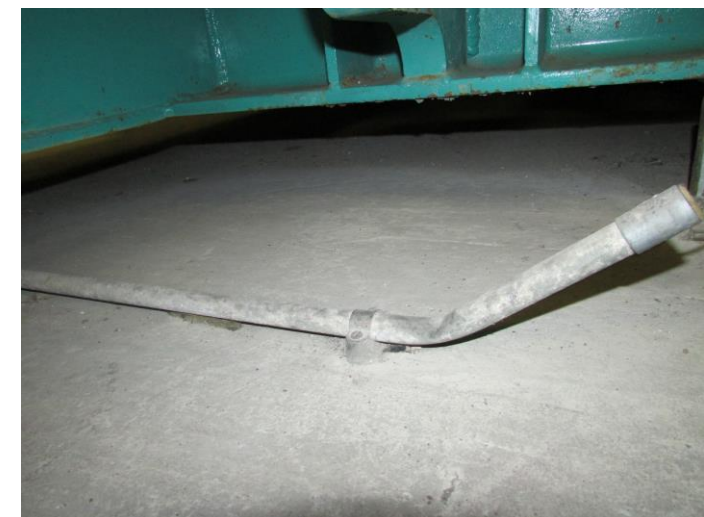
HS1 View 5 - concrete floor condition underneath emergency generators

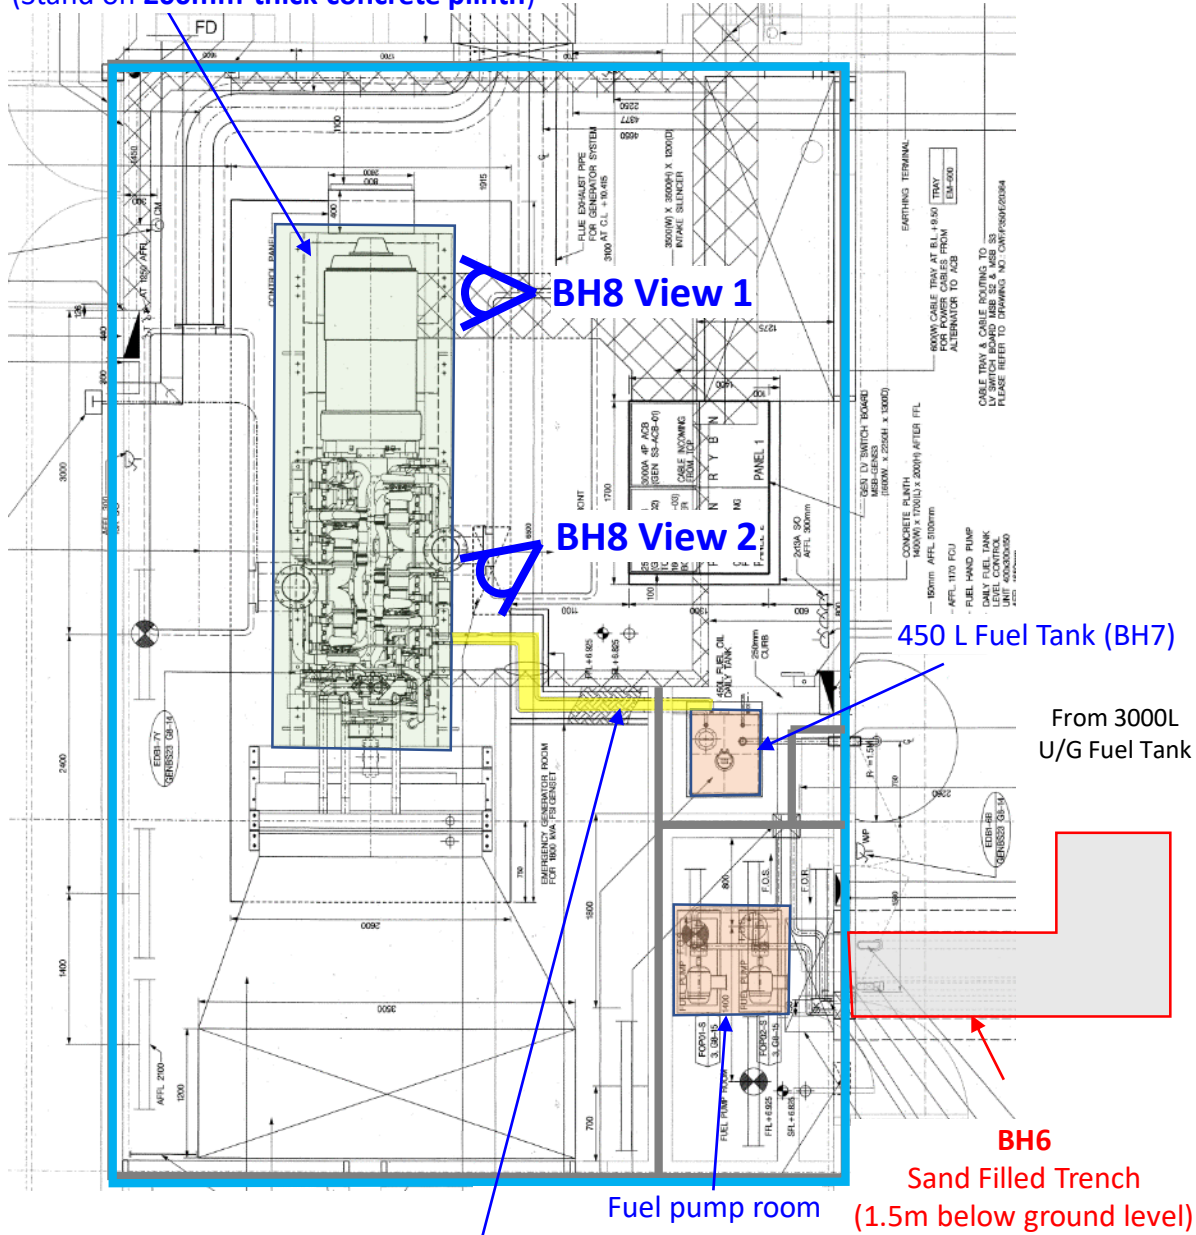
Emergency Generator (BH8)
(Stand on 200mm-thick concrete plinth)

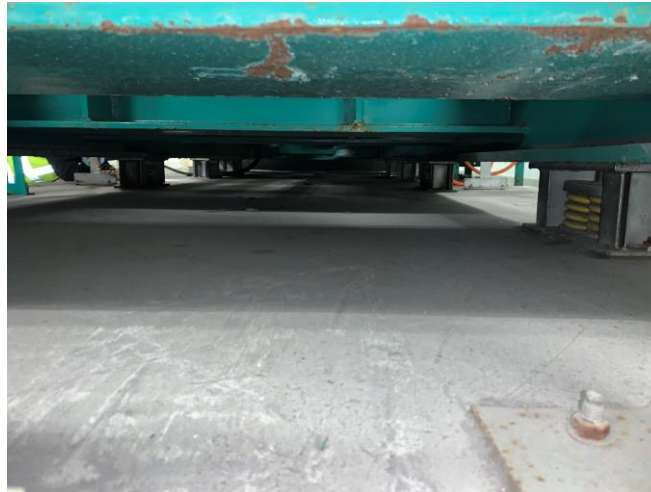
BH8 View 1 - concrete floor condition underneath emergency generator

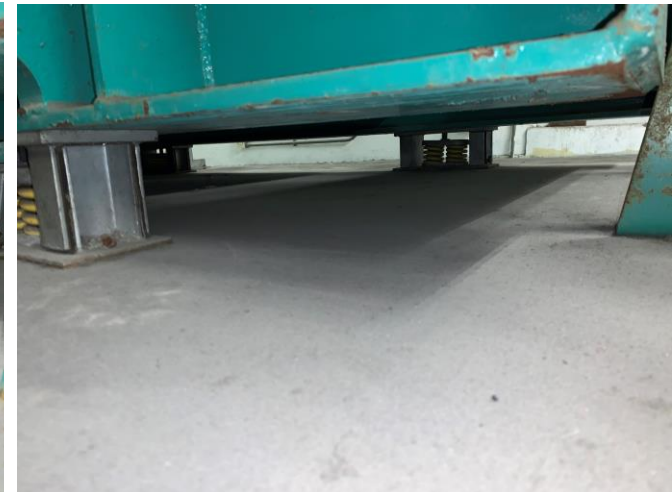
BH8 View 2 - concrete floor condition underneath emergency generator

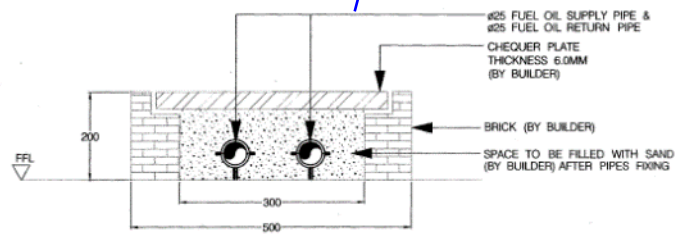
Supply and return pipe from fuel oil tank
(Sand Filled Trench at floor level)

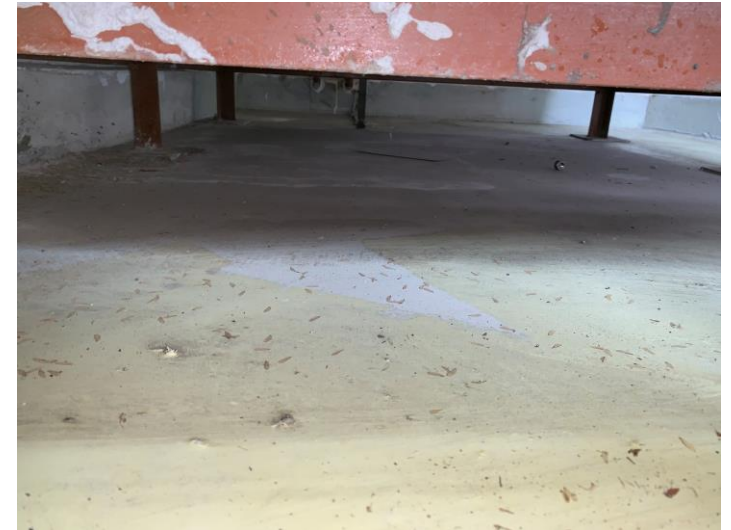
HS4 View 1 - concrete floor condition underneath 1,500L Above-ground Fuel Tank

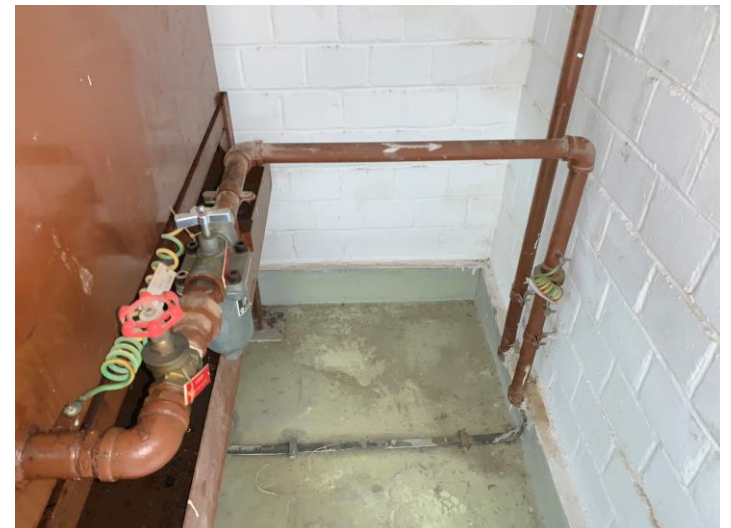
HS4 View 2 - concrete floor condition of fuel tank room with 1,500 L above-ground fuel tank

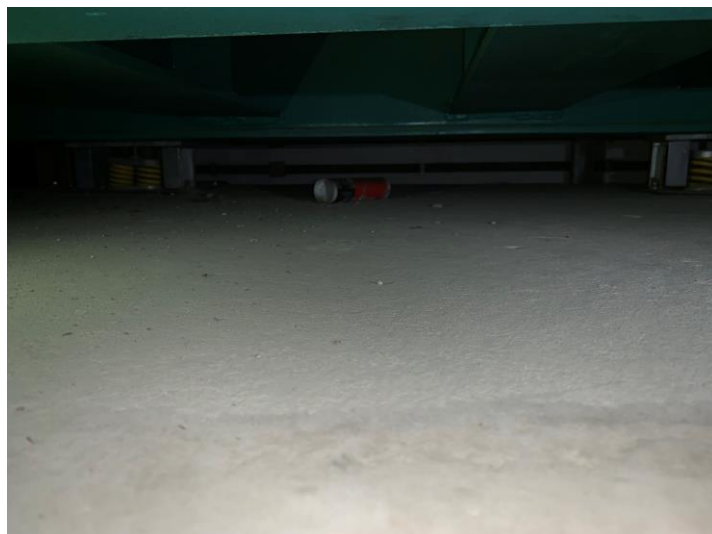
HS5 View 1 - concrete floor condition underneath emergency generator

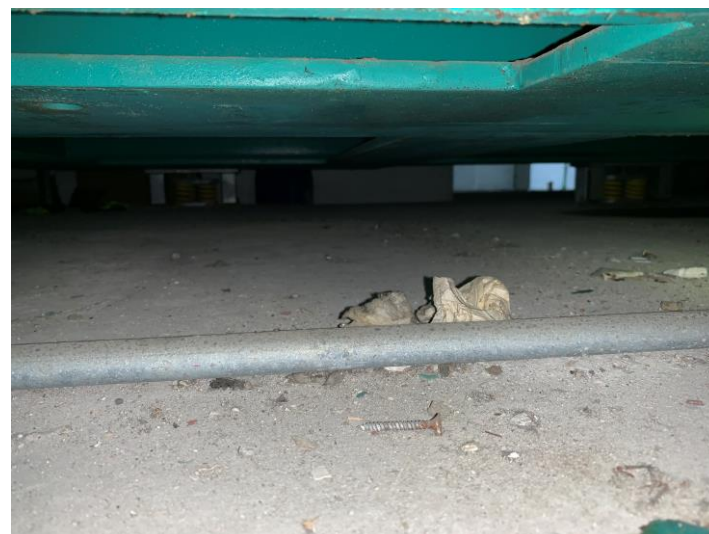
HS5 View 2 - concrete floor condition underneath emergency generator
