Appendix H.1 Site Photo Record of Final Inspection for EPSS4 **BH10** (1,500L Above-ground Fuel Tank)

Appendix H.2 Site Photo Record of Final Inspection for EPSS4 **HS2** (Emergency Generator connected to 1,500L **Above-ground Fuel Tank (BH10)**)

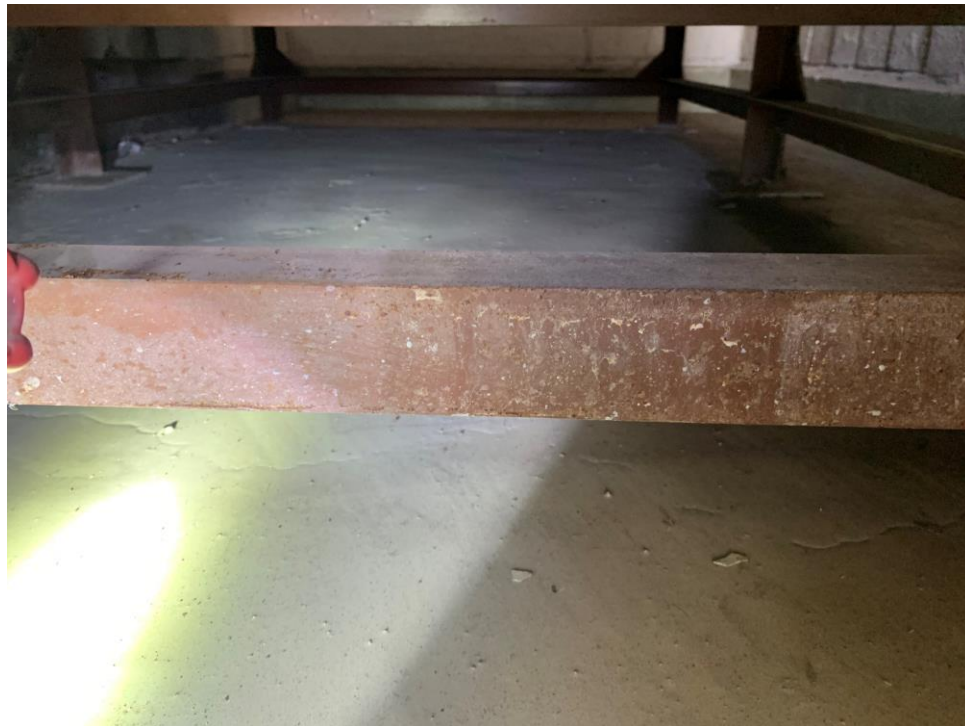
BH10 View 1 – concrete floor condition underneath 1,500L Above-ground Fuel Tank

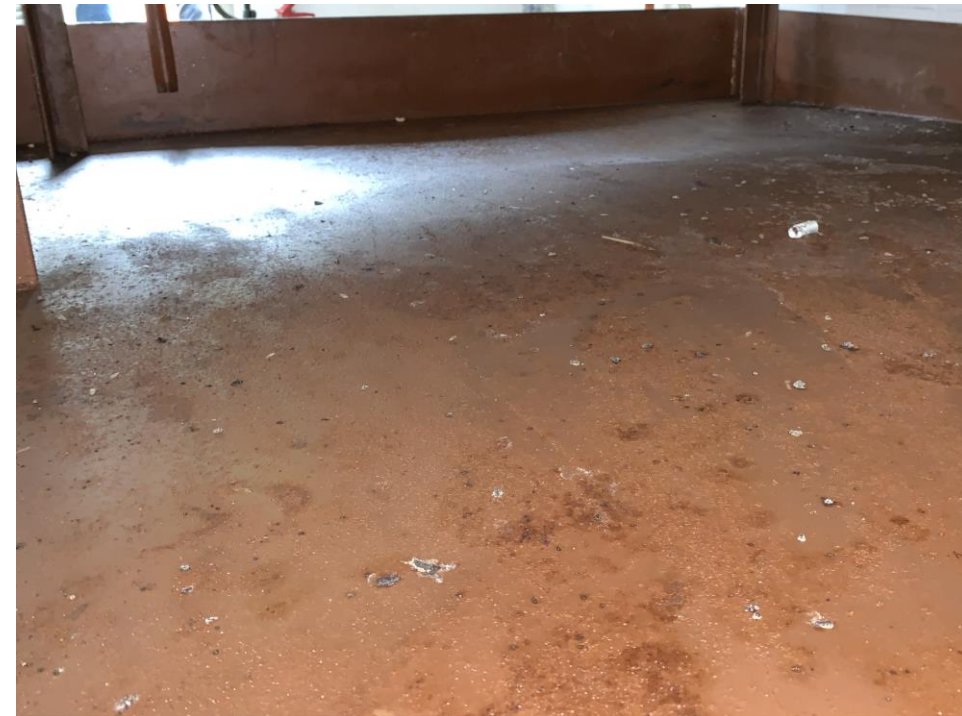
BH10 View 2 - drip tray condition of the 1,500L Above-ground Fuel Tank

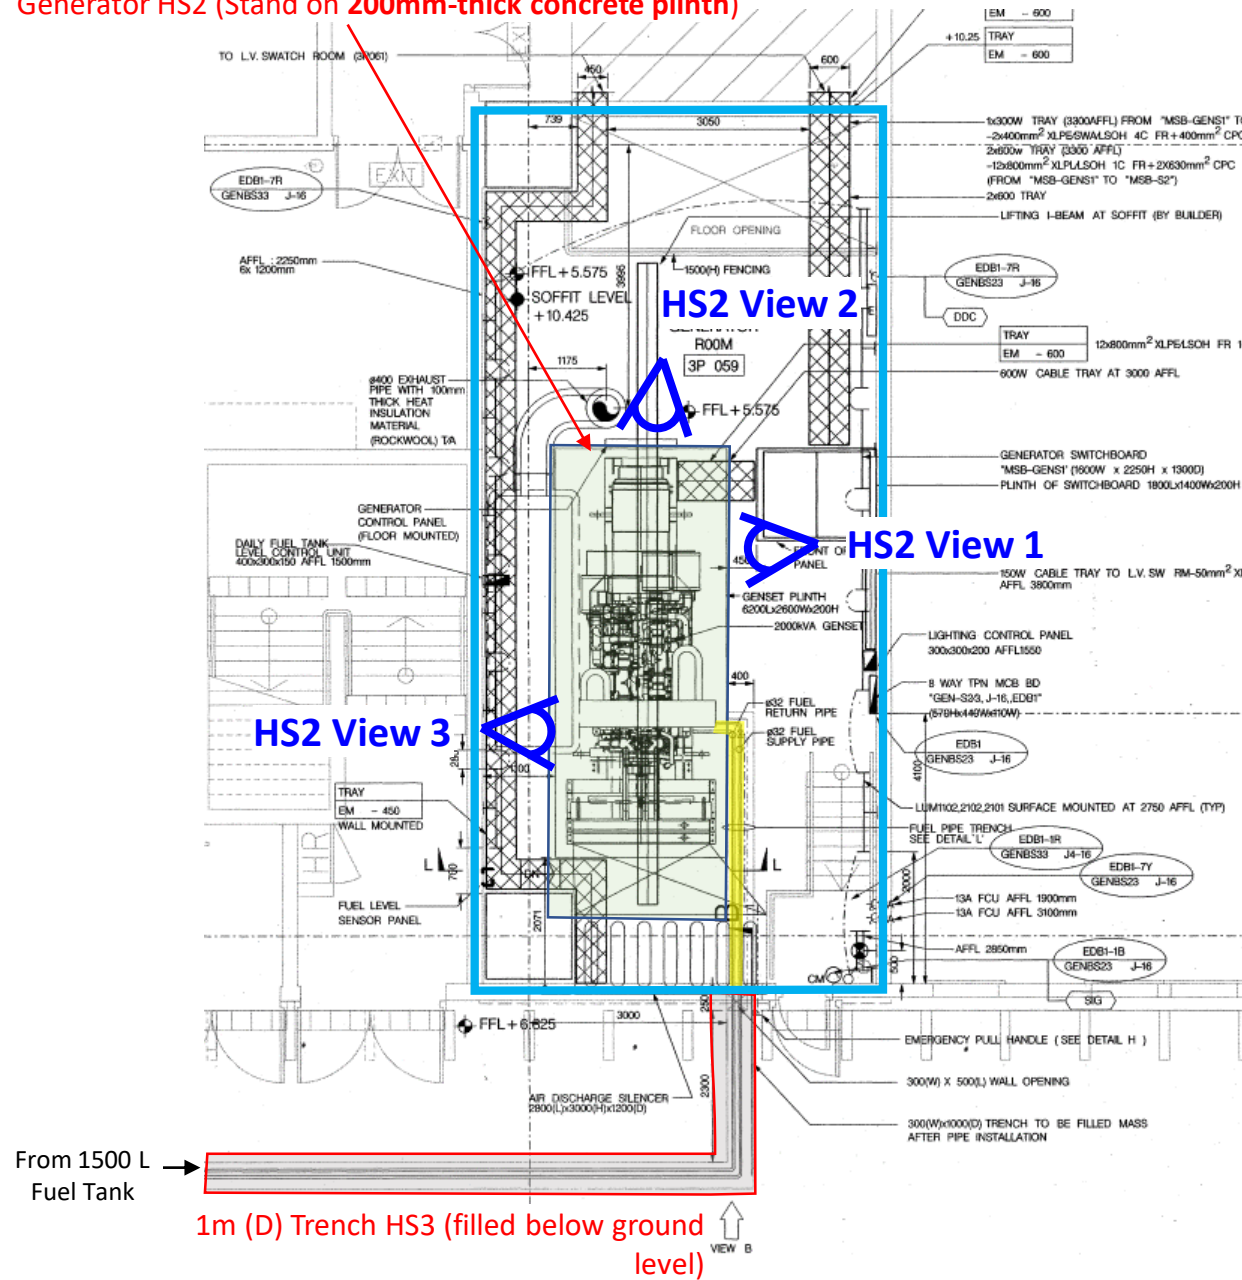
Generator HS2 (Stand on 200mm-thick concrete plinth)

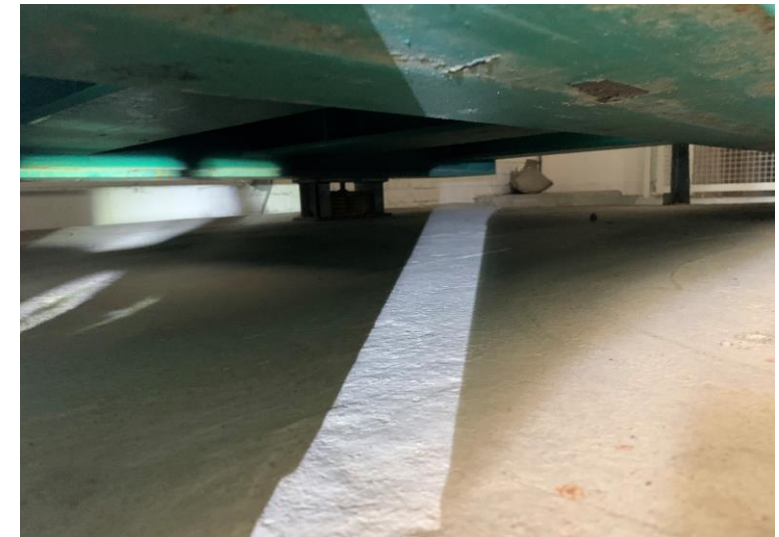
HS2 View 1 - concrete floor condition underneath emergency generator

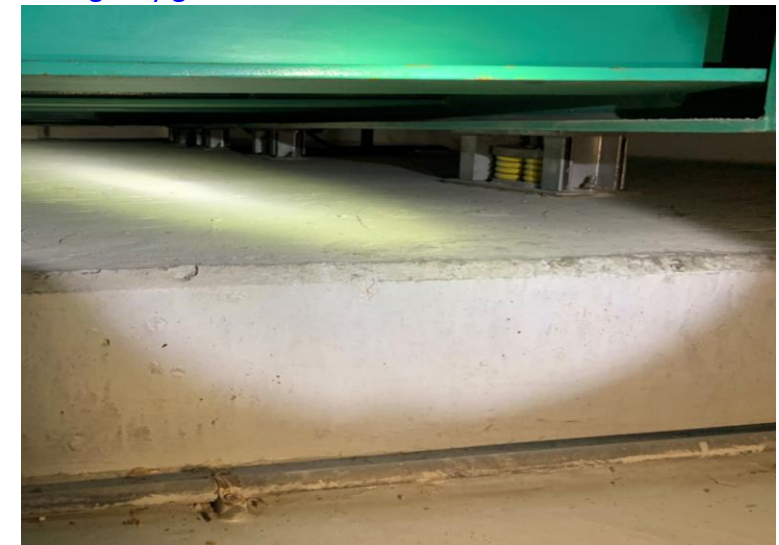
HS2 View 2 - concrete floor condition underneath emergency generator

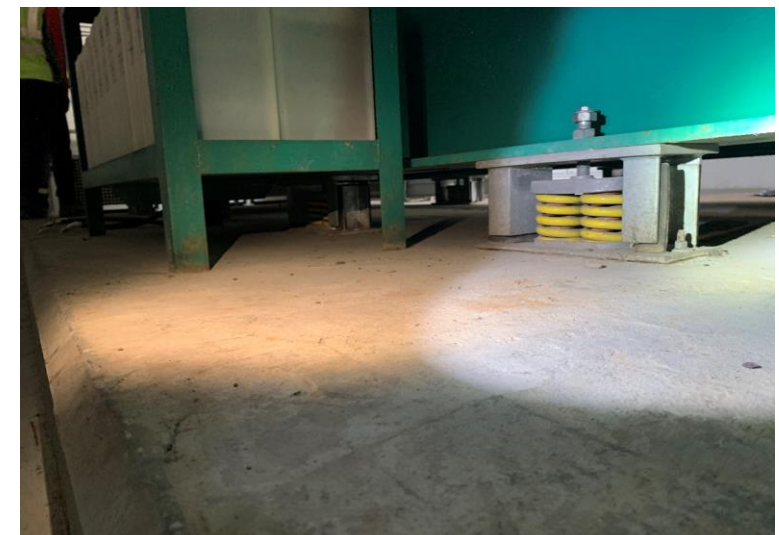
HS2 View 3 - concrete floor condition underneath emergency generator
