Expansion of Hong Kong International Airport into a Three-Runway System

Site Re-appraisal Summary Report
– Fire Training Facility

November 2023

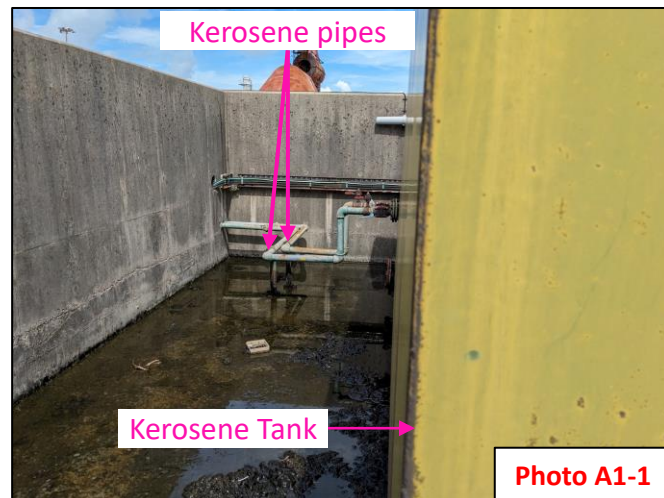
Photo A1-1

- Kerosene pipes connecting the kerosene tank and the fuel ramp control box

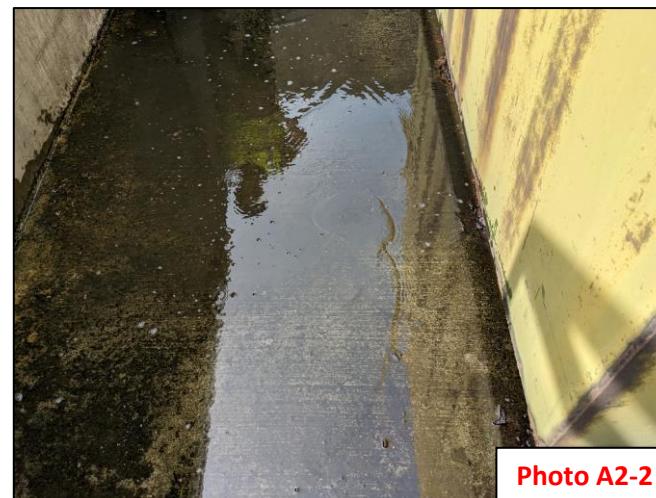
Photo A2-2

- Concrete-paved ground
- No oil stain or crack was observed for the whole concrete slab, including the portion underneath the kerosene tank

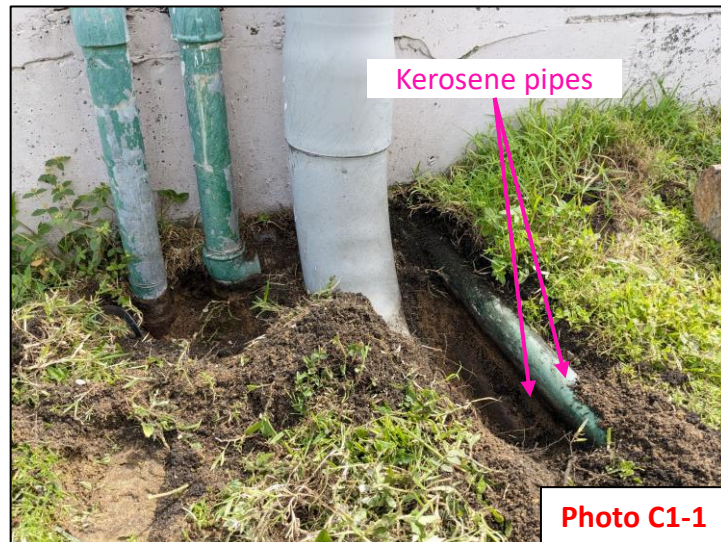
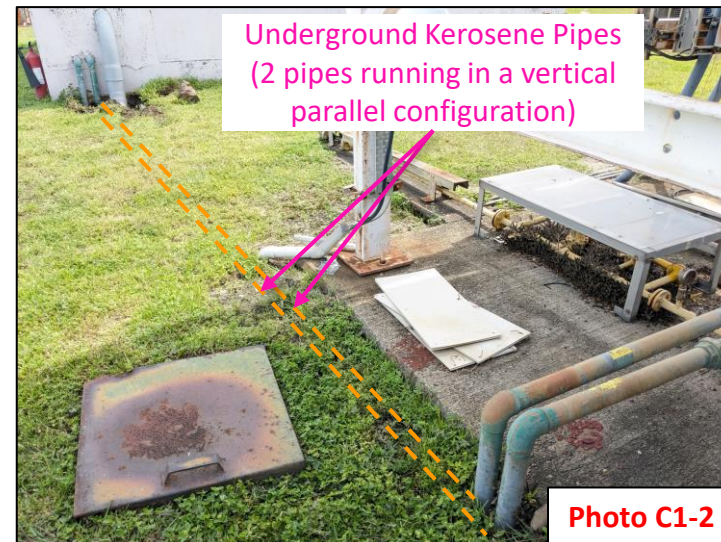
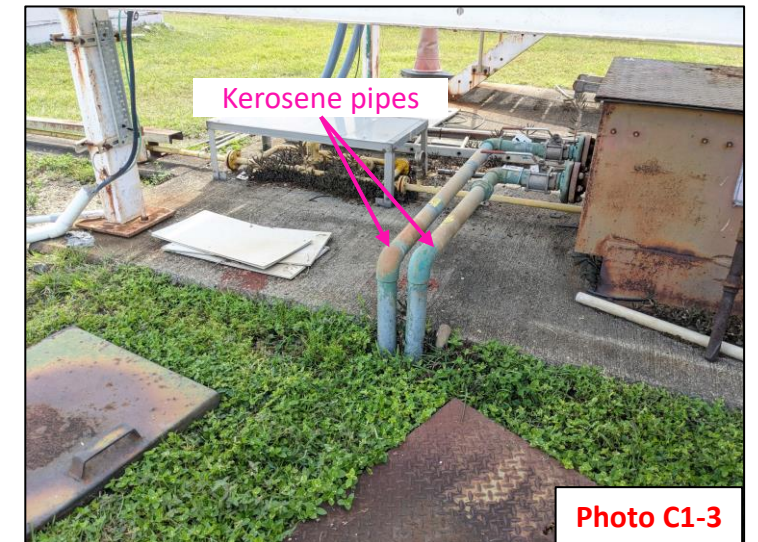
Drawing C1

For the section of underground kerosene pipes from the concrete bund wall towards the aboveground fuel ramp control box, which is covered by soil and grass. No sign of grass withering along the section was observed. No specific odour or visual observation in relation to kerosene leakage / spillage was identified for soil at the bottom of the kerosene pipes.

- Pipes between the concrete bund wall and the fuel ramp control box is located underground.
- The bottom level of this underground pipe section is approximately 200mm below ground level.
- Soil surrounding the bottom of the underground pipes near the bund wall have been taken for inspection.
- No specific odour or visual observations in relation to kerosene leakage / spillage have been identified.

- Section of underground pipes connecting the kerosene tank and fuel ramp control box
- No sign of grass withering

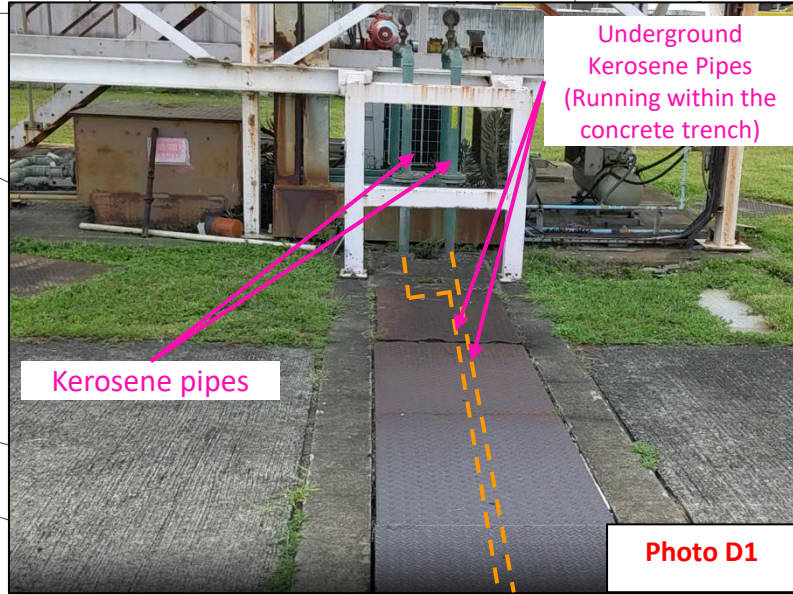
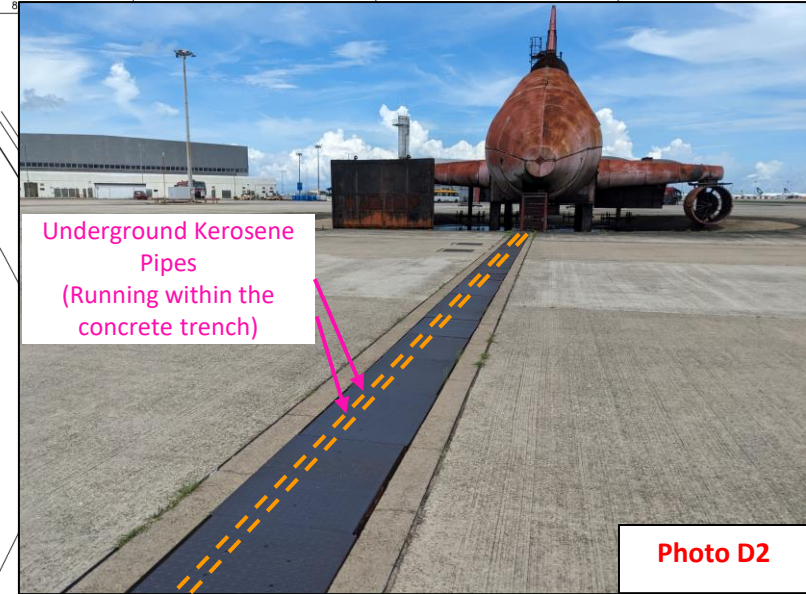
For the section of kerosene pipes from the aboveground fuel ramp control box to the simulator, the whole section is running within the concrete trench with cover plate sealed.

The whole section (marked in light blue box) of underground kerosene pipes is running through the concrete trench and sealed with cover plate.
