# **Expansion of Hong Kong International Airport into a Three-Runway System**

Construction Phase Annual EM&A Report No.1

May 2017

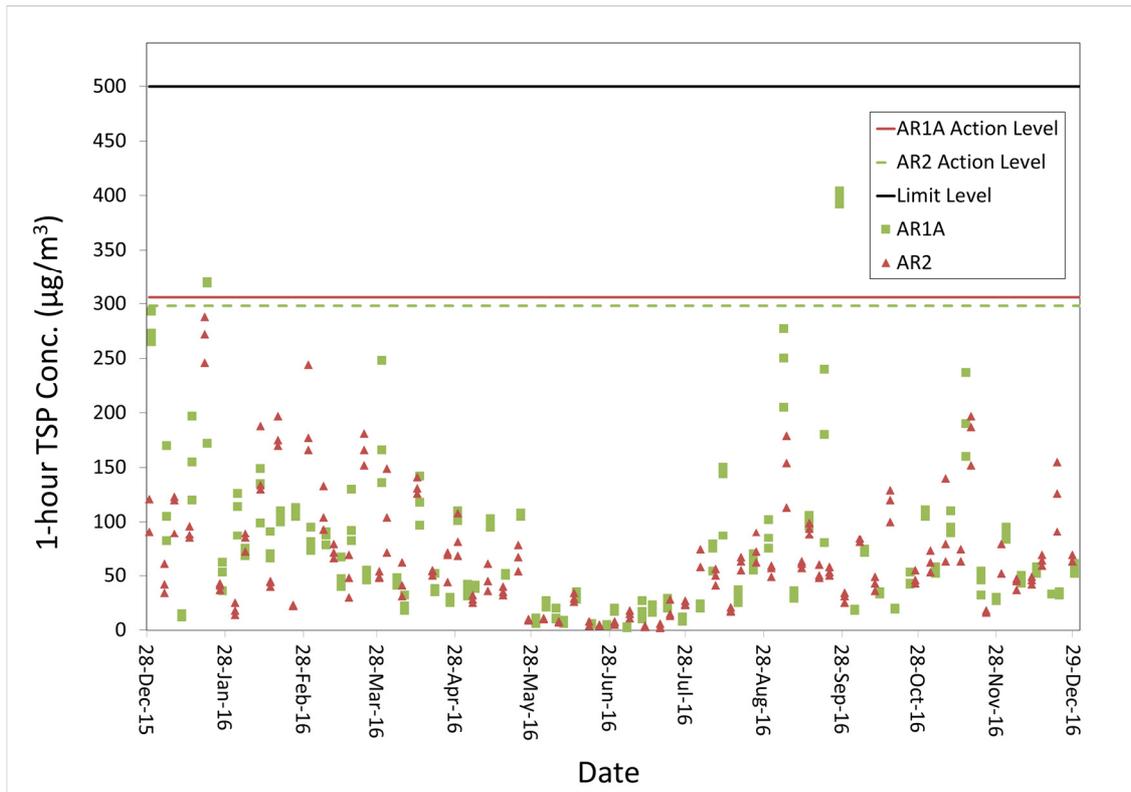
**Graph 1: Graphical Plot of 1-hour TSP concentration at AR1A and AR2 during the Reporting Period**

Two Action Level exceedances of 1-hour TSP monitoring started at 10:00 and 11:00 were recorded at AR1A on 21 January 2016. Actions were taken accordingly based on the established Event and Action Plan as presented in the Manual. IEC and AAHK were informed of the exceedances. It was confirmed that no major dusty construction activities were conducted by contract P560(R), the major land works, when the exceedances were measured. It is thus considered that the exceedances were not related to the Project.

Another three Action Level exceedances of 1-hour TSP monitoring started at 08:52, 09:52 and 10:52 were recorded at AR1A on 27 September 2016. Actions were taken accordingly based on the established Event and Action Plan as presented in the Manual. IEC and AAHK were informed of the exceedances. According to on-site observation by monitoring team, hazy weather was observed during monitoring. It was confirmed that no major dusty construction activities were conducted by P560(R) contractor when the exceedances were measured. The exceedances of 1-hr TSP might possibly be due to the changes in the background air quality level and not project-related.

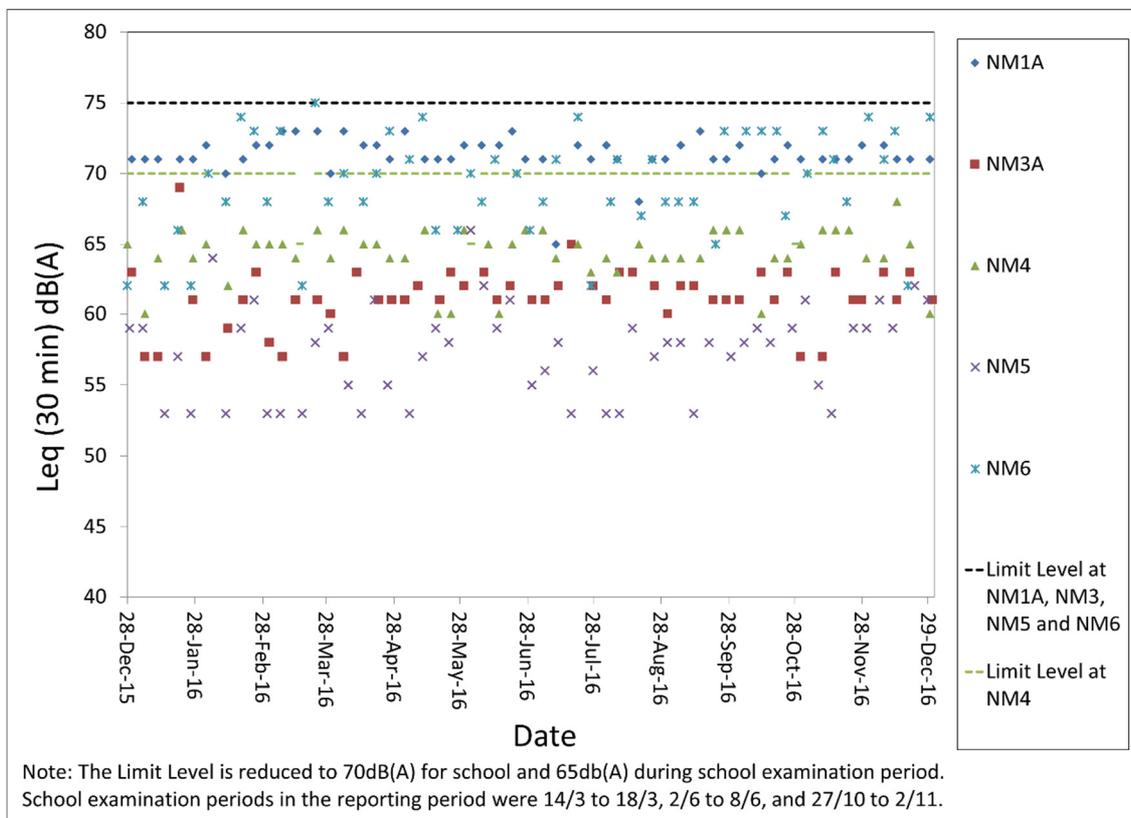
**Graph 2: Graphical Plot of  $L_{eq}$  (30 min) at NM1A, NM3A, NM4, NM5, and NM6 during the Reporting Period**

No exceedance of the Action and Limit Level was recorded at all monitoring stations in the reporting period.

The key activities undertaken in the reporting period were not likely to cause adverse noise impact. The active construction work is around 900 metres away from the nearest noise sensitive receivers in the villages in North Lantau. The major noise sources during the reporting period were observed to be aircraft noise at NM3A and NM5, aircraft noise and helicopter noise at NM6, road traffic noise at NM1A, and school activities at NM4 in the background. It is considered that the monitoring work in the reporting period was effective and there was no adverse impact attributable to the works of the Project.

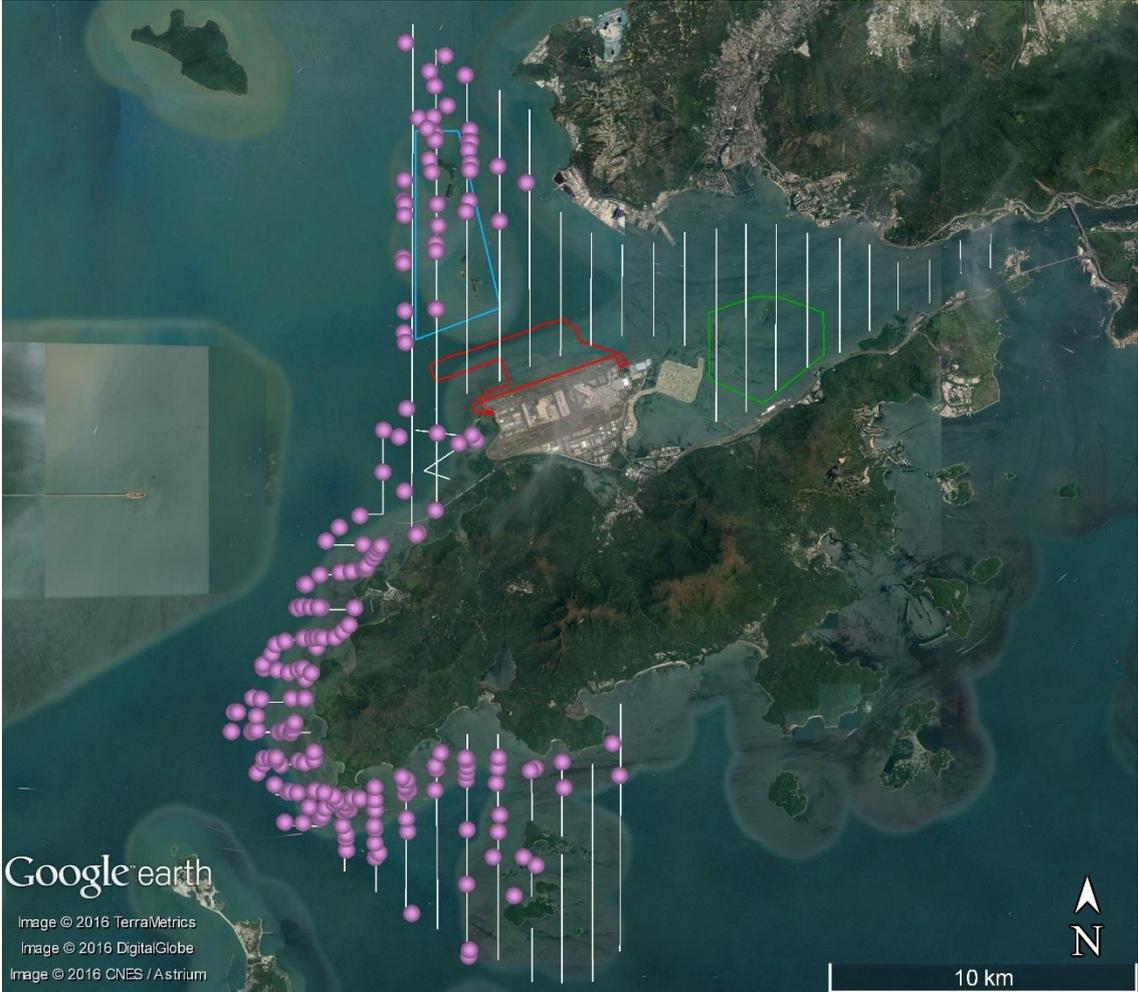
**Figure 1: Sightings Distribution of Chinese White Dolphins**

[Pink circle: Sighting locations of CWD, White line: Vessel survey transects, Blue polygon: Sha Chau and Lung Kwu Chau Marine Park (SCLKCMP), Green polygon: Brothers Marine Park (BMP), Red polygon: 3RS land-formation footprint]

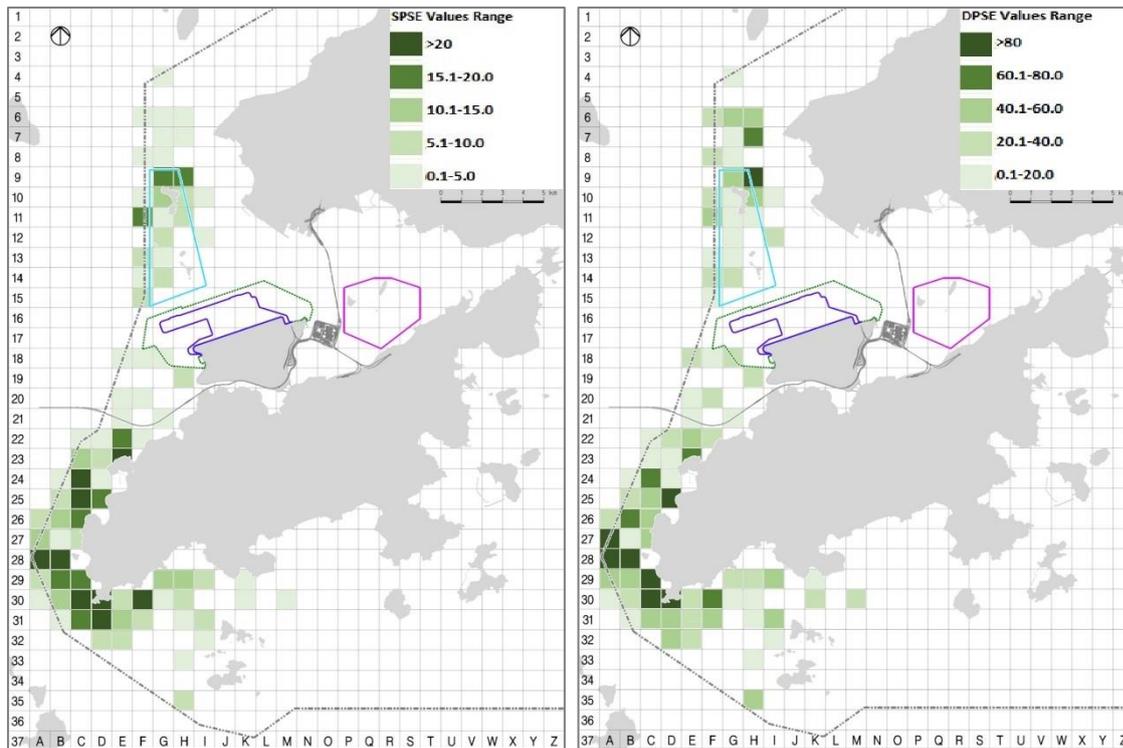
**Figure 5: SPSE and DPSE of CWDs with Corrected Survey Effort per km<sup>2</sup> from Dec 2015 to Dec 2016**

[Left: SPSE = no. of on-effort dolphin sightings per 100 units of survey effort, Right: DPSE = no. of dolphins per 100 units of survey effort, Pink polygon: BMP, Blue polygon: SCLKCMP, Purple polygon: 3RS land-formation footprint, Green dotted line: 3RS temporary works area boundary]

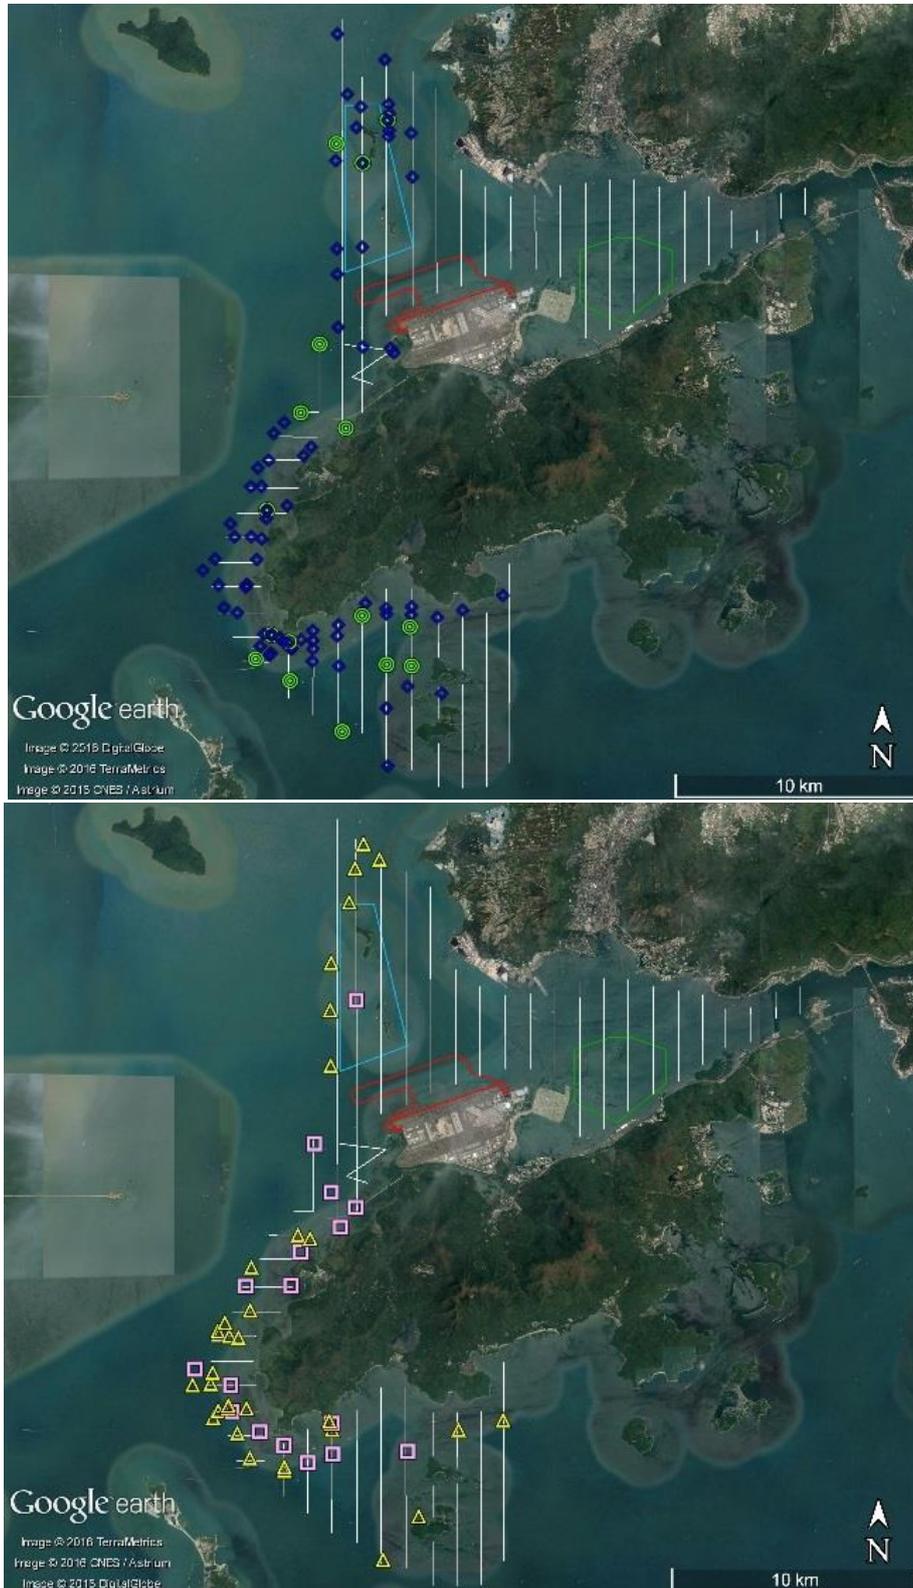
**Figure 7: Sighting Locations of CWD Groups Engaged in Different Activities**

[Indigo rhombus: Foraging, Green circle: Socializing, Pink square: Resting/milling, Yellow triangle: Travelling, White line: Vessel survey transects, Blue polygon: SCLKCMP, Brothers Marine Park (BMP), Red polygon: 3RS land-formation footprint]

During the reporting period from mid-December 2015 to December 2016, a total of 84 and 16 groups of CWDs were observed engaging in feeding and socializing activities, comprising of 40.4% and 7.7% of all CWD sightings respectively. Moreover, 34 and 17 groups of CWDs were sighted engaging in travelling and resting/milling activities respectively. The sighting locations of CWD groups engaged in different types of activities are depicted in Figure 7 of **Appendix E**.

Feeding activities mainly occurred north of Lung Kwu Chau in NWL and along the coast of WL and SWL, from Sham Wat to Shui Hau. Occasional feeding activities were also observed in southwestern corner of SCLKCMP and AW in NWL, and the central and western parts of Soko Islands. Considering the sample size of sighting data of different survey areas, AW has the highest percentage of feeding (although it should be kept in mind that the sample size in AW was very small), followed by SWL (Table 6, **Appendix E**).

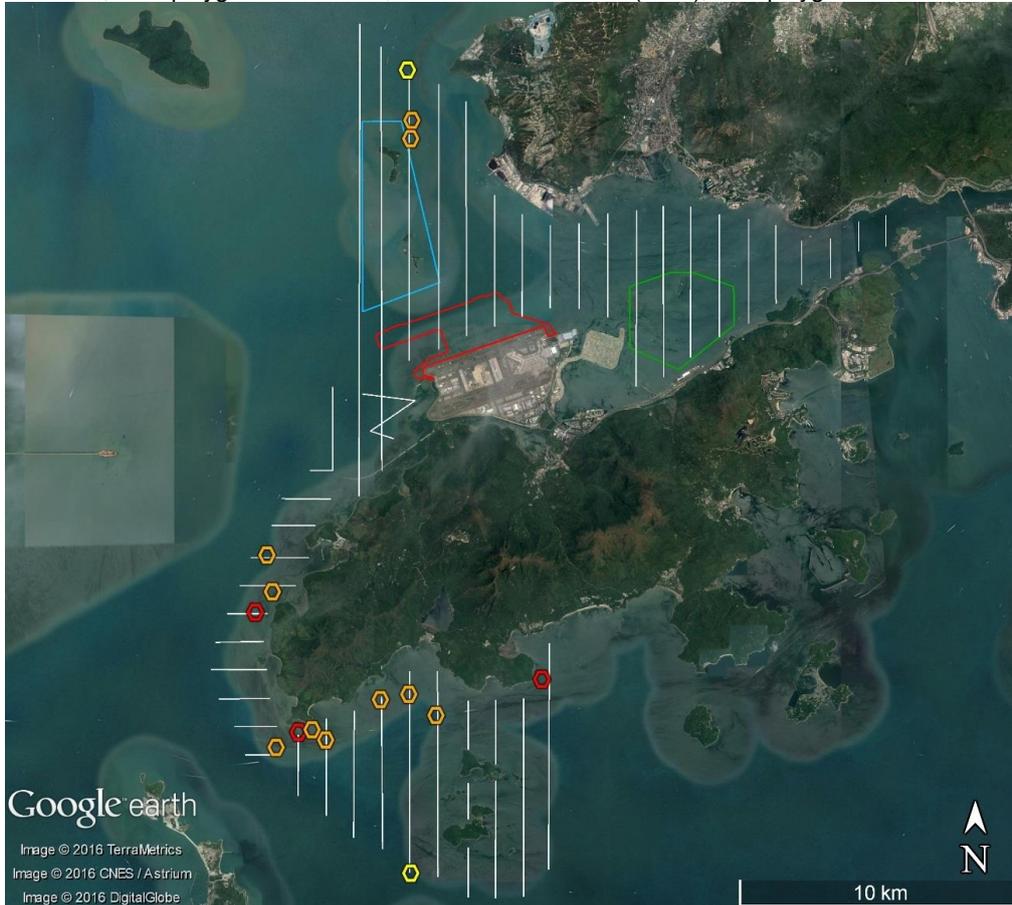
**Figure 8: Sighting Locations of CWD Groups in Association with Fishing Boat**

[Red hexagon: Gillnetter, Orange hexagon: Purse Seiner, Yellow hexagon: Trawler, White line: Vessel survey transects, Blue polygon: SCLKCMP, Brothers Marine Park (BMP), Red polygon: 3RS land-formation footprint]

A total number of 15 sightings of CWDs were observed associating with operating fishing boats, including gill netters (three groups), purse seiners (10 groups), single trawlers (one group) and pair trawlers (one group), accounted for 7.2% of all sightings. Although a trawling ban has been implemented in December 2012, illegal trawling activities were still often observed near the western and south-western borders of Hong Kong. Two groups of CWDs, one in NWL and another in SWL were observed feeding in association with trawling activities. Purse seiners were the most often observed fishing boat type that CWDs associated with. The operation of purse seiners with aggregated fisheries resources that the CWDs might have found beneficial to associate with. Operations of purse seiners were often observed in northern waters off Lung Kwu Chau and along the coastal waters of WL and SWL where CWDs also frequented. The sighting locations of CWD groups associated with operating fishing boats were depicted in Figure 8 of **Appendix E**.

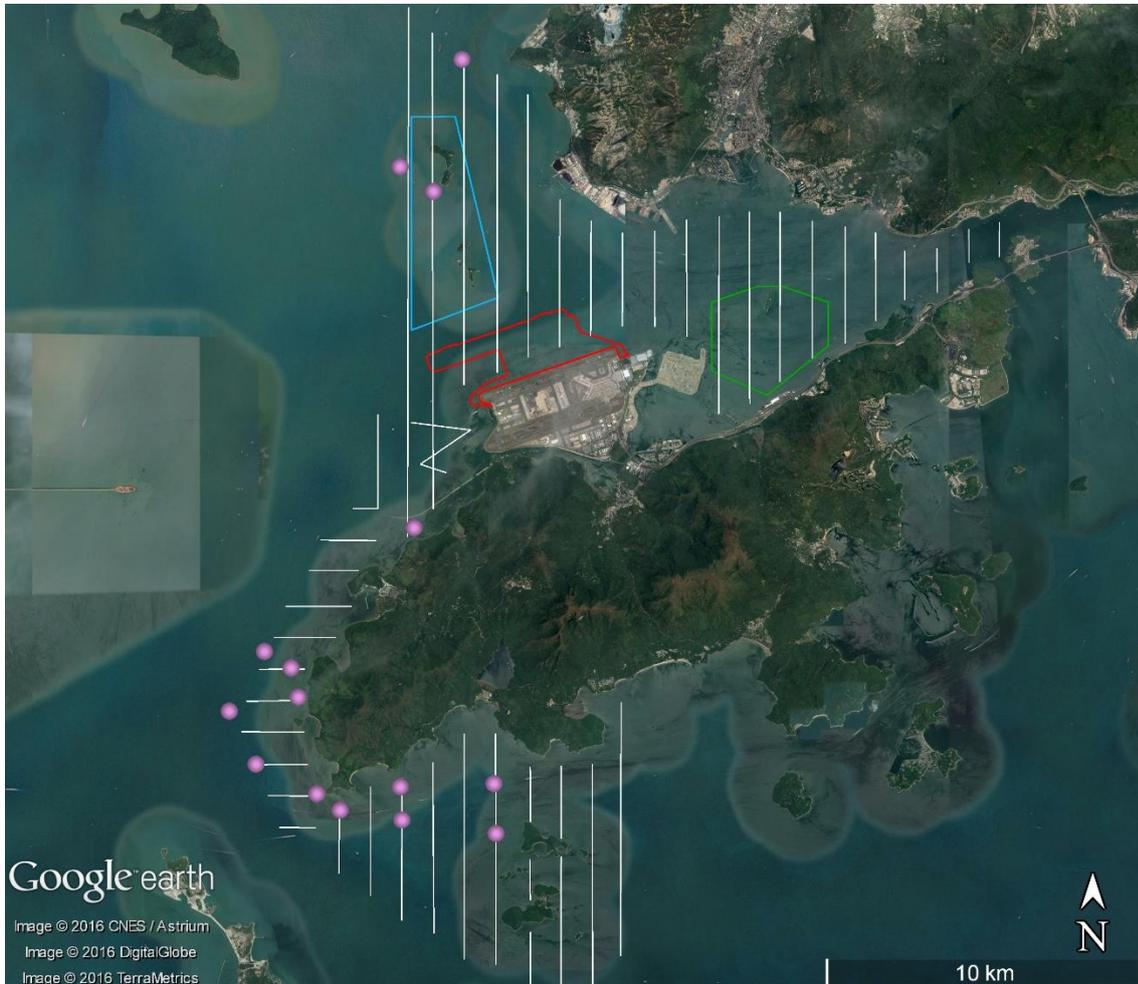
**Figure 9: Sighting Locations of Mother-Calf Pairs**

[Pink circle: Sighting locations of mother-calf pairs, White line: Vessel survey transects, Blue polygon: Sha Chau and Lung Kwu Chau Marine Park (SCLKCMP), Green polygon: Brothers Marine Park (BMP), Red polygon: 3RS land-formation footprint]

During the reporting period from mid-December 2015 to December 2016, 15 out of all sightings were observed having mother-and-unspotted calf, or mother-and-unspotted juvenile pairs. The percentages of sightings with mother-calf pairs in NWL, WL and SWL were 8.7%, 6.3% and 8.0% respectively. These percentages were calculated by dividing the no. of sightings with mother-calf pairs of a survey area by the total no. of sightings of that survey area. The sighting distribution of mother-calf pairs are depicted in Figure 9 of **Appendix E**.

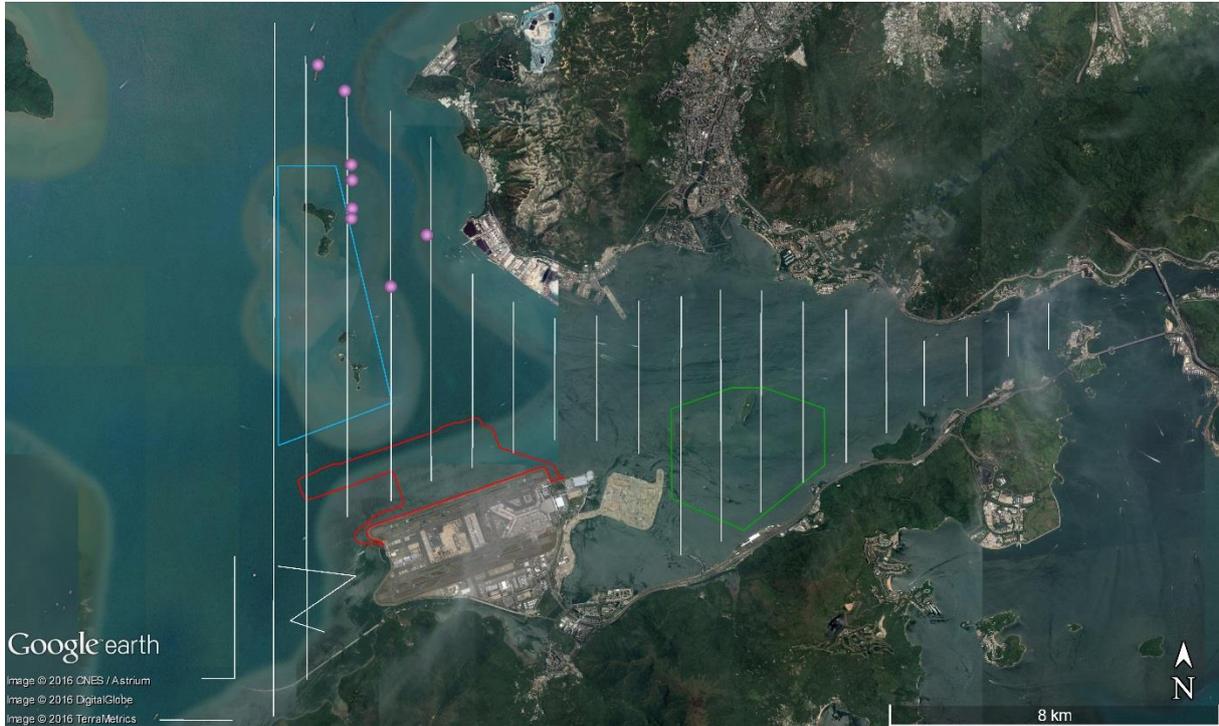
NLMM002

**Figure 11 (batch): Photo Identification – Re-sighting Locations**

[Pink circle: Sighting locations of individual dolphin, White line: Vessel survey transects, Blue polygon: Sha Chau and Lung Kwu Chau Marine Park (SCLKCMP), Red polygon: 3RS land-formation footprint]

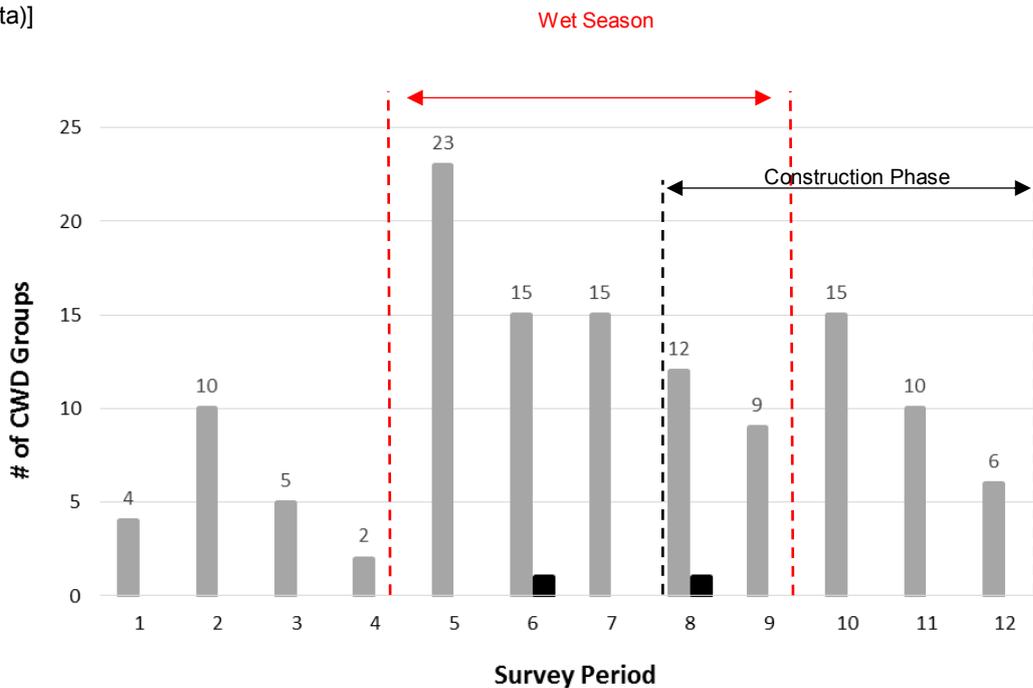
**Figure 13: CWD Groups Sighted and Tracked from Lung Kwu Chau (gray bars) and Sha Chau (black bars) Based on Month of the Year**

[The numbers above the bars indicate the total number of CWD groups tracked per study period (prior to filtering data)]

The highest percentage of CWD groups observed from LKC was during the 5<sup>th</sup> study period, between 18 April and 17 May 2016 (18.25%), as the wet season began, and the lowest percentage observed was during the 4<sup>th</sup> study period, between 18 March and 17 April 2016 (1.59%). CWDs were only observed from SC during the 6<sup>th</sup> and 8<sup>th</sup> survey months between 18 May and 17 June, and August 2016. For details, refer to Figure 13).

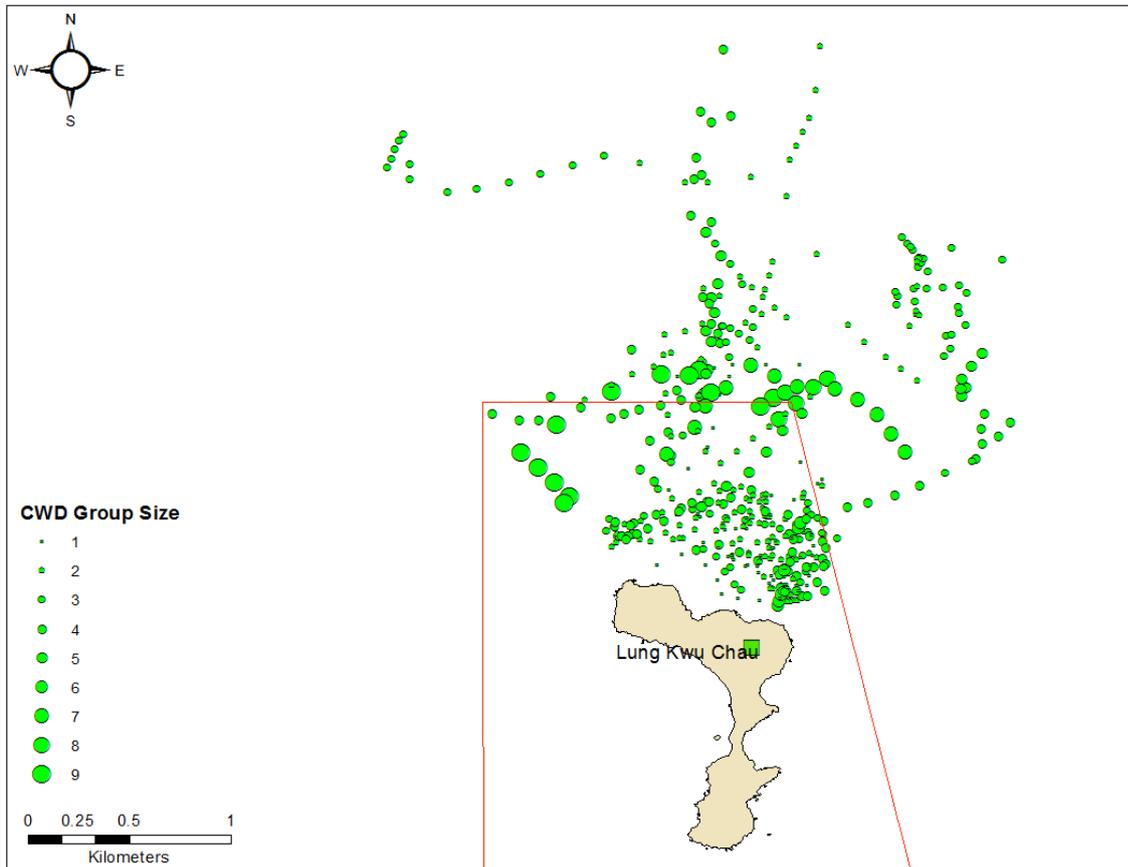
**Figure 14: Plots of CWD Short-track Positions (Standardized Segments) relative to Group Size obtained from Lung Kwu Chau**

[Station is indicated by large green square on land, fix positions of the CWD groups by green circles (increasing in size with CWD group size), and SCLKCMP boundary by red lines.]

The mean group size of CWD filtered tracks off LKC was  $3.08 \pm 1.81$ , ranging from singletons to a maximum group size of 9. The sighting distribution of CWDs relative to group sizes is represented in Figure 14 of **Appendix E**. Singletons were most often observed near shore and group sizes of CWDs were largest around the SCLKCMP boundary where ferry traffic is routed around the perimeter of the marine park. The mean group size of CWDs was  $2.59 \pm 1.64$  ( $n=37$ ) within the park,  $3.19 \pm 1.44$  ( $n=25$ ) outside of the park, and  $3.85 \pm 2.39$  ( $n=16$ ) crossing the marine park boundary. A basic one-way ANOVA and sequential Bonferonni post hoc test showed a significantly larger mean group size, at alpha level 0.05, of CWDs around the marine park boundary than those within the marine park ( $p=0.016$ ). As will be mentioned in discussion, this trend may reflect sighting bias wherein single individuals may be more difficult to locate farther from the survey platform and easier to find and track larger group sizes at greater distances. However, CWD group sizes were not significantly larger beyond the park boundary relative to those around the boundary perimeter.

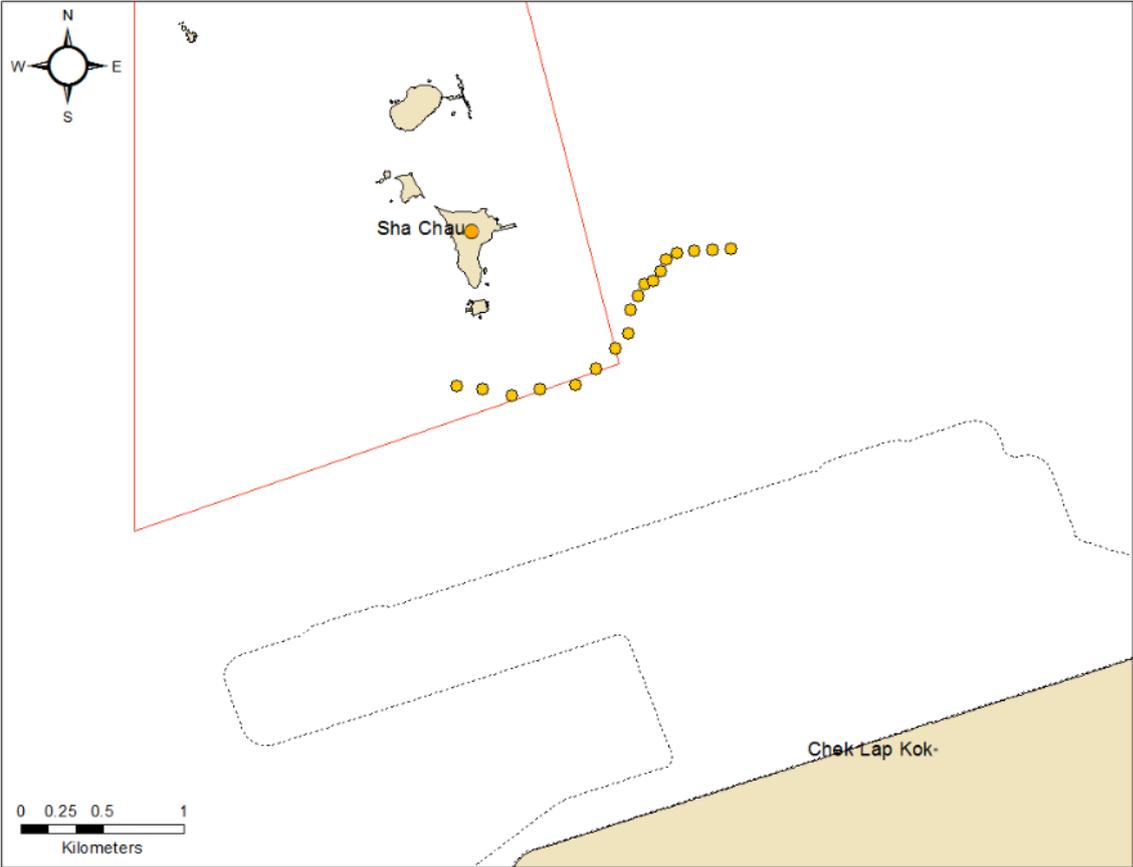
**Figure 15: Plots of CWD Short-track Positions (Standardized Segments) relative to Group Size obtained from Sha Chau**

[Station is indicated by large orange circle on land, fix positions of the CWD group by orange circles, SCLKCMP boundary by red lines, and proposed third runway by black dotted line.]

Only two groups, both with 4 individuals, were observed off SC (shown in Figure 15 of **Appendix E**). Detailed information on group size is shown in Table 10 of **Appendix E**.
