# Appendix C. Monitoring Results

## **Air Quality Monitoring Results**

# Noise Monitoring Results

# Water Quality Monitoring Results

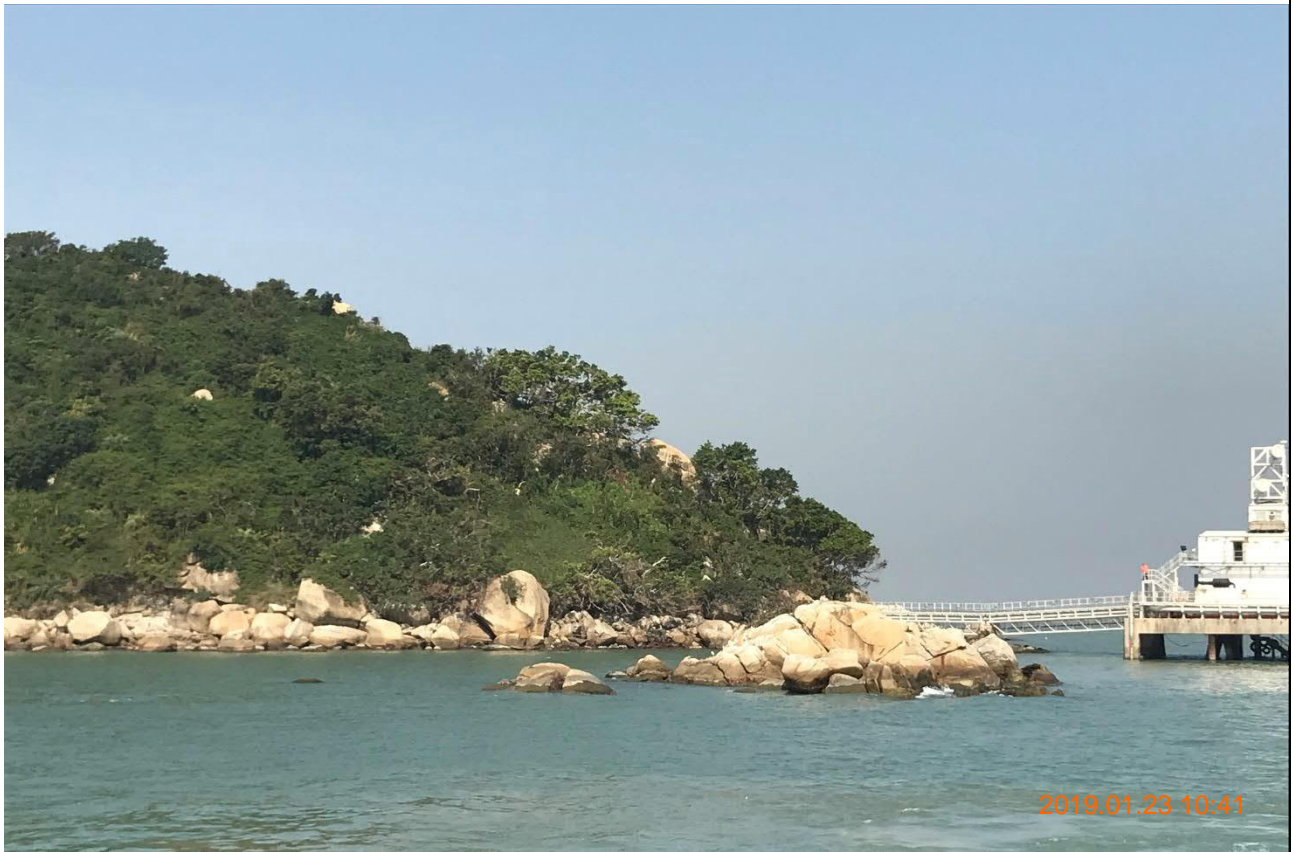
**Photo record of View 1**

### Terrestrial Ecological Monitoring – location map and site photos regarding the monthly ecological monitoring for the egret area on Sheung Sha Chau and the HDD daylighting location
