Appendix C. Monitoring Results

Air Quality Monitoring Results

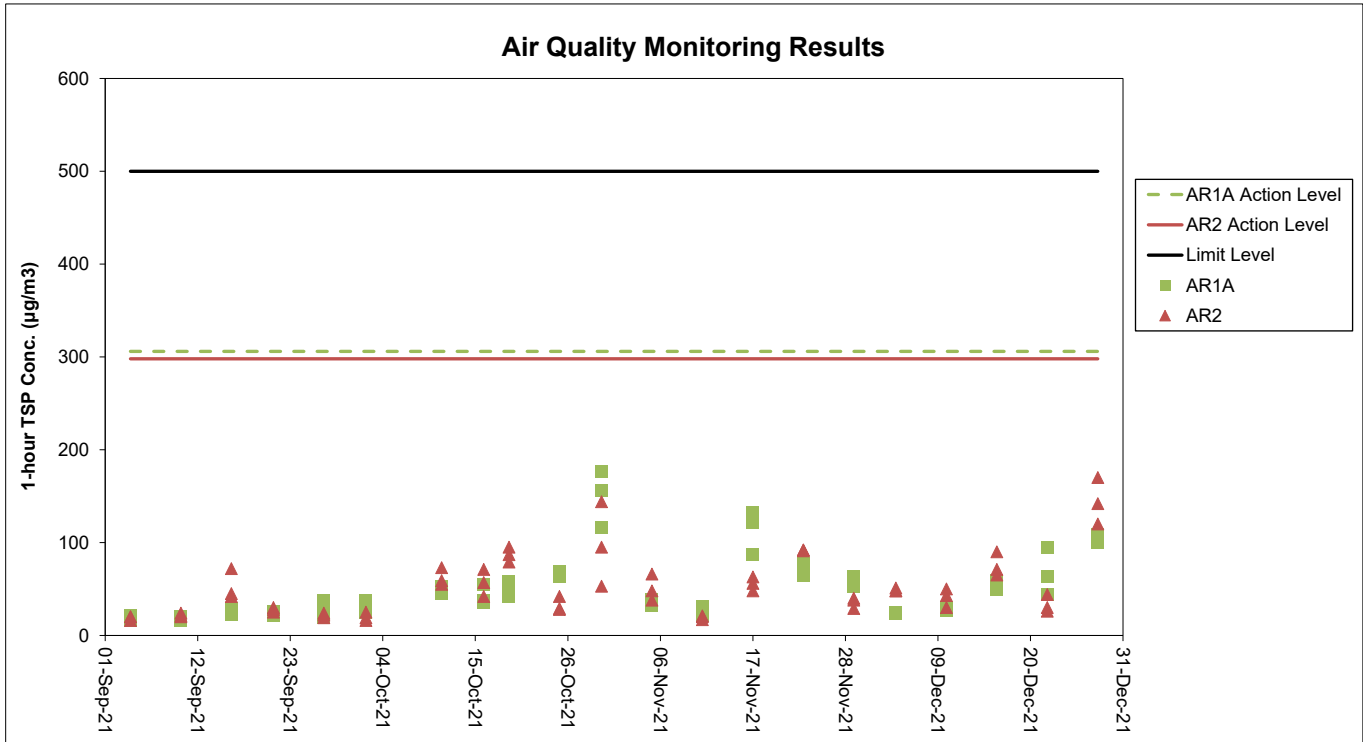
1. The key activities of the Project carried out in the reporting period included reclamation works and land-based works. Works in the reclamation areas included marine filling, seawall and facilities construction, together with runway and associated works such as bored piling for approach lights. Land-based works on existing airport island involved mainly airfield works, foundation and substructure work for Terminal 2 expansion, modification and tunnel work for APM and BHS systems, and preparation work for utilities, with activities include site establishment, site office construction, road and drainage works, cable ducting, demolition of existing facilities, piling, and excavation works.

3. QA/ QC requirements as stipulated in the EM&A Manual were carried out during measurement.

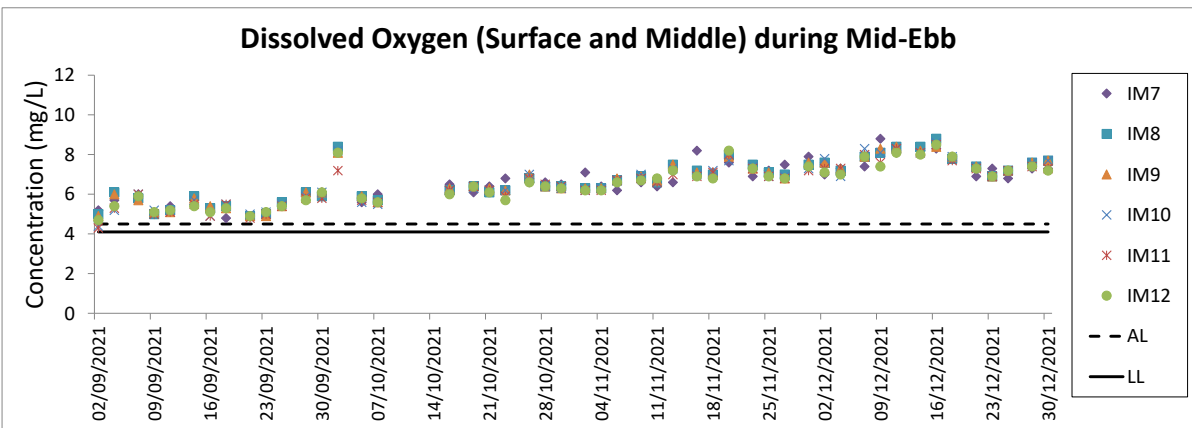
Water Quality Monitoring Results

- Notes:
1. The key marine works activities of the Project during monitoring included marine filling, seawall and facilities construction, together with runway and associated works such as bored piling for approach lights
 2. General weather condition during monitoring ranged from sunny to rainy, with sea condition ranged from calm to rough. Detailed meteorological conditions can be referred to Table 2.11 of this Report and corresponding Monthly EM&A Reports.
 3. QA/ QC requirements as stipulated in the EM&A Manual were carried out during measurement.
 4. The monitoring session on 9 October 2021 was cancelled due to No. 8 Southeast Gale or Storm Signal.
 5. The monitoring sessions on 12 October 2021 and ebb tide on 14 October were cancelled due to Strong Wind Signal No.3 in force.
