Expansion of Hong Kong International Airport into a Three-Runway System

Construction Phase Quarterly EM&A Report
No.23 (1 July to 30 September 2021)

November 2021

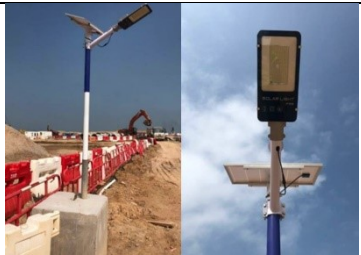
Use of automated water sprinklers with timers for dust suppression purpose	Use of solar lighting systems for energy saving and lighting purpose	Use of silt curtain for marine bored piling works of the approach lights

1. Automated water sprinklers system with timers were installed and implemented within the construction site to suppress potential fugitive dust emission.
2. Solar lighting systems were installed at construction site to minimise energy consumption and provide safe and convenient lighting environment for workers and construction vehicular drivers.
3. Silt curtain was deployed in order to minimise potential water quality impact caused by the release of sediment plume during marine bored piling works of the approach lights.
