Expansion of Hong Kong International Airport into a Three-Runway System

Construction Phase Quarterly EM&A Report
No.26 (1 April to 30 June 2022)

August 2022

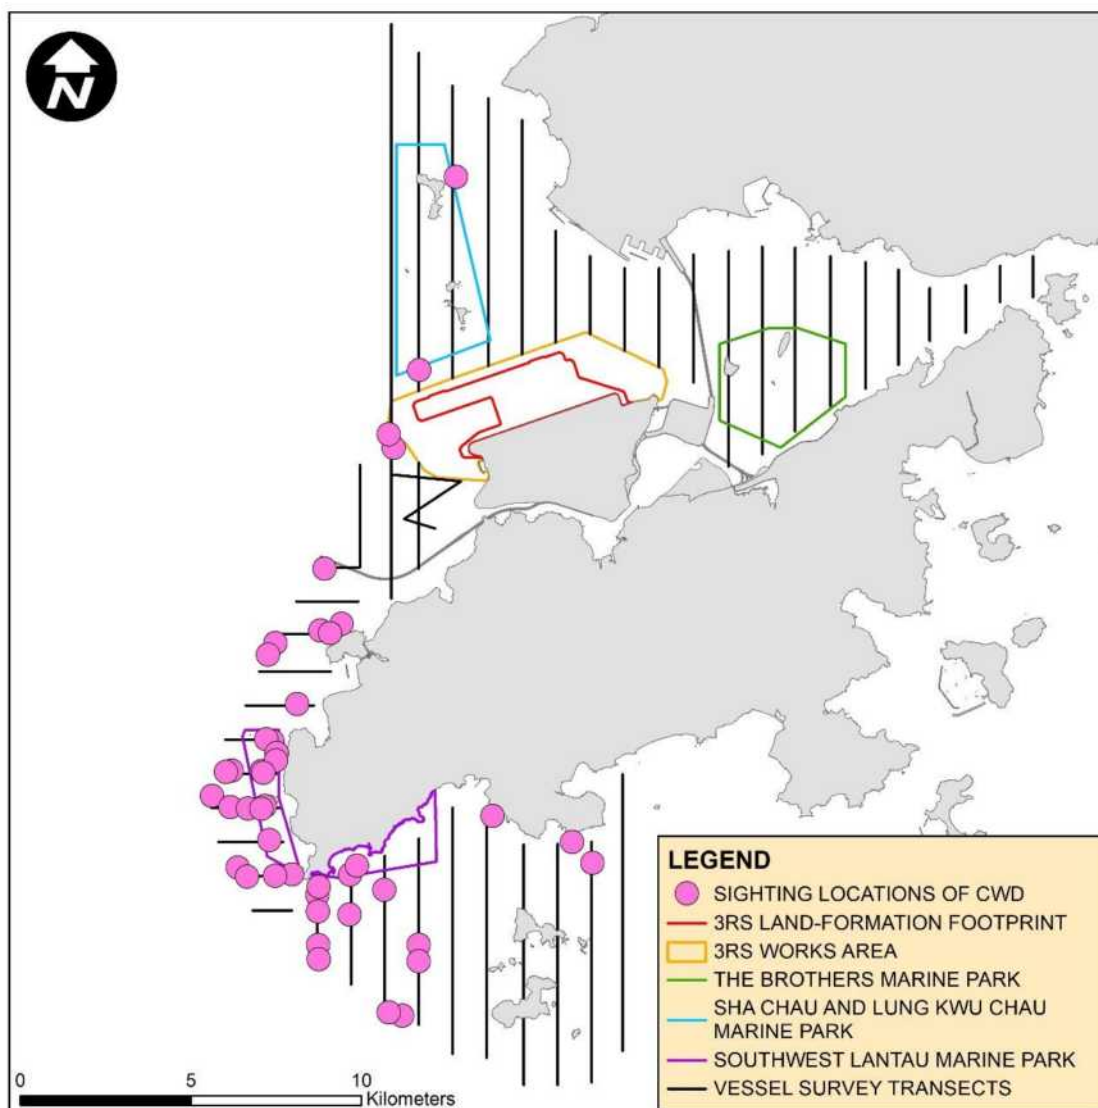
Figure 2.5: Sightings Distribution of Chinese White Dolphins from April to June 2022

The distribution of CWD sightings recorded from April to June 2022 is illustrated in **Figure 2.5**. In NWL, there were CWD sightings recorded near SCLKCMP, as well as waters to the west of 3RS area. In WL, CWD sightings were scattered amongst the entire survey area from North of Tai O to Fan Lau, with relatively more sightings clustered around Peaked Hill. In SWL, CWD sightings were mostly recorded in the northwestern part of the survey area around Fan Lau, with few sightings located to the west of the Soko Islands and around Lo Kei Wan. No CWD sightings were recorded in NEL survey area during the reporting period. Details of the sighting data are presented in **Appendix C**.

Remarks: (1) Please note that there are 45 pink circles on the map indicating the sighting locations of CWD. Some of them were very close to each other and therefore appear overlapped on this sighting distribution map. (2) Marine park excludes land area and the landward boundary generally follows the high water mark along the coastline.

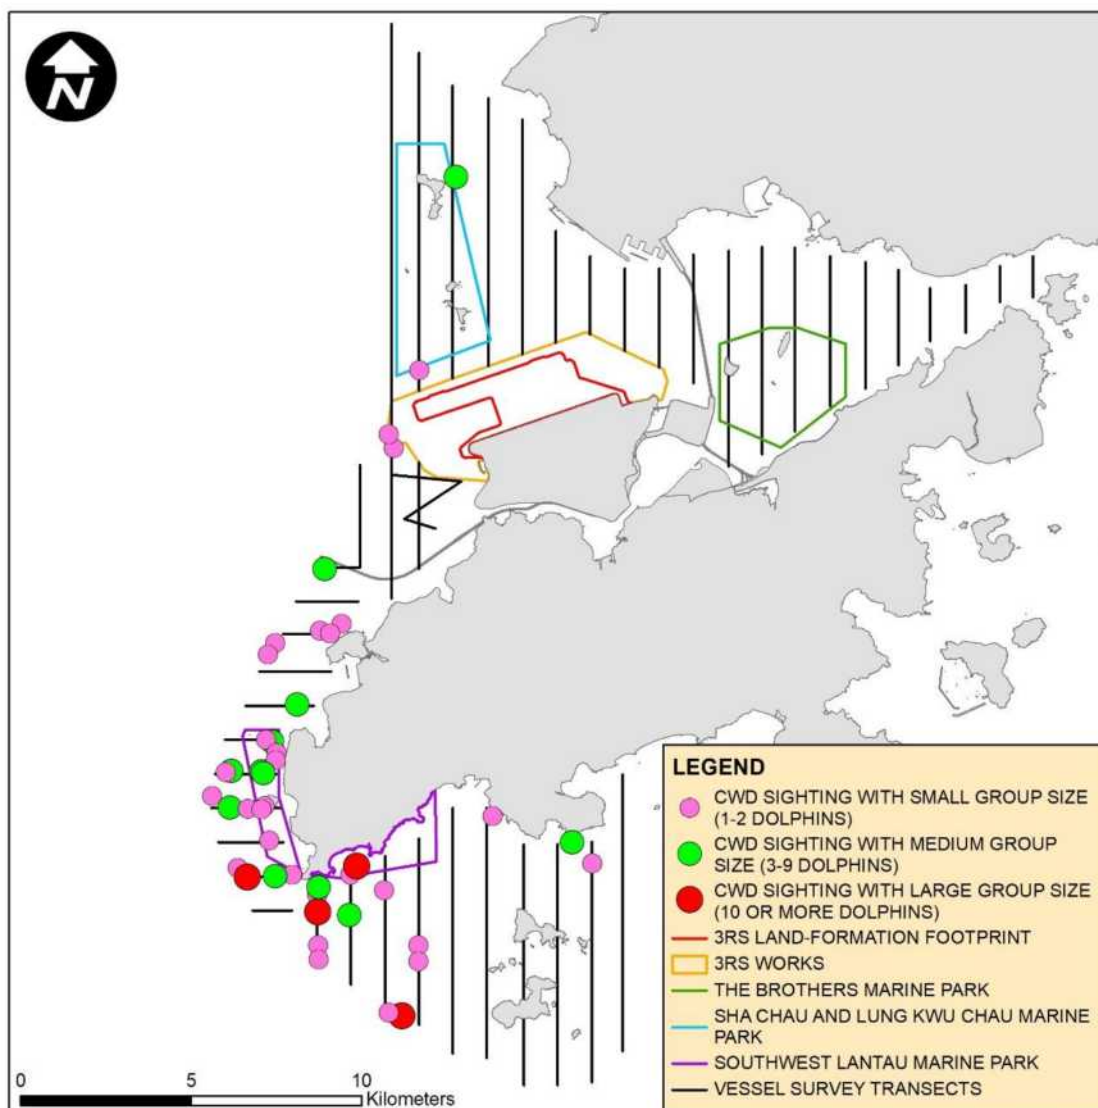
Figure 2.6: Sighting Locations of Chinese White Dolphins with Different Group Sizes

There are no observable differences in the distribution pattern between small-sized and medium-sized dolphin groups in WL and SWL as they all scattered. In NWL, small-sized dolphin groups appeared to distribute closer to the 3RS area. Sighting locations of CWD groups with different group sizes are depicted in **Figure 2.6**.

Remarks: (1) Please note that there are 45 circles on the map indicating the sighting locations of CWD. Some of them were very close to each other and therefore appear overlapped on this sighting distribution map. (2) Marine park excludes land area and the landward boundary generally follows the high water mark along the coastline.

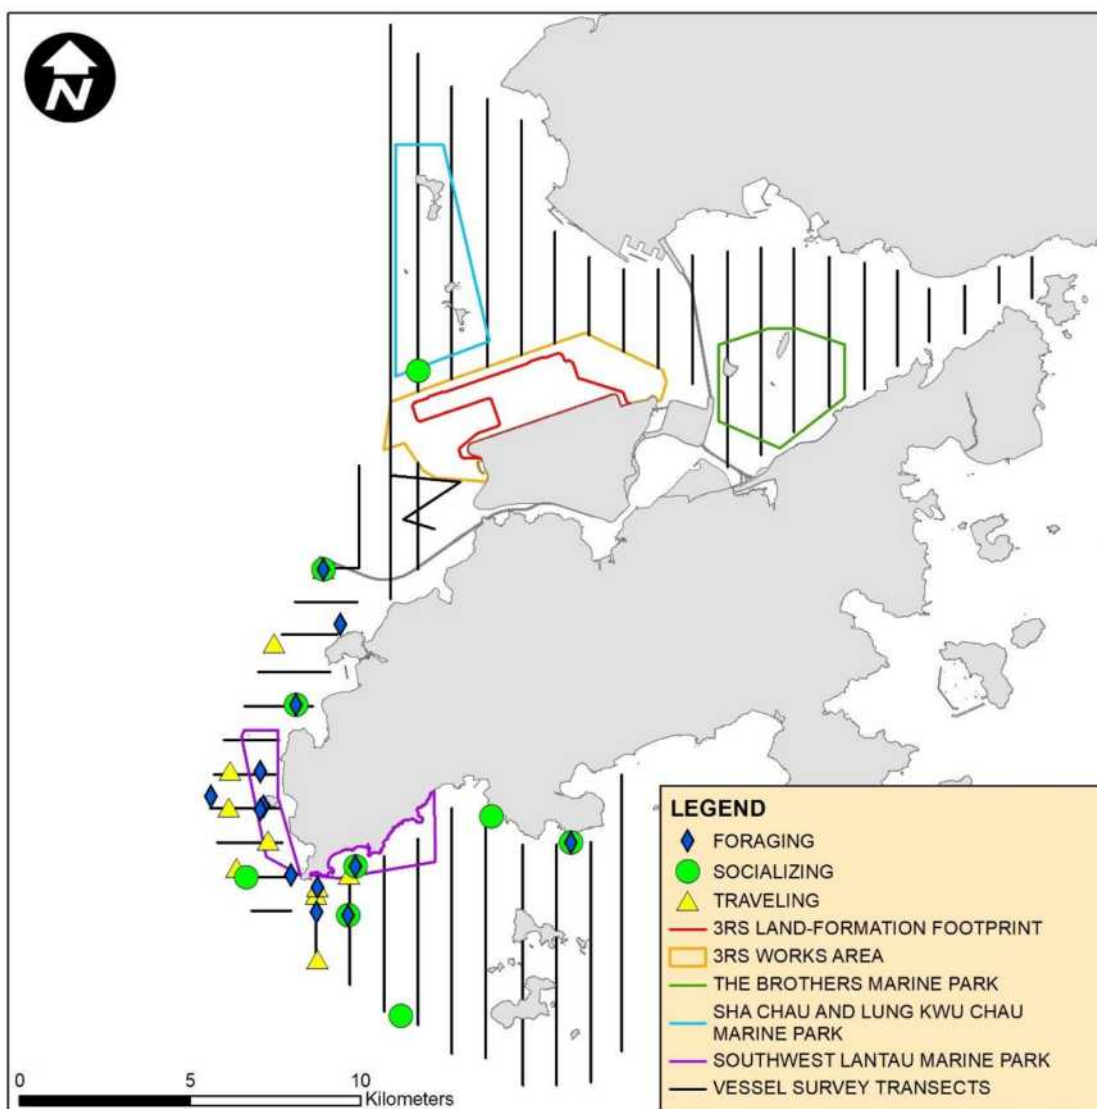
Figure 2.7: Sighting Locations of Chinese White Dolphins Engaged in Different Behaviours

The sighting locations of CWDs engaged in different behaviours during the current reporting period are illustrated in **Figure 2.7**.

Remarks: Marine park excludes land area and the landward boundary generally follows the high water mark along the coastline.

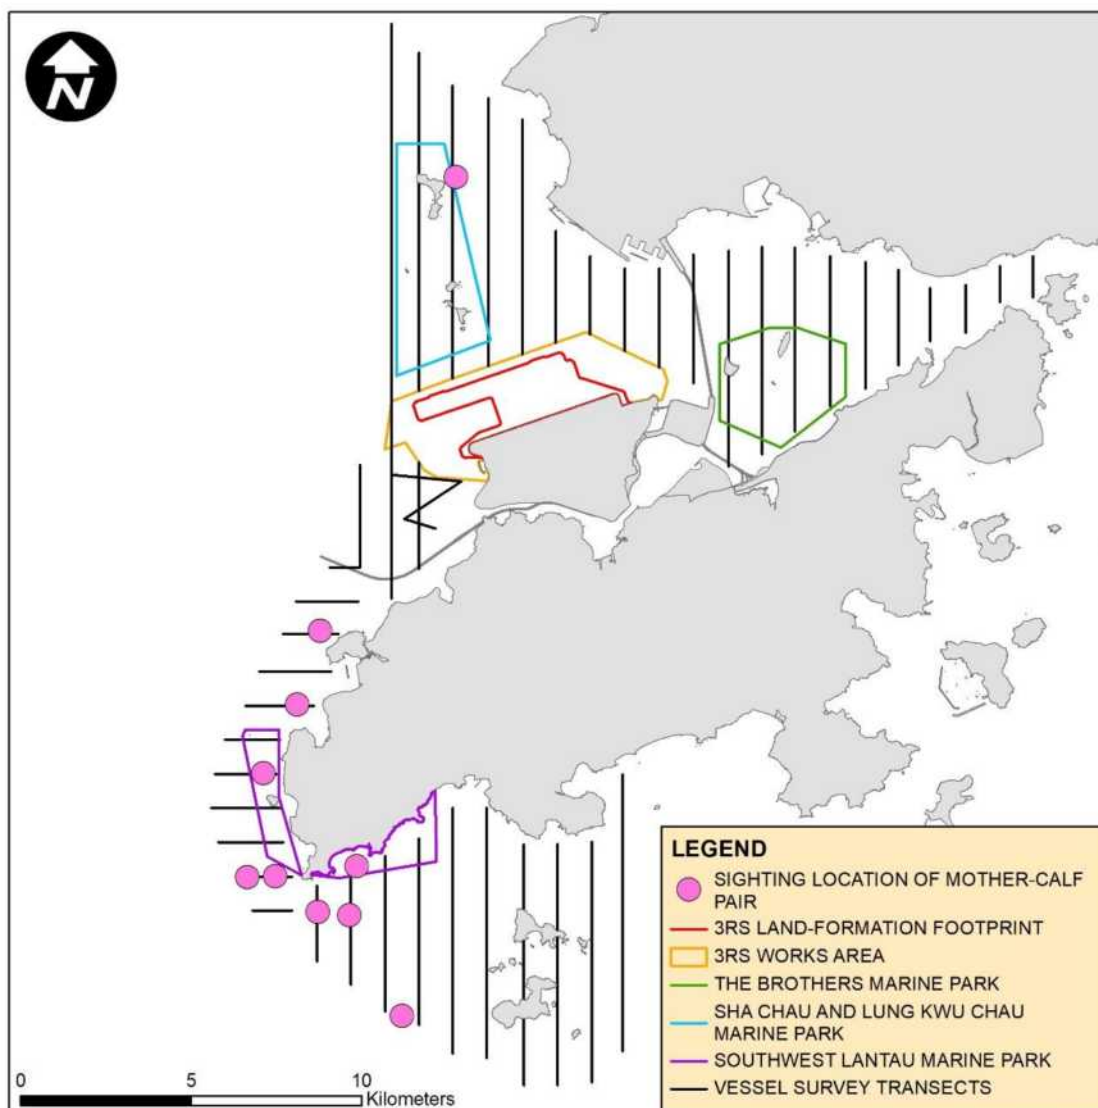
Figure 2.8: Sighting Locations of Mother-calf Pairs

From April to June 2022, 10 sightings of CWD were recorded with the presence of mother-and-unspotted juvenile pairs and/or mother-and-unspotted calf pairs observed, which is slightly higher than that recorded in the previous reporting quarter (i.e. nine sightings between January and March 2022). The number of CWD sightings with the presence of mother-calf pairs is also higher than that recorded in the same quarter of last year (i.e. six sightings between April and June 2021). These 10 sightings were recorded in NWL, WL and SWL survey areas, including a sighting in SWL with four mother-and-unspotted juvenile pairs observed.

The locations of CWD sightings with the presence of mother-calf pairs are shown in **Figure 2.8**.

Remarks: (1) Please note that there are 10 circles on the map indicating the sighting locations of Mother-Calf pairs. (2) Marine park excludes land area and the landward boundary generally follows the high water mark along the coastline.

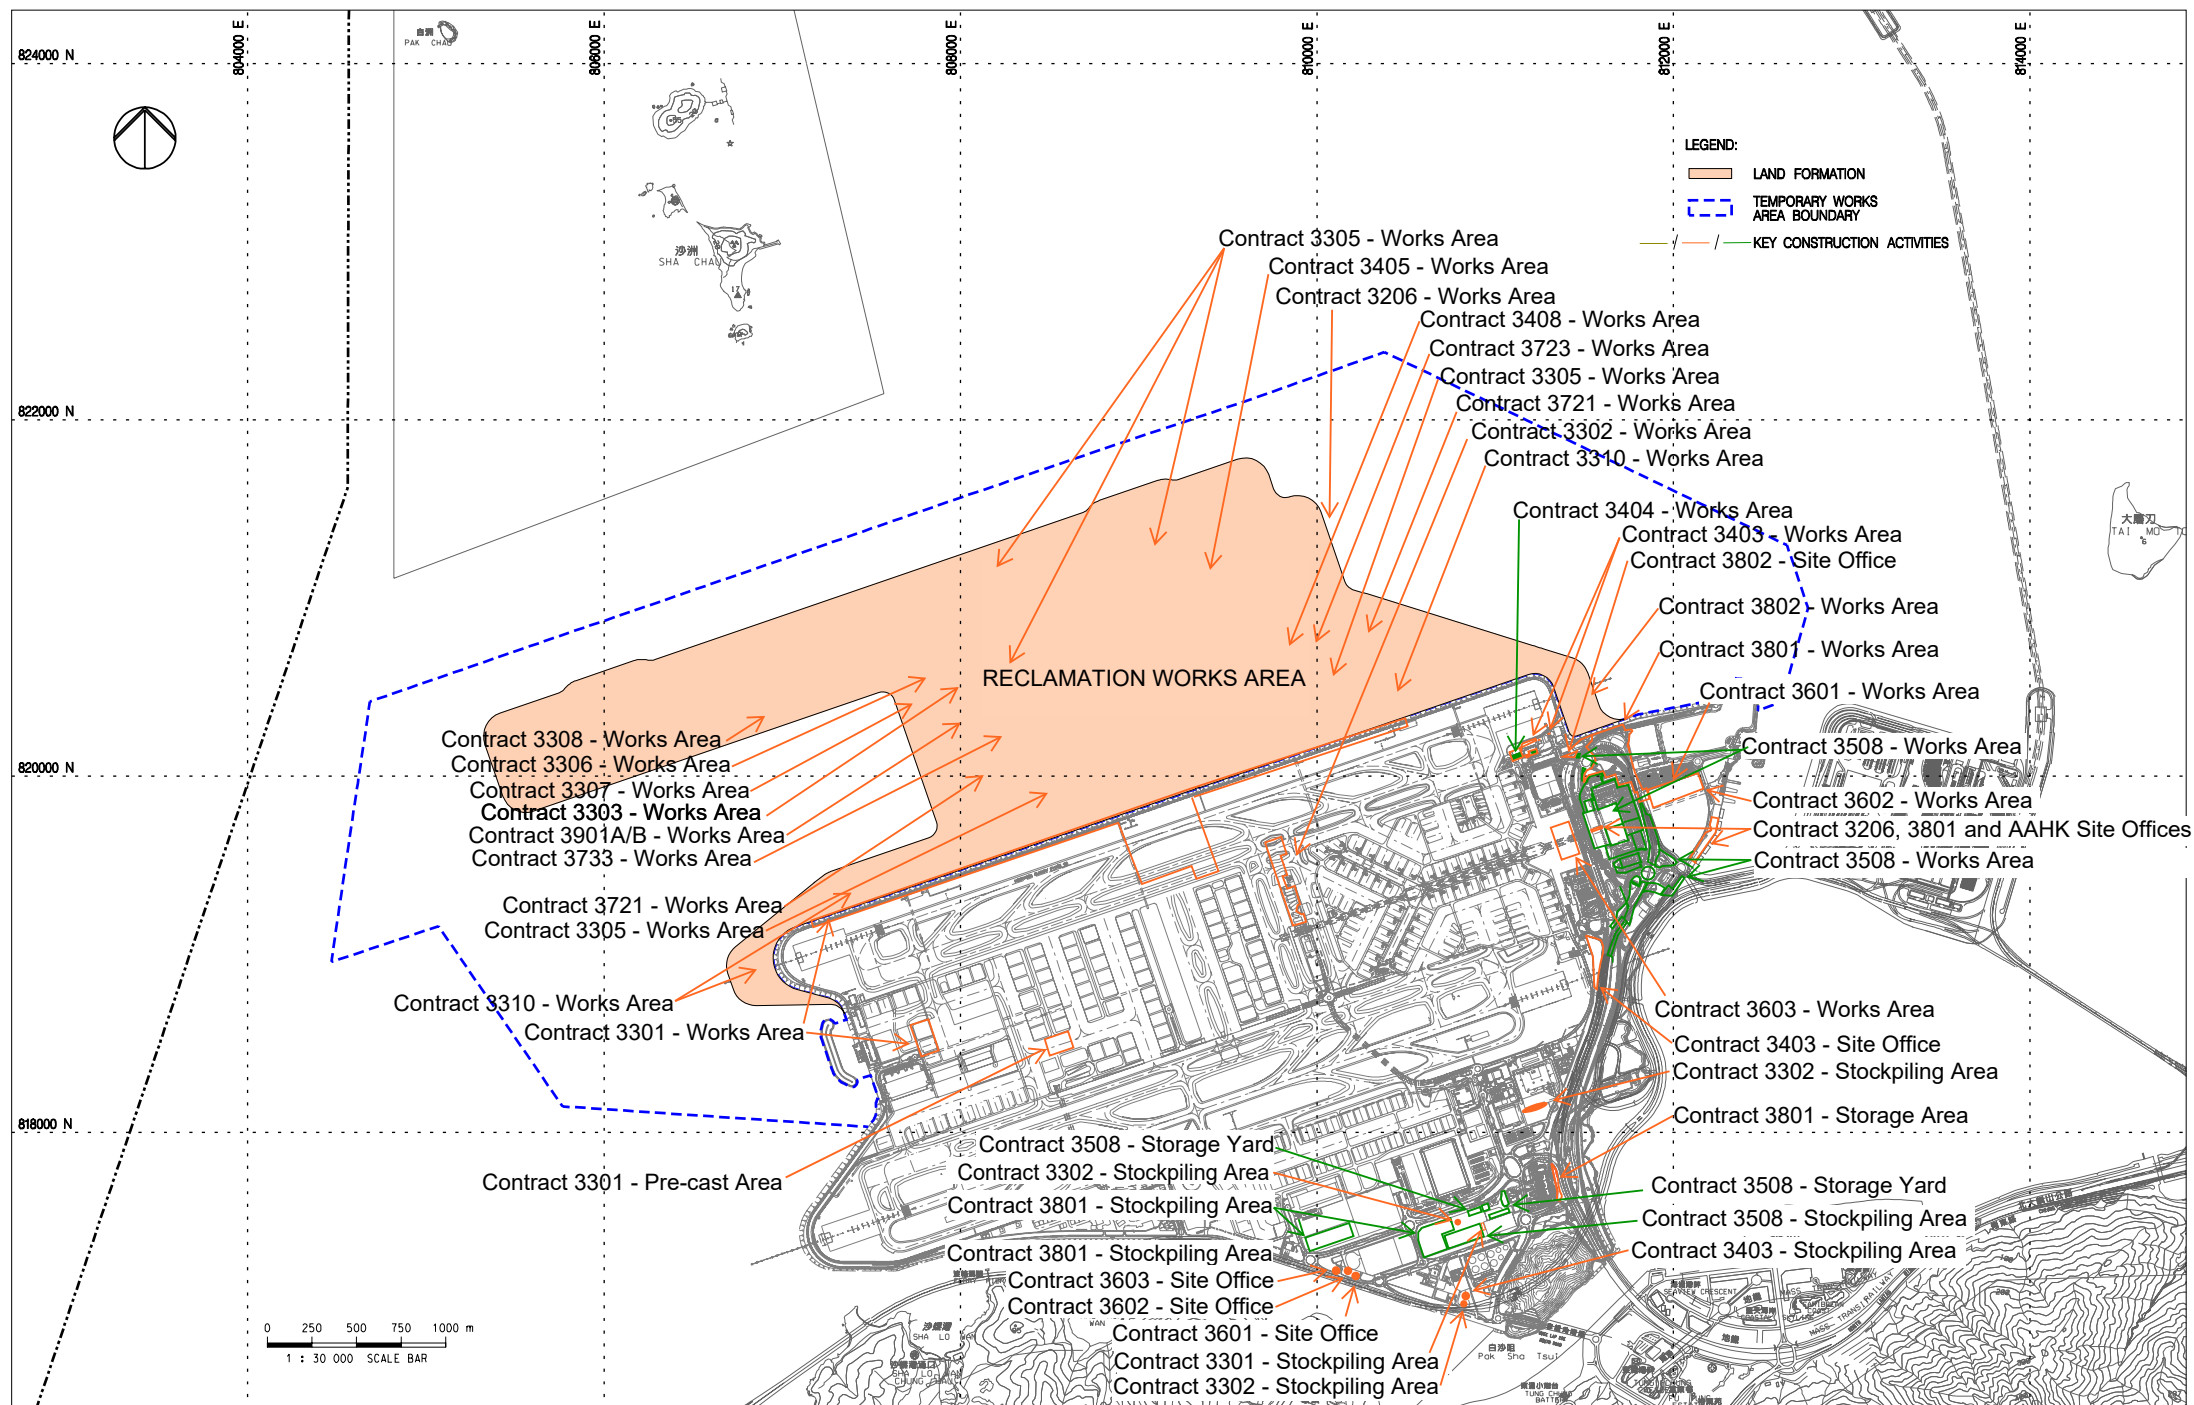
FIGURE 1.1 LOCATIONS OF KEY CONSTRUCTION ACTIVITIES

Note: The locations are for indicative purpose. The actual construction work locations are in accordance with the construction work programme.

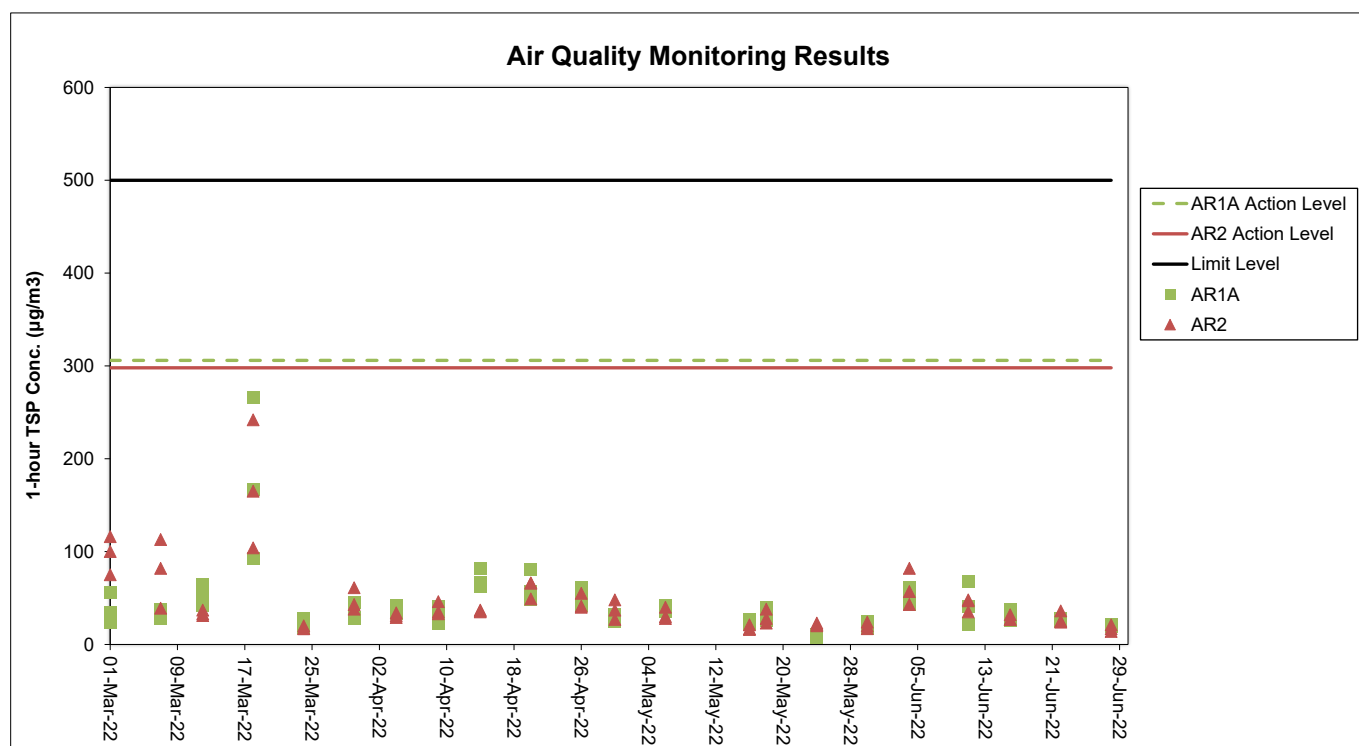
Air Quality Monitoring Results

1. The key activities of the Project carried out in the reporting period included reclamation works and land-based works. Works in the reclamation areas included filling, seawall construction and ground improvement works, together with runway, concourse and associated works. Land-based works on existing airport island involved mainly airfield works, Terminal 2 expansion works, modification and tunnel work for Automated People Mover (APM) and Baggage Handling System (BHS), and preparation work for utilities, with activities include road and drainage works, cable ducting, demolition, piling, and excavation works.

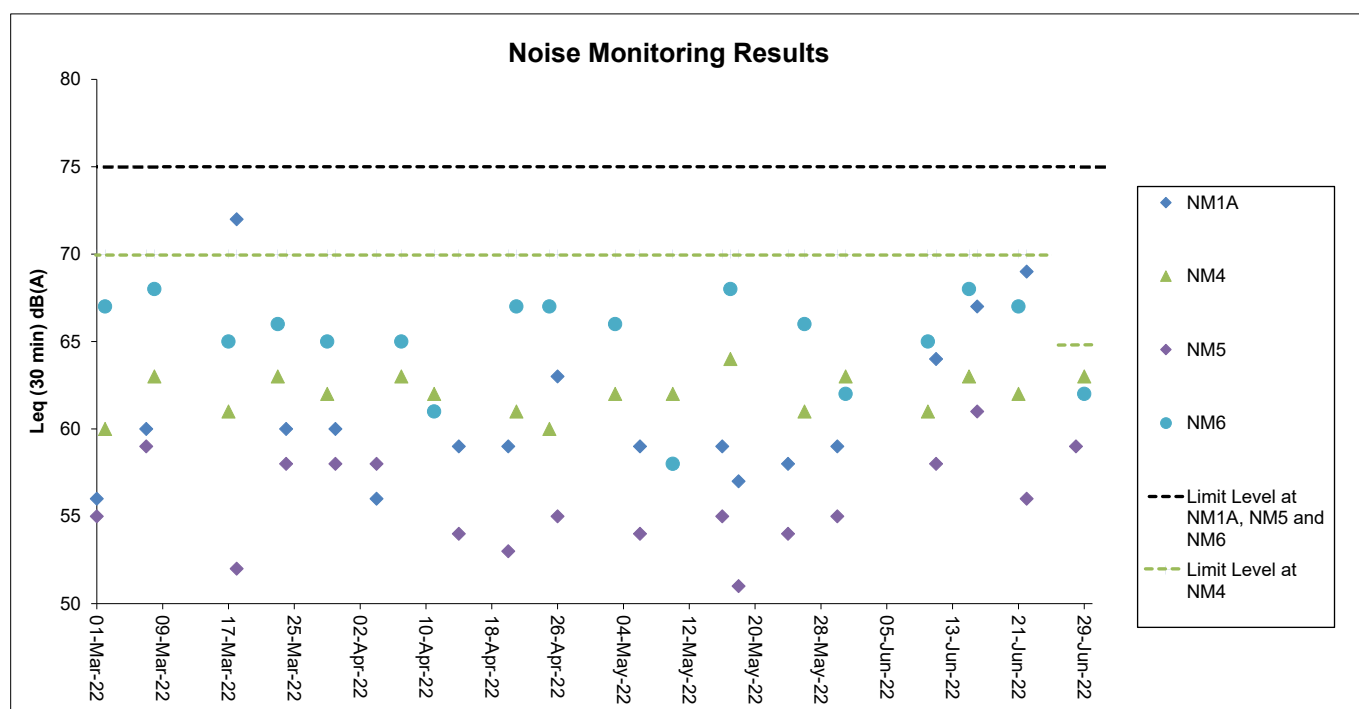
Noise Monitoring Results

1. The Limit Level is reduced to 70dB(A) for school and 65dB(A) during school examination period at NM4. School examination took place from 23 to 29 June during this reporting period.
