Expansion of Hong Kong International Airport into a Three-Runway System

Construction Phase Quarterly EM&A Report No.5
(1 January to 31 March 2017)

June 2017

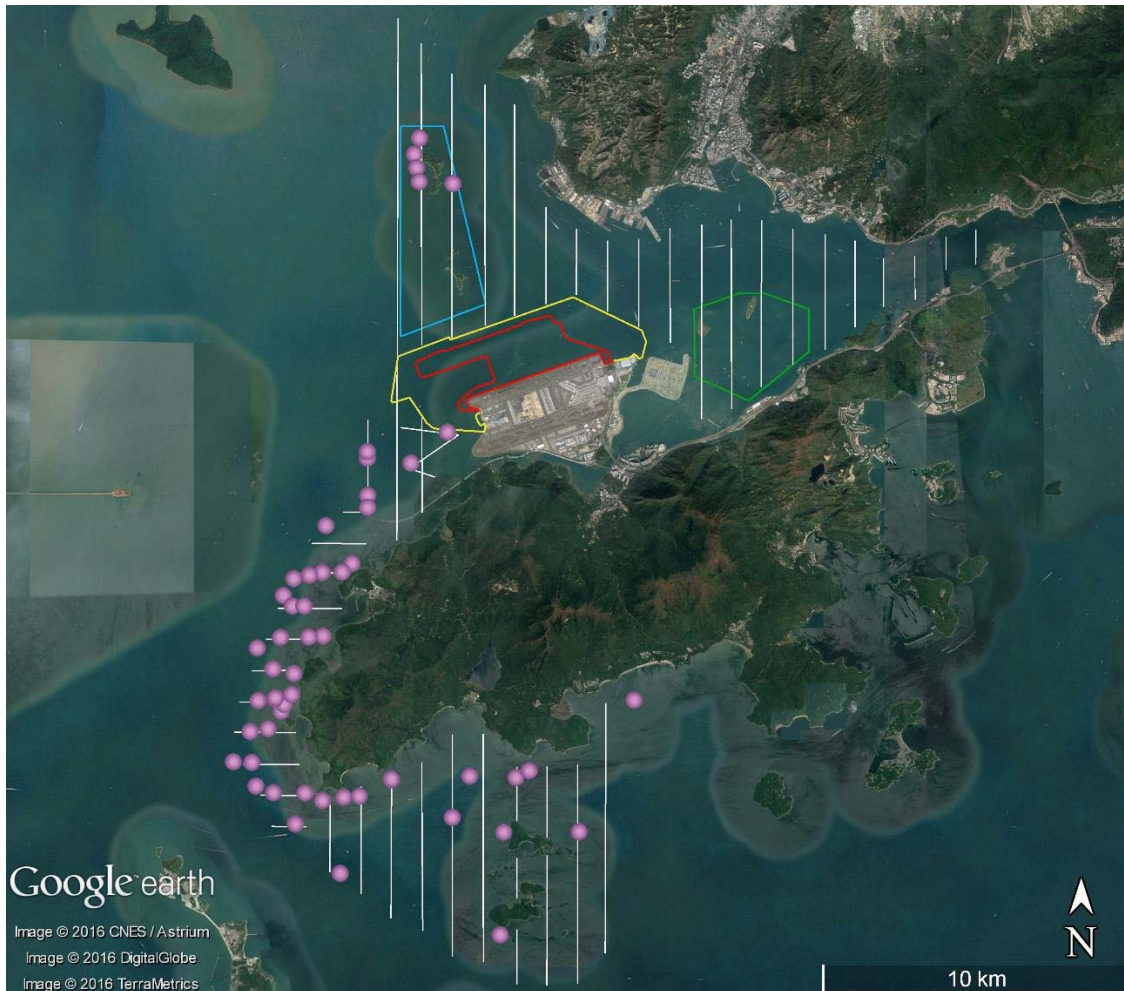
Figure 2.5: Sightings Distribution of Chinese White Dolphins

Distribution of CWD sightings recorded from January to March 2017 during on-effort search under favourable weather condition are illustrated in **Figure 2.5**. CWD sightings were more frequent in WL than in NWL and SWL. In NWL, sightings were mainly recorded around Lung Kwu Chau particularly the western side. Two sightings were recorded in AW survey area with one of them located close to the boundary of 3RS temporary works area. In WL survey area, CWD sightings were quite evenly distributed in both coastal and off-shore waters from the waters north to the Hong Kong-Zhuhai-Macao Bridge Hong Kong Link Road alignment to Fan Lau, with relatively more sightings recorded between Tai O and Yi O. In SWL waters, CWDs sighting locations ranged from Fan Lau to Cheung Sha with several sightings scattered around Soko Islands. Details of the sighting data were presented in **Appendix E**.

[Pink circle: Sighting locations of CWD, White line: Vessel survey transects, Blue polygon: Sha Chau and Lung Kwu Chau Marine Park (SCLKCMP), Green polygon: Brothers Marine Park (BMP), Red polygon: 3RS land-formation footprint, Yellow line: 3RS temporary works area boundary]

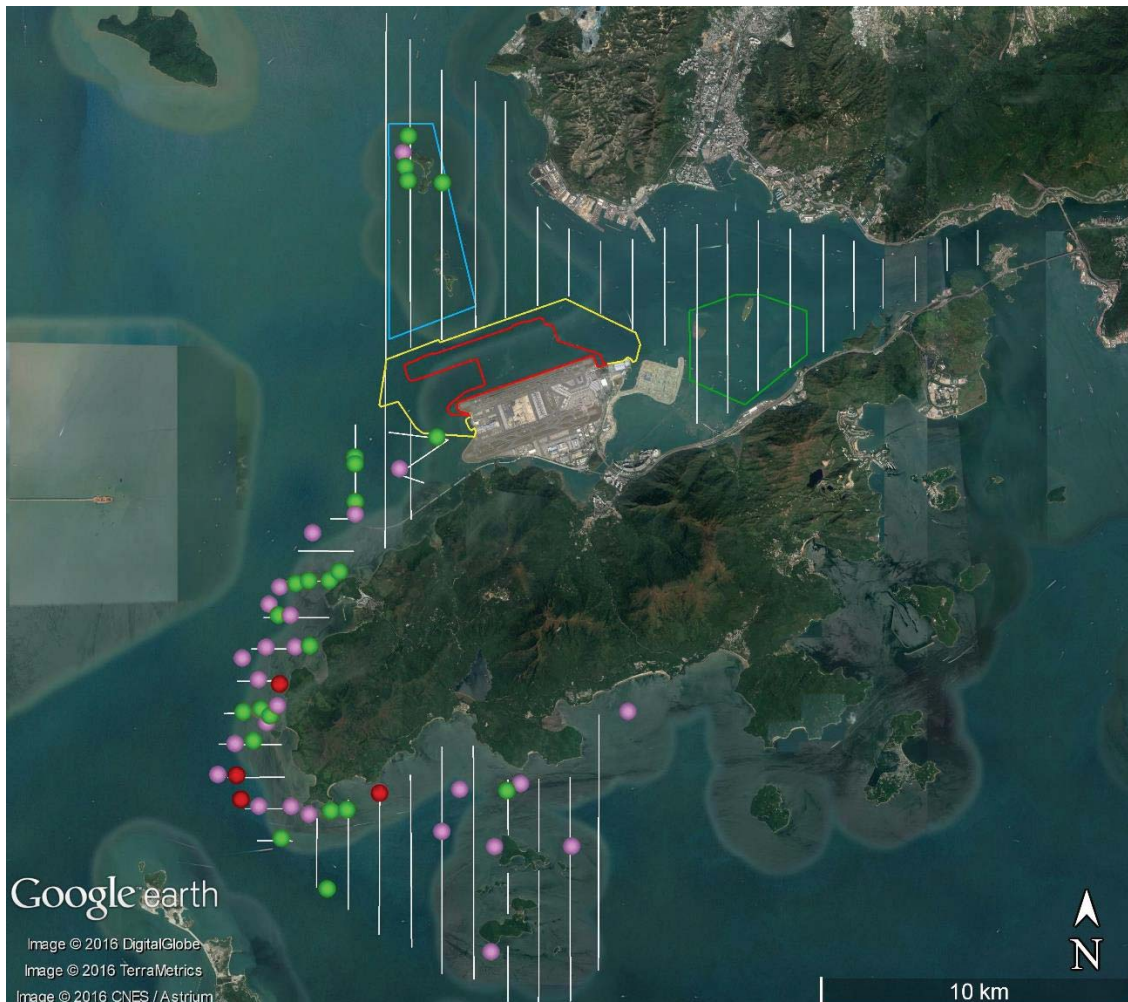
Figure 2.6: Sighting Locations of Chinese White Dolphins with Different Group Sizes

[Pink circle: Sighting locations of CWD with group size from 1 to 2 individuals, Green circle: Sighting locations of CWD with group size from 3 to 9 individuals, Red circle: Sighting locations of CWD with group size of 10 or above, White line: Vessel survey transects, Blue polygon: Sha Chau and Lung Kwu Chau Marine Park (SCLKCMP), Green polygon: Brothers Marine Park (BMP), Red polygon: 3RS land-formation footprint, Yellow line: 3RS temporary works area boundary]

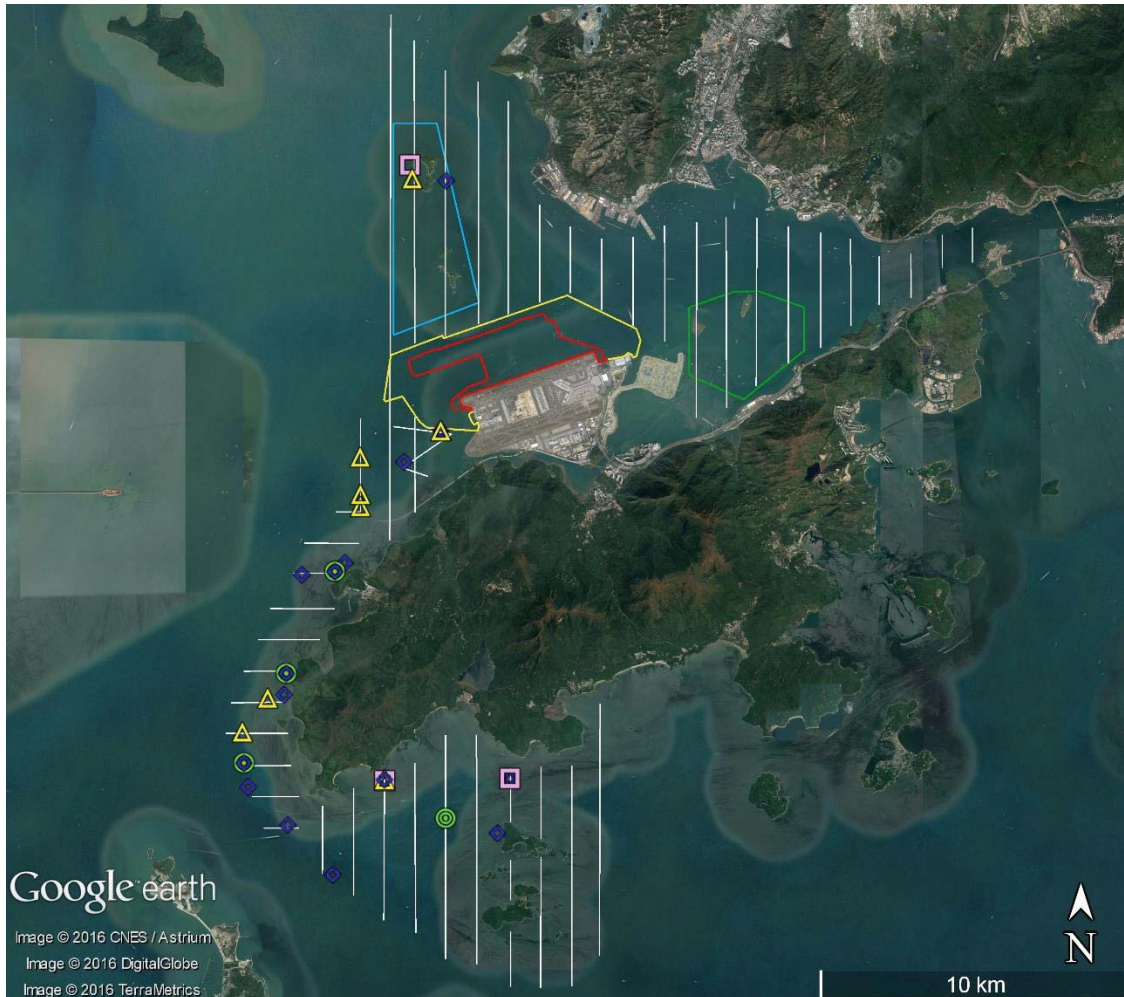
Figure 2.7: Sighting Locations of Chinese White Dolphins Engaged in Different Behaviours

During January to March 2017, 15 groups of CWDs were sighted with feeding activities. Amongst these 15 groups of feeding CWDs, 10 groups were observed in association with operating pair fishing boats including gillnetters, purse seiners and pair trawlers in AW, WL and SWL survey areas. The sighting locations of CWDs engaged in different behaviours during the reporting quarter were illustrated in **Figure 2.7**.

[Indigo rhombus: Foraging, Green circle: Socializing, Pink square: Milling/Resting, Yellow triangle: Travelling, White line: Vessel survey transects, Blue polygon: Sha Chau and Lung Kwu Chau Marine Park (SCLKCMP), Green polygon: Brothers Marine Park (BMP), Red polygon: 3RS land-formation footprint, Yellow line: 3RS temporary works area boundary]

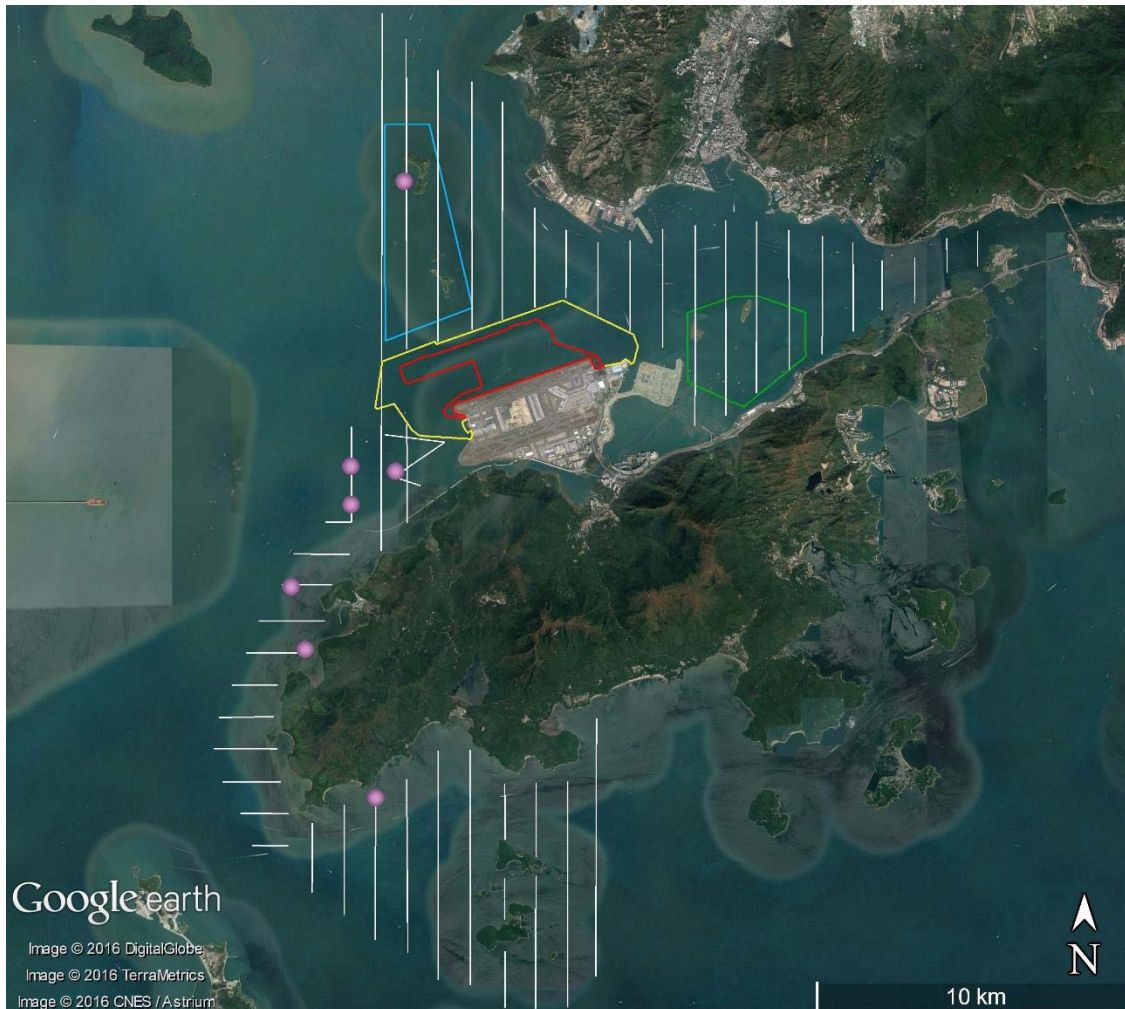
Figure 2.8: Sighting Locations of Mother-calf Pairs

From January to March 2017, seven sightings of mother-and-unspotted juvenile pairs were recorded. Amongst these seven sightings, a mother-and-unspotted juvenile pair (WLMM071 and WLMM060) were recorded twice, in AW and WL survey areas. The sighting locations of mother-and-unspotted juvenile pairs were shown in **Figure 2.8**.

[Pink circle: Sighting locations of mother-calf pairs, White line: Vessel survey transects, Blue polygon: Sha Chau and Lung Kwu Chau Marine Park (SCLKCMP), Green polygon: Brothers Marine Park (BMP), Red polygon: 3RS land-formation footprint, Yellow line: 3RS temporary works area boundary]

Note: Only on-effort sightings under Beaufort 3 or below were presented in the figure.

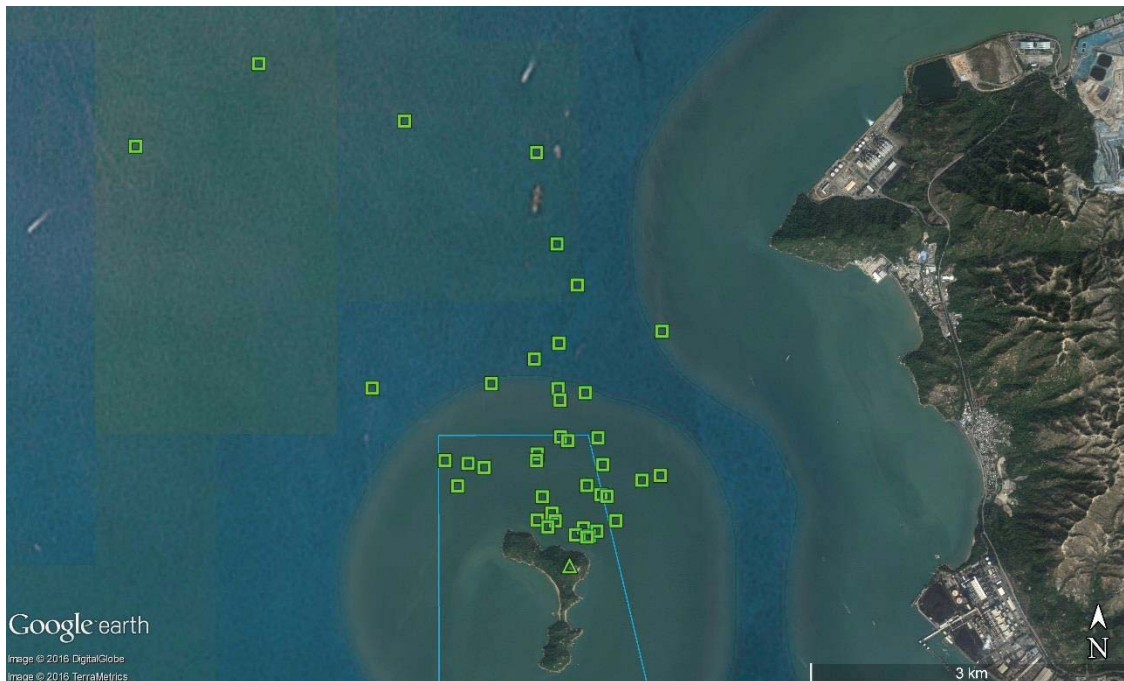
Figure 2.9: Plots of First Sightings of All CWD Groups from Land-based Stations

[Green triangle: LKC station; Green square: CWD group off LKC; Blue line: SCLKCMP boundary]

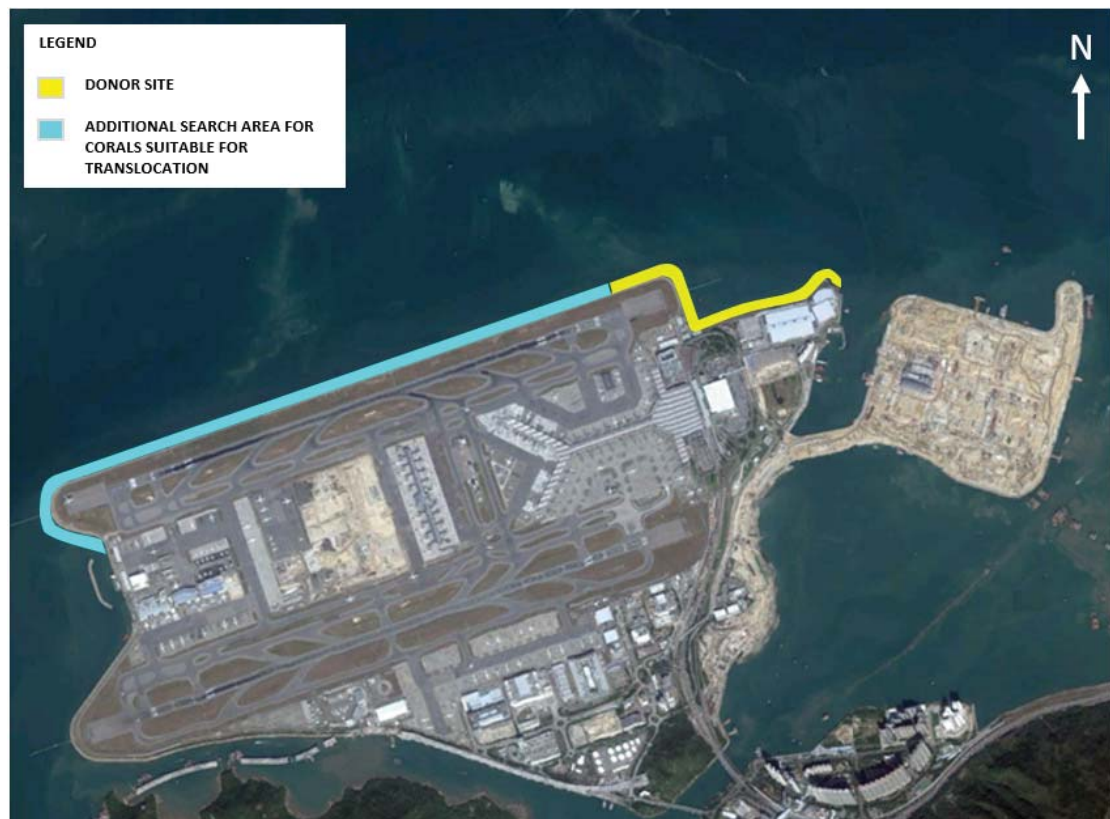
In addition to the donor site along the north-eastern seawall of the airport island, the seawall on the northern side of the airport island was also searched for additional suitable coral colonies so as to translocate as many coral colonies as possible. The additional search area for corals suitable for translocation is shown in **Appendix F**. Fourteen additional coral colonies suitable for translocation were found around the boat launch area and the adjacent outfall in the mid-point of the northern seawall. These coral colonies were translocated immediately after they were located. The location of recipient site is shown in **Appendix F**.

Location plan showing the additional search area for corals suitable for translocation

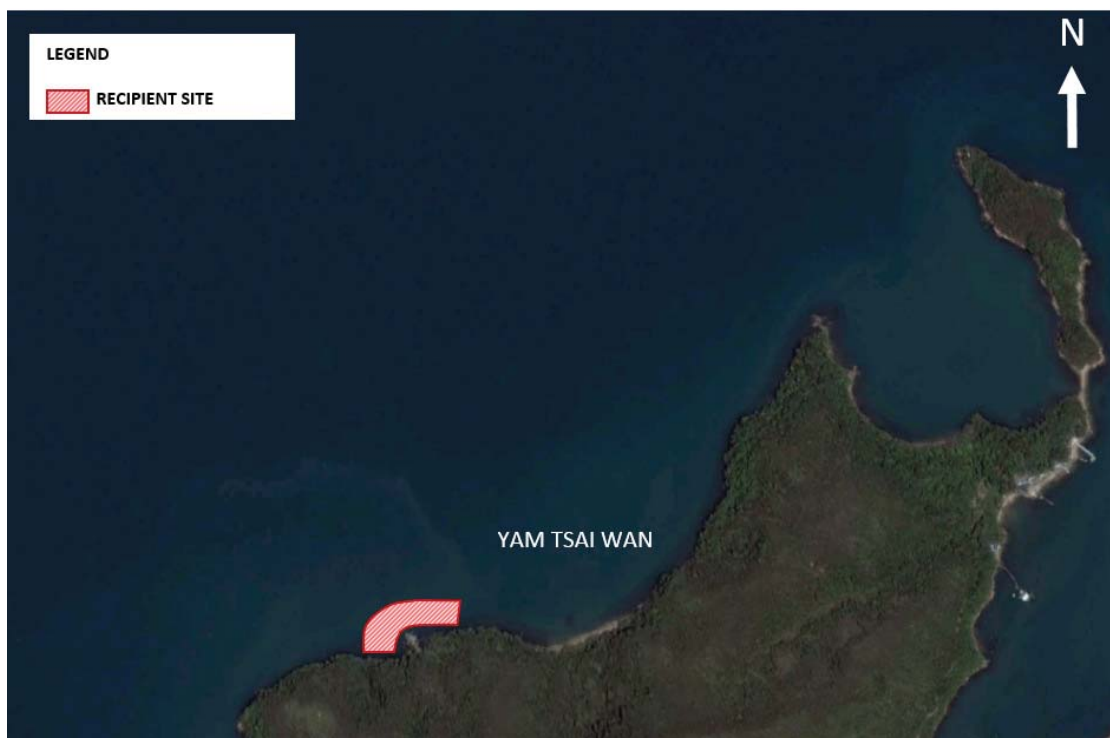
The location of recipient site

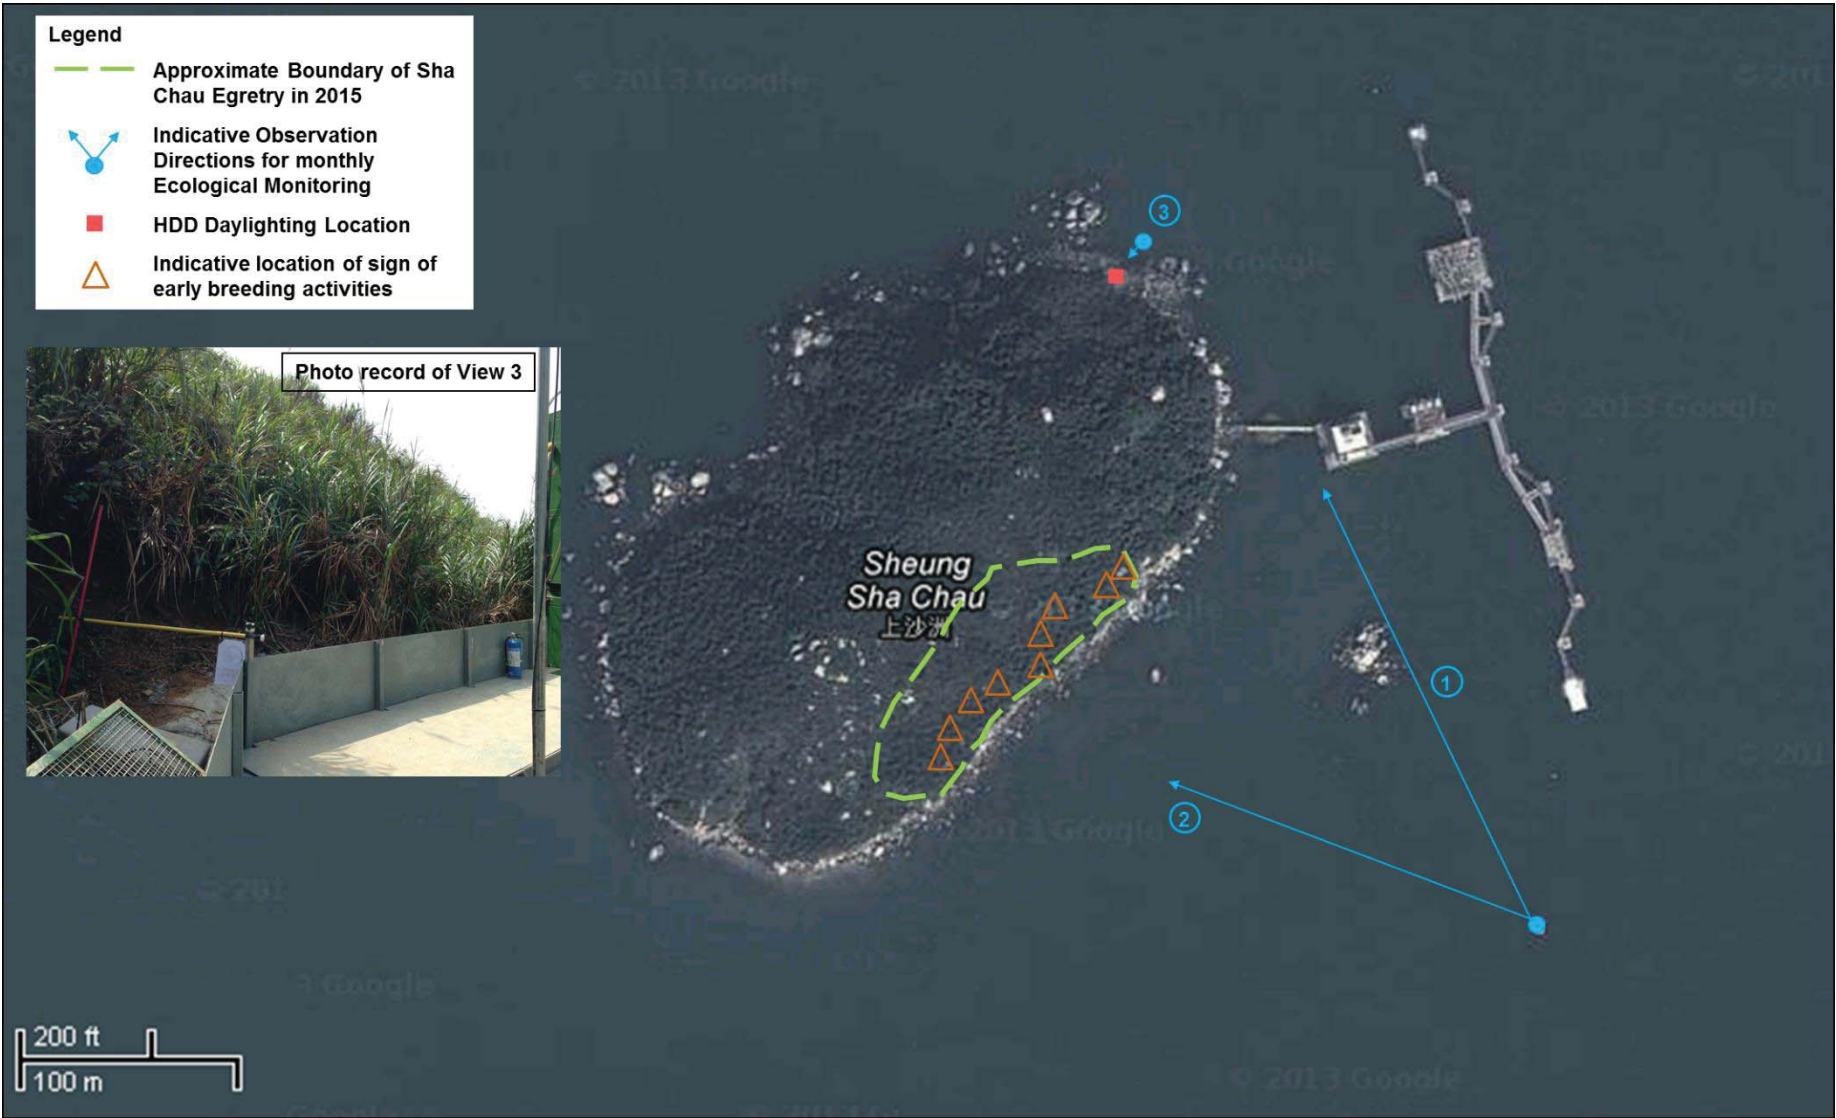
Monthly ecological monitoring was carried out in January, February, and March 2017 on Sheung Sha Chau Island. No encroachment of any works upon the egret area nor any significant disturbance to the egrets on the island by the works was recorded during ecological monitoring. Signs of early breeding activities by Black-crowned Night Heron and Little Egret were observed in March 2017 on trees located at the previously identified egret area where it is at the southern side of Sheung Sha Chau Island. At the HDD daylighting location, neither nest nor breeding activity of birds were found during the monthly ecological monitoring and weekly site inspections in the reporting quarter. The site photos and location map regarding the ecological monitoring for the HDD works and egret area are provided in **Appendix G** for reference. All works on Sheung Sha Chau had been retreated on 31 March 2017. No works will be conducted on Sheung Sha Chau Island during the ardeid's breeding season.

Ecological Monitoring – site photos and location map regarding the monthly ecological monitoring for the egretty area on Sheung Sha Chau and the HDD works
