Expansion of Hong Kong International Airport into a Three-Runway System

Construction Phase Quarterly EM&A Report
No.12 (1 October to 31 December 2018)

March 2019

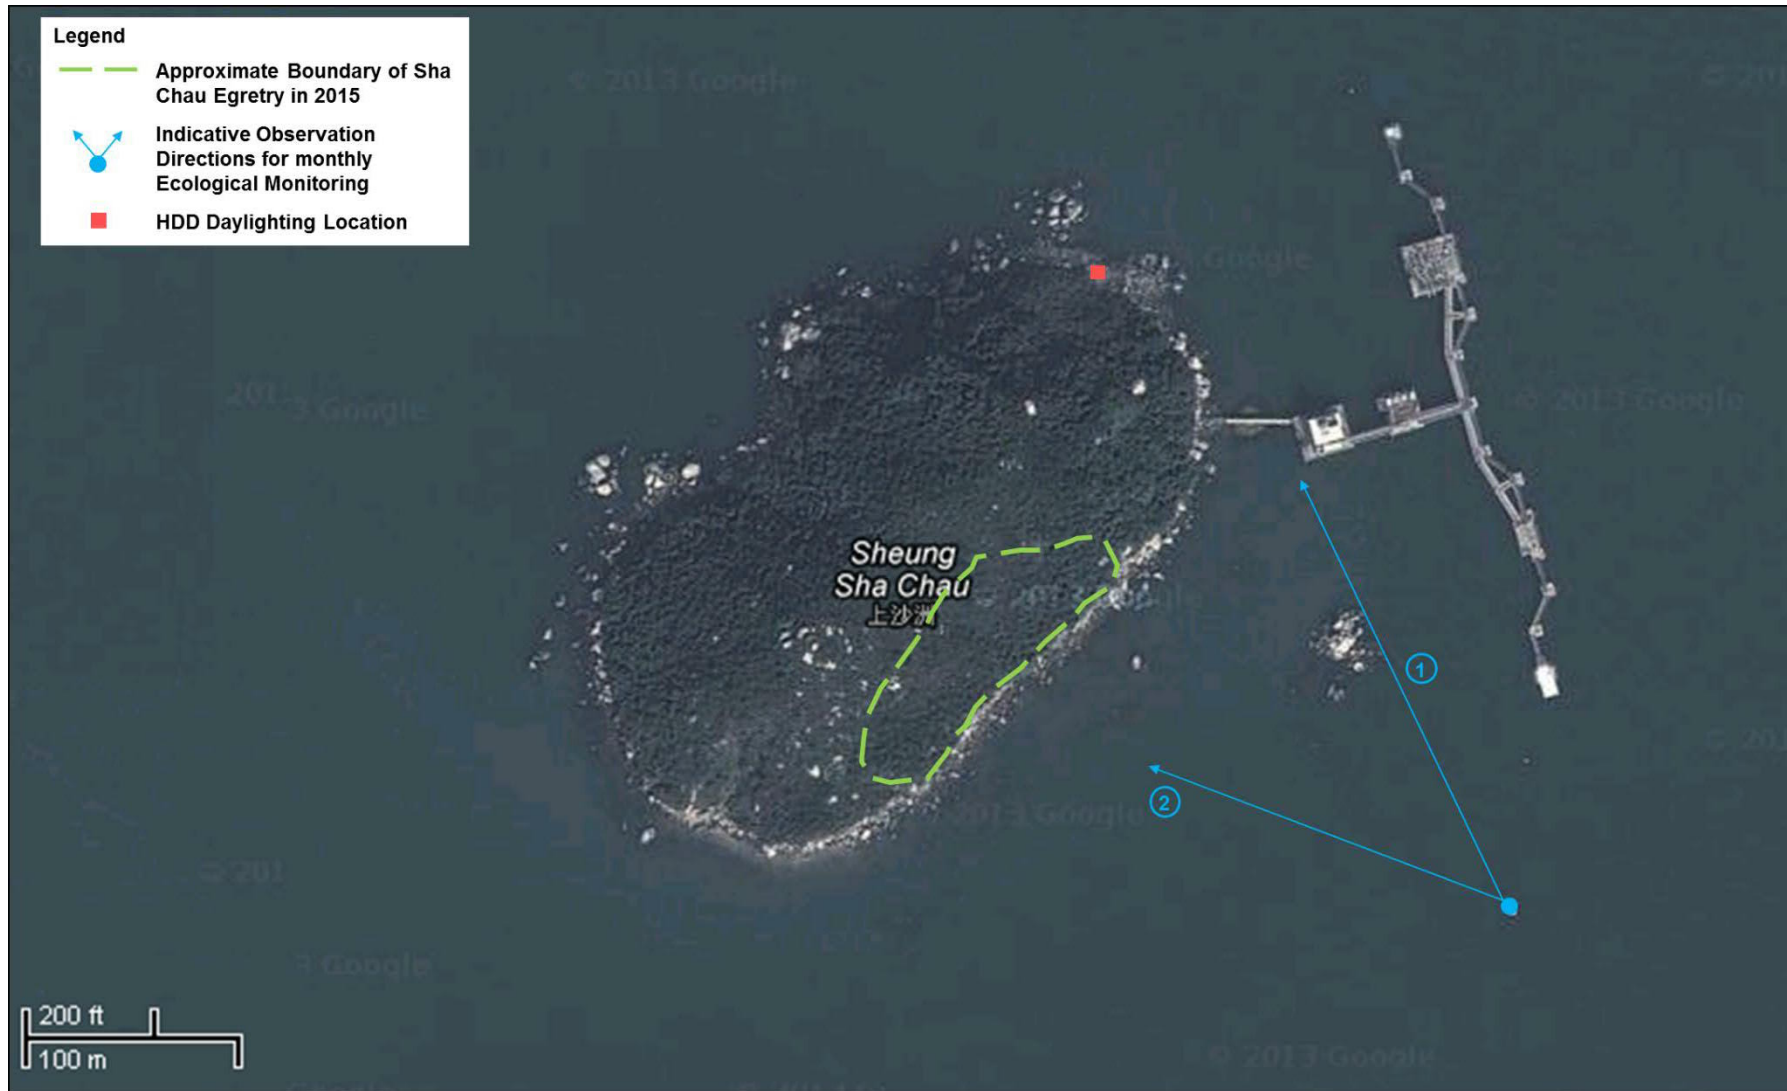
Terrestrial Ecological Monitoring – location map and site photos regarding the monthly ecological monitoring for the egretty area on Sheung Sha Chau and the HDD daylighting location

Monthly ecological monitoring was carried out in October, November and December 2018 on Sheung Sha Chau Island in accordance with the Manual. No encroachment of any works upon the egret area nor any significant disturbance to the ardeids foraging at Sheung Sha Chau by the works were recorded during ecological monitoring. No signs of breeding or nursery activities were observed. At the HDD daylighting location, neither nest nor breeding activity of ardeids were found during the monthly ecological monitoring and weekly site inspections from October to December 2018. The site photos and location map regarding the ecological monitoring for HDD daylighting location and egret area are provided in **Appendix C** for reference.
