Expansion of Hong Kong International Airport into a Three-Runway System

Detailed Coral Translocation Report

May 2017

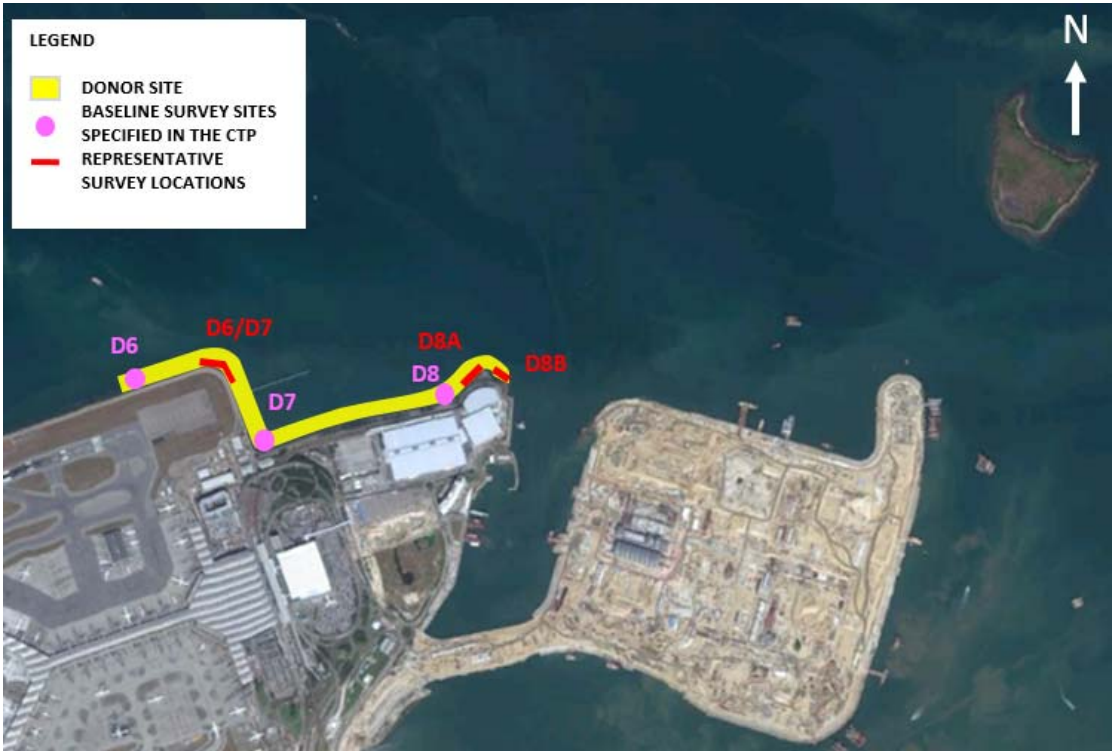
Figure 1: Map showing the areas surveyed in the Pre-Translocation Survey

Based on the baseline coral dive survey findings as presented in the CTP, the main donor site was confirmed as the area along the north-eastern side of the existing airport island (i.e. in the vicinity of locations D6, D7 and D8 as identified in the CTP). While the survey locations D6, D7 and D8 in the baseline dive survey followed the same locations as in the EIA study, the baseline survey also included a re-check of the seawall / rocky shore at the north-eastern tip of the airport island. Coral colonies on small boulders were found in this area, thus the area around D6, D7 and D8 was identified as the donor site (shown in **Figure 1**).

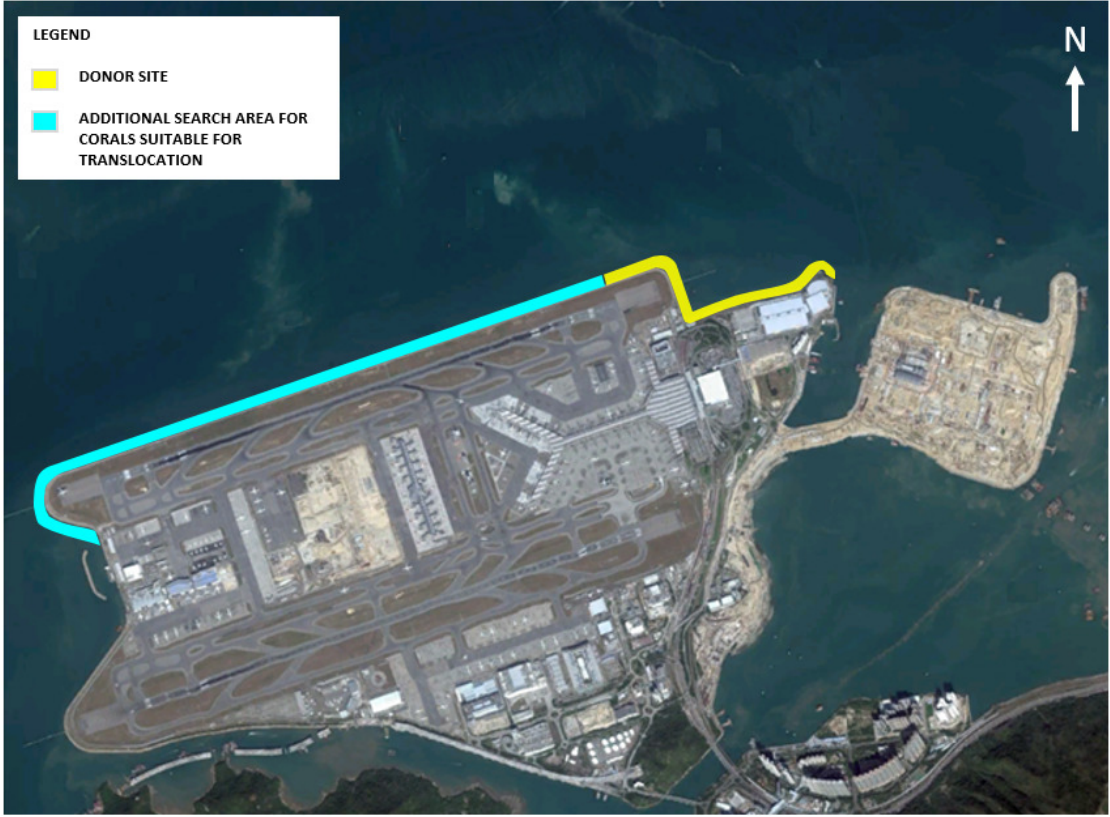
ADDITIONAL SEARCH AREA FOR CORALS SUITABLE FOR TRANSLOCATION

During the additional diving search along the northern seawall a small number of additional coral colonies suitable for translocation were found, mainly around the boat launch area and the adjacent outfall in the mid-point of the northern seawall. The small number of coral colonies identified here were translocated immediately after they were located.

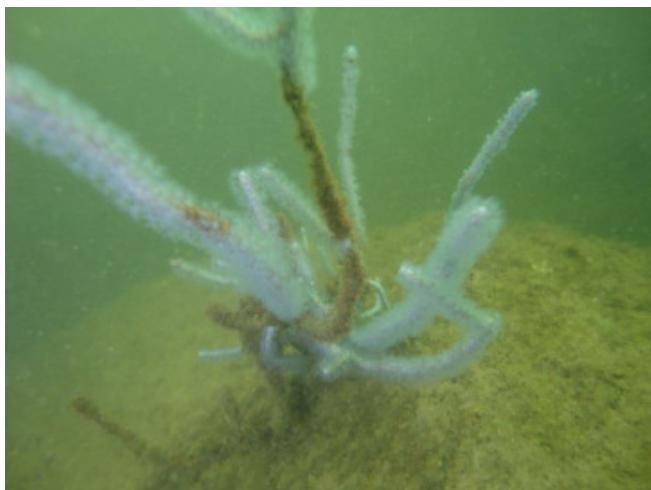
Plate 9. Gorgonian community at the donor site with partial mortality.

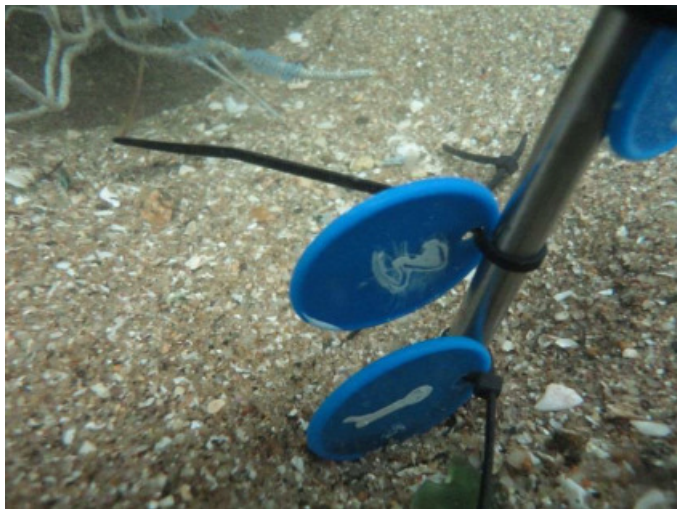
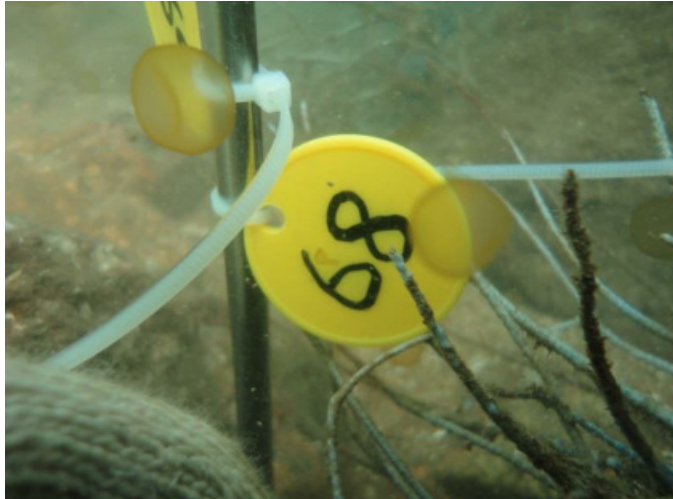
Plate 15. Tags for control colonies

Plate 16. Tags for impact colonies.

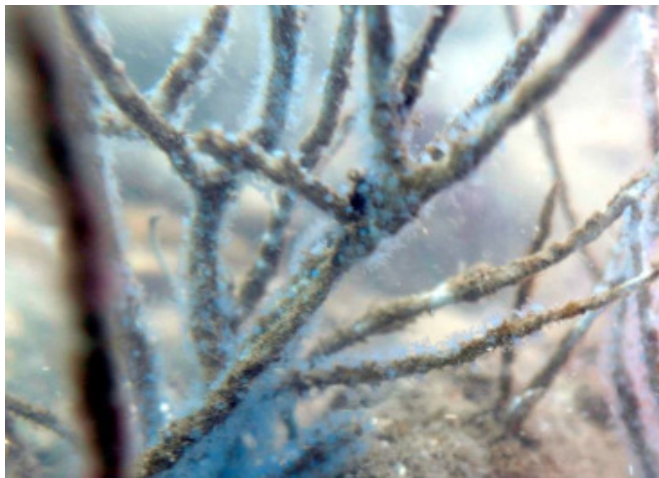
Plate 17. Close-up of a colony with thick shedding.

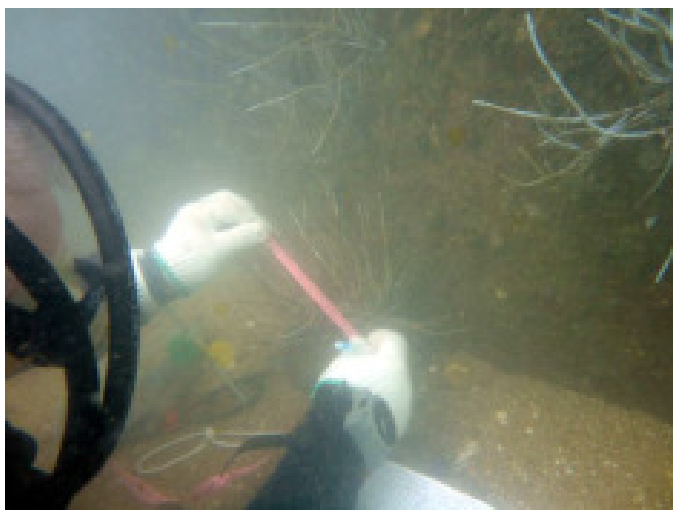
Plate 20. Measuring maximum height of gorgonians.

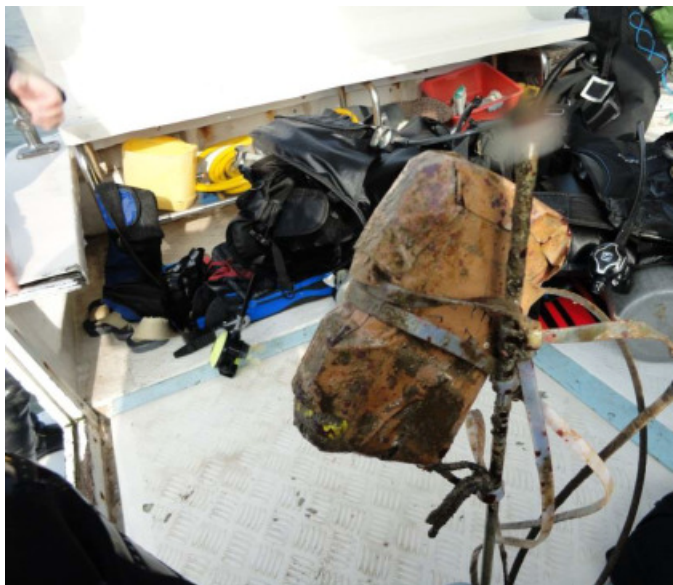
Plate 21. Data logger wrapped in a protected plastic sheet for recording environmental parameters.

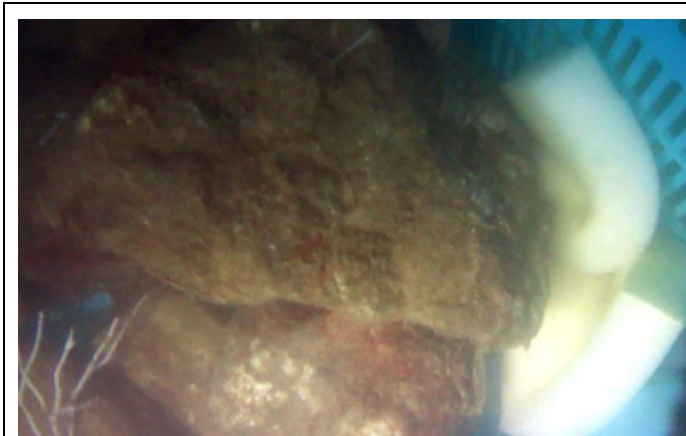
Plate 22. Soft corals in a lifter with protection by a piece of sponge.
