Appendix C. Monitoring Results

Air Quality Monitoring Results

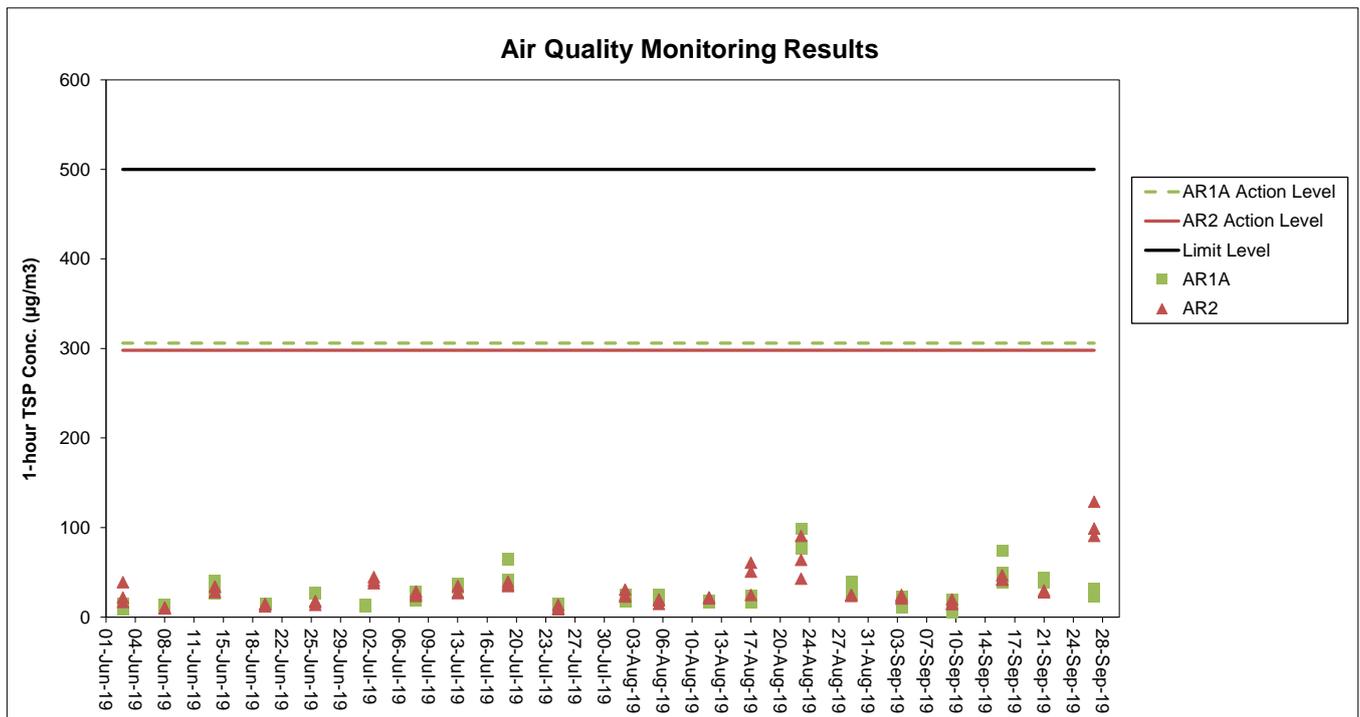
1. The key activities of the Project during monitoring included reclamation works and land-side works. Reclamation works included deep cement mixing (DCM) works, marine filling, and seawall construction. Land-side works involved mainly foundation and substructure work for Terminal 2 expansion, modification and tunnel work for Automated People Mover (APM) and Baggage Handling System (BHS), and preparation work for utilities.
2. General weather condition during monitoring ranged from sunny to rainy. Detailed meteorological conditions can be referred to Table 2.3 of this Report and corresponding Monthly EM&A Reports.
3. QA/ QC requirements as stipulated in the EM&A Manual were carried out during measurement.

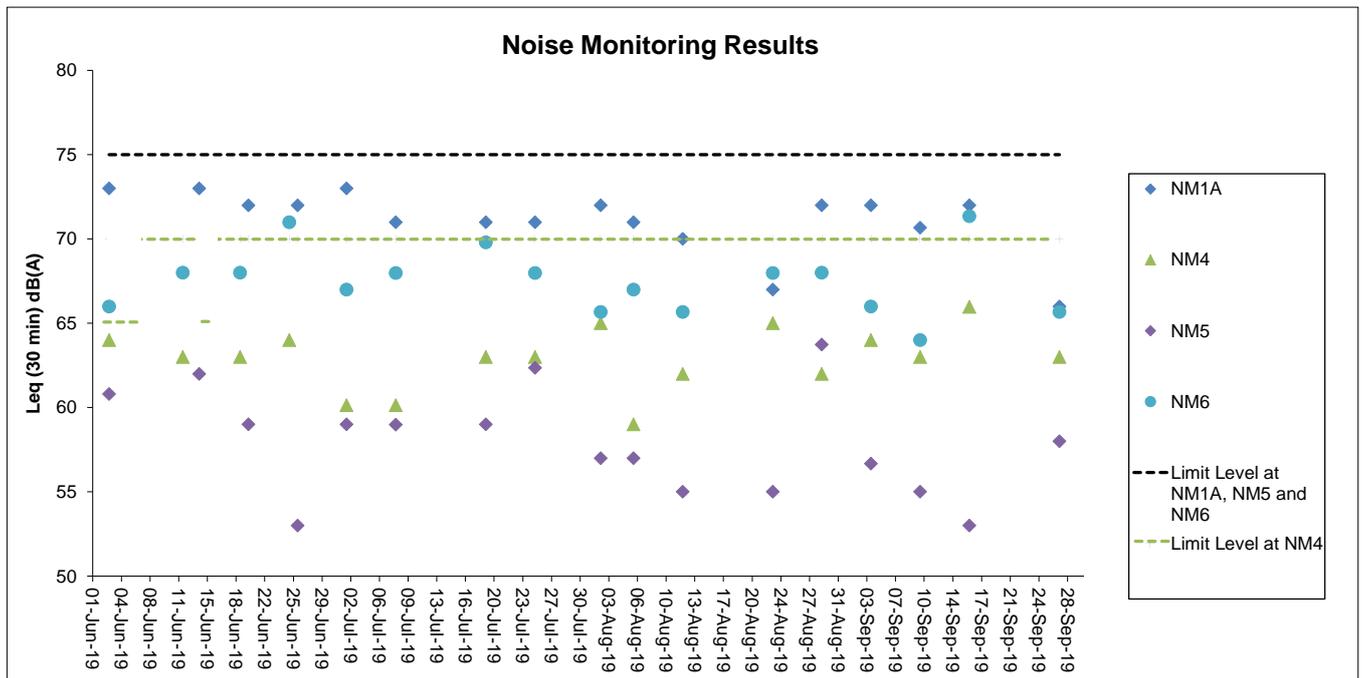
Noise Monitoring Results

1. The Limit Level is reduced to 70dB(A) for school and 65dB(A) during school examination period at NM4. School examination periods in the reporting period were 1/6 to 6/6 and 11/6 to 12/6.
2. The key activities of the Project during monitoring included reclamation works and land-side works. Reclamation works included deep cement mixing (DCM) works, marine filling, and seawall construction. Land-side works involved mainly foundation and substructure work for Terminal 2 expansion, modification and tunnel work for Automated People Mover (APM) and Baggage
3. General weather condition during monitoring ranged from sunny to drizzle. Detailed meteorological conditions can be referred to Table 2.6 of this Report and corresponding Monthly EM&A
4. QA/ QC requirements as stipulated in the EM&A Manual were carried out during measurement.

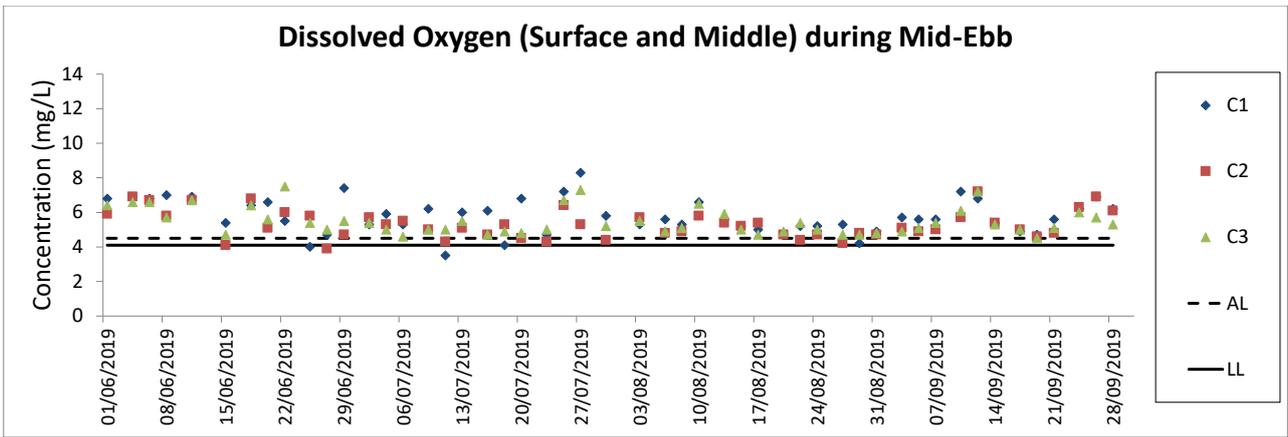
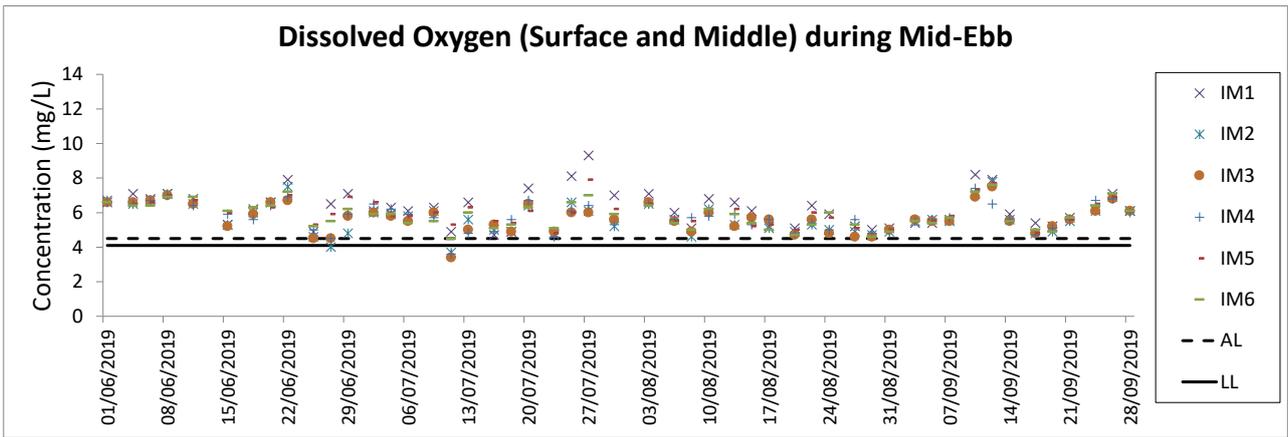
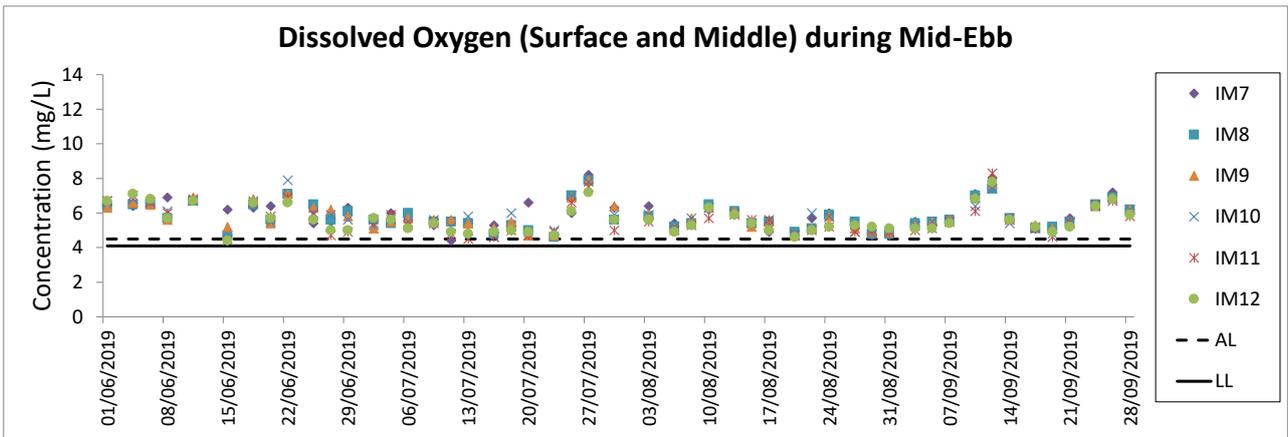
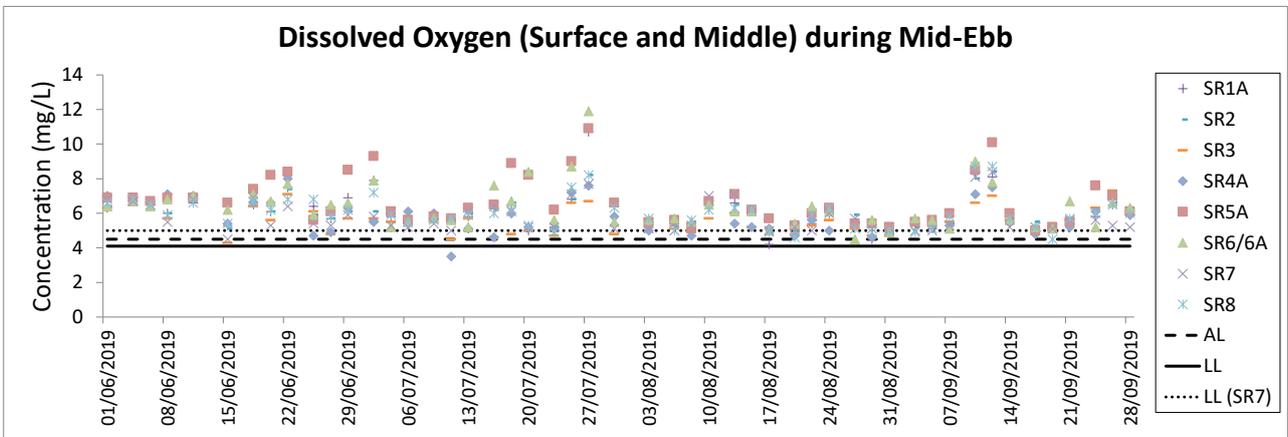
Water Quality Monitoring Results

- Notes:
1. The key marine works activities of the Project during monitoring included deep cement mixing (DCM) works, marine filling, and seawall construction.
 2. General weather condition during monitoring ranged from sunny to rainy, with sea condition ranged from calm to rough. Detailed meteorological conditions can be referred to Table 2.11 of this Report and corresponding Monthly EM&A Reports.
 3. QA/ QC requirements as stipulated in the EM&A Manual were carried out during measurement.
 4. As the access to SR6 was obstructed by the construction activities and temporary structures for Tung Chung New Town Extension, the monitoring location has been relocated to SR6A starting from 8 August 2019.

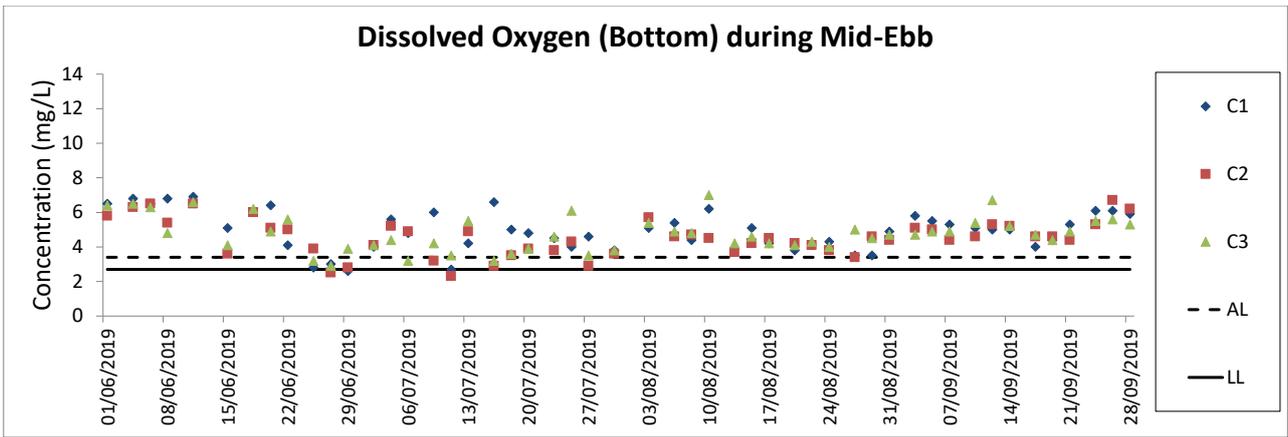
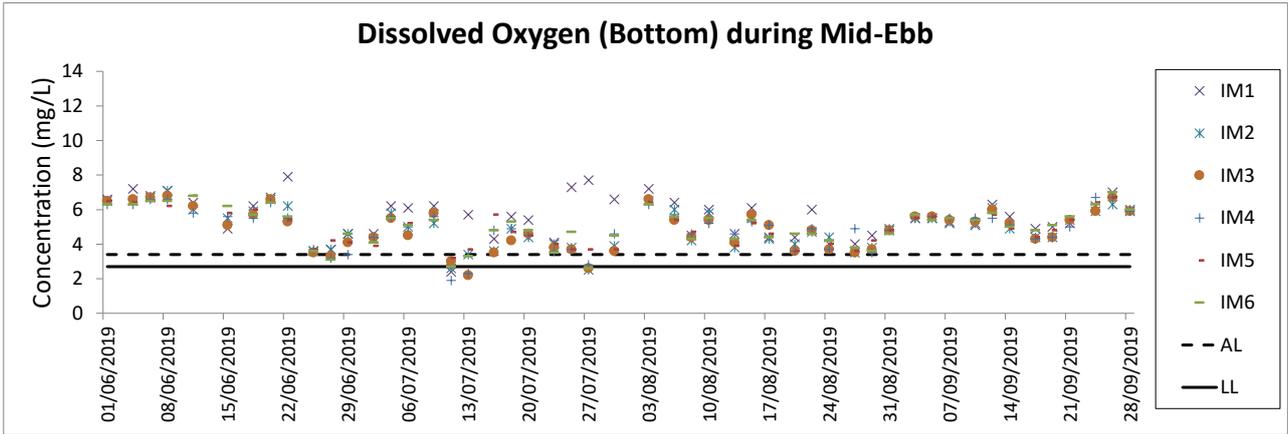
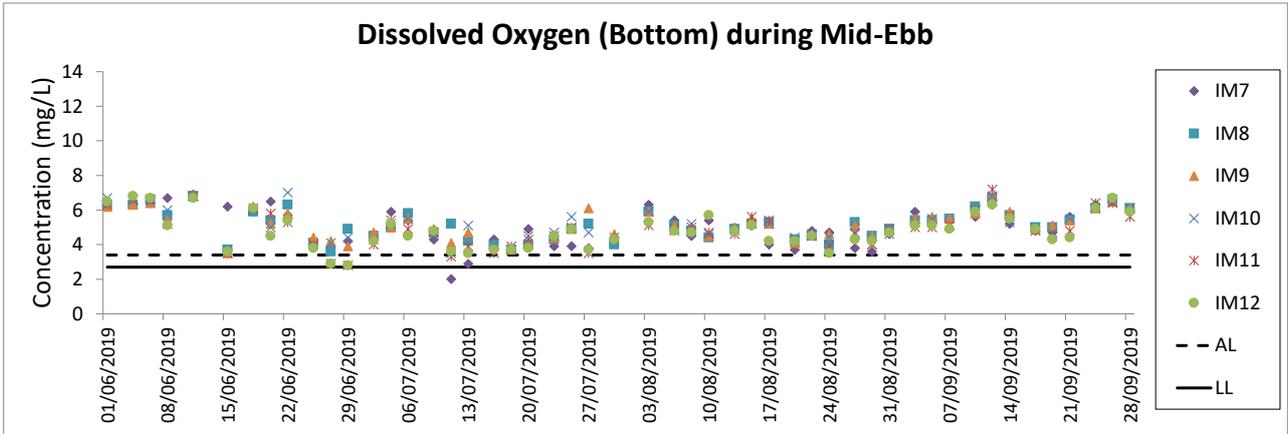
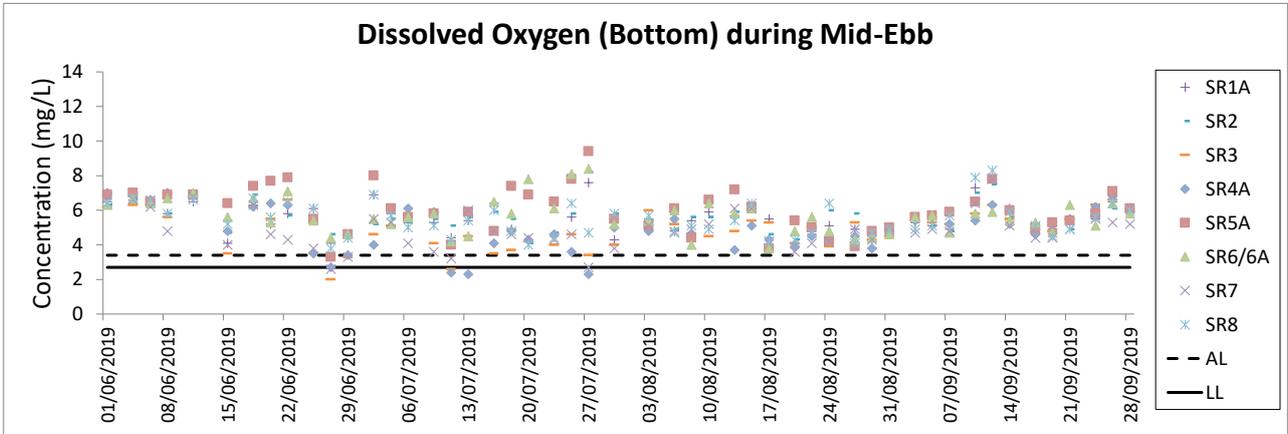
1. The key marine works activities of the Project during monitoring included deep cement mixing (DCM) works, marine filling, and seawall construction.
2. General weather condition during monitoring ranged from sunny to rainy, with sea condition ranged from calm to rough. Detailed meteorological conditions can be referred to Table 2.11 of this Report and corresponding Monthly EM&A Reports.
3. QA/ QC requirements as stipulated in the EM&A Manual were carried out during measurement.
4. As the access to SR6 was obstructed by the construction activities and temporary structures for Tung Chung New Town Extension, the monitoring location has been relocated to SR6A starting from 8 August 2019.

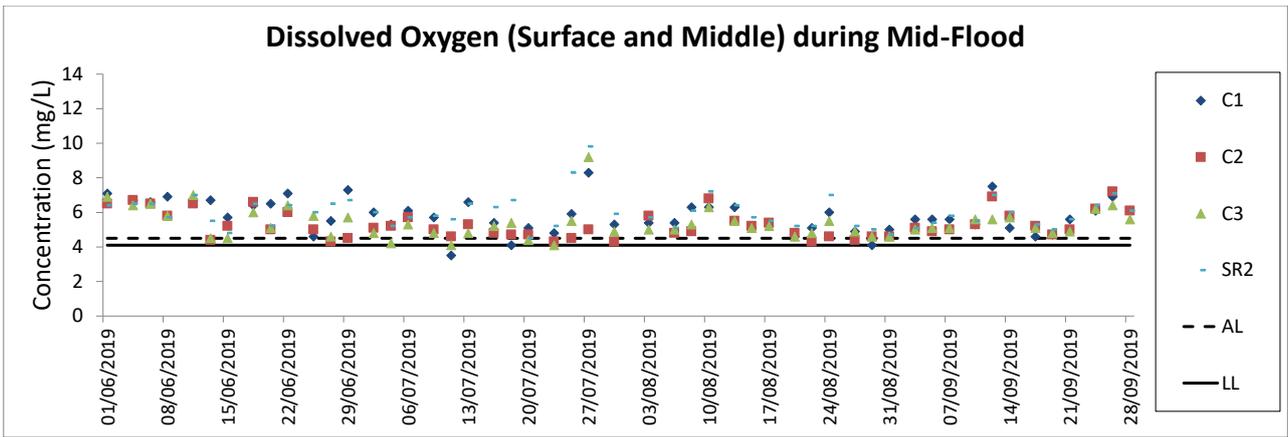
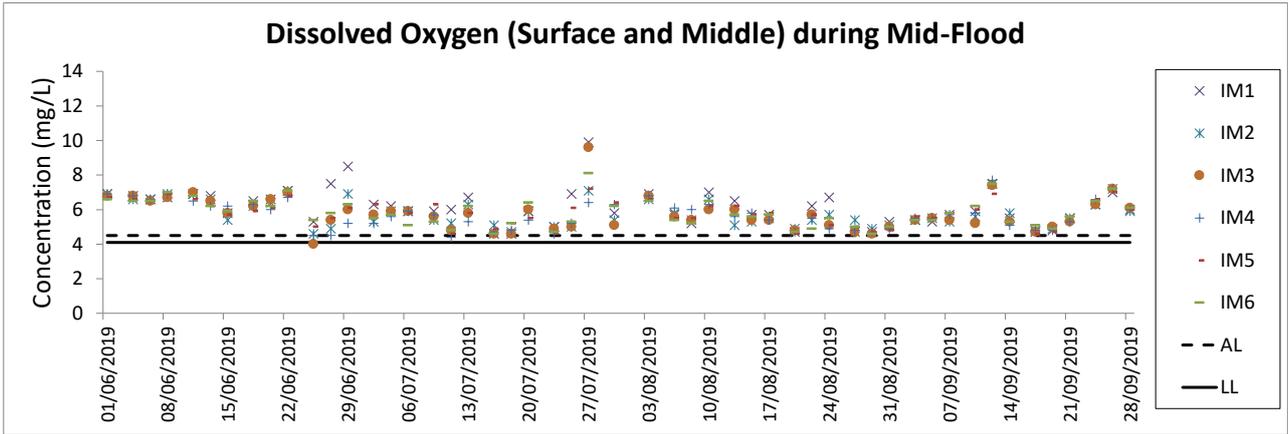
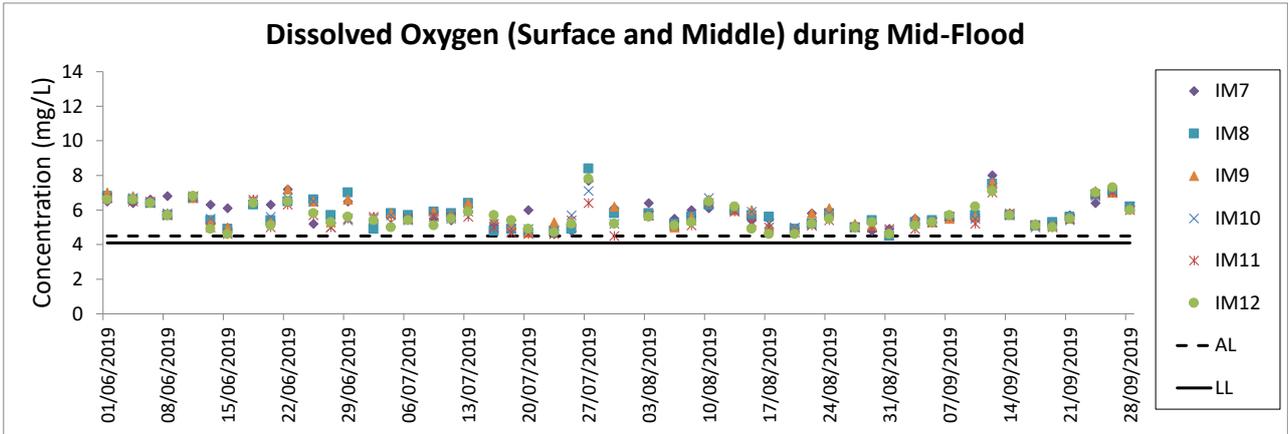
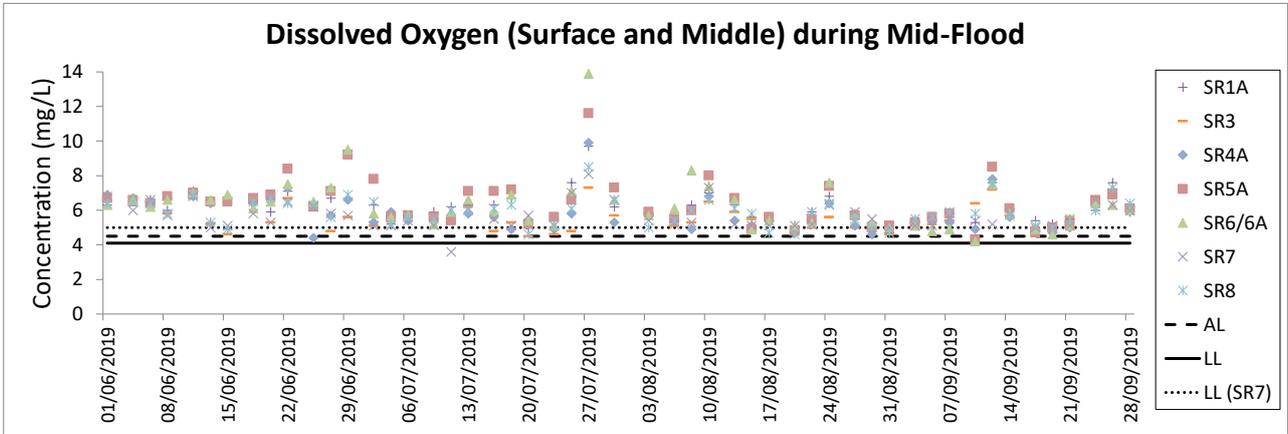
1. The key marine works activities of the Project during monitoring included deep cement mixing (DCM) works, marine filling, and seawall construction.
2. General weather condition during monitoring ranged from sunny to rainy, with sea condition ranged from calm to rough. Detailed meteorological conditions can be referred to Table 2.11 of this Report and corresponding Monthly EM&A Reports.
3. QA/ QC requirements as stipulated in the EM&A Manual were carried out during measurement.
4. As the access to SR6 was obstructed by the construction activities and temporary structures for Tung Chung New Town Extension, the monitoring location has been relocated to SR6A starting from 8 August 2019.

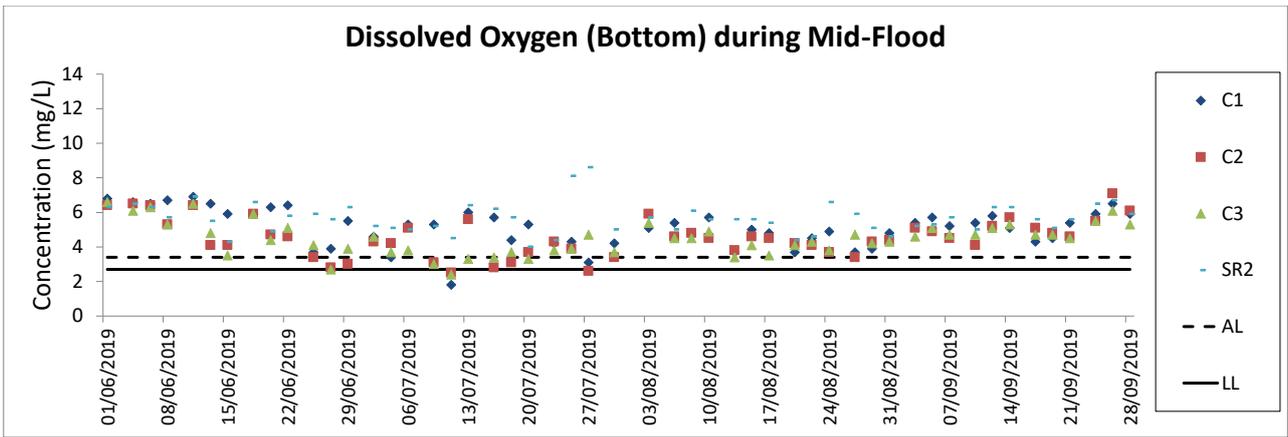
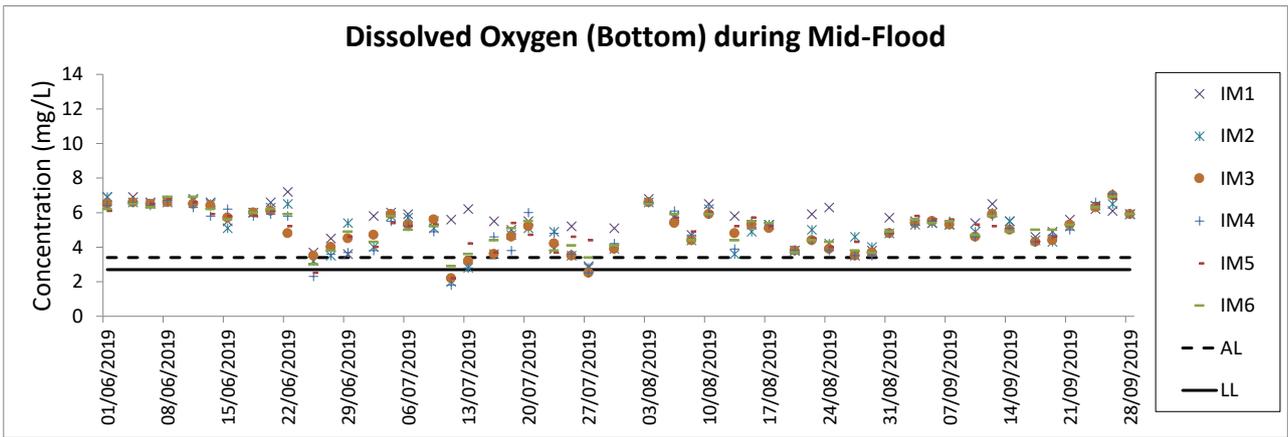
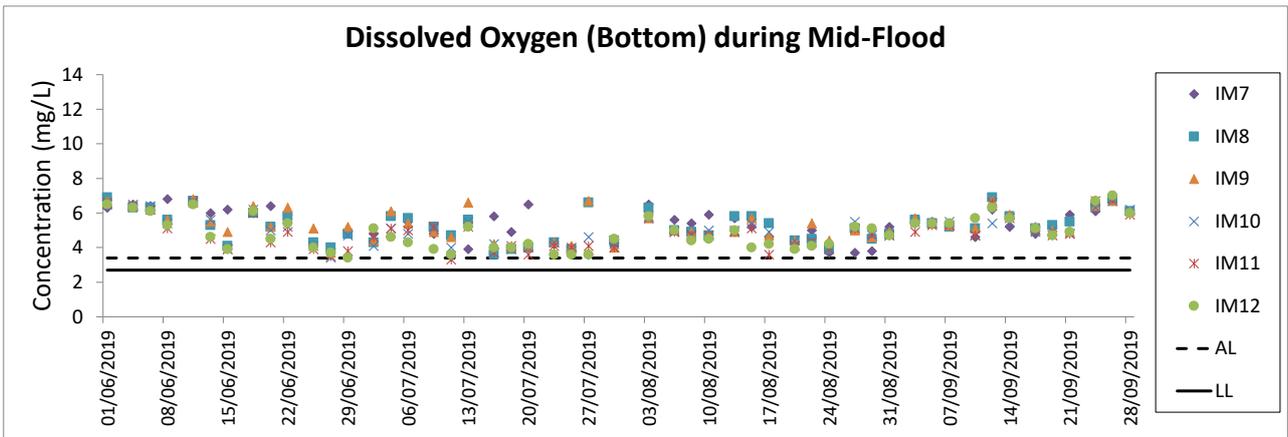
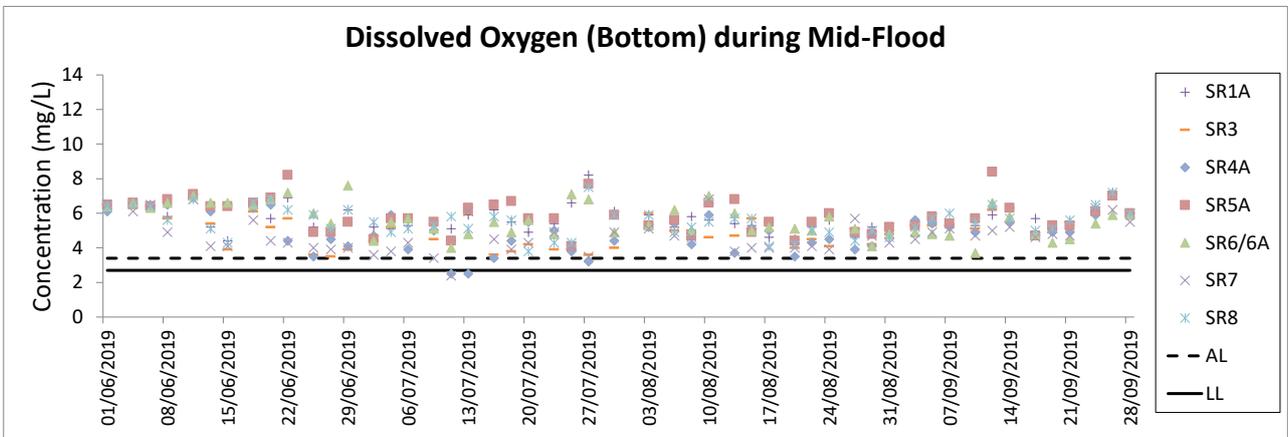
- Notes:
1. The key marine works activities of the Project during monitoring included deep cement mixing (DCM) works, marine filling, and seawall construction.
 2. General weather condition during monitoring ranged from sunny to rainy, with sea condition ranged from calm to rough. Detailed meteorological conditions can be referred to Table 2.11 of this Report and corresponding Monthly EM&A Reports.
 3. QA/ QC requirements as stipulated in the EM&A Manual were carried out during measurement.
 4. As the access to SR6 was obstructed by the construction activities and temporary structures for Tung Chung New Town Extension, the monitoring location has been relocated to SR6A starting from 8 August 2019.

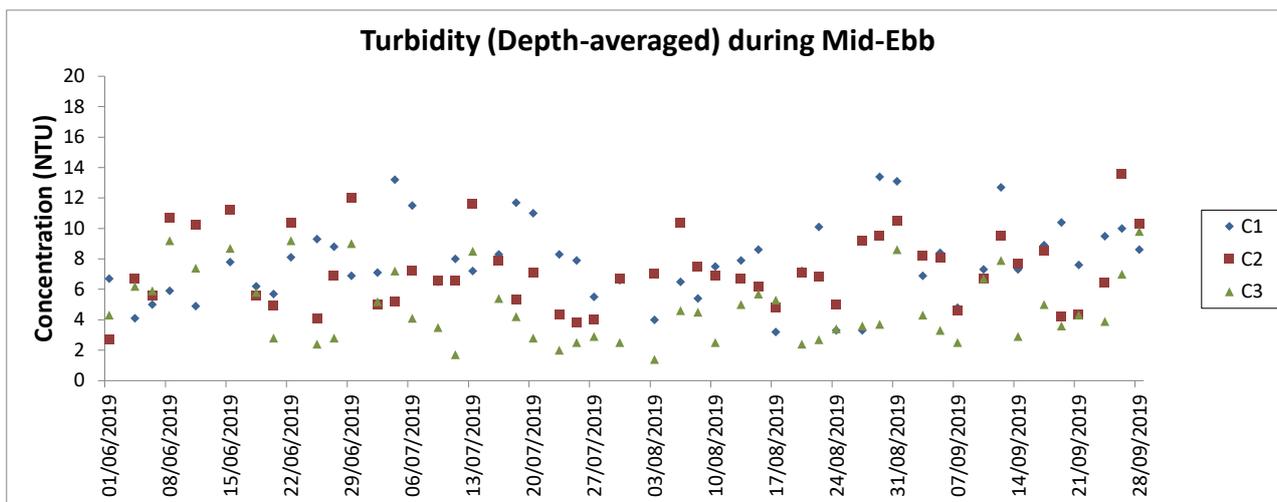
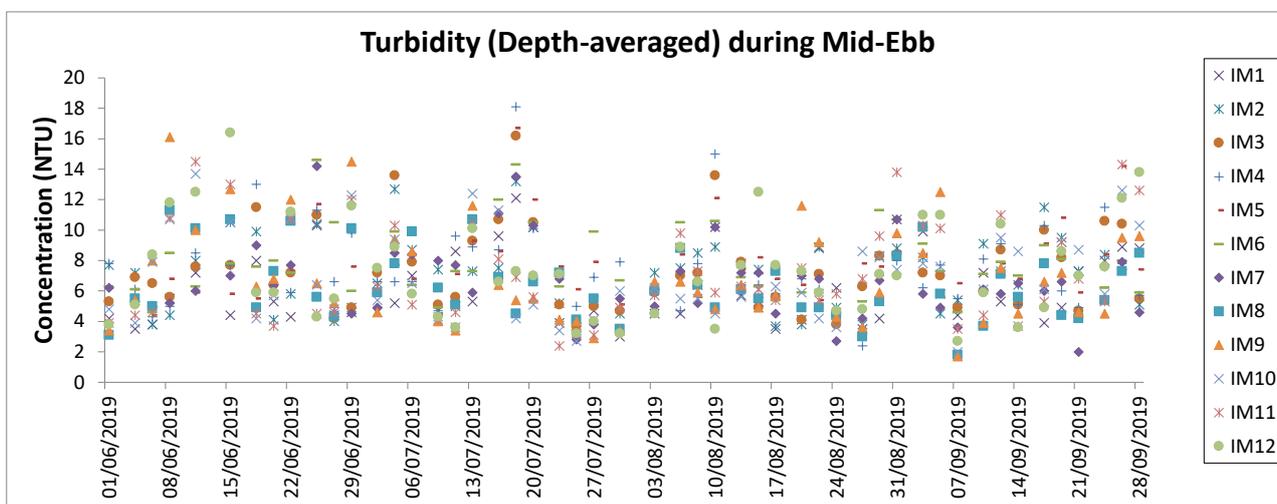
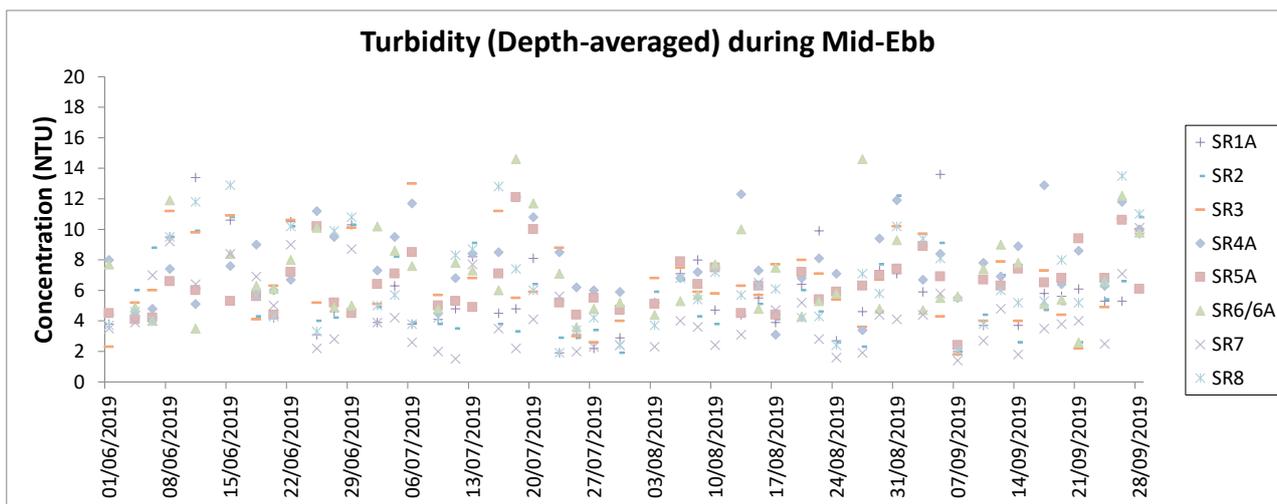
1. The Action and Limit Levels can be referred to Table 2.8 of this Report.
2. The key marine works activities of the Project during monitoring included deep cement mixing (DCM) works, marine filling, and seawall construction.
3. General weather condition during monitoring ranged from sunny to rainy, with sea condition ranged from calm to rough. Detailed meteorological conditions can be referred to Table 2.11 of this Report and corresponding Monthly EM&A Reports.
4. QA/ QC requirements as stipulated in the EM&A Manual were carried out during measurement.
5. As the access to SR6 was obstructed by the construction activities and temporary structures for Tung Chung New Town Extension, the monitoring location has been relocated to SR6A starting from 8 August 2019.

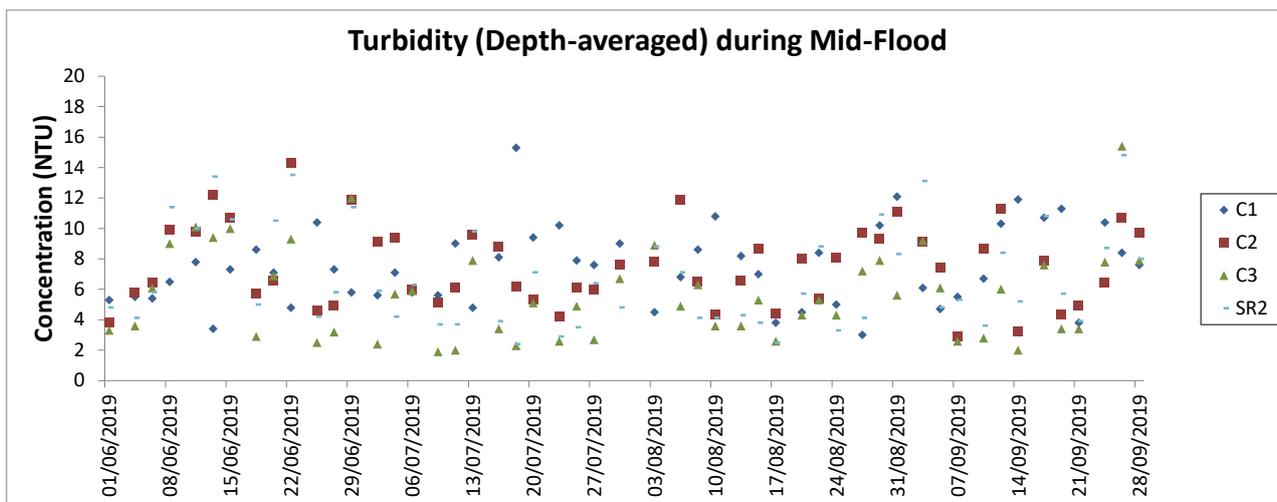
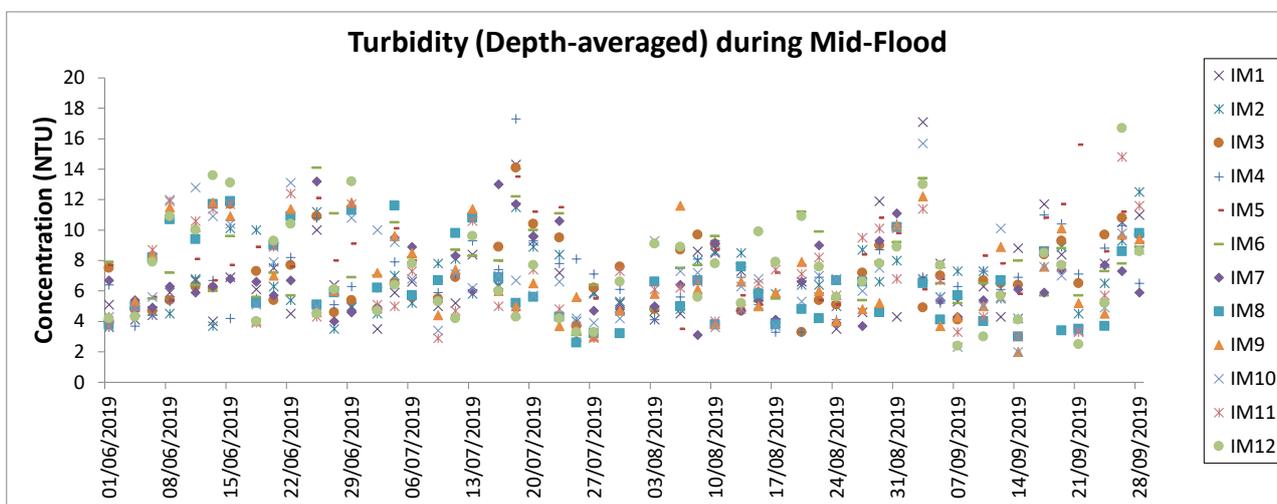
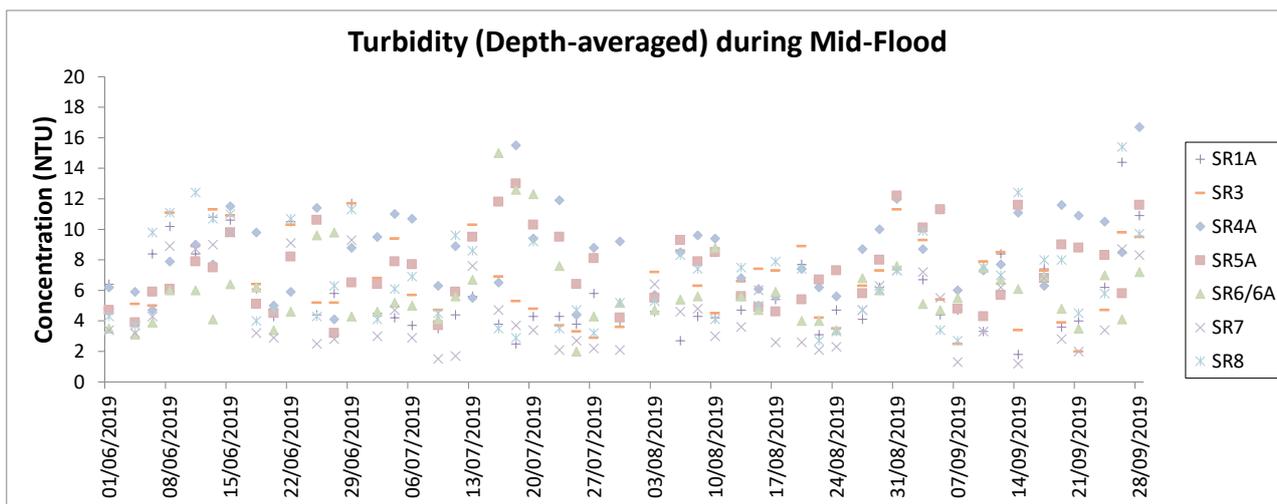
1. The Action and Limit Levels can be referred to Table 2.8 of this Report.
2. The key marine works activities of the Project during monitoring included deep cement mixing (DCM) works, marine filling, and seawall construction.
3. General weather condition during monitoring ranged from sunny to rainy, with sea condition ranged from calm to rough. Detailed meteorological conditions can be referred to Table 2.11 of this Report and corresponding Monthly EM&A Reports.
4. QA/ QC requirements as stipulated in the EM&A Manual were carried out during measurement.
5. As the access to SR6 was obstructed by the construction activities and temporary structures for Tung Chung New Town Extension, the monitoring location has been relocated to SR6A starting from 8 August 2019.

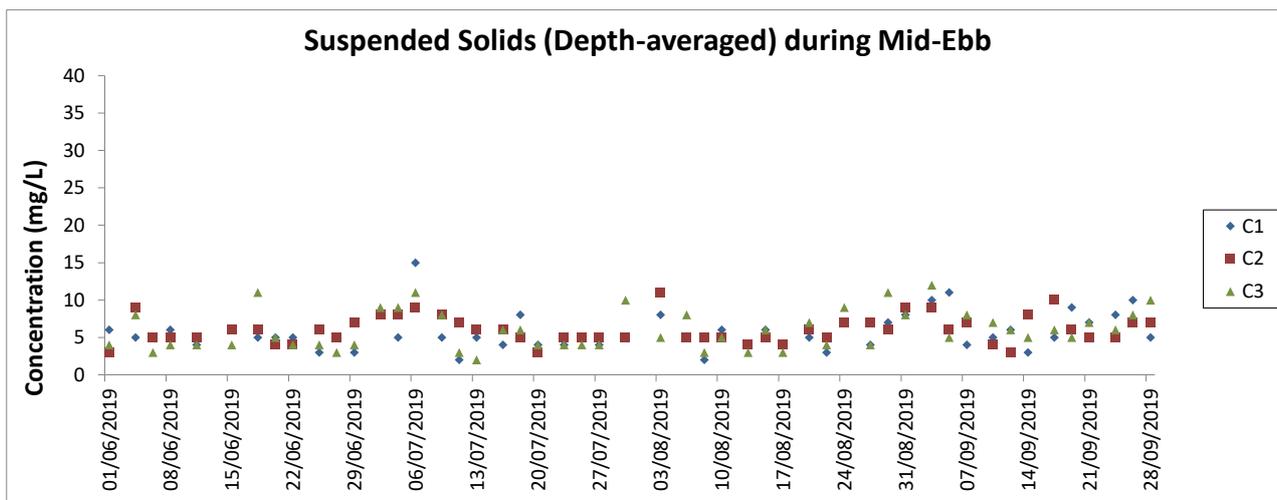
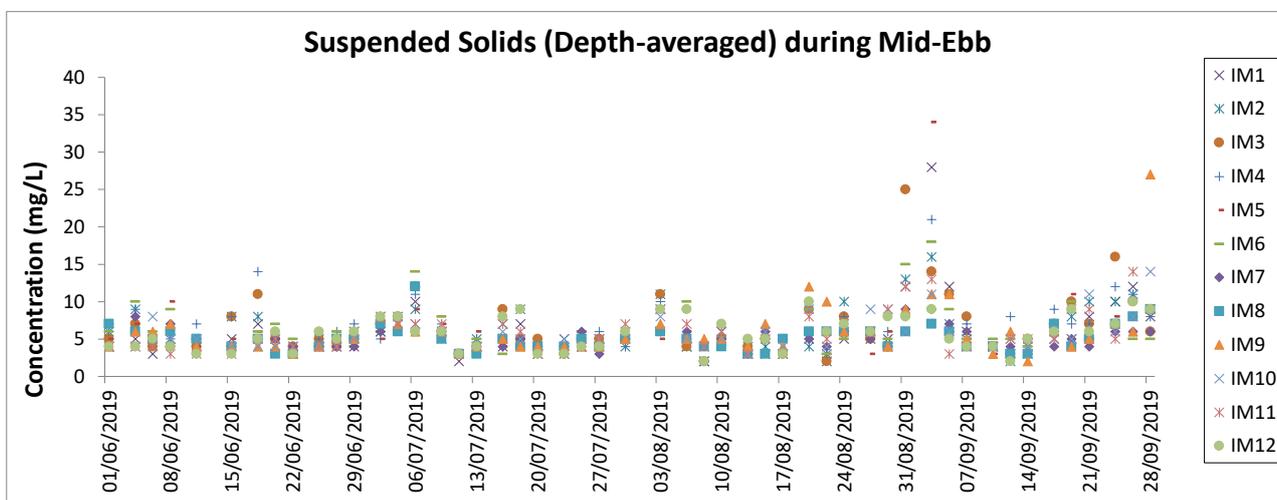
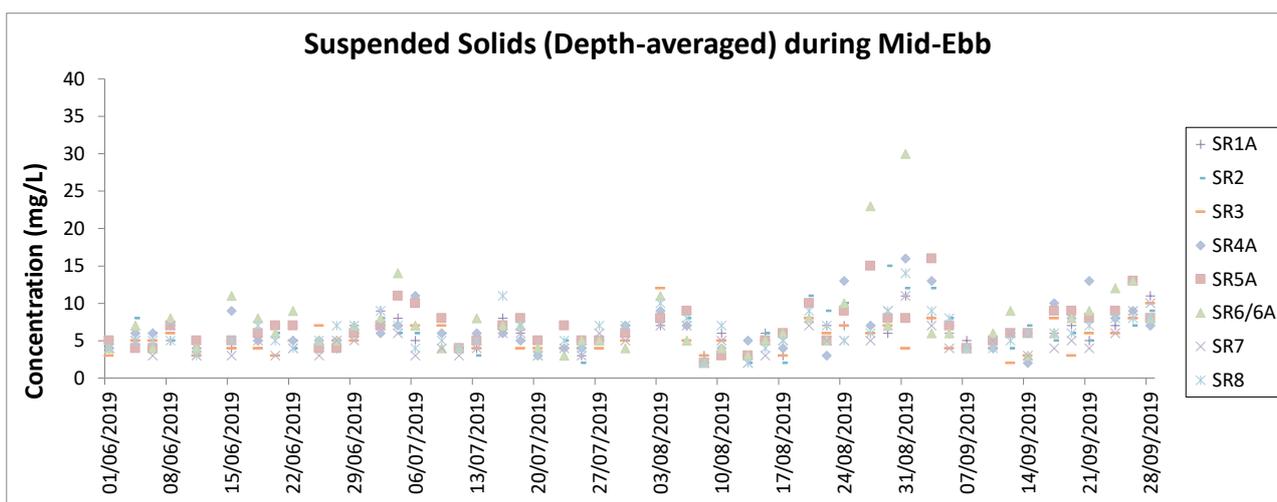
1. The Action and Limit Levels can be referred to Table 2.8 of this Report.
2. The key marine works activities of the Project during monitoring included deep cement mixing (DCM) works, marine filling, and seawall construction.
3. General weather condition during monitoring ranged from sunny to rainy, with sea condition ranged from calm to rough. Detailed meteorological conditions can be referred to Table 2.11 of this Report and corresponding Monthly EM&A Reports.
4. QA/ QC requirements as stipulated in the EM&A Manual were carried out during measurement.
5. As the access to SR6 was obstructed by the construction activities and temporary structures for Tung Chung New Town Extension, the monitoring location has been relocated to SR6A starting from 8 August 2019.

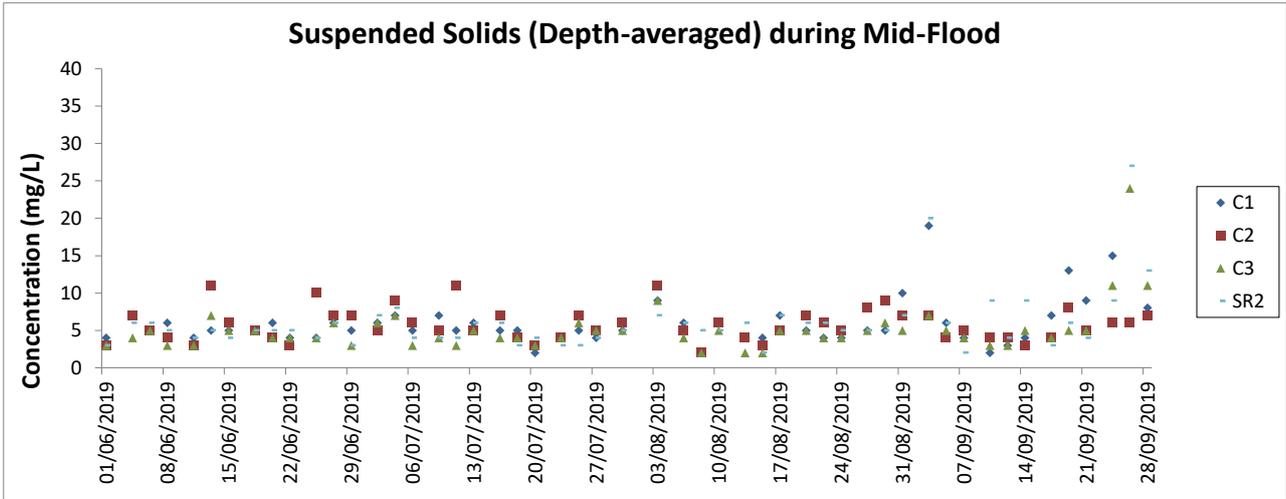
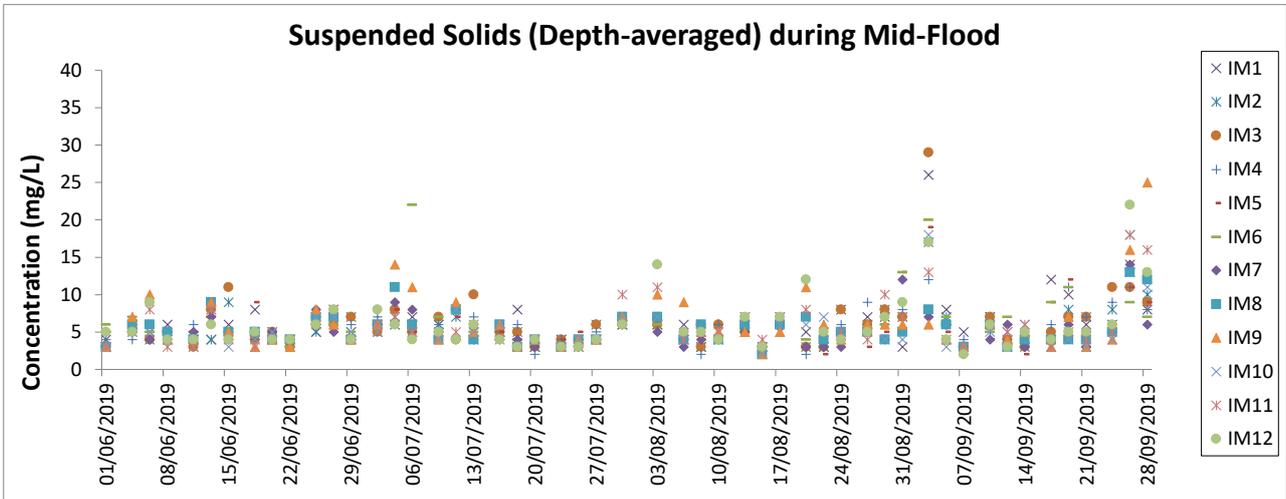
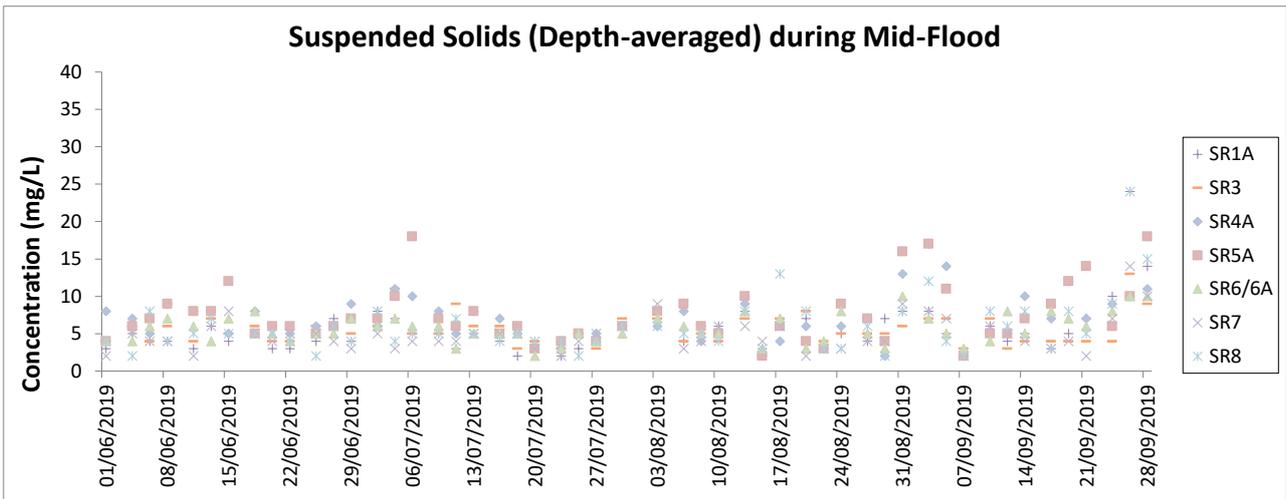
1. The Action and Limit Levels can be referred to Table 2.8 of this Report.
2. The key marine works activities of the Project during monitoring included deep cement mixing (DCM) works, marine filling, and seawall construction.
3. General weather condition during monitoring ranged from sunny to rainy, with sea condition ranged from calm to rough. Detailed meteorological conditions can be referred to Table 2.11 of this Report and corresponding Monthly EM&A Reports.
4. QA/ QC requirements as stipulated in the EM&A Manual were carried out during measurement.
5. As the access to SR6 was obstructed by the construction activities and temporary structures for Tung Chung New Town Extension, the monitoring location has been relocated to SR6A starting from 8 August 2019.

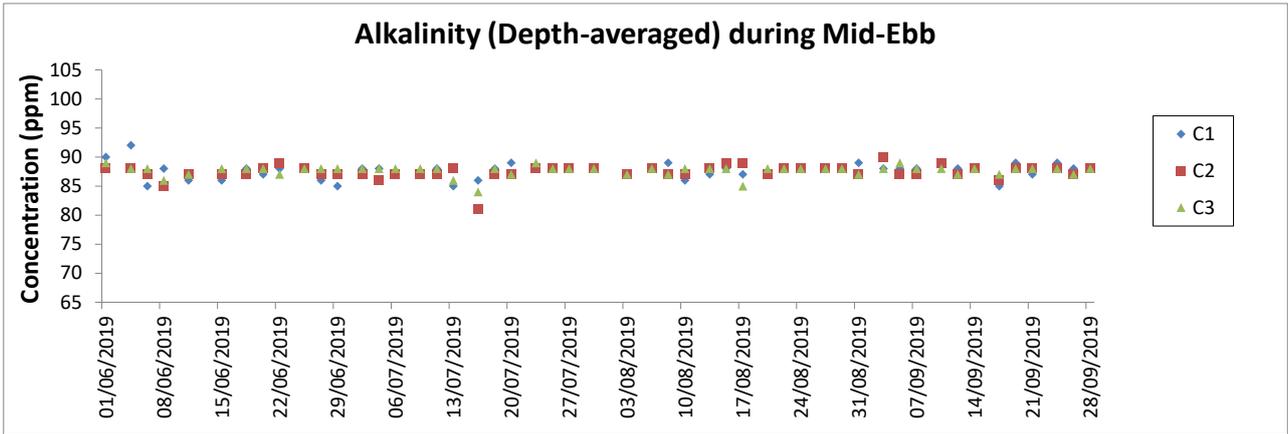
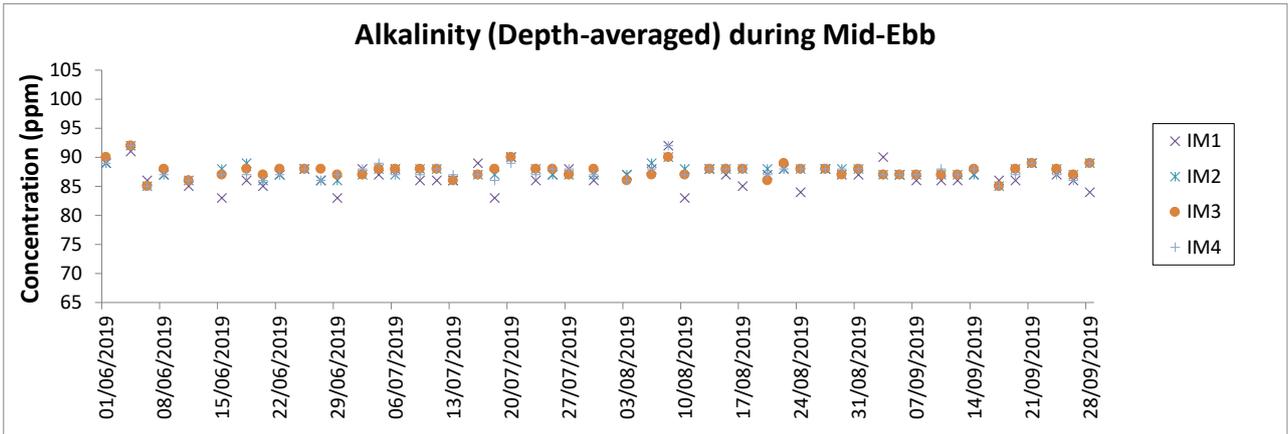
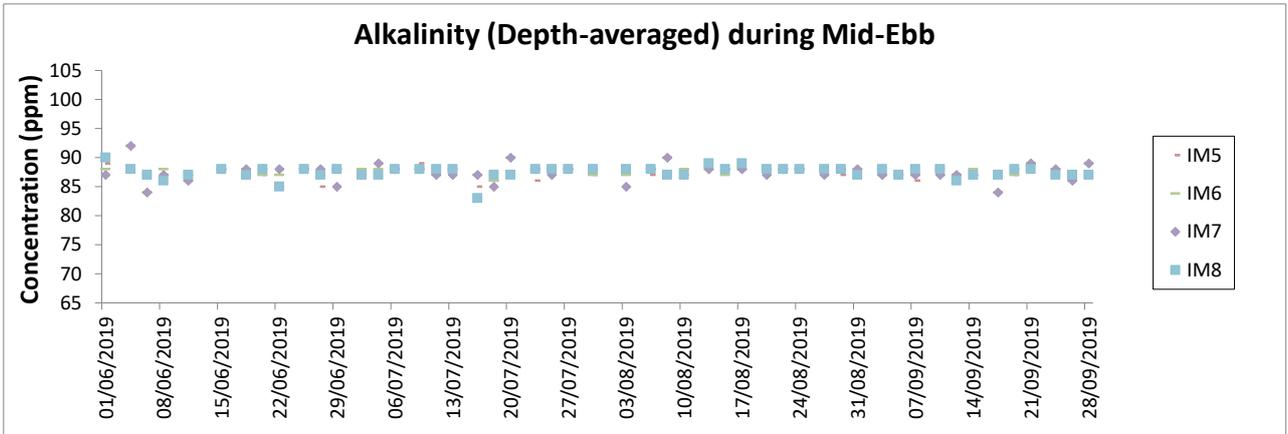
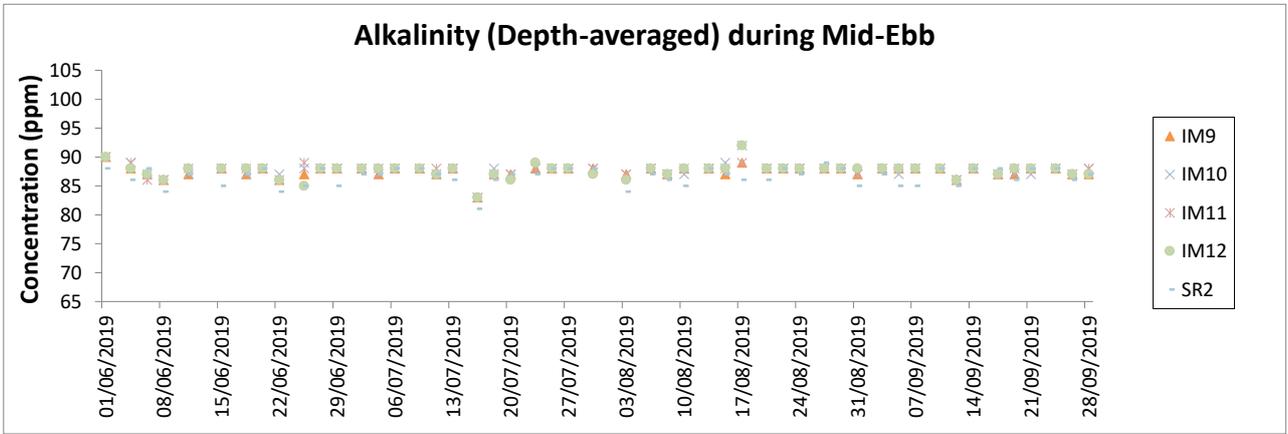
- Notes:
1. The Action and Limit Levels can be referred to Table 2.8 of this Report.
 2. The key marine works activities of the Project during monitoring included deep cement mixing (DCM) works, marine filling, and seawall construction.
 3. General weather condition during monitoring ranged from sunny to rainy, with sea condition ranged from calm to rough. Detailed meteorological conditions can be referred to Table 2.11 of this Report and corresponding Monthly EM&A Reports.
 4. QA/ QC requirements as stipulated in the EM&A Manual were carried out during measurement.
