Appendix C. Monitoring Results

Air Quality Monitoring Results

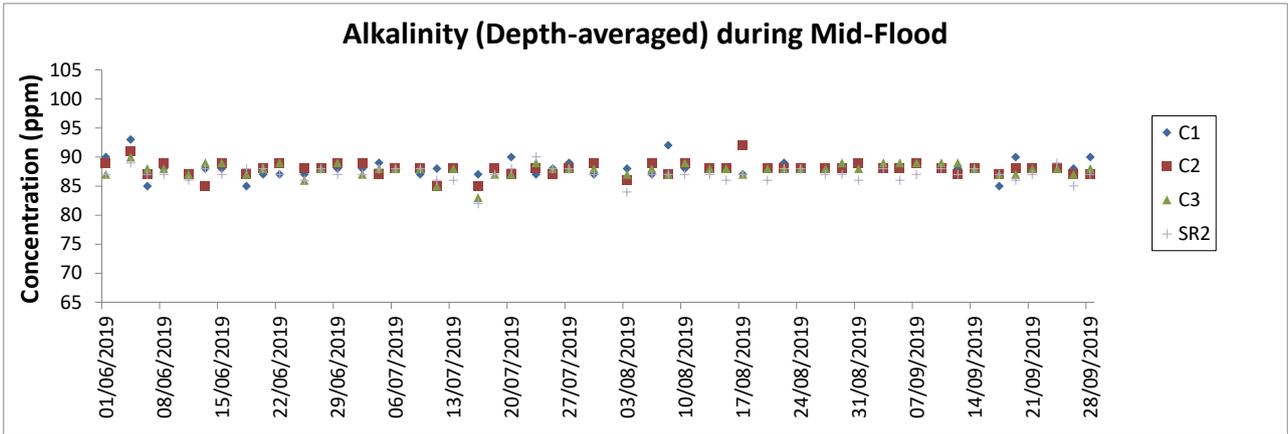
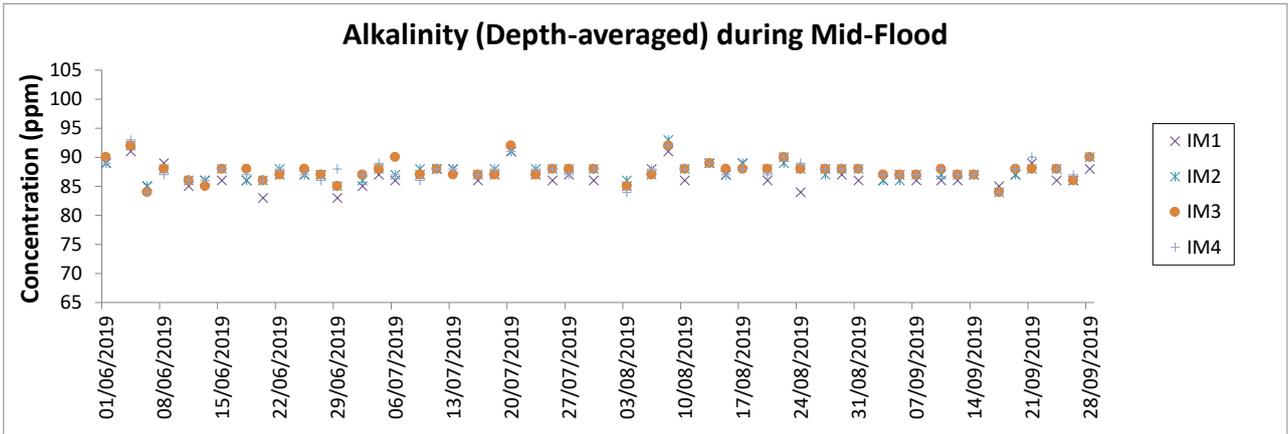
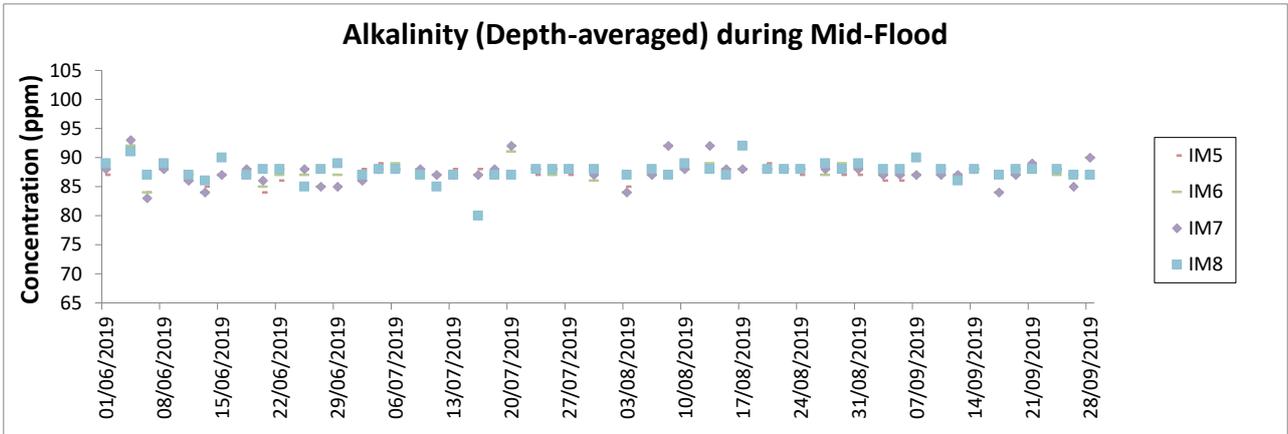
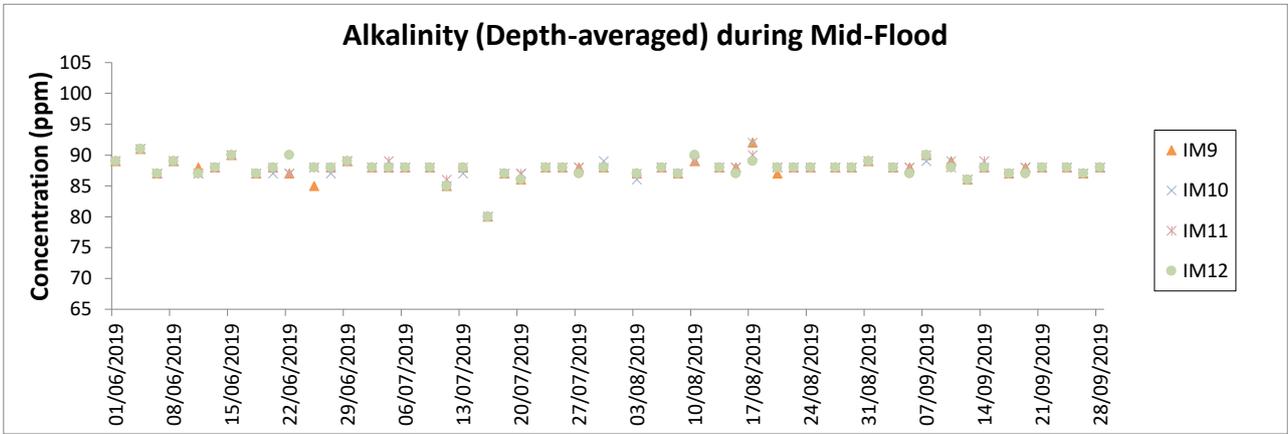
- Notes:
1. The Action and Limit Levels can be referred to Table 2.8 of this Report.
 2. The key marine works activities of the Project during monitoring included deep cement mixing (DCM) works, marine filling, and seawall construction.
 3. General weather condition during monitoring ranged from sunny to rainy, with sea condition ranged from calm to rough. Detailed meteorological conditions can be referred to Table 2.11 of this Report and corresponding Monthly EM&A Reports.
 4. QA/ QC requirements as stipulated in the EM&A Manual were carried out during measurement.

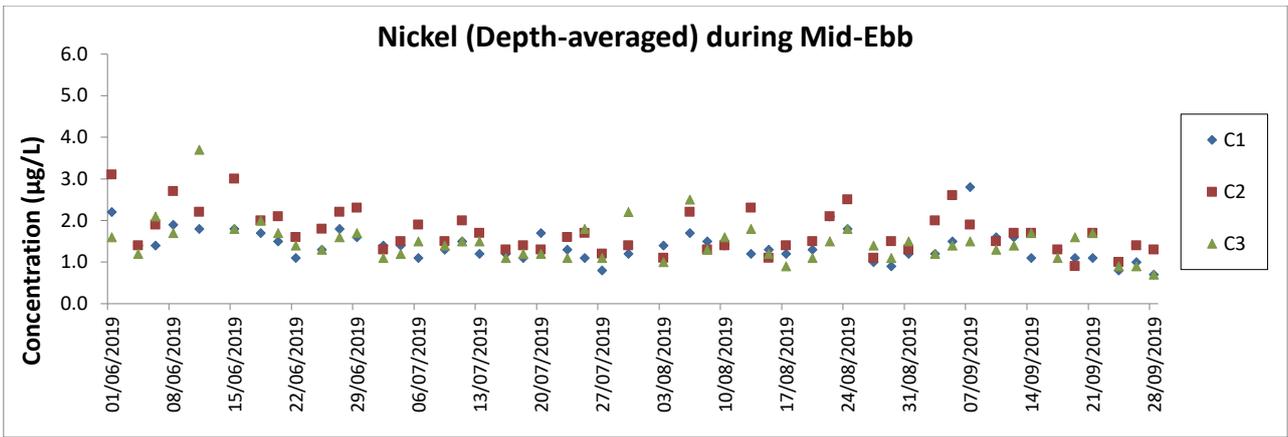
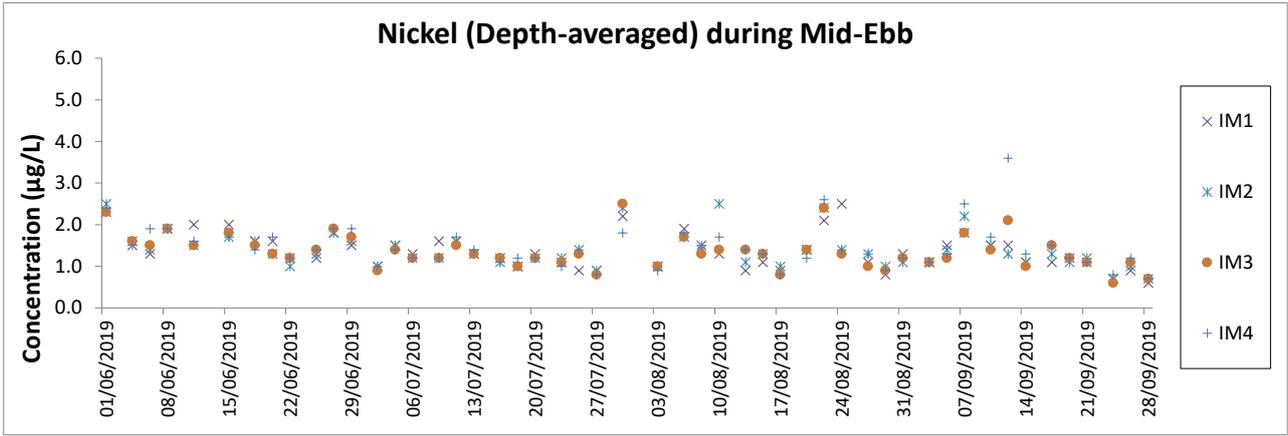
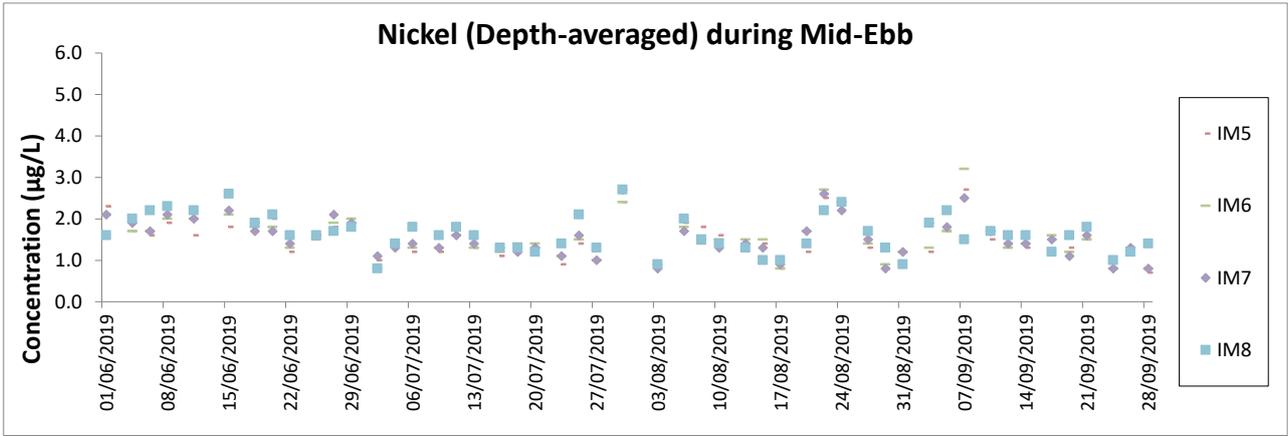
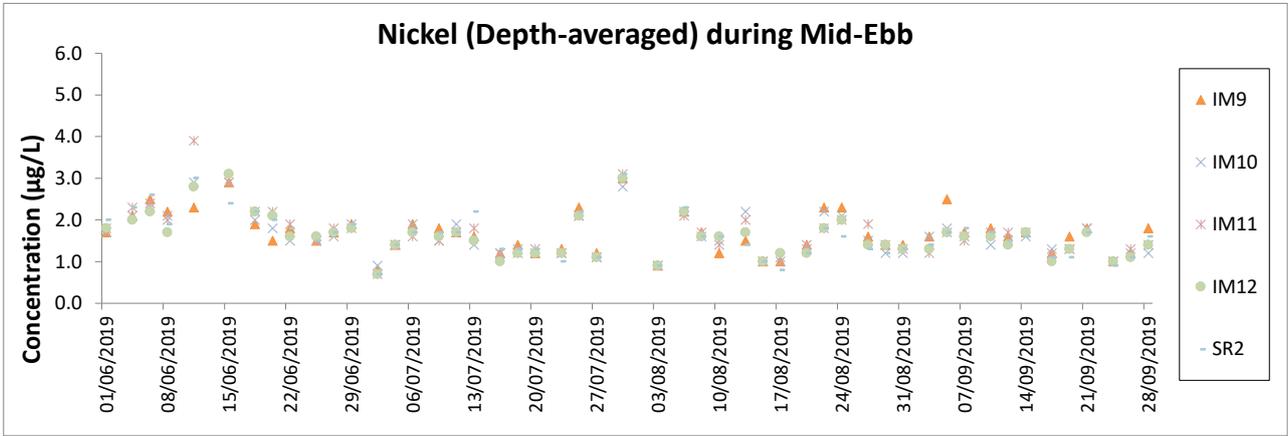
1. The Action and Limit Levels can be referred to Table 2.8 of this Report.
2. The key marine works activities of the Project during monitoring included deep cement mixing (DCM) works, marine filling, and seawall construction.
3. General weather condition during monitoring ranged from sunny to rainy, with sea condition ranged from calm to rough. Detailed meteorological conditions can be referred to Table 2.11 of this Report and corresponding Monthly EM&A Reports.
4. QA/ QC requirements as stipulated in the EM&A Manual were carried out during measurement.

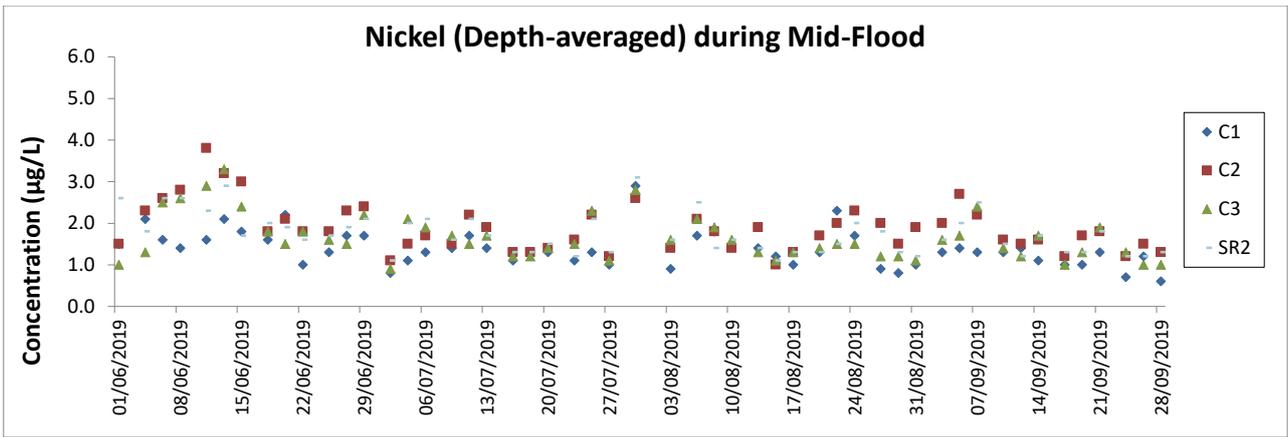
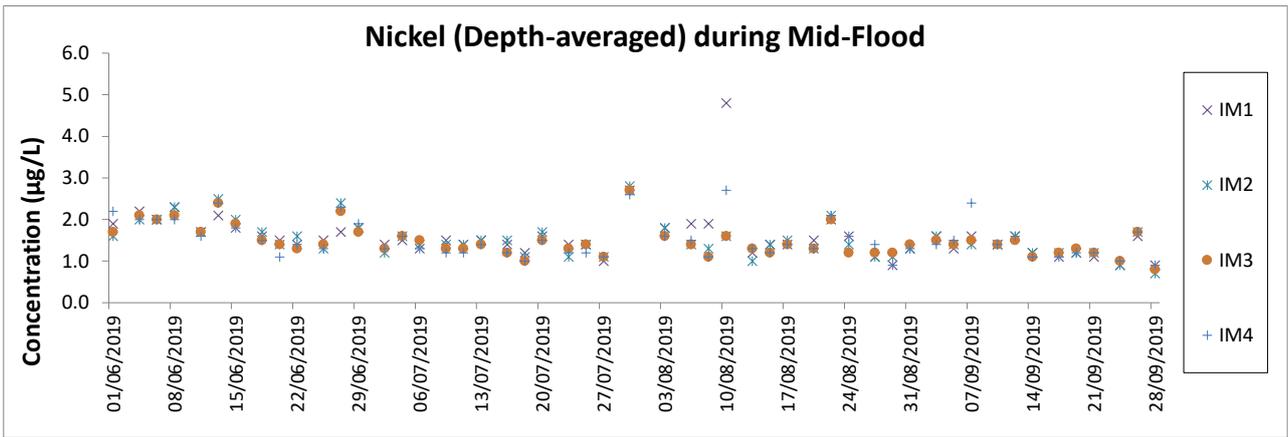
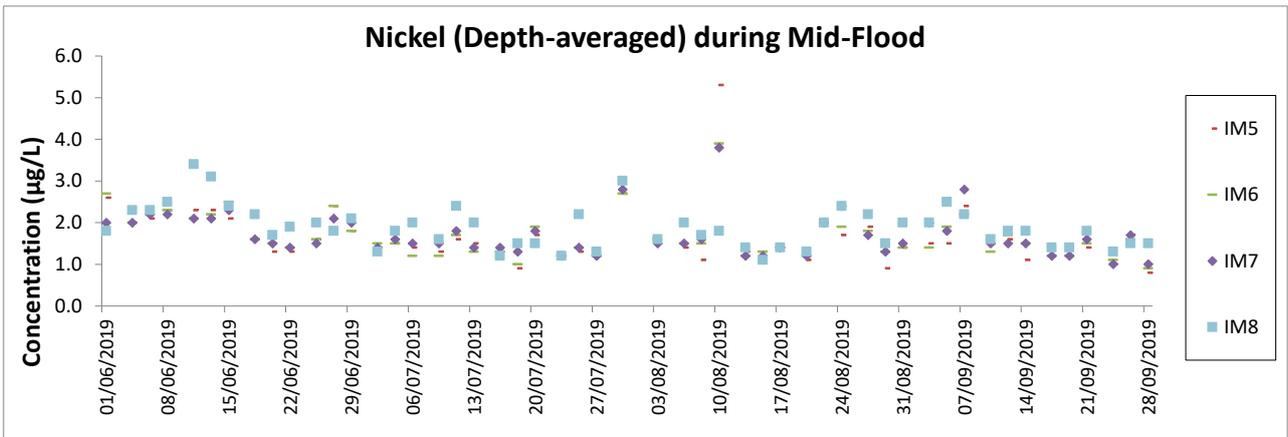
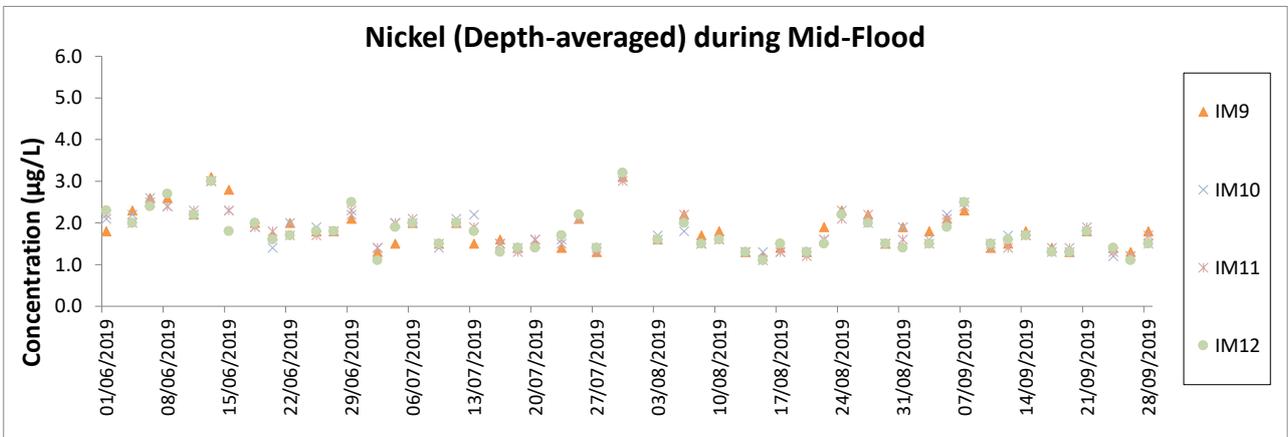
1. The Action and Limit Levels can be referred to Table 2.8 of this Report.
2. The key marine works activities of the Project during monitoring included deep cement mixing (DCM) works, marine filling, and seawall construction.
3. General weather condition during monitoring ranged from sunny to rainy, with sea condition ranged from calm to rough. Detailed meteorological conditions can be referred to Table 2.11 of this Report and corresponding Monthly EM&A Reports.
4. QA/ QC requirements as stipulated in the EM&A Manual were carried out during measurement.
5. All chromium results in the reporting period was below the reporting limit 0.2 µg/L.
