Appendix C. Monitoring Results

Air Quality Monitoring Results

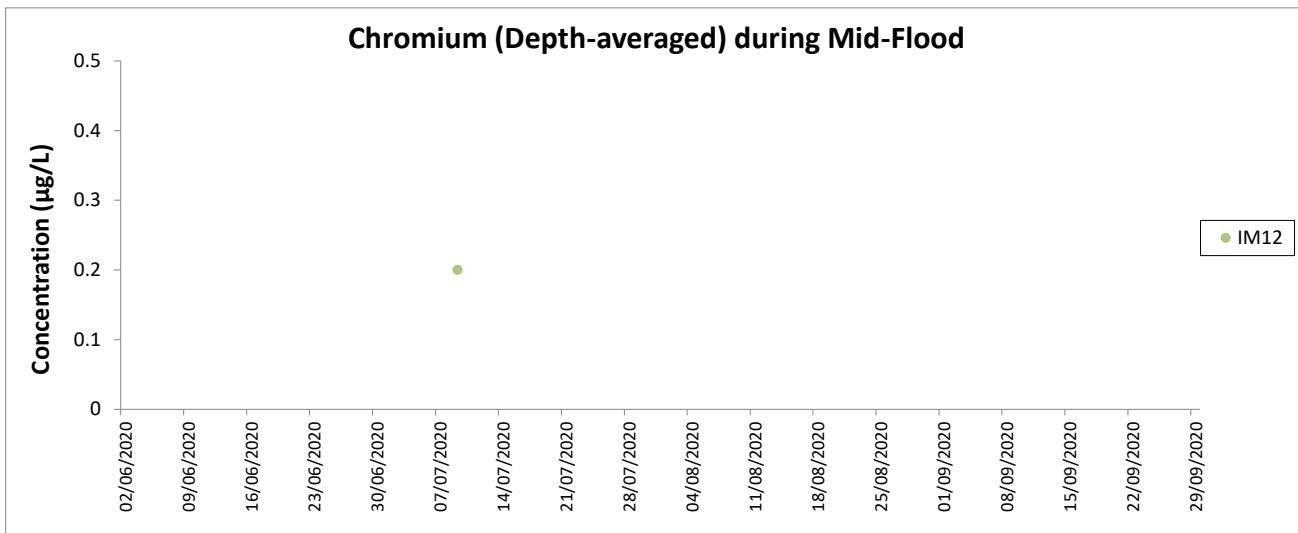
1. The Action and Limit Levels can be referred to Table 2.8 of this Report.
2. The monitoring results of chromium not presented above were below the reporting limit of 0.2 µg/L.
3. The key marine works activities of the Project during monitoring included deep cement mixing (DCM) works, marine filling, seawall and facilities construction, together with runway
4. General weather condition during monitoring ranged from sunny to rainy, with sea condition ranged from calm to rough. Detailed meteorological conditions can be referred to Table 2.11 of this Report and corresponding Monthly EM&A Reports.
5. QA/ QC requirements as stipulated in the EM&A Manual were carried out during measurement.
