Expansion of Hong Kong International Airport into a Three-Runway System

Construction Phase Quarterly EM&A Report
No.10 (1 April to 30 June 2018)

July 2018

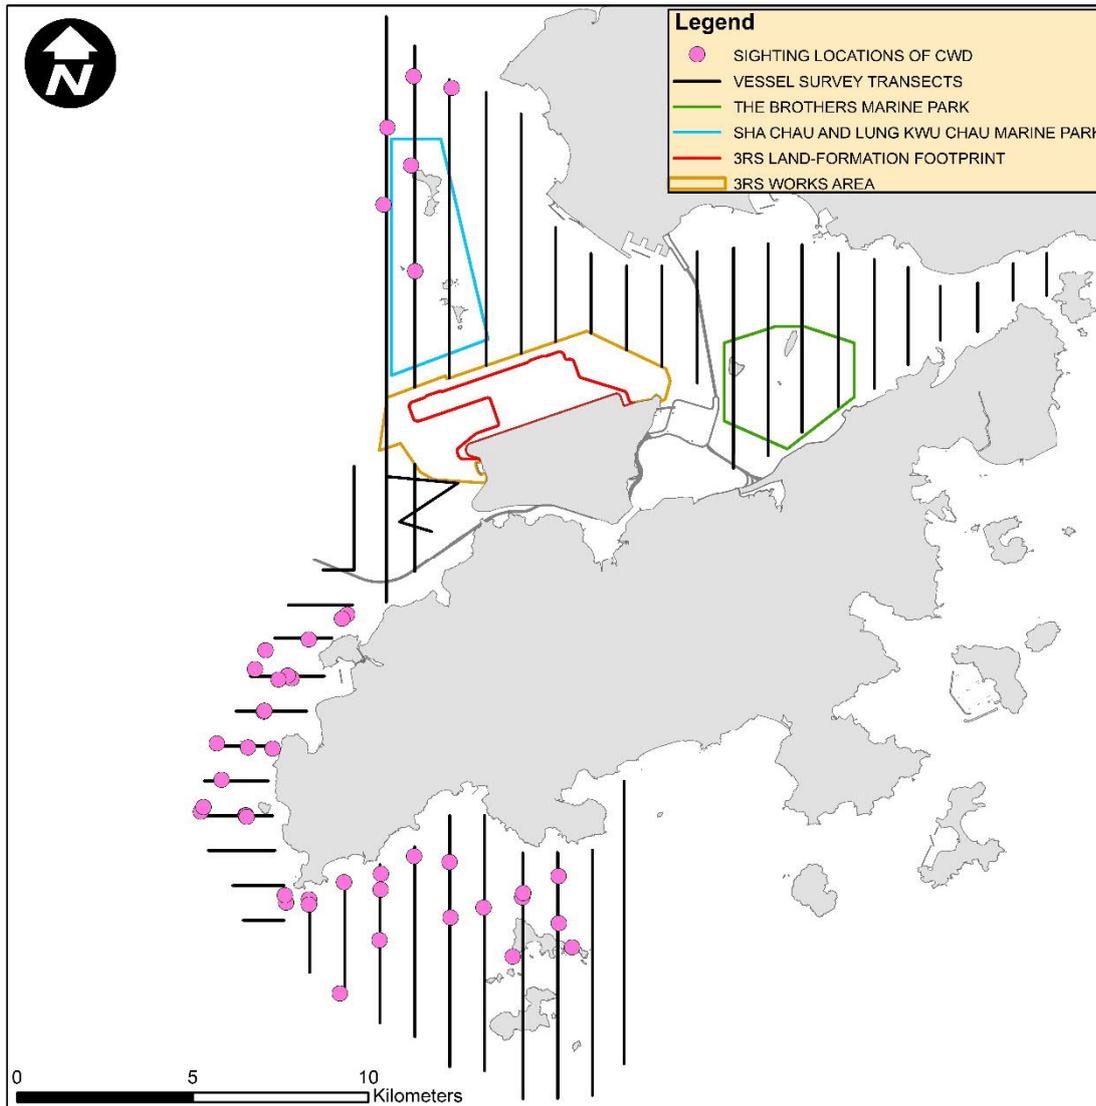
Figure 2.6: Sightings Distribution of Chinese White Dolphins from April to June 2018

Distribution of CWD sightings recorded from April to June 2018 is illustrated in **Figure 2.6**. In NWL, all CWD sightings were located at the northwestern part of the survey, particularly the northern and western waters of Lung Kwu Chau. No CWD was sighted in close vicinity to the 3RS works area and also in NEL. In WL, most CWD sightings were recorded on transects from Tai O to Peaked Hill. Two sightings were recorded at the waters off Fan Lau. While in SWL, CWD sightings were distributed from Fan Lau to Lo Kei Wan, with some sightings recorded around Soko Islands. Details of the sighting data are presented in **Appendix C**.

Remarks: Please note that there are 44 pink circles on the map indicating the sighting locations of CWD. Some of them were very close to each other and therefore appear overlapped on this sighting distribution map.

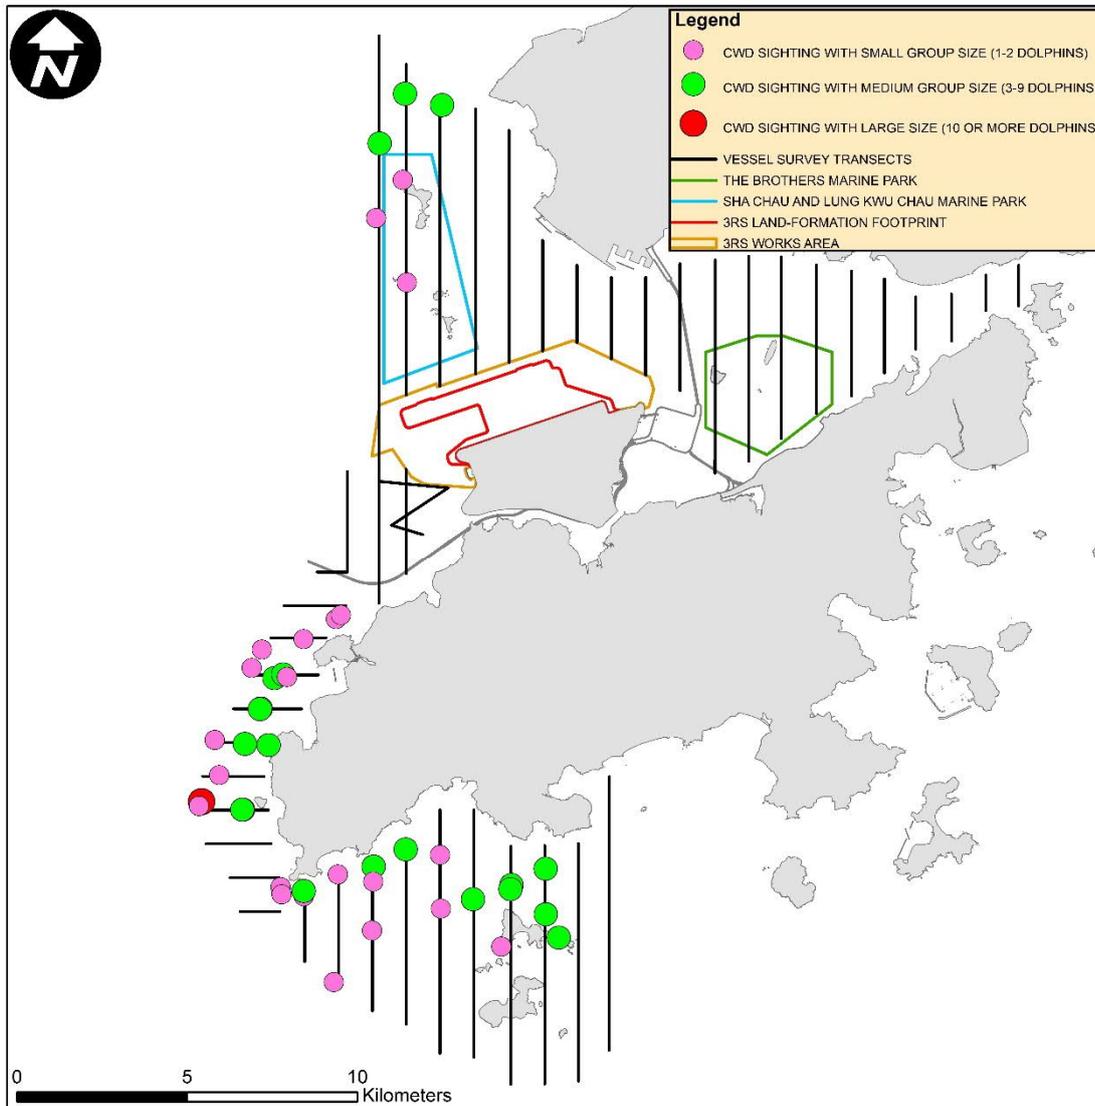
Figure 2.7: Sighting Locations of Chinese White Dolphins with Different Group Sizes

small group size and the number of sightings with medium group size were the similar. Sightings with small group size scattered on both coastal and off-shore waters from Fan Lau to Soko Islands while most of the medium sized sightings appeared on the waters between Lantau and Soko Islands.

Remarks: Please note that there are 44 circles on the map indicating the sighting locations of CWD. Some of them were very close to each other and therefore appear overlapped on this sighting distribution map.

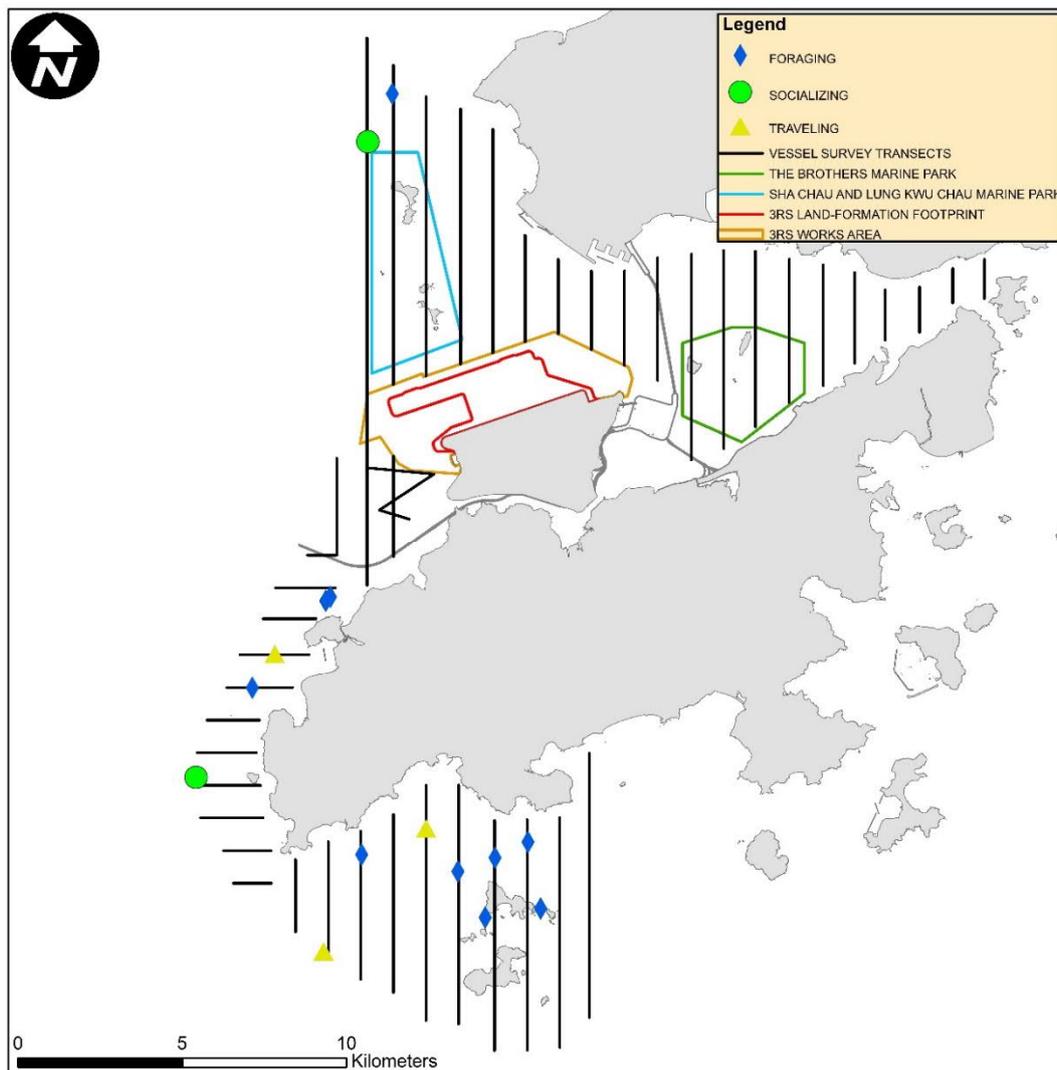
Figure 2.8: Sighting Locations of Chinese White Dolphins Engaged in Different Behaviours

During April to June 2018, 10 sightings of CWDs were recorded with feeding activities. Amongst these 10 sightings, two were observed in association with operating fishing boats. One was associated with purse seiner while another was associated with shrimp trawler. These two sightings were recorded in WL.

Compared with the data in the same quarter of last year, CWD sightings with feeding activities significantly decreased by 52%. Nevertheless, the number of sightings with association with operating fishing boats was also low (i.e. with only one sighting) in same quarter of last year. The sighting locations of CWDs engaged in different behaviours during the current reporting period are illustrated in **Figure 2.8**.

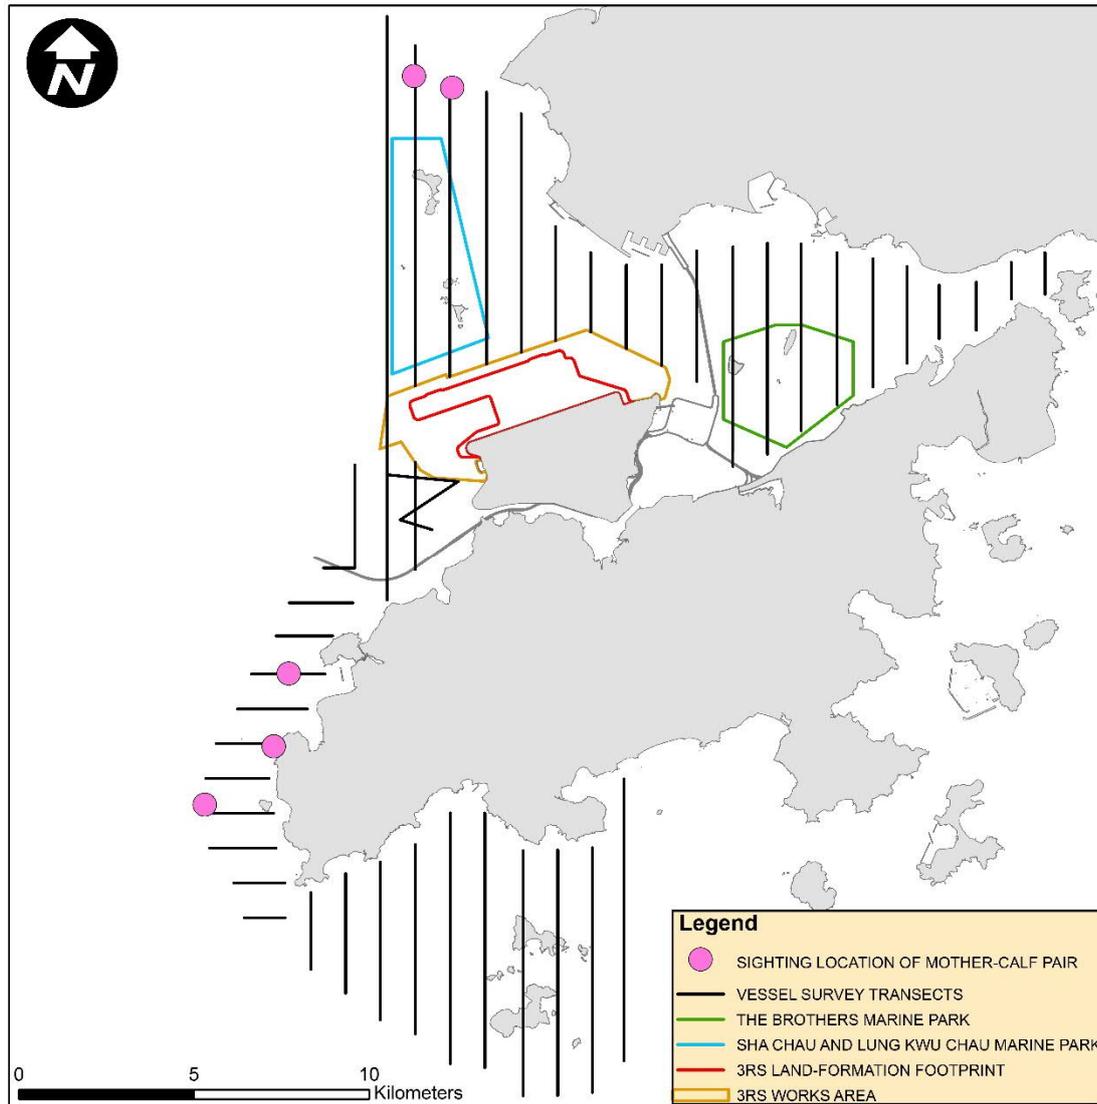
Figure 2.9: Sighting Locations of Mother-calf Pairs

From April to June 2018, five sightings of CWDs were recorded with the presence of mother-and-unspotted juvenile. Three of these sightings were recorded in WL while others were sighted in NWL. The sighting locations of mother-calf pairs are shown in **Figure 2.9**.

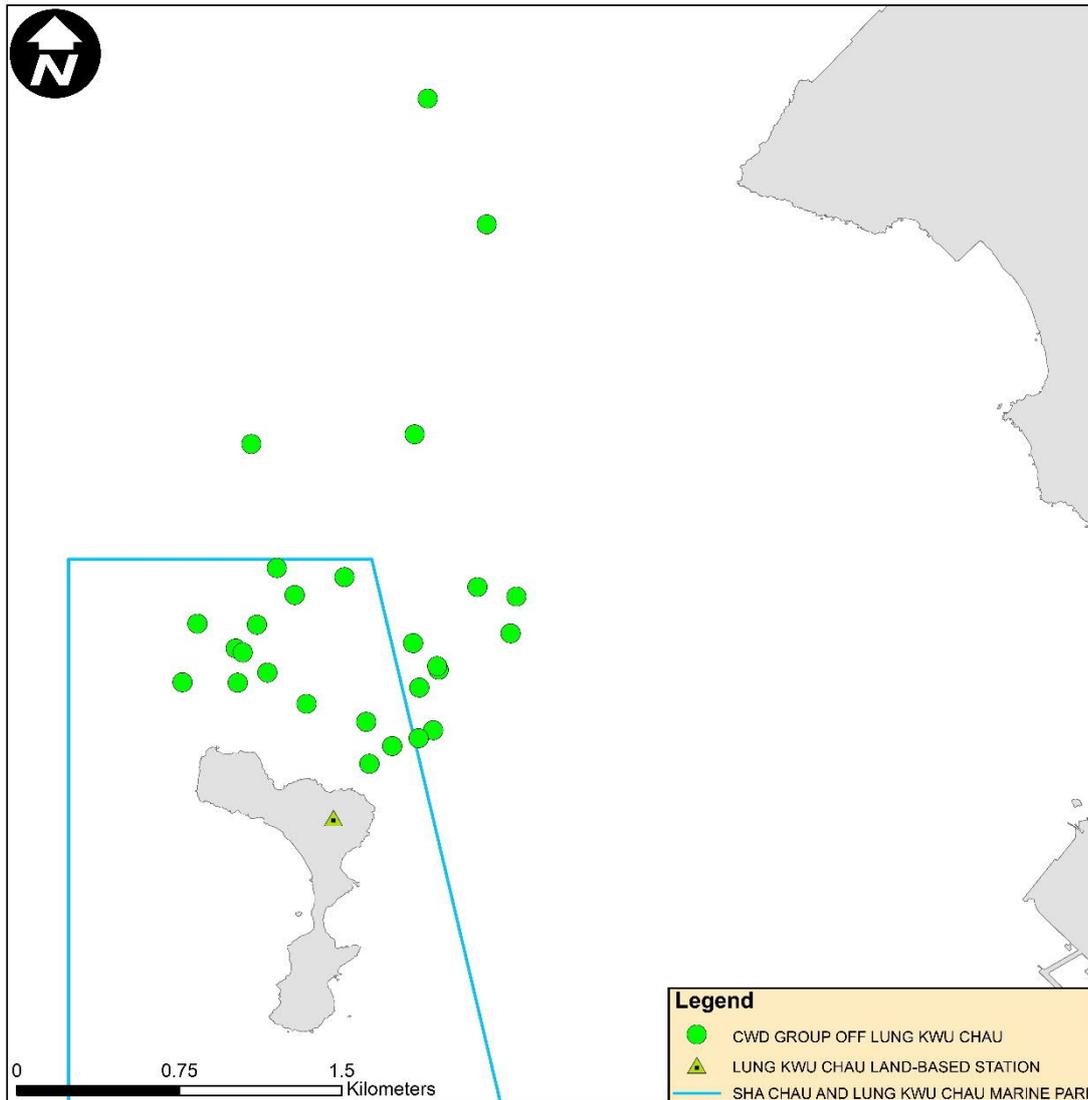
Figure 2.10: Plots of First Sightings of All CWD Groups from Land-based Stations

Remarks: Please note that there are 27 green circles on the map indicating the first sighting locations of CWD groups tracked off Lung Kwu Chau. Some of them were very close to each other and therefore appear overlapped on this map.

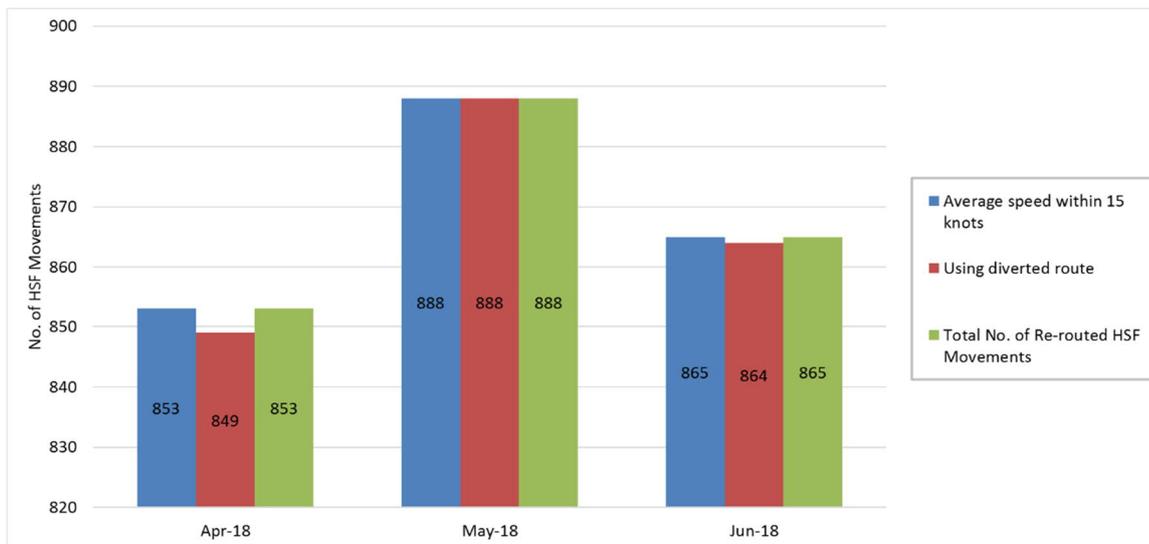
Graph 3: Summary of SkyPier High Speed Ferries Monitoring Results

Insufficient AIS data were received from some HSFs during the reporting period. After investigation, it was found that AIS data for the concerned ferries were missing due to effects of interference of the signal as reported by the ferry operators after checking the condition of the AIS transponders. Vessel captains were requested to provide the radar track photos which indicated the vessels entered the SCZ through the gate access points and there was no speeding in the SCZ. Ferry operators' explanation was accepted.

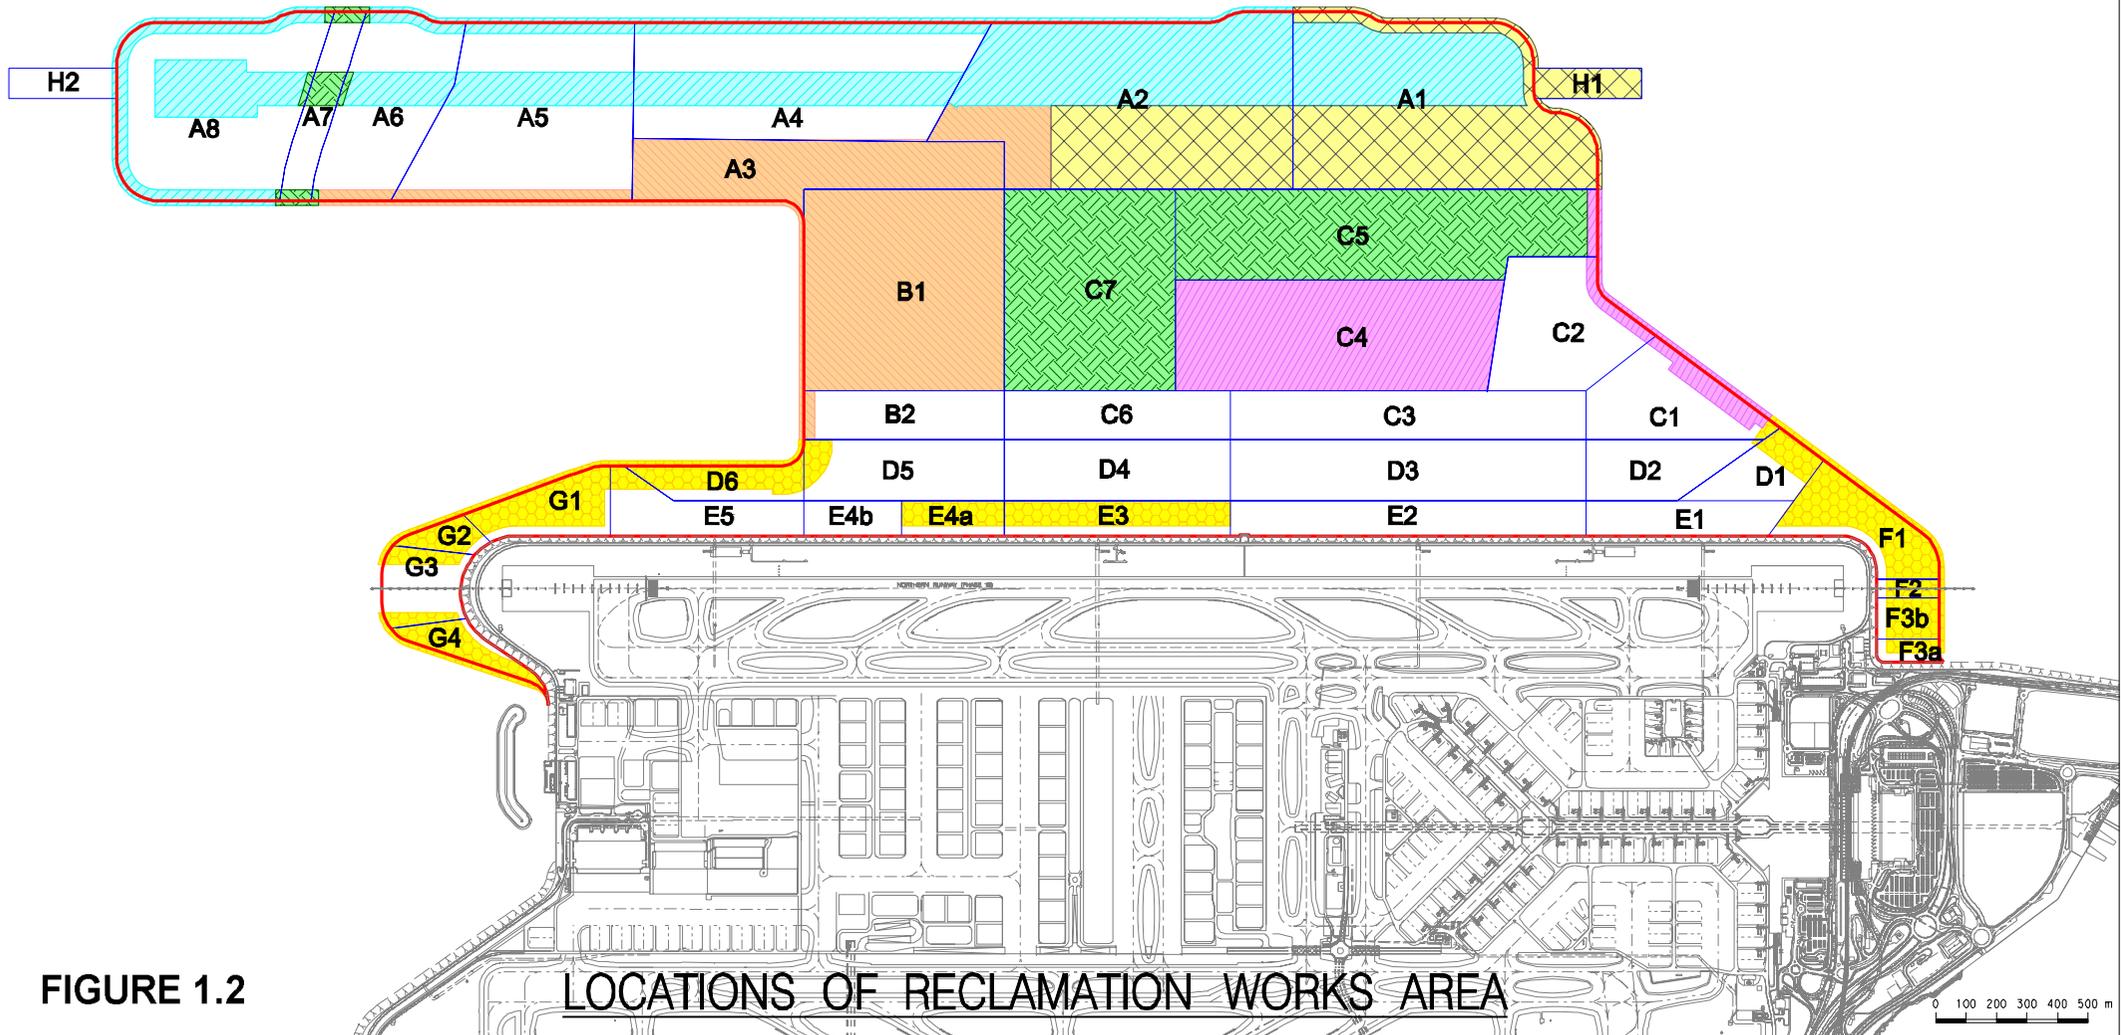
FIGURE 1.2

LOCATIONS OF RECLAMATION WORKS AREA

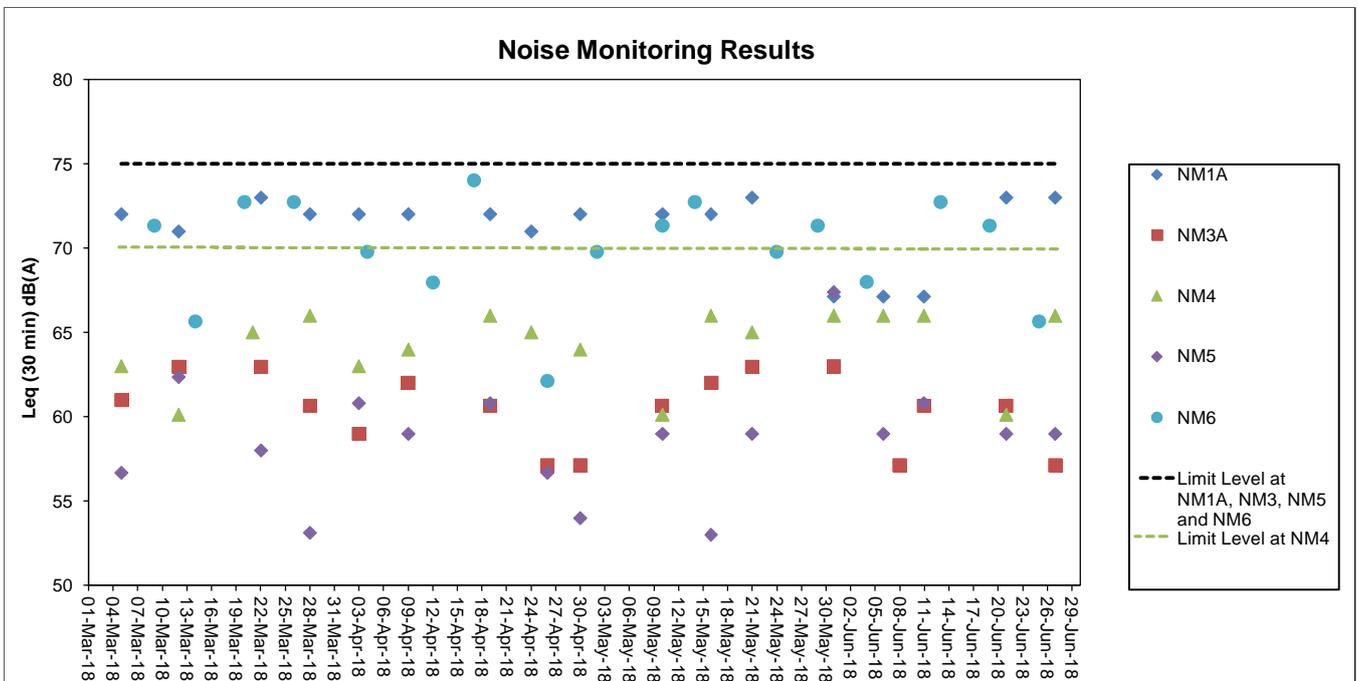
Noise Monitoring Results

Note: School examination took place from 4 to 8 June 2018 in the reporting period. Impact noise monitoring at NM4 on 6 Jun 2018 was conducted after the end of school examination that day (8:30 am to 12:00 pm). The corresponding Limit Level for the monitoring session was 70 dB(A).

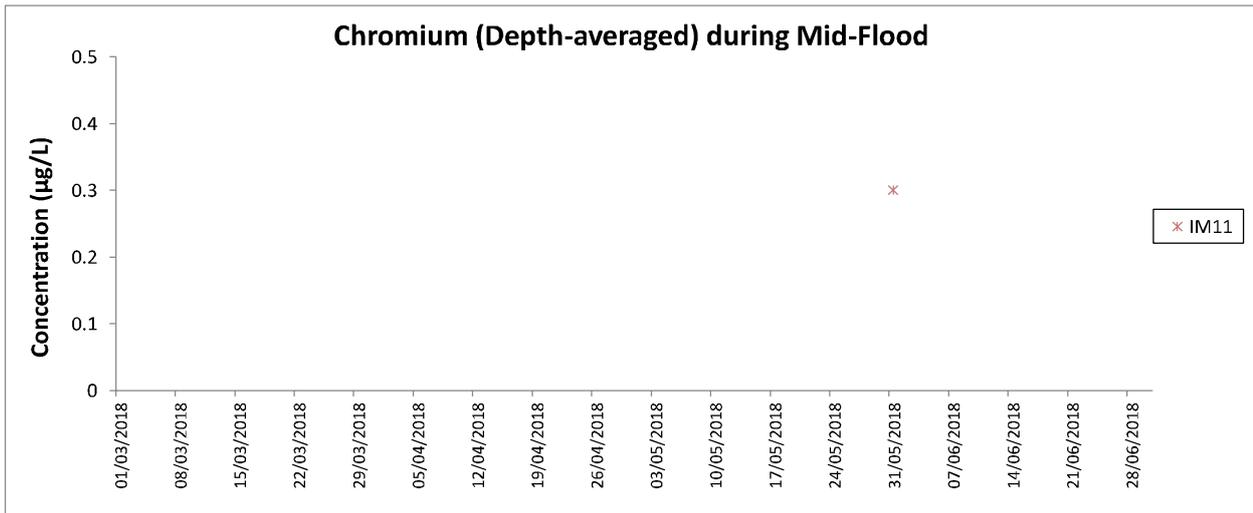
Note: The action and limit level of Chromium can be referred to Table 2.7 of the quarterly EM&A report.
The monitoring results of chromium at all other monitoring stations during mid-flood and mid-ebb were below the reporting limit 0.2 µg/L.
