Expansion of Hong Kong International Airport into a Three-Runway System

Construction Phase Quarterly EM&A Report
No.11 (1 July to 30 September 2018)

November 2018

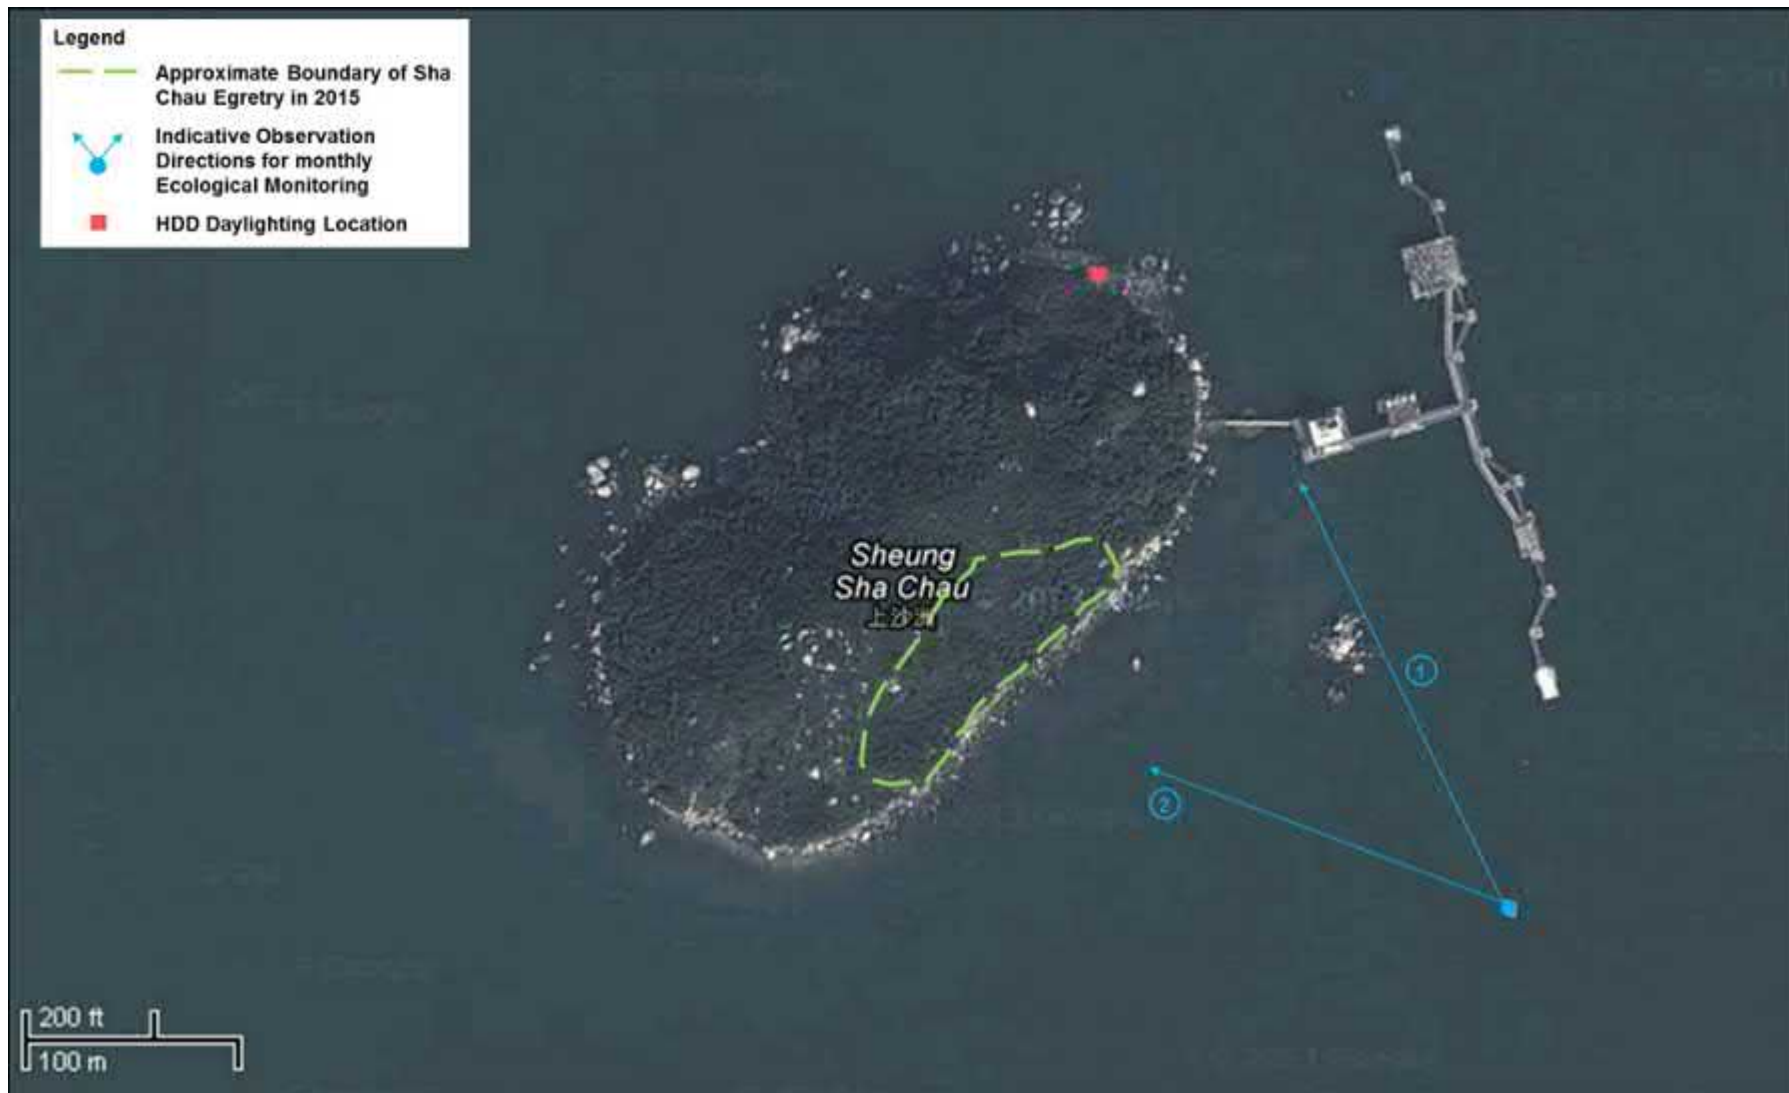
No construction works were conducted on Sheung Sha Chau Island in July 2018 (i.e. during the ardeid's breeding season) in accordance with the Manual. Monthly ecological monitoring was carried out in August and September 2018 on Sheung Sha Chau Island. No encroachment of any works upon the egret area nor any significant disturbance to the ardeids on the island by the works was recorded during ecological monitoring. Sign of a few nursery activities by Little Egret was observed in August on trees located at the previously identified egret area where it is at the southern side of Sheung Sha Chau Island. At the HDD daylighting location, neither nest nor breeding activity of ardeids were found during the monthly ecological monitoring and weekly site inspections in August and September 2018. The site photos and location map regarding the ecological monitoring for HDD daylighting location and egret area are provided in **Appendix C** for reference.

Terrestrial Ecological Monitoring – site photos and location map regarding the monthly ecological monitoring for the egretty area on Sheung Sha Chau and the HDD daylighting location
