# **Expansion of Hong Kong International Airport into a Three-Runway System**

Construction Phase Quarterly EM&A Report  
No.21 (1 January to 31 March 2021)

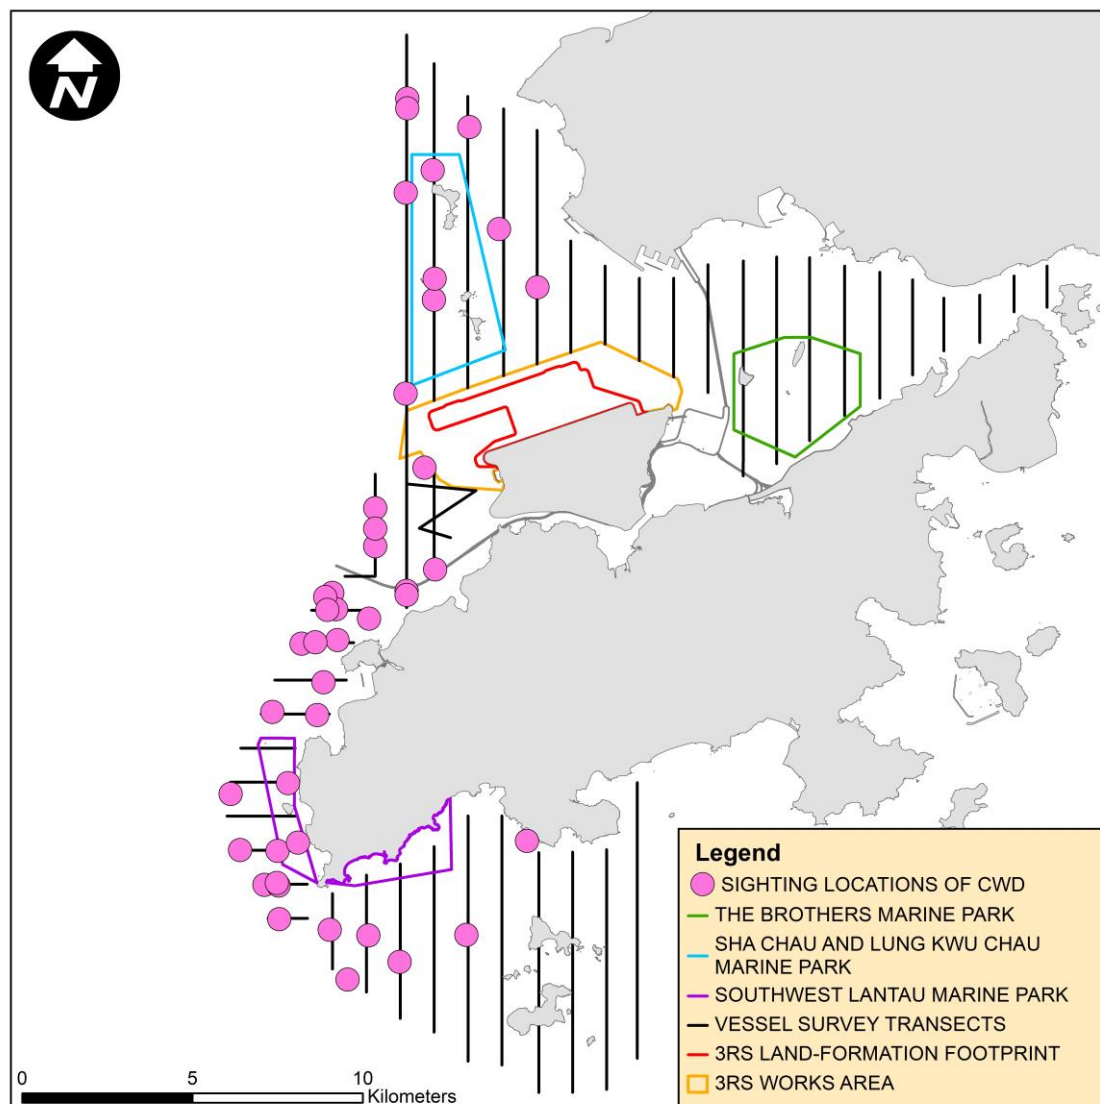
**Figure 2.5: Sightings Distribution of Chinese White Dolphins from January to March 2021**

The distribution of CWD sightings recorded from January to March 2021 is illustrated in **Figure 2.5**. In NWL (including AW transects), the majority of the CWD sightings were recorded within and around SCLKCMP, with a few sightings located at the southwestern corner of the survey area, close to Hong Kong-Zhuhai-Macao Bridge Hong Kong Link Road. In WL, CWD sightings were scattered throughout the survey area with the majority clustered near Tai O and scattered from Peaked Hill to Fan Lau. In SWL, dolphin sightings were recorded in the relatively offshore waters between Fan Lau and Soko Islands. No CWD sightings were recorded in NEL survey area. Details of the sighting data are presented in **Appendix C**.

Remarks: (1) Please note that there are 43 pink circles on the map indicating the sighting locations of CWD. Some of them were very close to each other and therefore appear overlapped on this sighting distribution map. (2) Marine park excludes land area and the landward boundary generally follows the high water mark along the coastline.

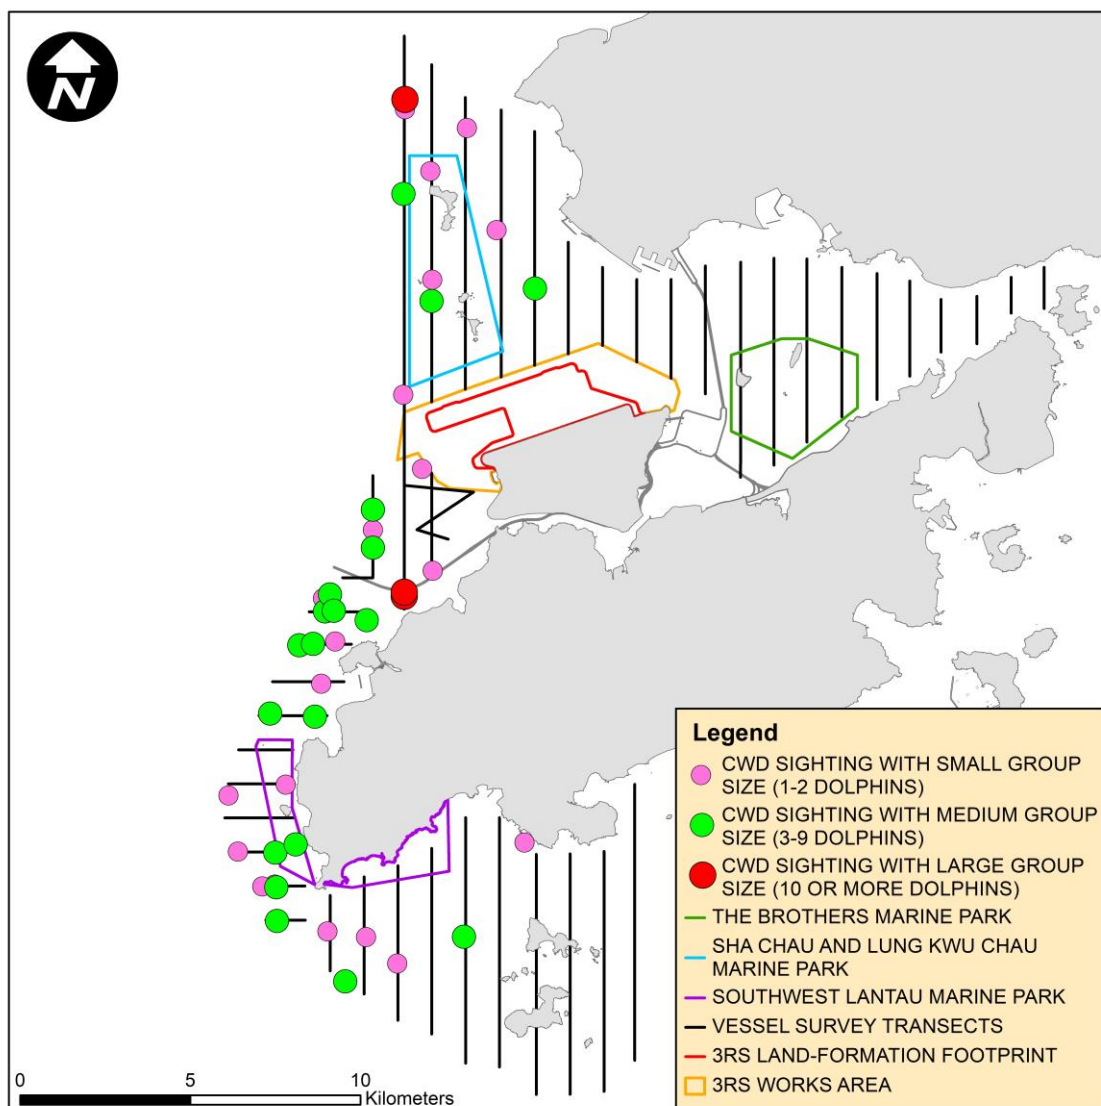
**Figure 2.6: Sighting Locations of Chinese White Dolphins with Different Group Sizes**

There are no observable difference in the distribution pattern between small-sized and medium-sized dolphin groups as they all scattered amongst NWL, WL and SWL survey areas. However, all the three sighting with large group size were exclusively recorded in NWL survey area only. Sighting locations of CWD groups with different group sizes are depicted in **Figure 2.6**.

Remarks: (1) Please note that there are 43 circles on the map indicating the sighting locations of CWD. Some of them were very close to each other and therefore appear overlapped on this sighting distribution map. (2) Marine park excludes land area and the landward boundary generally follows the high water mark along the coastline.

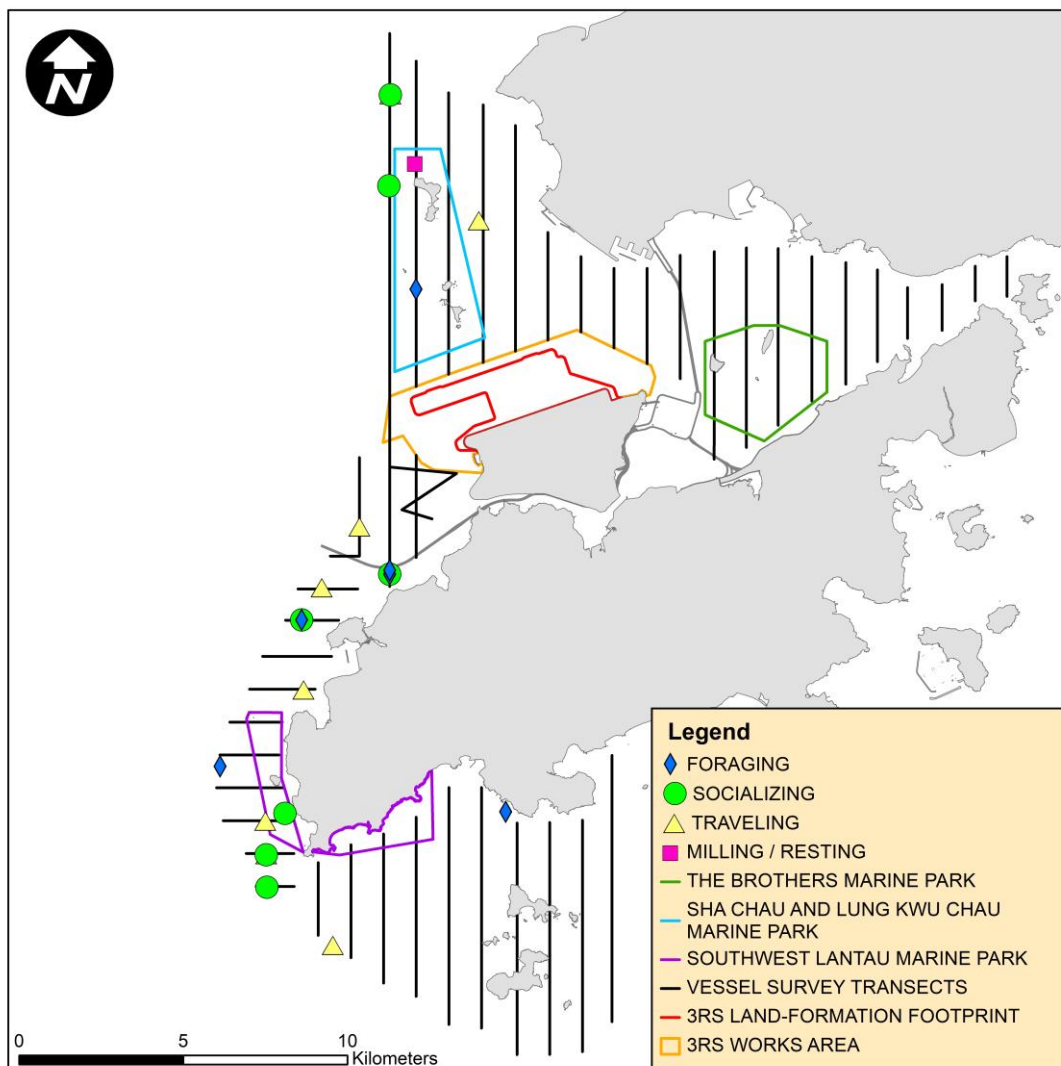
**Figure 2.7: Sighting Locations of Chinese White Dolphins Engaged in Different Behaviours**

The sighting locations of CWDs engaged in different behaviours during the current reporting period are illustrated in **Figure 2.7**.

Remarks: Marine park excludes land area and the landward boundary generally follows the high water mark along the coastline.

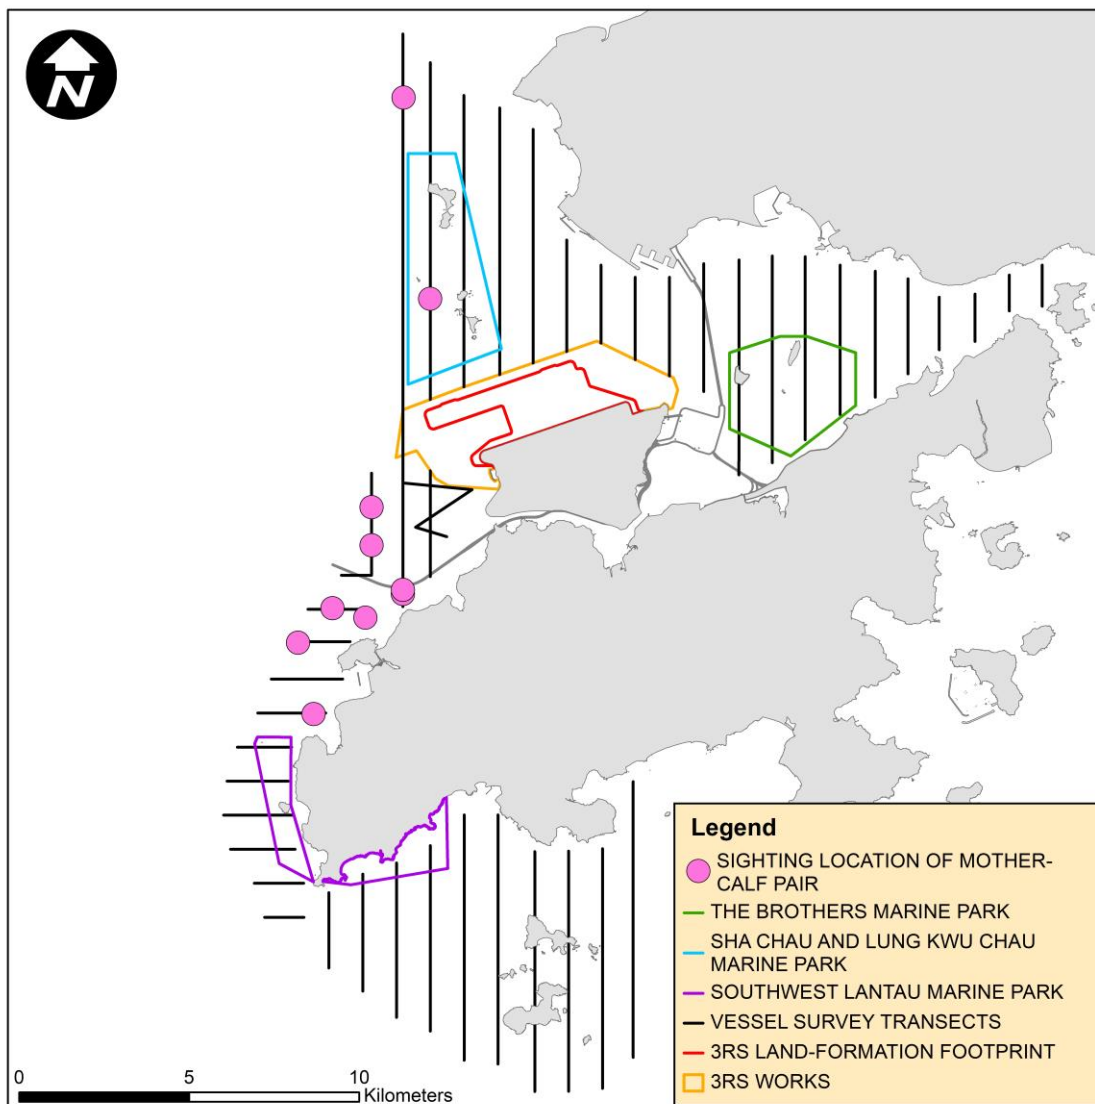
**Figure 2.8: Sighting Locations of Mother-calf Pairs**

The locations of CWD sightings with the presence of mother-and-unspotted juvenile pairs are shown in **Figure 2.8**.

Remarks: (1) Please note that there are seven circles on the map indicating the sighting locations of Mother-Calf pair. (2) Marine park excludes land area and the landward boundary generally follows the high water mark along the coastline.

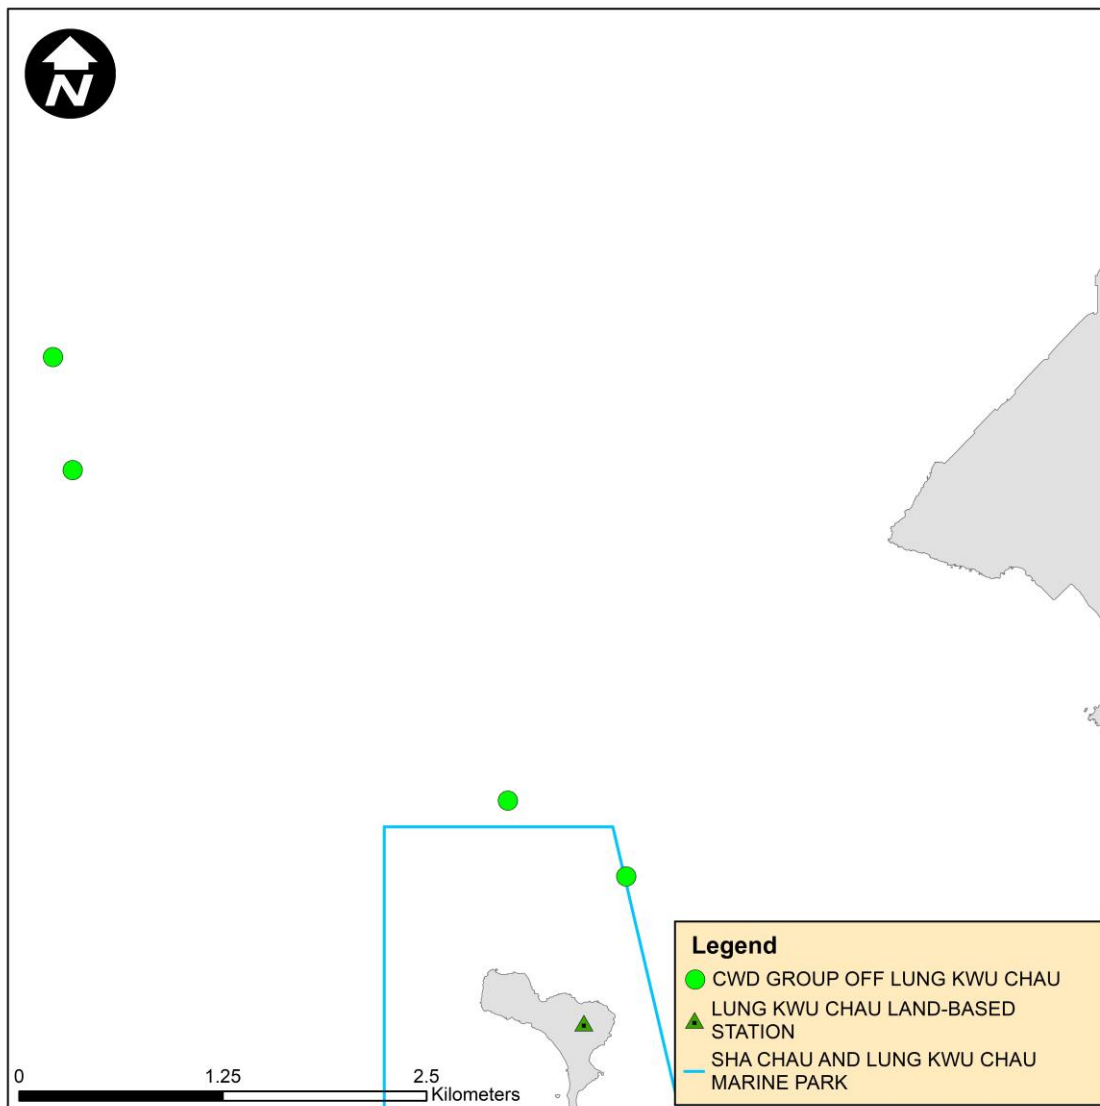
**Figure 2.9: Plots of First Sightings of All CWD Groups from Land-based Stations**

Land-based Station	# of Survey Sessions	Survey Effort (hh:mm)	# CWD Groups Sighted	CWD Group Sighting per Survey Hour
<b>TOTAL</b>	<b>2</b>	<b>12:00</b>	<b>1</b>	<b>0.08</b>
<b>March 2021</b>				
Lung Kwu Chau	1	06:00	0	0
Sha Chau	1	06:00	0	0
<b>TOTAL</b>	<b>2</b>	<b>12:00</b>	<b>0</b>	<b>0</b>
<b>OVERALL</b>	<b>6</b>	<b>36:00</b>	<b>4</b>	<b>0.11</b>

Remark: Marine park excludes land area and the landward boundary generally follows the high water mark along the coastline.

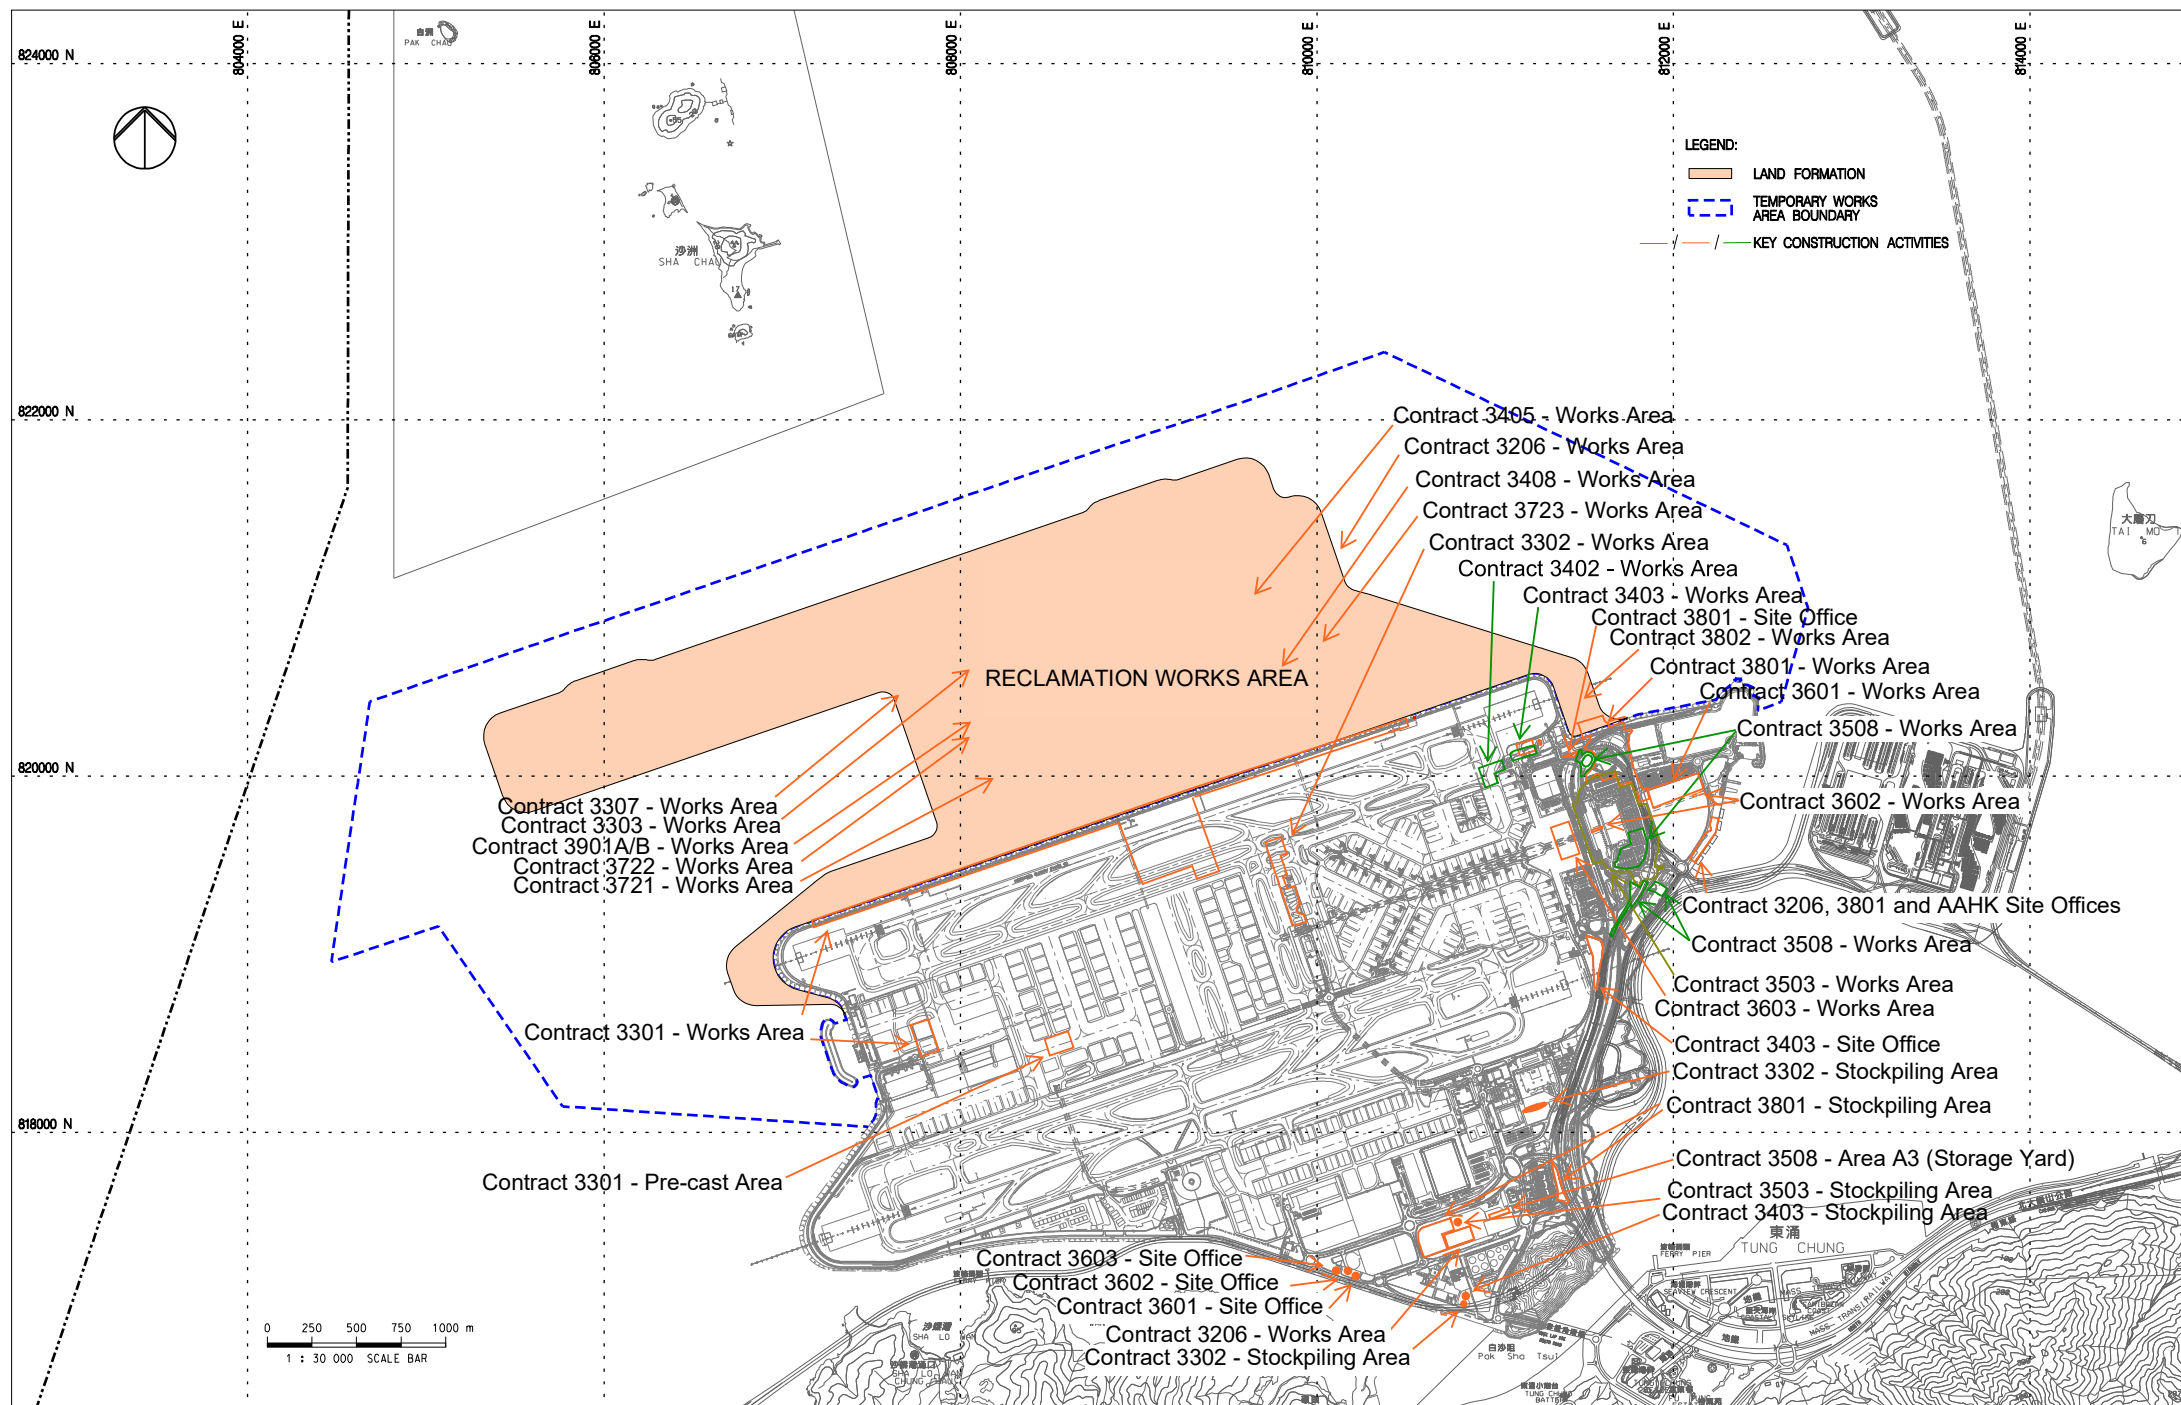
FIGURE 1.1 LOCATIONS OF KEY CONSTRUCTION ACTIVITIES

Note: The locations are for indicative purpose. The actual construction work locations are in accordance with the construction work programme.

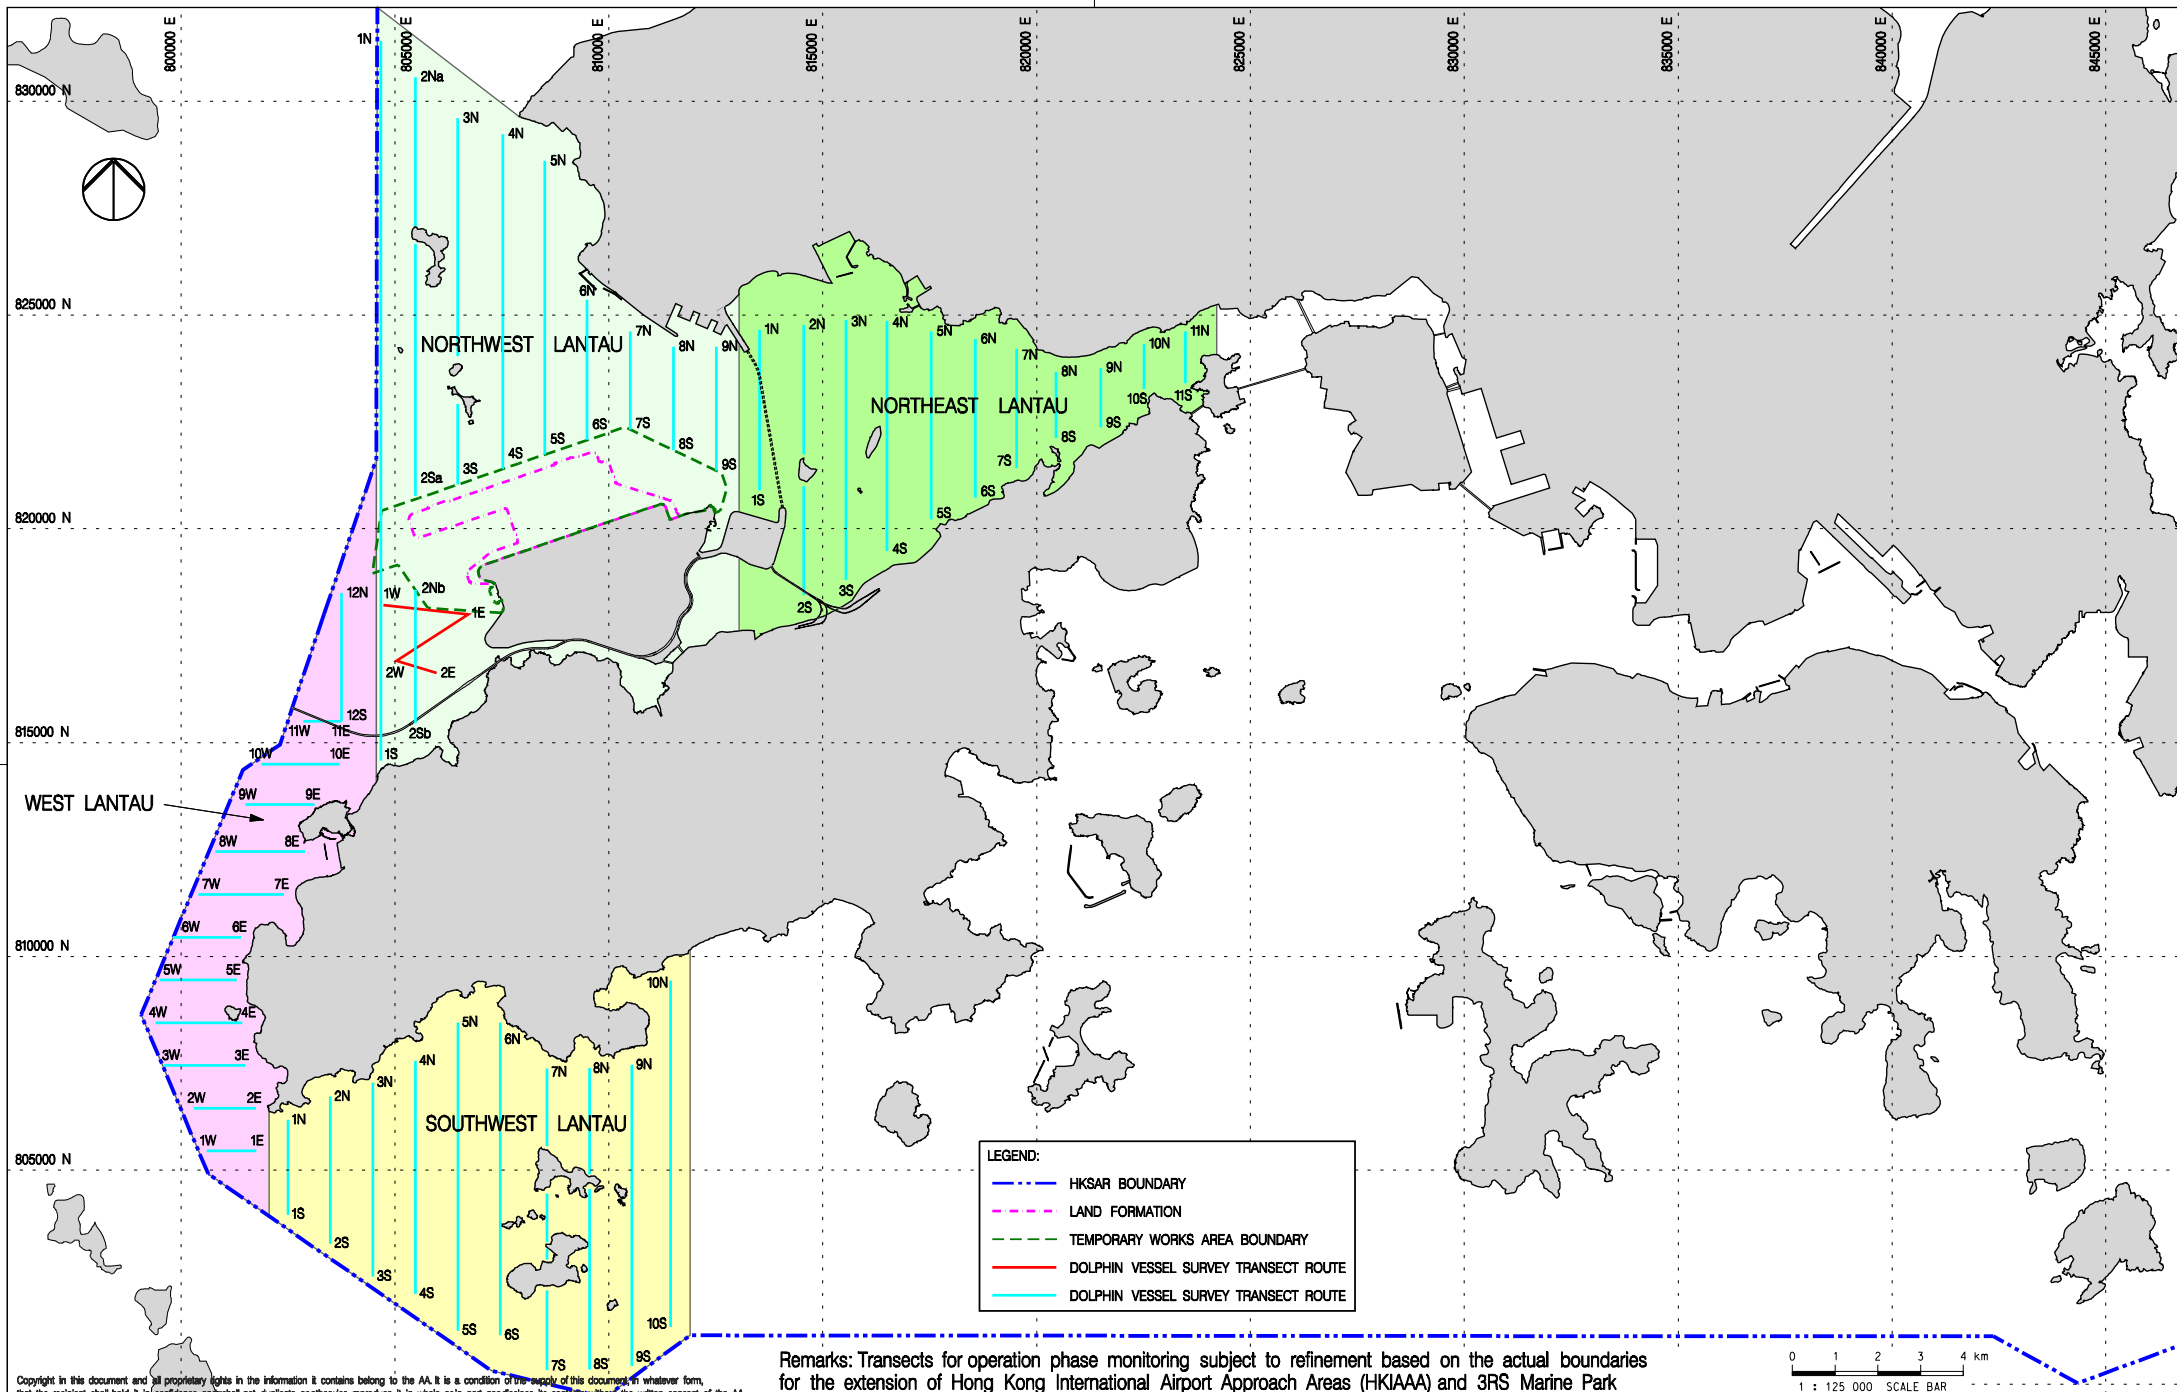
EXPANSION OF HONG KONG INTERNATIONAL AIRPORT INTO A THREE-RUNWAY SYSTEM		Scale at A3 1 : 125000
Drawing No.	FIGURE 2.3	Rev. F

Remarks: Transects for operation phase monitoring subject to refinement based on the actual boundaries for the extension of Hong Kong International Airport Approach Areas (HKIAAA) and 3RS Marine Park

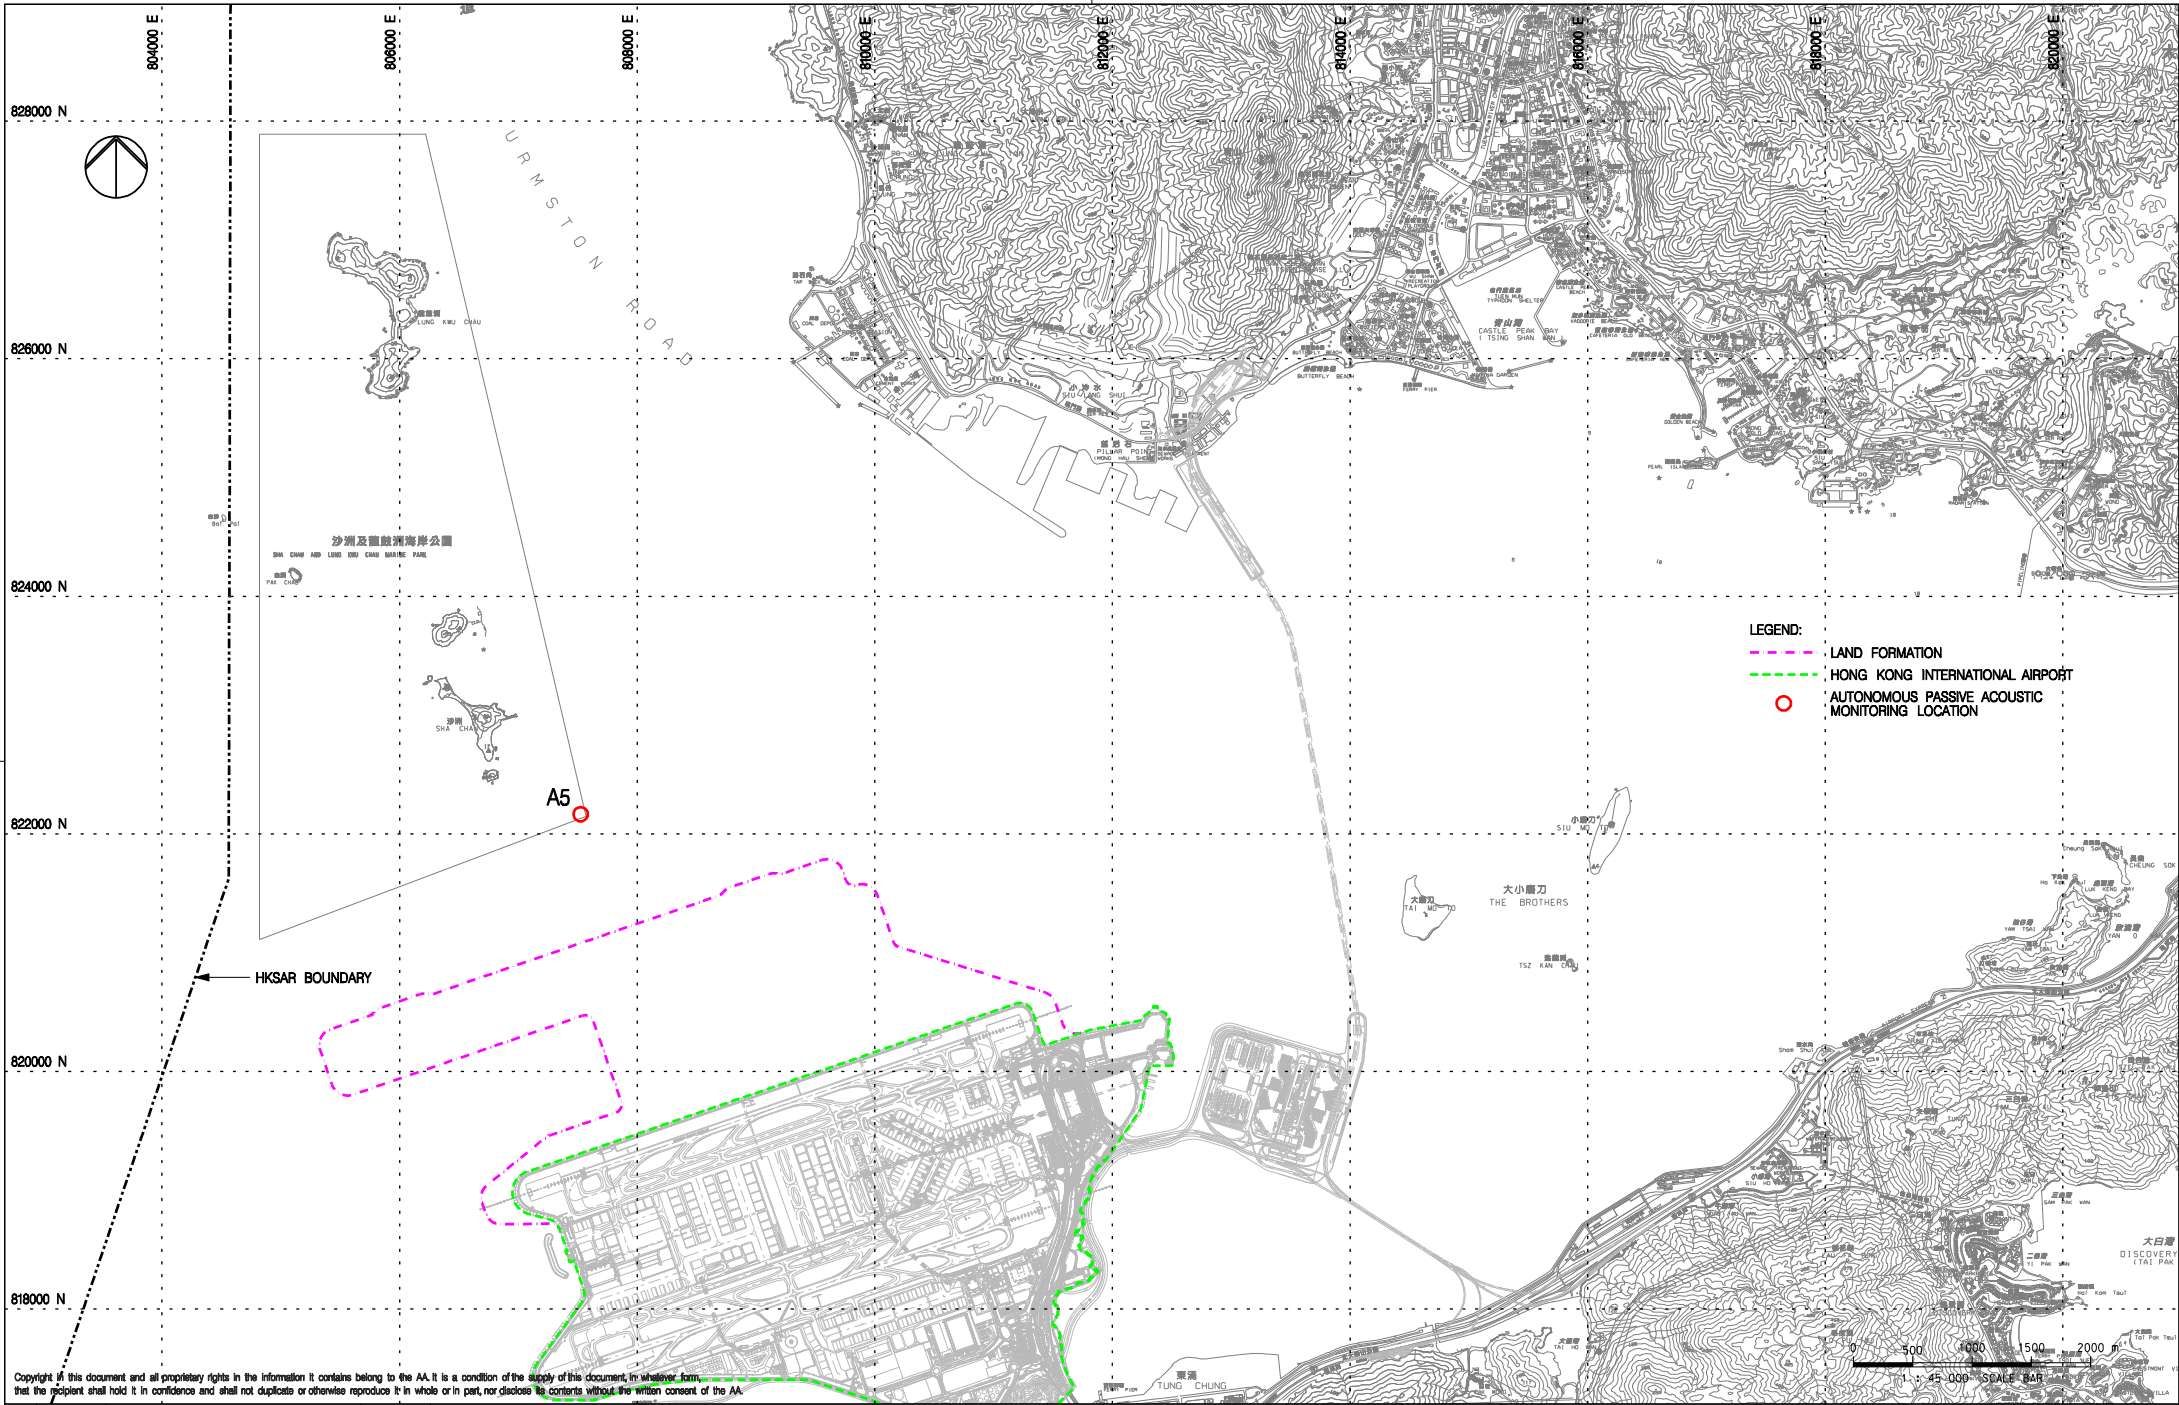
EXPANSION OF HONG KONG INTERNATIONAL AIRPORT INTO A THREE-RUNWAY SYSTEM		Scale at A3 1: 45000
Drawing No.		Rev.
FIGURE 2.10		C

- LEGEND:
- LAND FORMATION
  - HONG KONG INTERNATIONAL AIRPORT
  - AUTONOMOUS PASSIVE ACOUSTIC MONITORING LOCATION

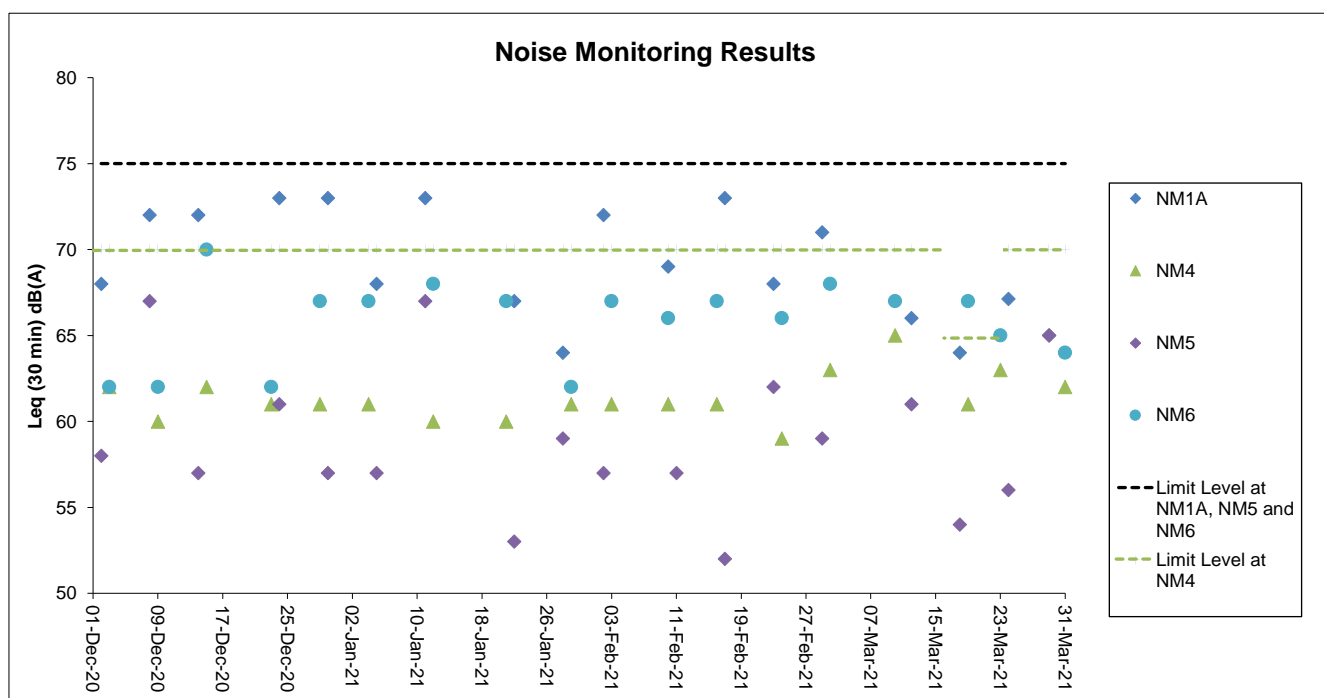
# Noise Monitoring Results

1. The Limit Level is reduced to 70dB(A) for school and 65dB(A) during school examination period at NM4. School examination took place from 18 to 24 March 2021 during this reporting period.
