Expansion of Hong Kong International Airport into a Three-Runway System

Construction Phase Quarterly EM&A Report
No.25 (1 January to 31 March 2022)

June 2022

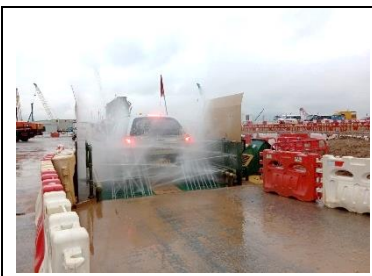
Use of automatic wheel wash system for dust suppression purpose	Provision of regular maintenance for wastewater treatment facility	Provision of tool-box talk for site personnel

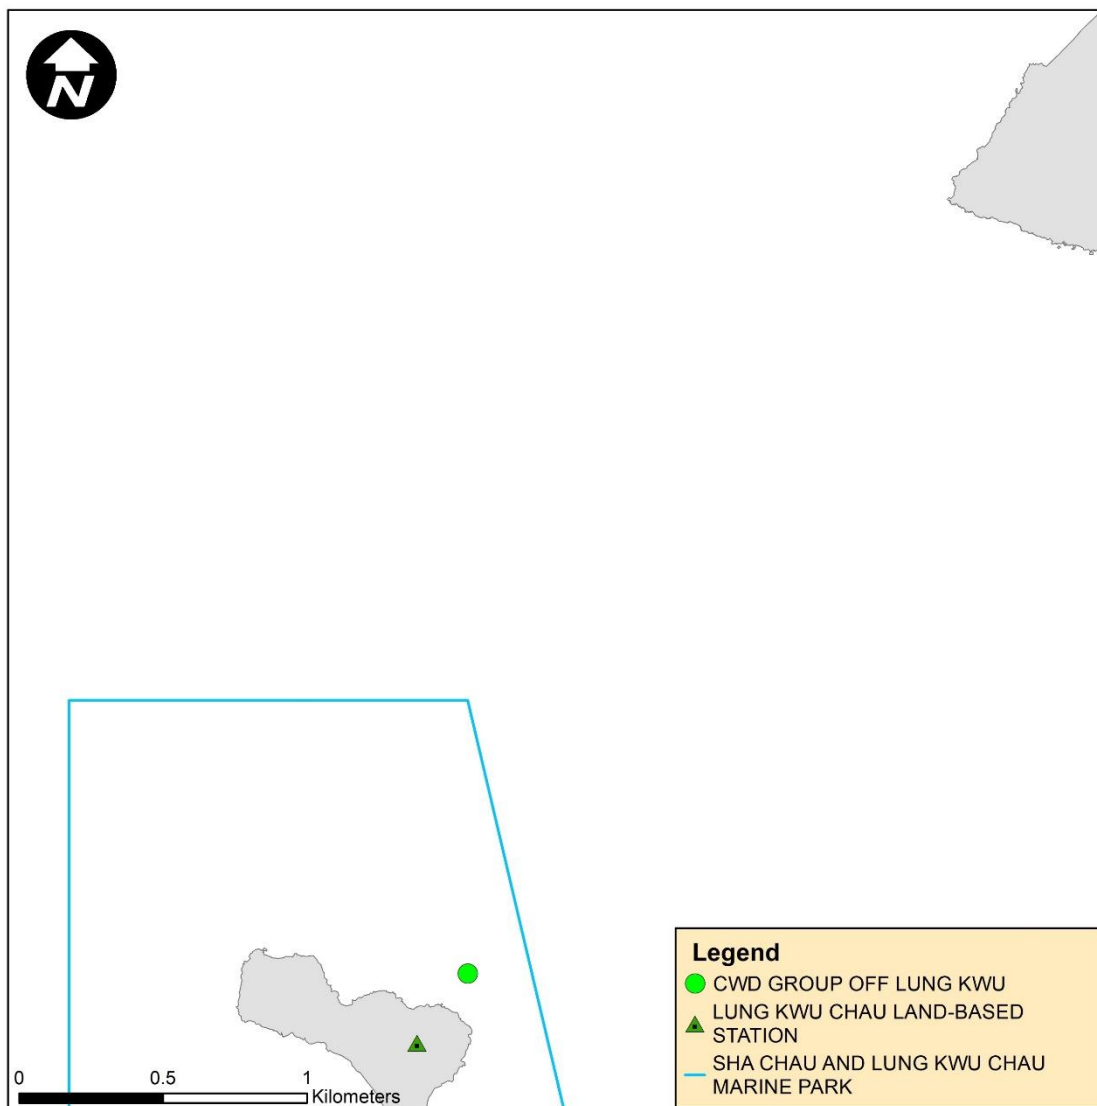
Figure 2.9: Plots of First Sightings of All CWD Groups from Land-based Stations

Remark: Marine park excludes land area and the landward boundary generally follows the high water mark along the coastline.

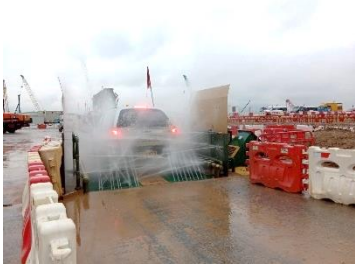
1. Automatic wheel wash system was installed and implemented within the construction site to ensure no earth, mud, debris, and the like is deposited by vehicles to public areas.

Use of automatic wheel wash system for dust suppression purpose	Provision of regular maintenance for wastewater treatment facility	Provision of tool-box talk for site personnel

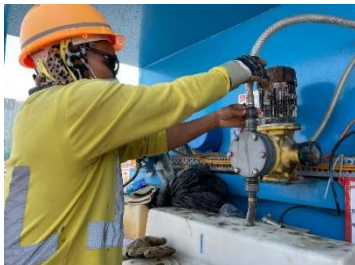
2. Regular maintenance for wastewater treatment facility was provided by contractor to ensure its proper and efficient operation in particular during rainstorm.
3. Tool-box talk was provided to workers for proper waste management and marine sediment handling procedures.

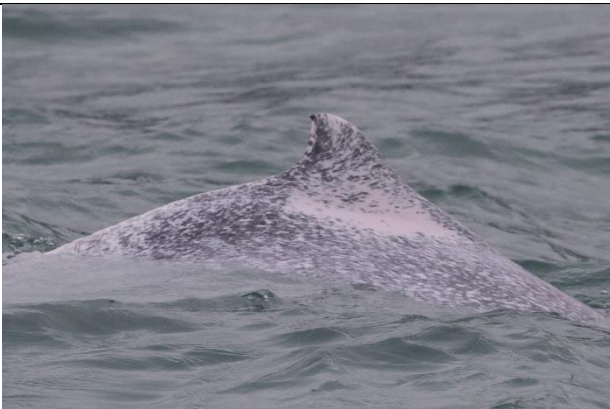
<p>WLMM149</p>	<p>WLMM150</p>

Photo Identification – Re-sighting Locations
