# **Expansion of Hong Kong International Airport into a Three-Runway System**

Construction Phase Quarterly EM&A Report No.4  
(1 October to 31 December 2016)

February 2017

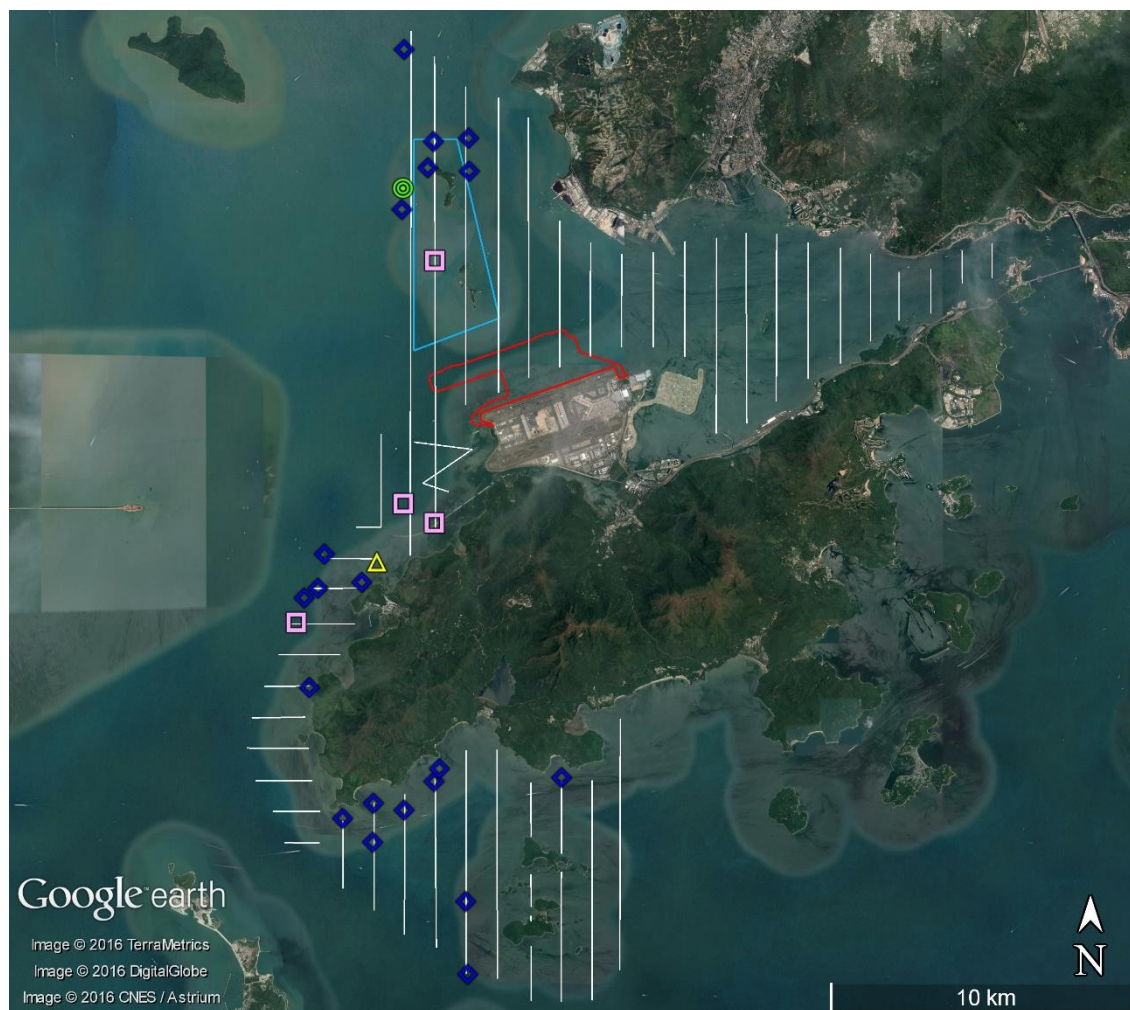
### Figure 2.7: Sighting Locations of Chinese White Dolphins Engaged in Different Behaviours

During October to December 2016, 20 groups of CWDs were sighted with feeding activities. Amongst these 20 groups of feeding CWDs, one group was observed in association with operating pair trawlers at southwestern corner of Soko Islands close to the boundary of Hong Kong waters, two groups were sighted in association with operating purse seiners in NWL and SWL. In NWL waters, the majority of the feeding activities of CWDs were observed north to Lung Kwu Chau. In WL, CWDs were mainly being observed feeding in waters around Tai O. In SWL, more feeding sightings of CWDs were recorded along the coast from Fan Lau to Tai Long Wan Campgroup. The sighting locations of CWDs engaged in different behaviours during the reporting quarter were illustrated in **Figure 2.7**.

[Indigo rhombus: Foraging, Green circle: Socializing, Pink square: Resting, Yellow triangle: Travelling, White line: Vessel survey transects, Blue polygon: SCLKCMP, Red polygon: 3RS land-formation footprint]

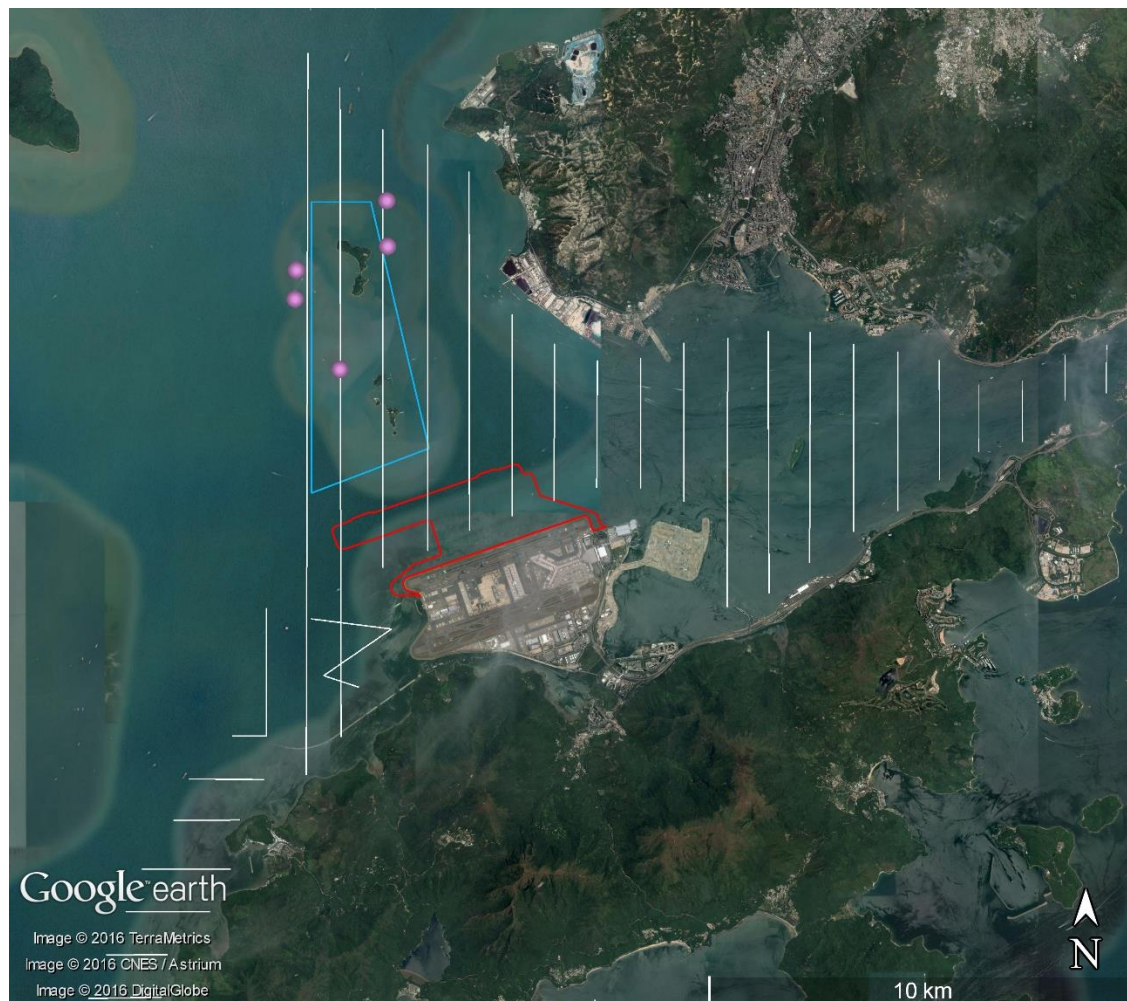
**Figure 2.8: Sighting Locations of Mother-calf Pairs**

[Pink circle: Sighting locations of mother-calf pairs, White line: Vessel survey transects, Blue polygon: Sha Chau and Lung Kwu Chau Marine Park (SCLKCMP), Red polygon: 3RS land-formation footprint]
