# **Expansion of Hong Kong International Airport into a Three-Runway System**

Construction Phase Quarterly EM&A Report No.8  
(1 October to 31 December 2017)

April 2018

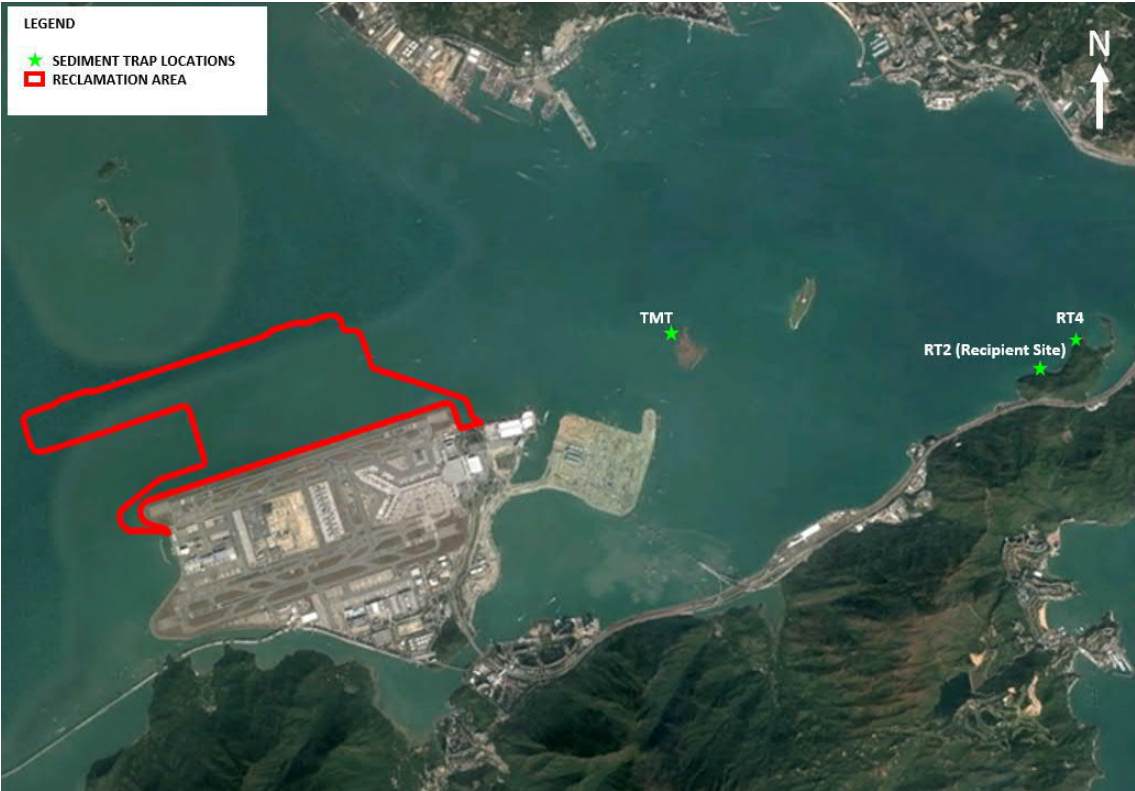
**Figure 2.11: Locations of Sediment Trap Deployment**

The sediment trap is a vertical pipe of 4 cm diameter with netting fitted over the top to prevent small animals from disturbing the contents of the traps. The traps were attached to specially prepared concrete bases which were placed in suitable locations in RT2, RT4 and TMT for a period of about 9 to 10 weeks. Locations of these three sites are shown in **Figure 2.11**.

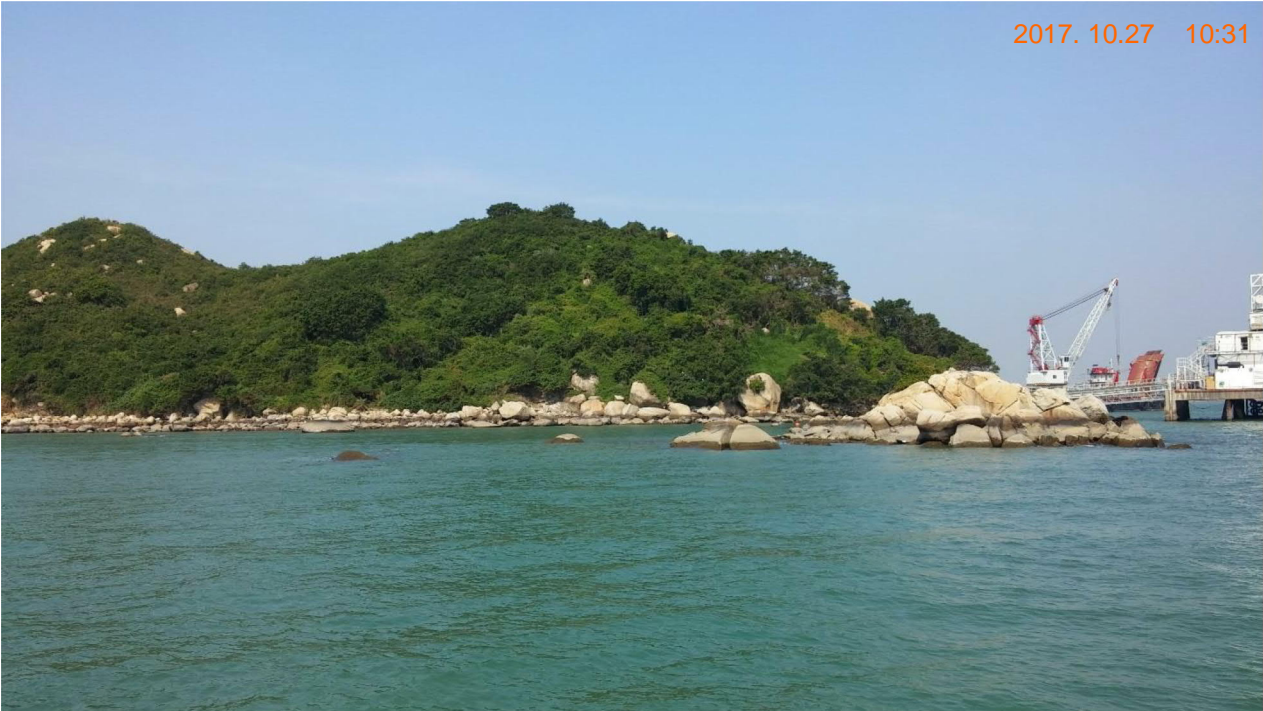
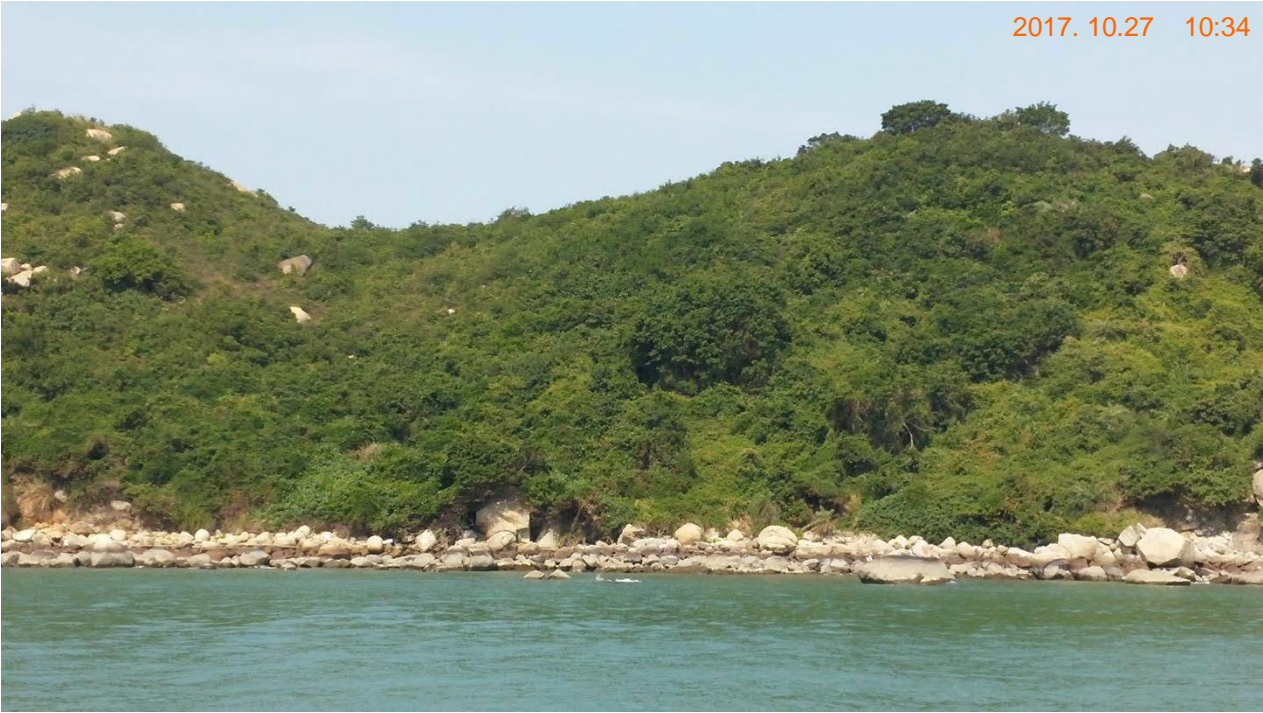
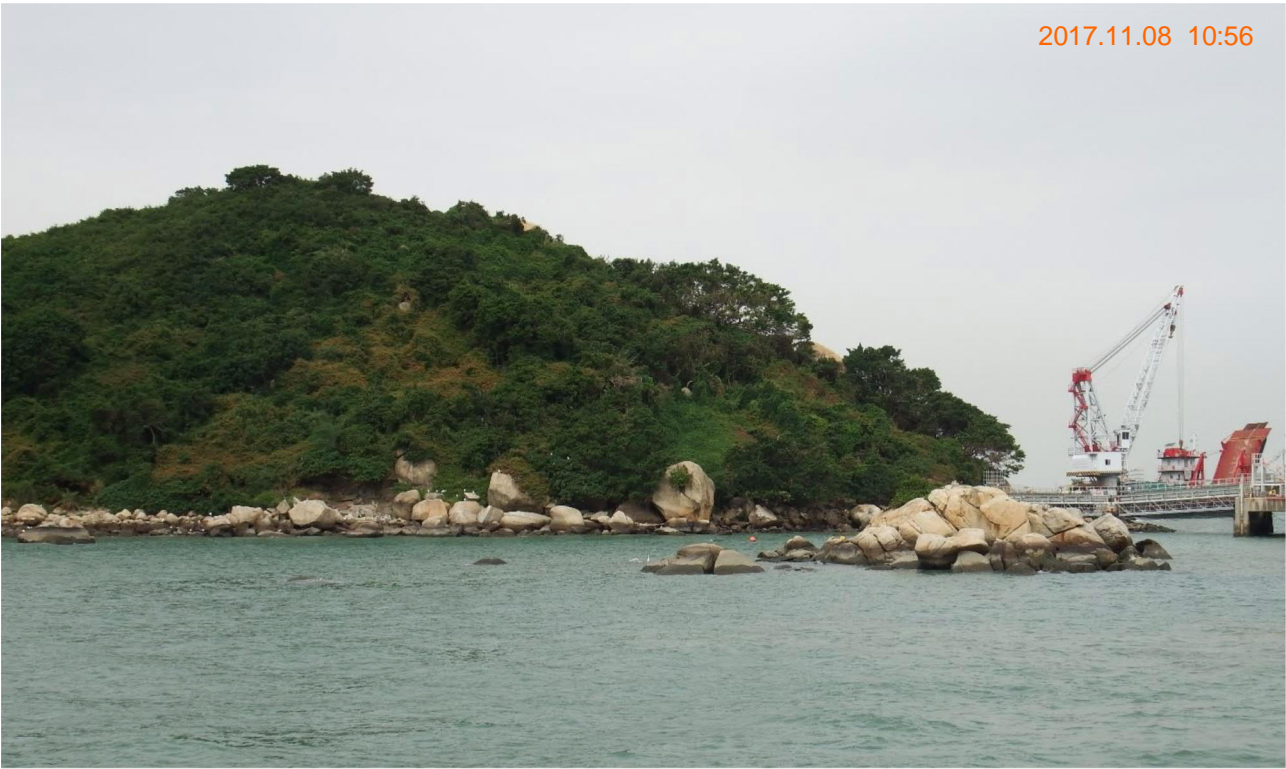
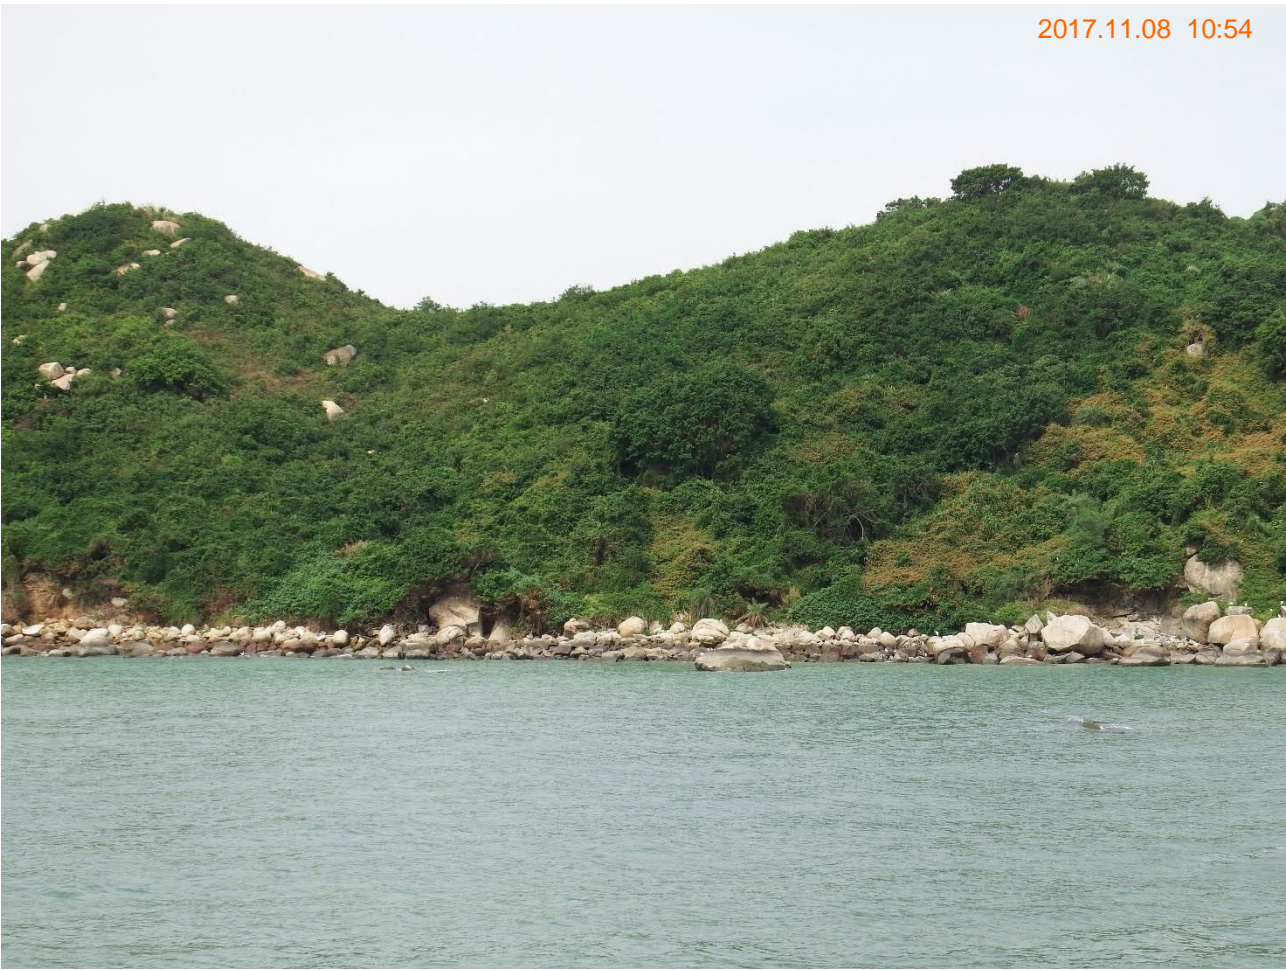
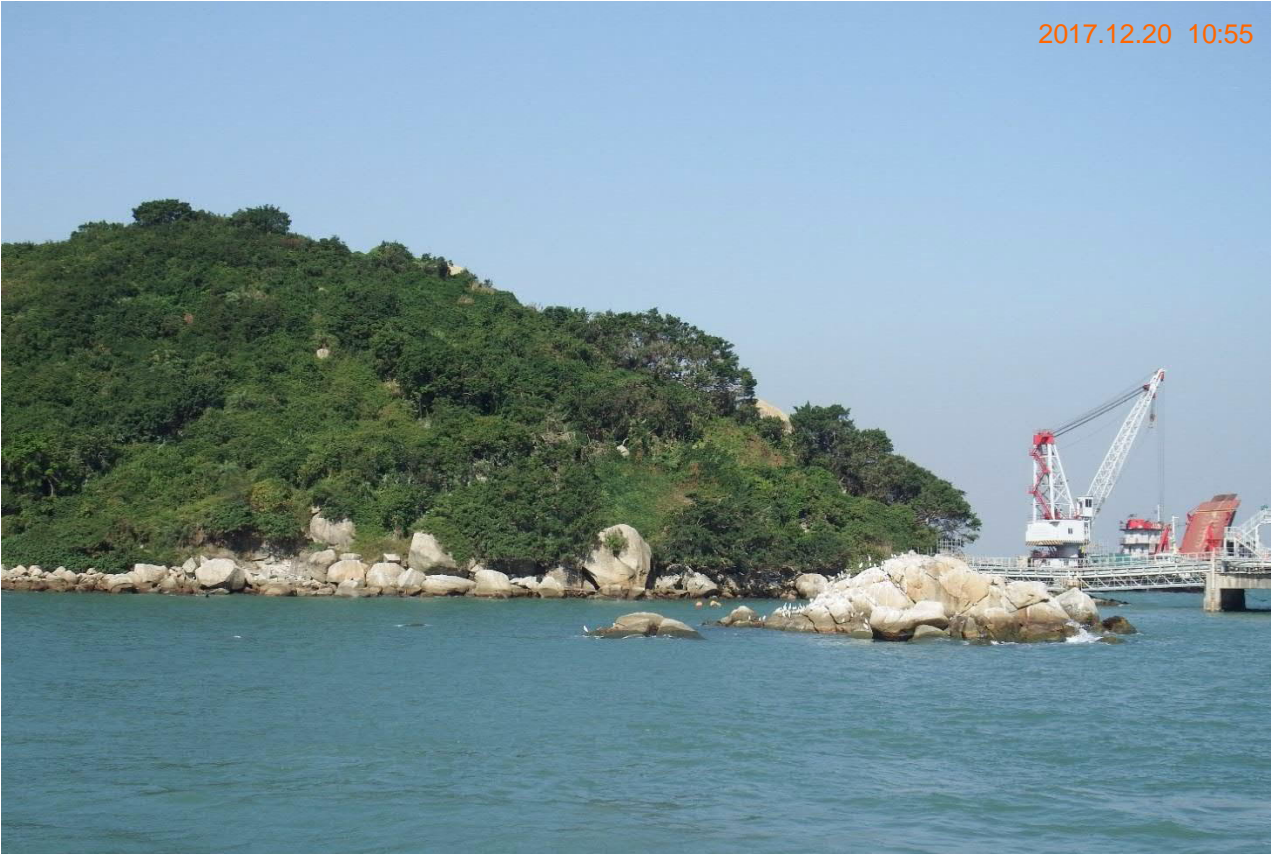
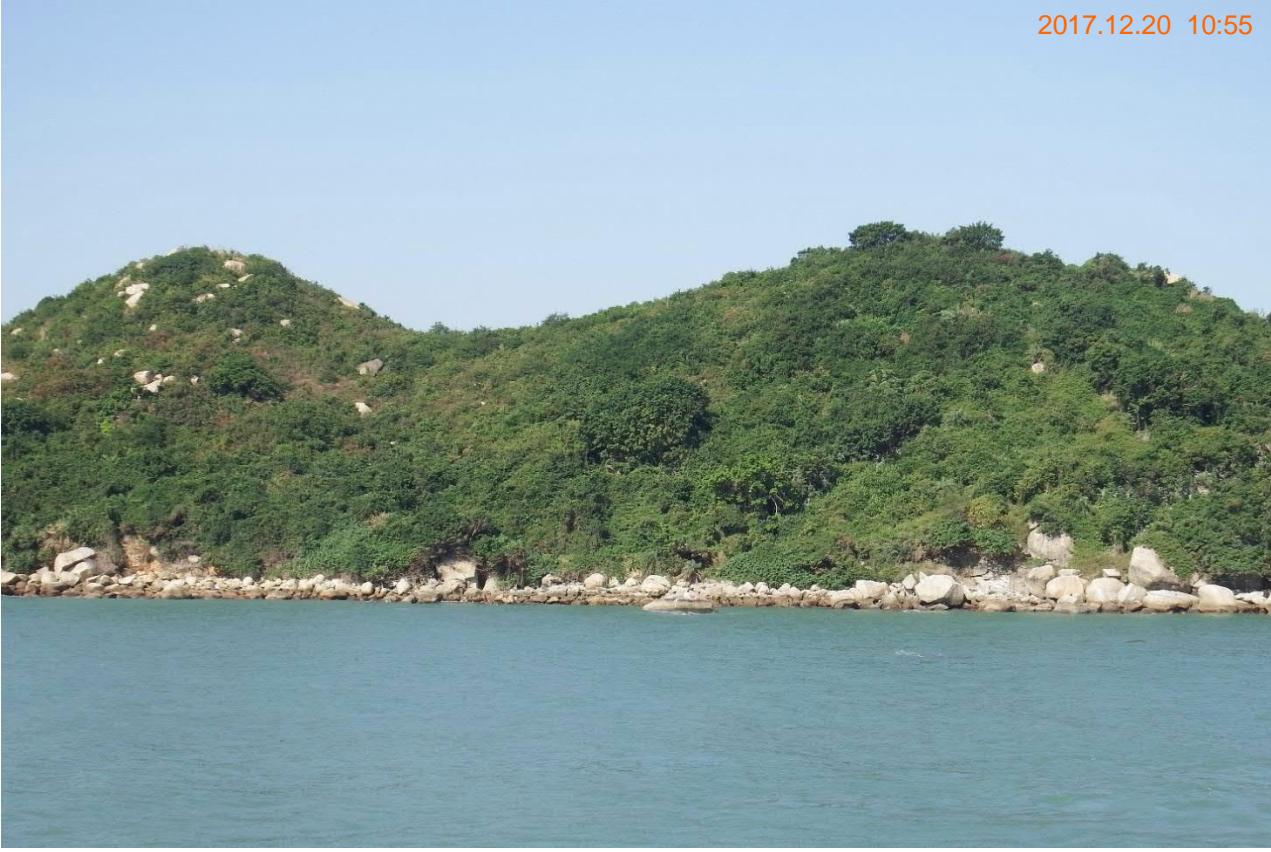
**Ecological Monitoring – site photos and location map regarding the monthly ecological monitoring for the egretty area on Sheung Sha Chau and the HDD works**

The monthly terrestrial ecology monitoring on Sheung Sha Chau observed that HDD works were conducted at the daylighting location and there was no encroachment upon the egret area nor any significant disturbance to egrets foraging at Sheung Sha Chau by the works.

Monthly ecological monitoring was carried out in October, November and December 2017 on Sheung Sha Chau Island. No encroachment of any works upon the egret area nor any significant disturbance to the egrets foraging on the island by the works was recorded during ecological monitoring. No sign of nursery activity was observed in the reporting period at the previously identified egret area at the southern side of Sheung Sha Chau Island. At the HDD daylighting location, neither nest nor breeding activity of birds were found during the monthly ecological monitoring and weekly site inspections in the reporting period. The site photos and location map regarding the ecological monitoring for HDD works and egret area are provided in **Appendix C** for reference.
