Expansion of Hong Kong International Airport into a Three-Runway System

Construction Phase Quarterly EM&A Report No.9
(1 January to 31 March 2018)

June 2018

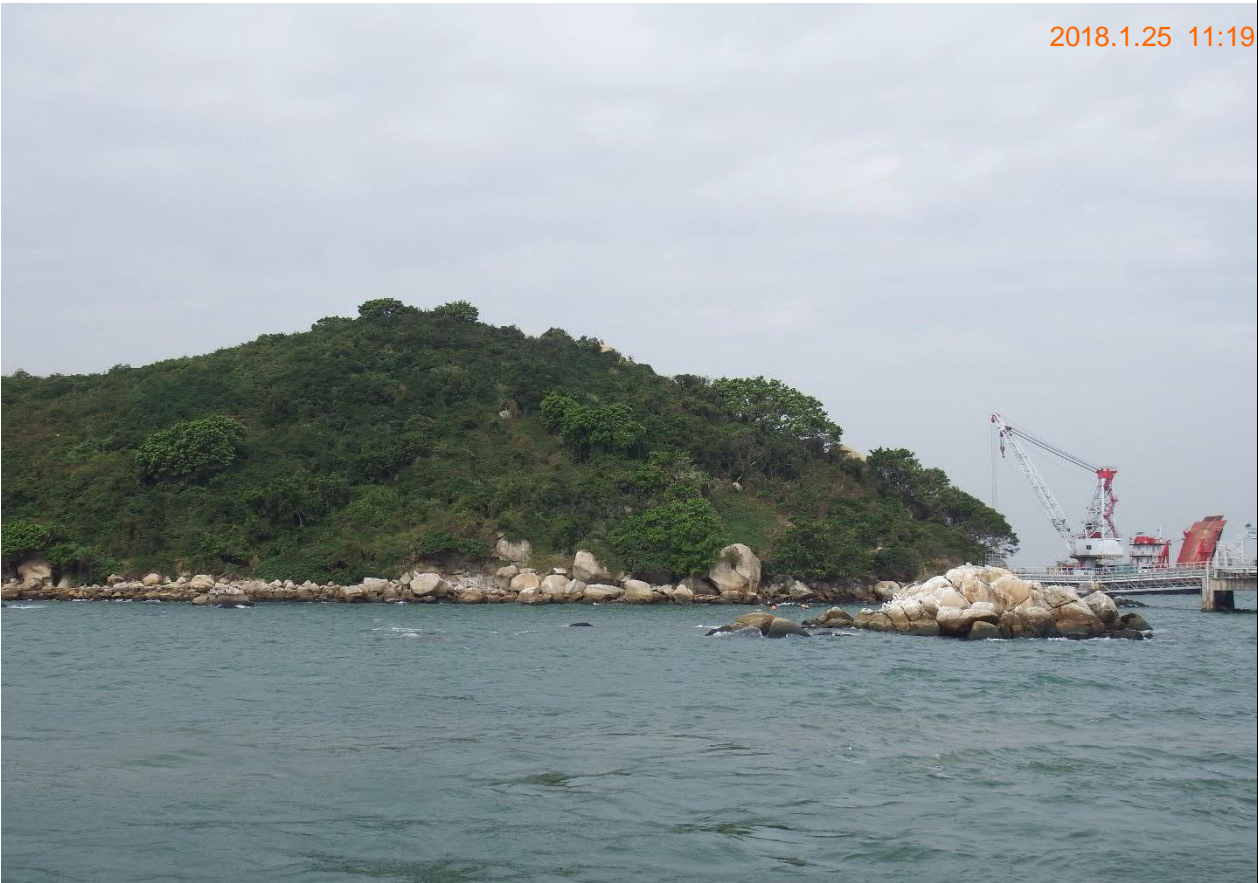
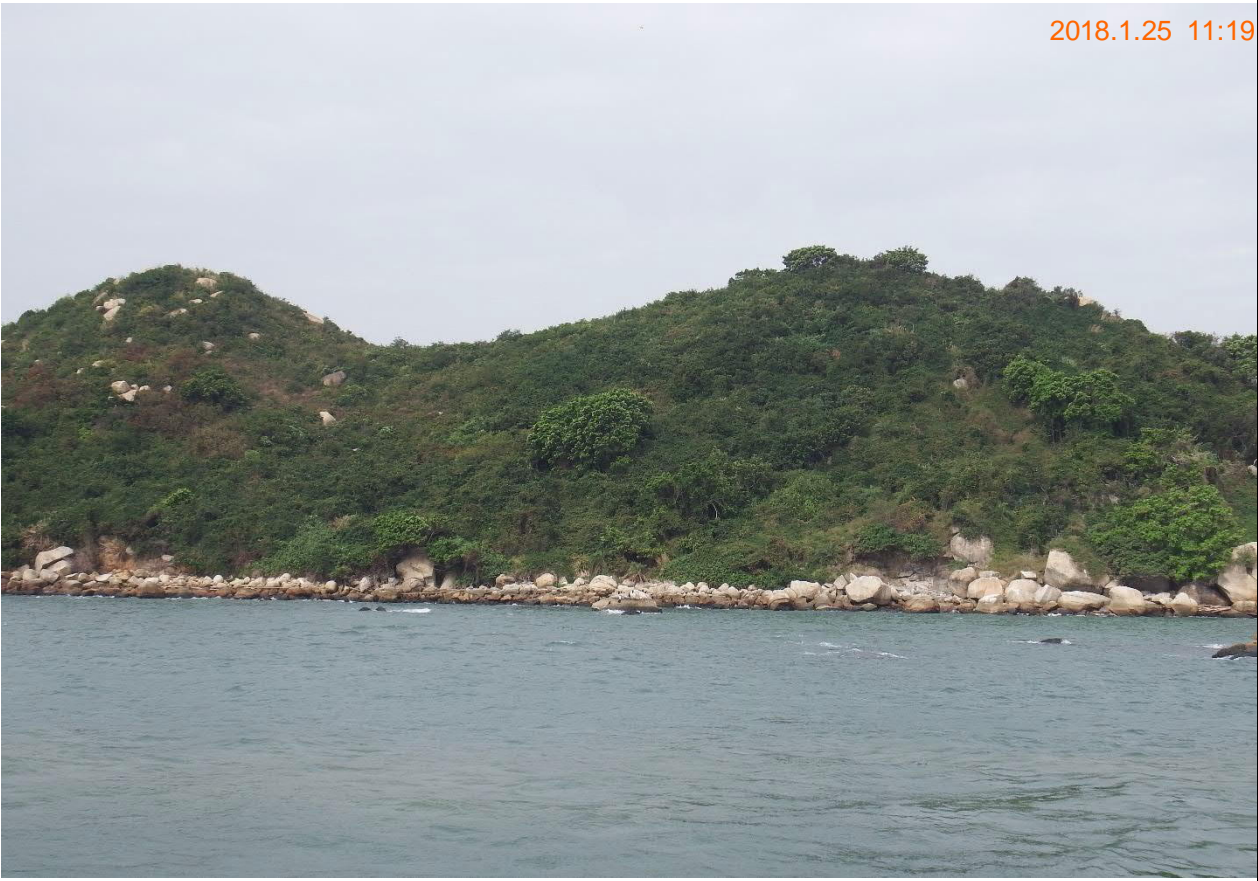
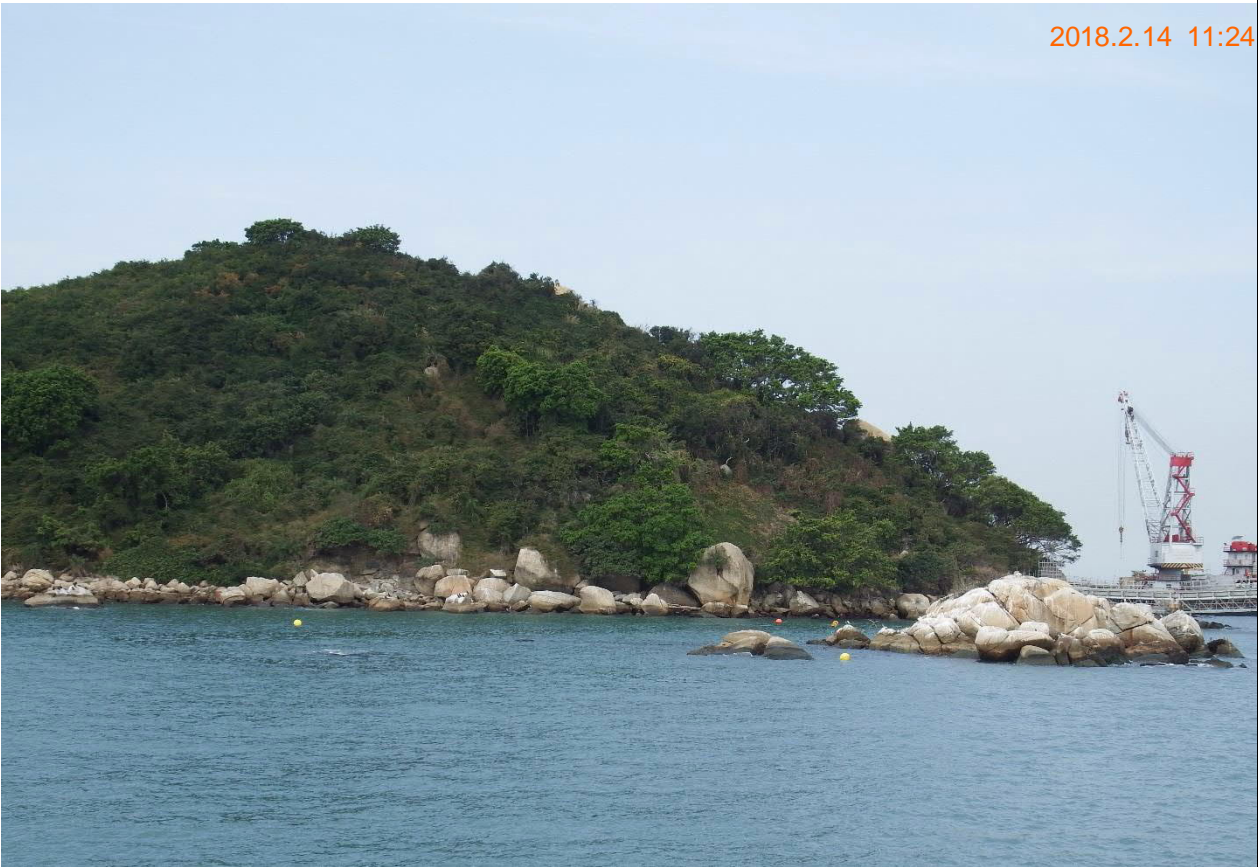
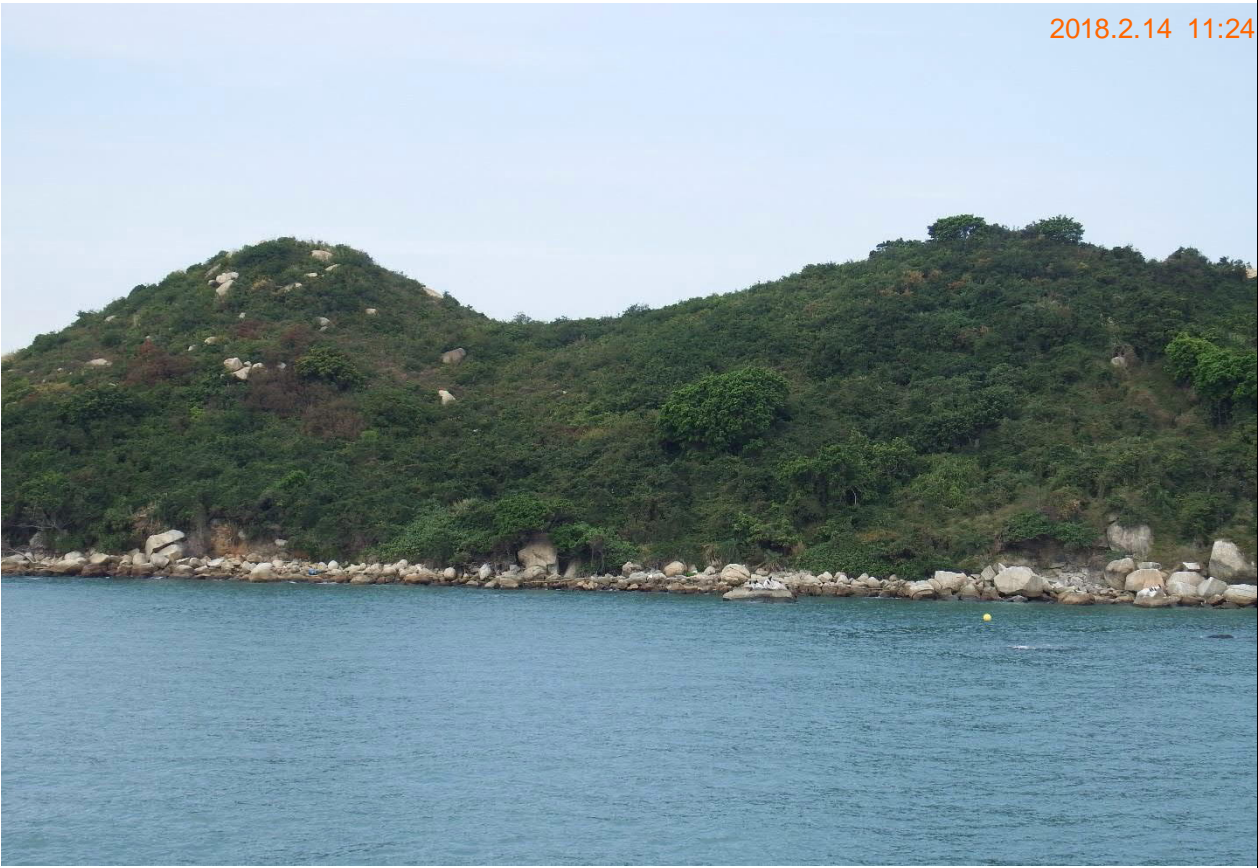
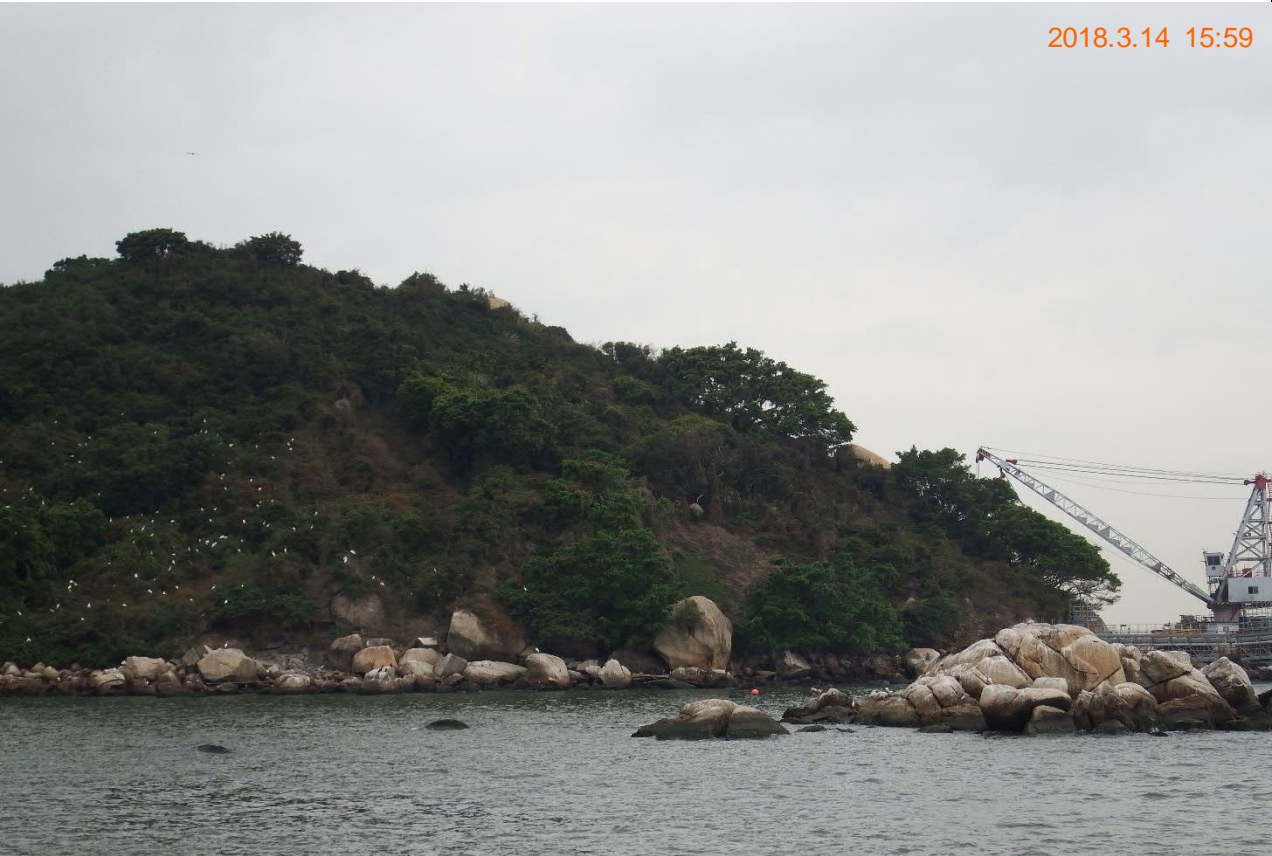
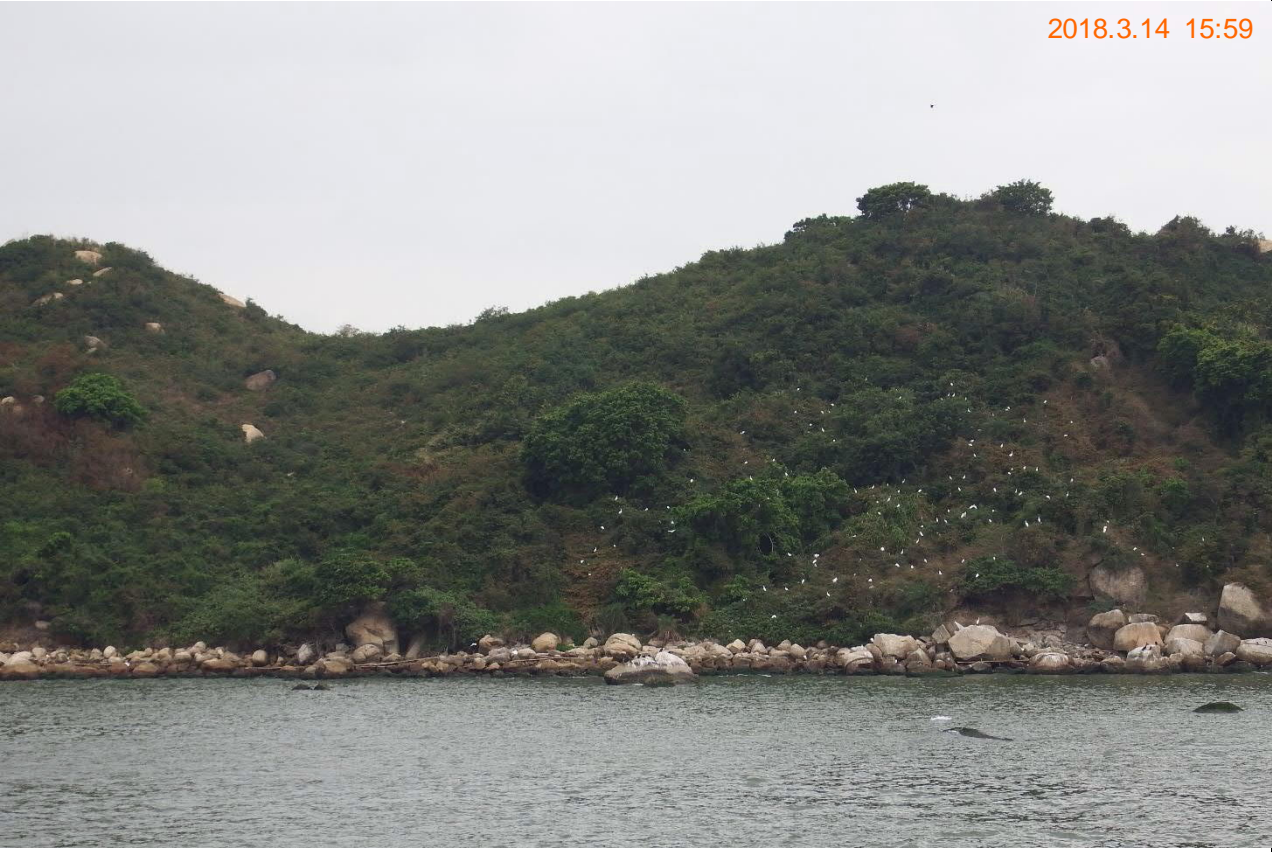
The monthly terrestrial ecology monitoring on Sheung Sha Chau observed that HDD works were conducted at the daylighting location and there was no encroachment upon the egret area nor any significant disturbance to ardeids at Sheung Sha Chau by the works.

Monthly ecological monitoring was carried out in January, February, and March 2018 on Sheung Sha Chau Island. No encroachment of any works upon the egret area nor any significant disturbance to the ardeids on the island by the works was recorded during ecological monitoring. Signs of early breeding activities by Black-crowned Night Heron and Little Egret were observed on trees located further east of the previously identified egret area where it is at the southern side of Sheung Sha Chau Island. At the HDD daylighting location, neither nest nor breeding activity of ardeids were found during the monthly ecological monitoring and weekly site inspections in the reporting period. The site photos and location map regarding the ecological monitoring for HDD works and egret area are provided in **Appendix C** for reference. All the HDD construction works on Sheung Sha Chau had been completed and retreated on 29 March 2018. No construction works will be conducted on Sheung Sha Chau Island during the ardeid's breeding season.
