Expansion of Hong Kong International Airport into a Three-Runway System

Construction Phase Quarterly EM&A Report
No.14 (1 April to 30 June 2019)

August 2019

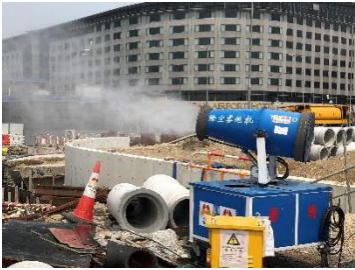
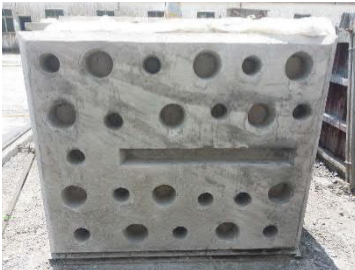
Snapshots of Good Environmental Practices in the Reporting Period

Water mist spraying machine deployed to suppress potential fugitive dust emission	Eco-enhancement designs for concrete seawall blocks	Video recording system to monitor movements of C&D waste
