Expansion of Hong Kong International Airport into a Three-Runway System

Construction Phase Quarterly EM&A Report
No.20 (1 October to 31 December 2020)

March 2021

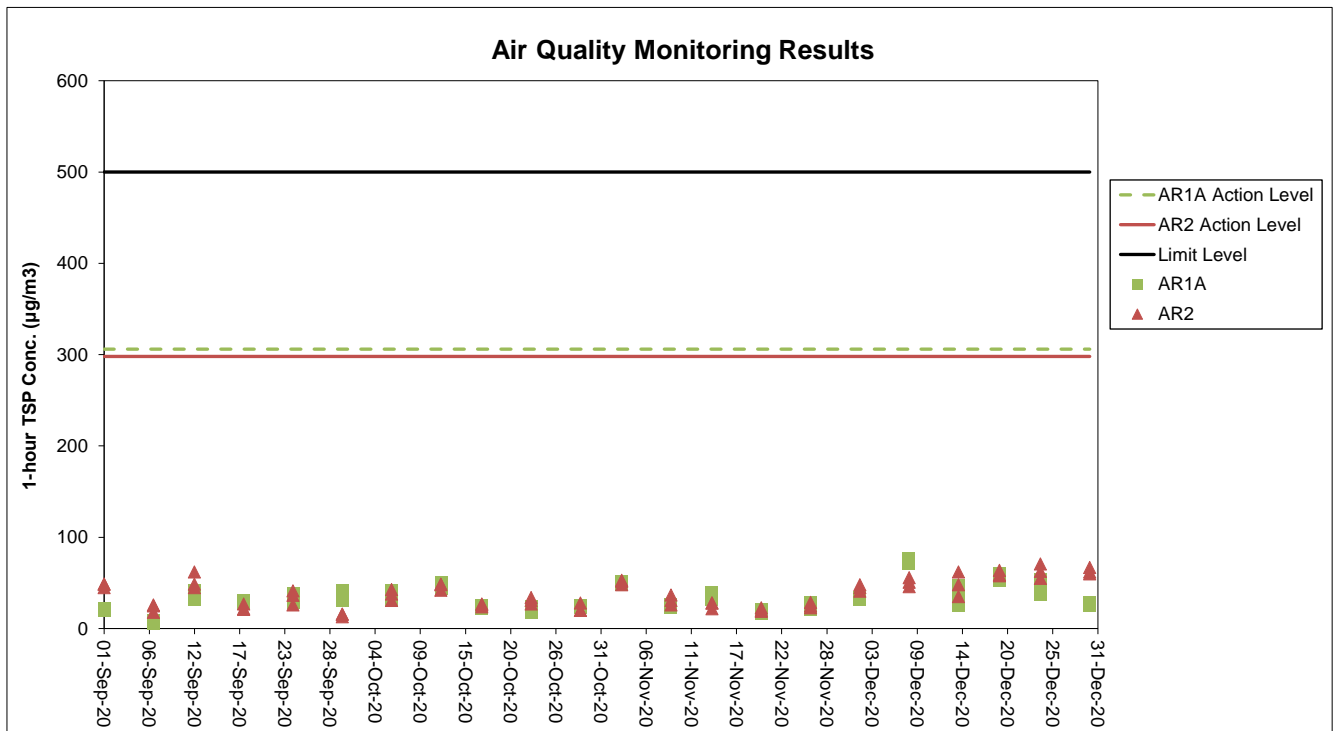
Air Quality Monitoring Results

1. The key activities of the Project carried out in the reporting period included reclamation works and land-based works. Works in the reclamation areas included DCM works, marine filling, seawall and facilities construction, together with runway and associated works. Land-based works on existing airport island involved mainly airfield works, foundation and substructure work for Terminal 2 expansion, modification and tunnel work for APM and BHS systems, and preparation work for utilities, with activities include site establishment, site office construction, road and drainage works, cable ducting, demolition of existing facilities, piling, and excavation works.

3. QA/ QC requirements as stipulated in the EM&A Manual were carried out during measurement.

No dust emission source was observed at the monitoring stations during the monitoring sessions. As the sensitive receivers were far away from the construction activities, with the implementation of dust control measures, there was no adverse impact at the sensitive receivers attributable to the works of the Project.

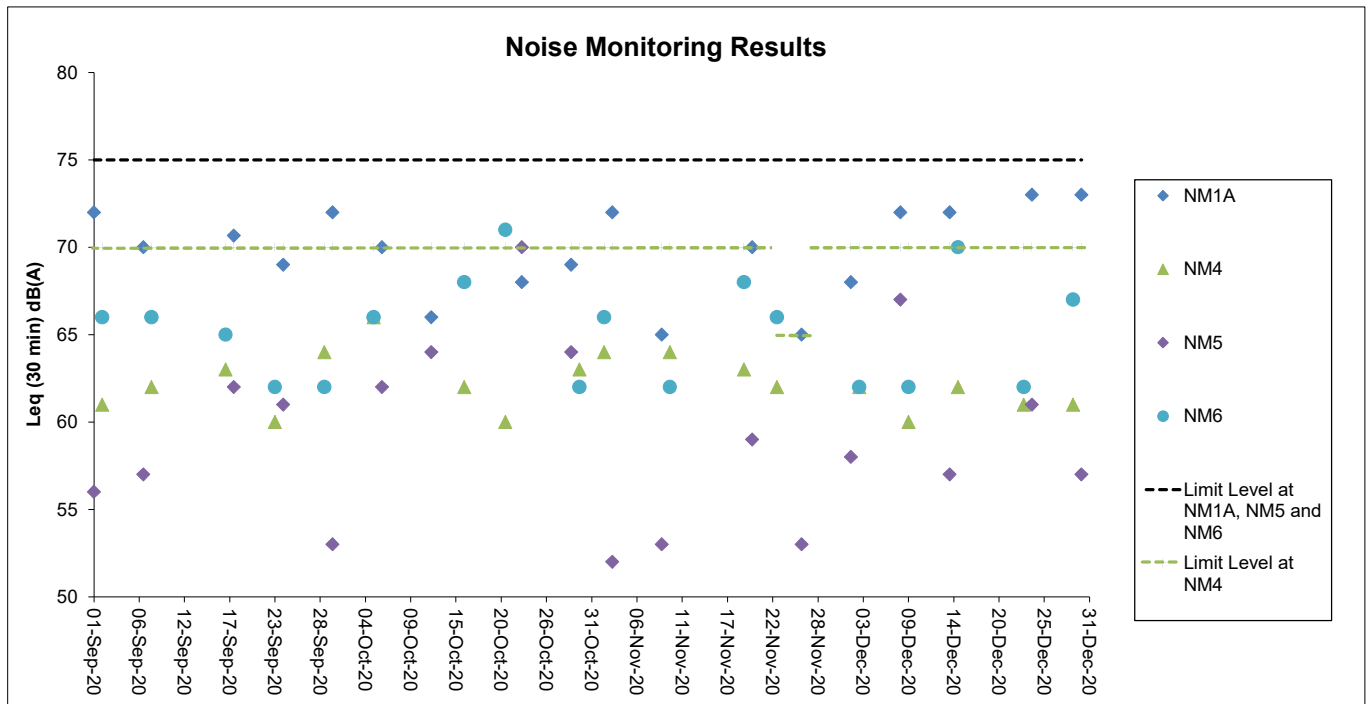
Noise Monitoring Results

1. The Limit Level is reduced to 70dB(A) for school and 65dB(A) during school examination period at NM4. School examination took place from 23 to 27 November during this reporting period.

4. QA/ QC requirements as stipulated in the EM&A Manual were carried out during measurement.

Major sources of noise dominating the monitoring stations observed during the construction noise impact monitoring were traffic noise near NM1A and aircraft noise near NM6. As the sensitive receivers were far away from the construction activities, with the implementation of noise control measures, there was no adverse impact at the sensitive receivers attributable to the works of the Project.

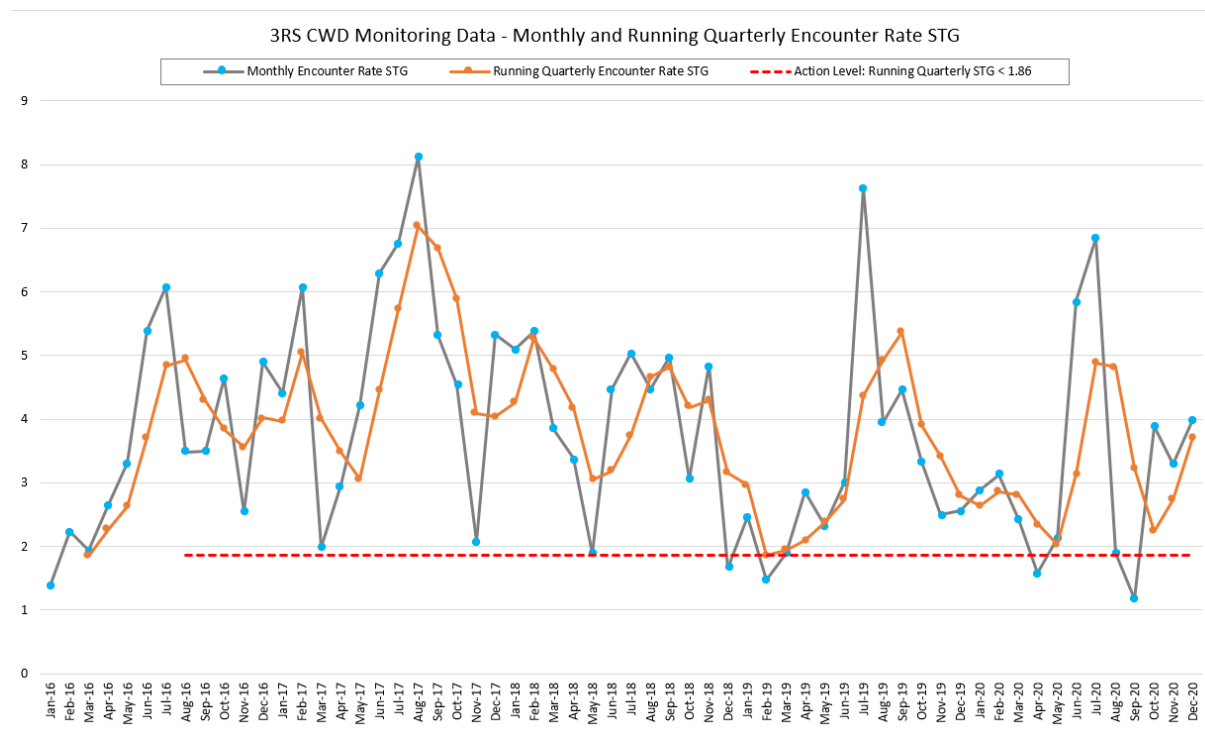
Encounter Rate STG:

Graphical Presentation of Monthly and Running Quarterly Encounter Rates for the entire monitoring period
