Expansion of Hong Kong International Airport into a Three-Runway System

Construction Phase Quarterly EM&A Report
No.30 (1 April to 30 June 2023)

August 2023

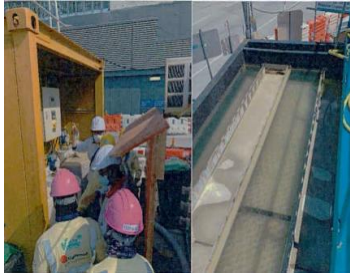
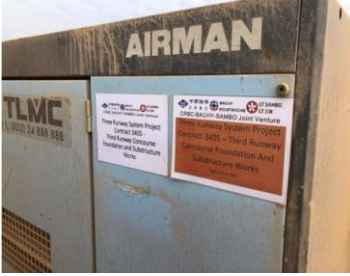
Snapshots of Good Environmental Practices in the Reporting Period

Use of automated water sprinklers with timers for dust suppression	Training was provided to designated operators for regular monitoring on discharge quality and wastewater treatment facility maintenance	Different colour of labels were applied to PMEs being used at different time period during restricted hours
