Expansion of Hong Kong International Airport into a Three-Runway System

Construction Phase Quarterly EM&A Report
No.31 (1 July to 30 September 2023)

November 2023

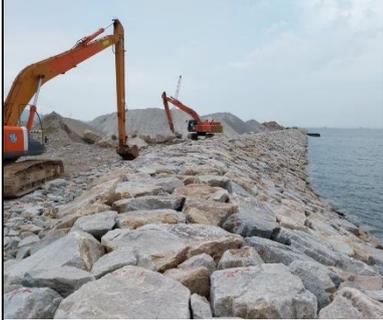
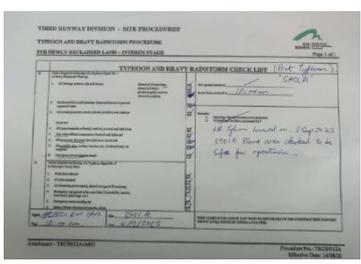
<p>Use of wet scrubber at silo exhaust pipe for dust control</p>	<p>Reuse of armour rocks for seawall construction</p>	<p>Post typhoon checking for the concrete batching plant was conducted by contractor</p>

1. Use of wet scrubber to replace traditional dust filter at silo exhaust pipe for dust control.
2. Armour rocks removed from the previous seawall were reused for seawall construction.
3. Post typhoon checking for the concrete batching plant was conducted by contractor to ensure its proper operation to prevent dust nuisance.

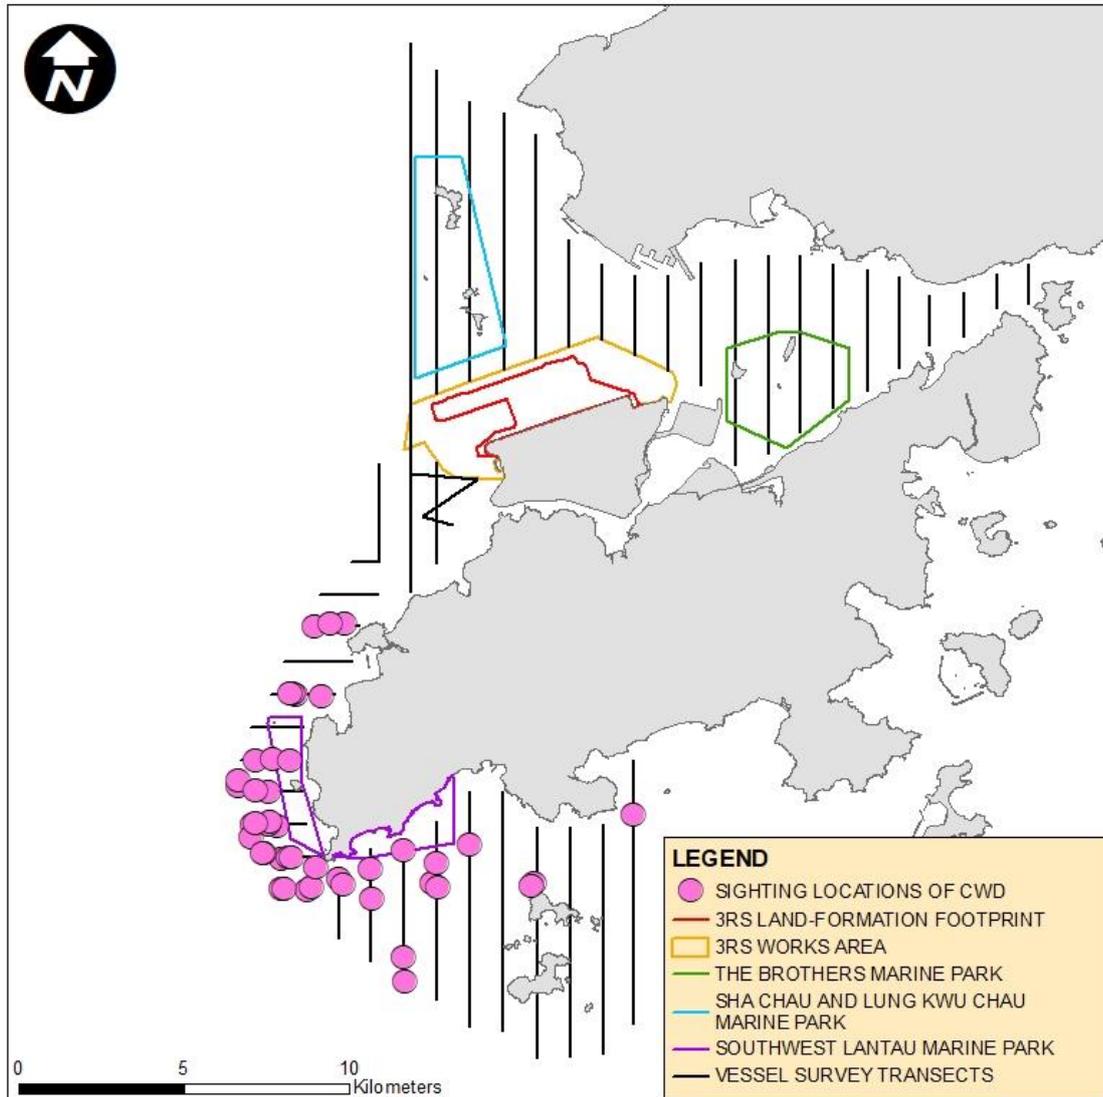
Figure 2.5: Sightings Distribution of Chinese White Dolphins from July to September 2023

The distribution of CWD sightings recorded from July to September 2023 is illustrated in **Figure 2.5**. In WL, CWD sightings were clustered at the waters between Tai O and Fan Lau. In SWL, CWD sightings were mostly recorded around Fan Lau and Tai Long Wan. No CWD sightings were recorded in NEL and NWL survey area during the reporting period. Details of the sighting data are presented in **Appendix C**.

Remarks: (1) Please note that there are 44 pink circles on the map indicating the sighting locations of CWD. Some of them were very close to each other and therefore appear overlapped on this sighting distribution map. (2) Marine Park excludes land area and the landward boundary generally follows the high water mark along the coastline.

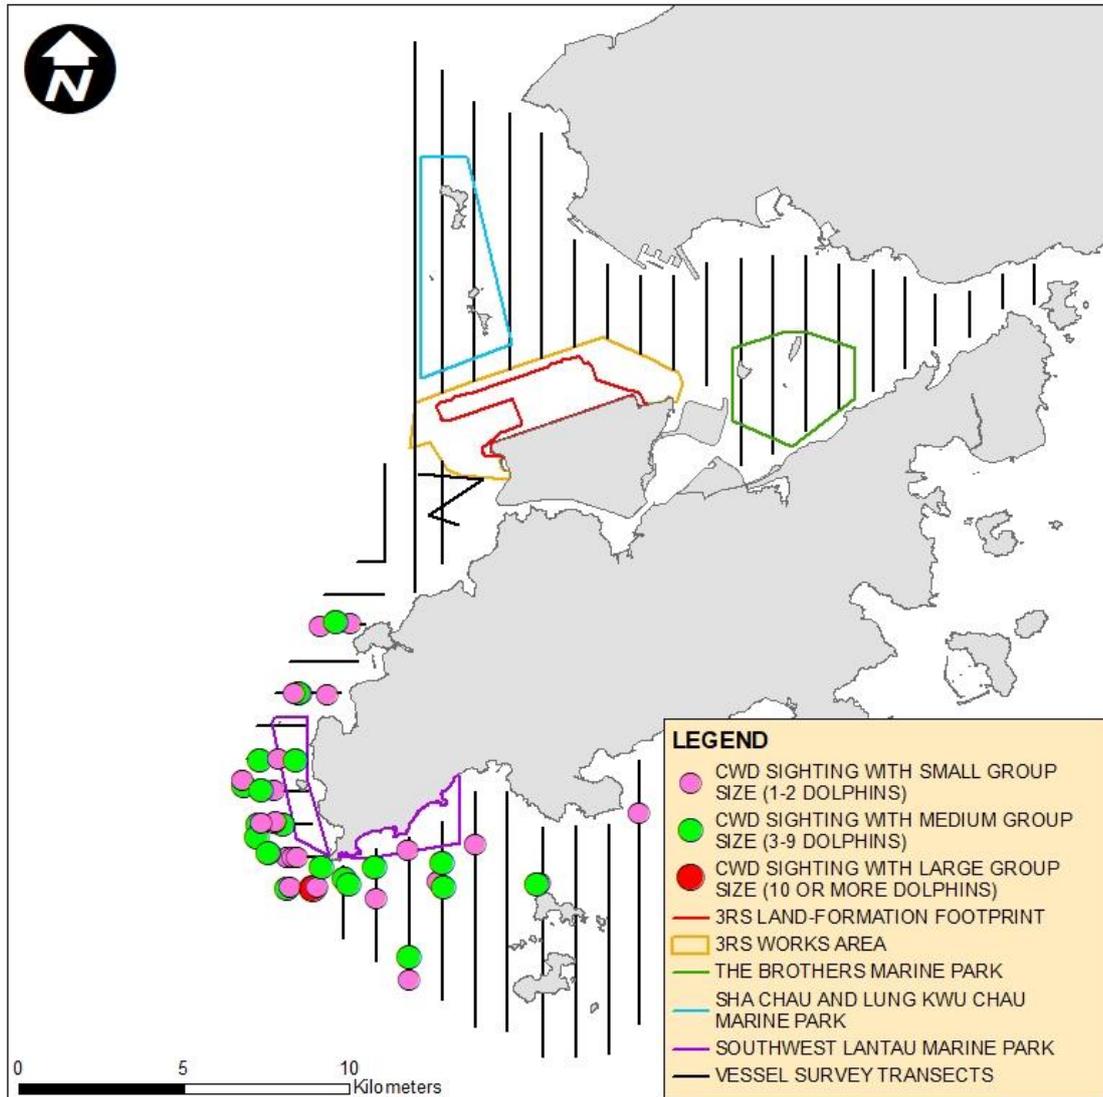
Figure 2.6: Sighting Locations of Chinese White Dolphins with Different Group Sizes

There was no apparent difference in the distribution of small-sized dolphin groups and medium-sized dolphin groups in all survey areas. Sighting locations of CWD groups with different group sizes are depicted in **Figure 2.6**.

Remarks: (1) Please note that there are 44 circles on the map indicating the sighting locations of CWD. Some of them were very close to each other and therefore appear overlapped on this sighting distribution map. (2) Marine park excludes land area and the landward boundary generally follows the high water mark along the coastline.

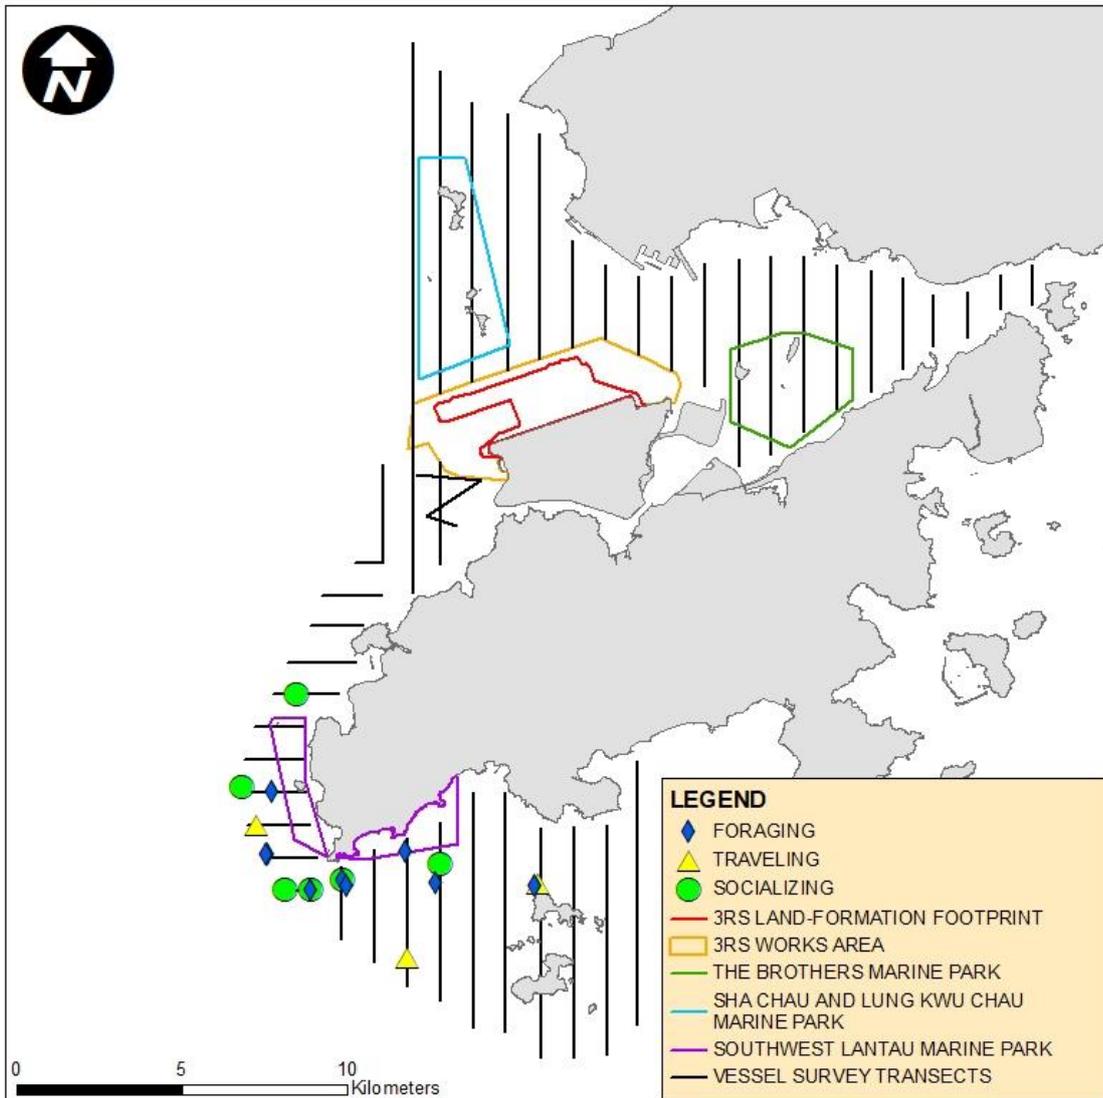
Figure 2.7: Sighting Locations of Chinese White Dolphins Engaged in Different Behaviours

From July to September 2023, 9 sightings of CWD were recorded with foraging activities. Amongst them, two sightings were observed associated with operating purse seiners. Both sightings were recorded in SWL.

The sighting locations of CWDs engaged in different behaviours during the current reporting period are illustrated in **Figure 2.7**.

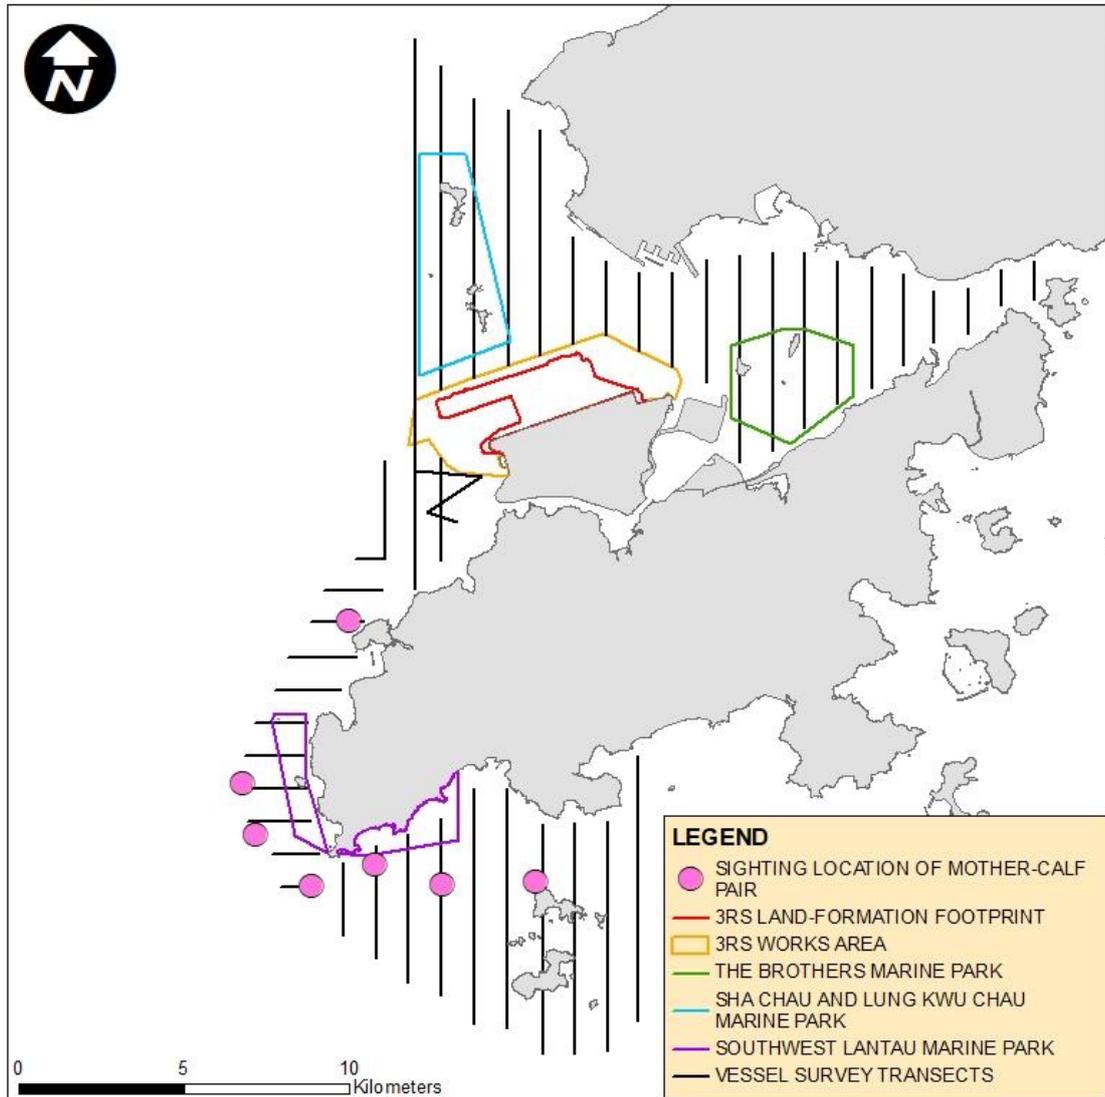
Figure 2.8: Sighting Locations of Mother-calf Pairs

These seven sightings with the presence of mother-calf pairs recording during the reporting period were all recorded in WL and SWL survey area (four pairs in WL and three pairs in SWL respectively). The locations of CWD sightings with the presence of mother-calf pairs are shown in **Figure 2.8**.

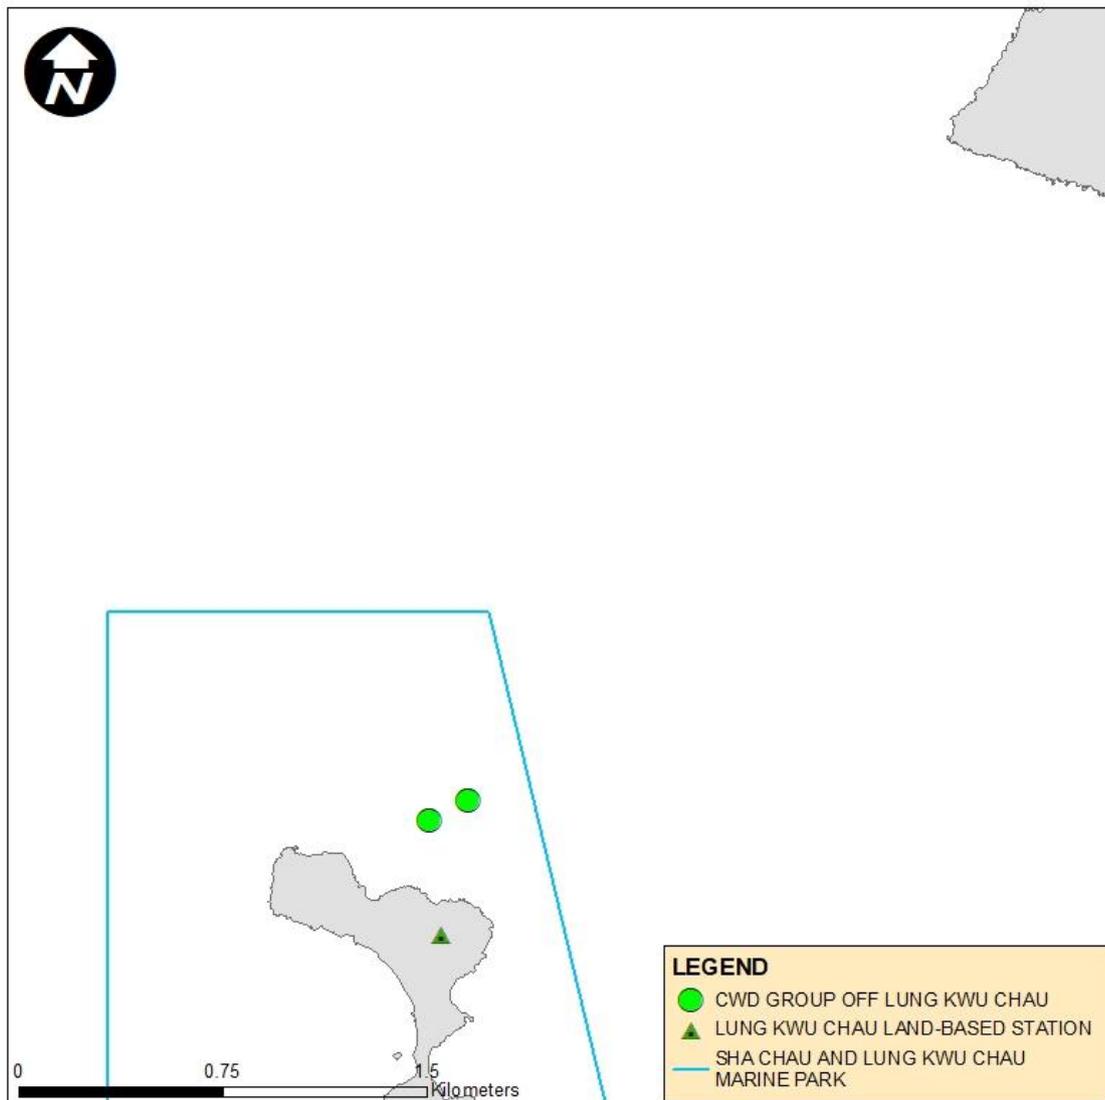
Figure 2.9: Plots of First Sightings of All CWD Groups from Land-based Stations

Land-based Station	# of Survey Sessions	Survey Effort (hh:mm)	# CWD Groups Sighted	CWD Group Sighting per Survey Hour
July 2023				
Lung Kwu Chau	1	06:00	1	0.17
Sha Chau	1	06:00	0	0
TOTAL	2	12:00	1	0.08
August 2023				
Lung Kwu Chau	1	06:00	1	0.17
Sha Chau	1	06:00	0	0
TOTAL	2	12:00	1	0.08
September 2023				
Lung Kwu Chau	1	06:00	0	0
Sha Chau	1	06:00	0	0
TOTAL	2	12:00	0	0
OVERALL	6	36:00	2	0.06

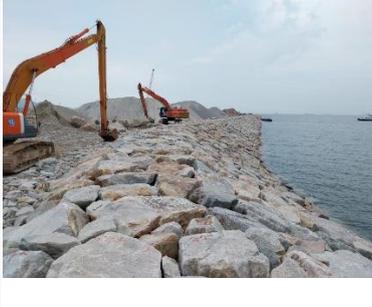
1. Use of wet scrubber to replace traditional dust filter at silo exhaust pipe for dust control.
2. Armour rocks removed from the previous seawall were reused for seawall construction.
3. Post typhoon checking for the concrete batching plant was conducted by contractor to ensure its proper operation to prevent dust nuisance..

<p>Use of wet scrubber at silo exhaust pipe for dust control</p>	<p>Reuse of armour rocks for seawall construction</p>	<p>Post typhoon checking for the concrete batching plant was conducted by contractor</p>

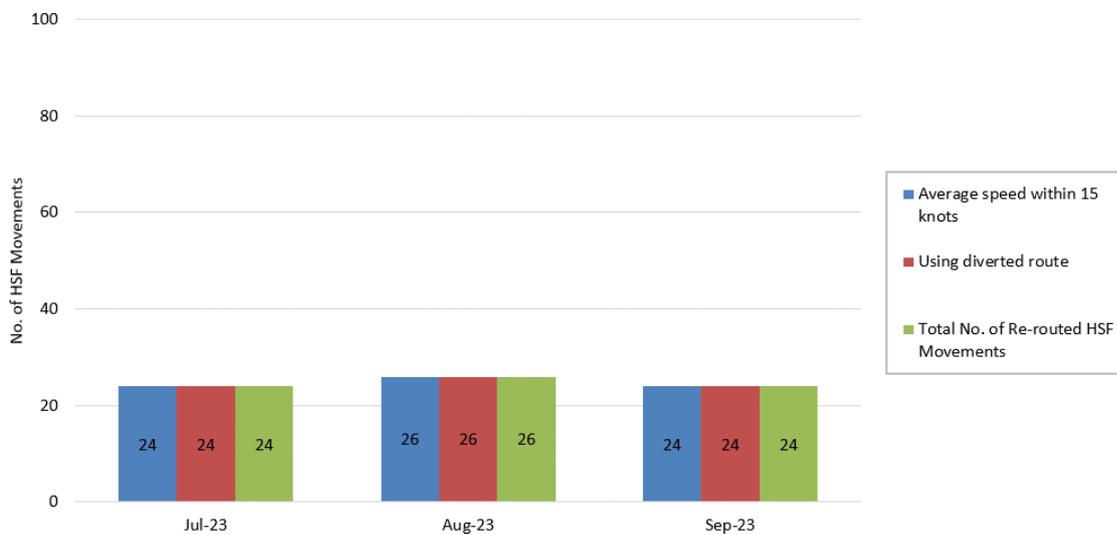
Graph 1: Summary of SkyPier High Speed Ferries Monitoring Results

Insufficient AIS data cases were received from HSF during the reporting period. After investigation, it was found that AIS data for the concerned ferry was missing due to AIS equipment malfunction as reported by the ferry operator after checking the condition of the AIS transponders. Maintenance works were carried out for the concerned AIS equipment to prevent reoccurrence. The ferry operator was requested to provide the radar track photo/video which indicated the vessel entered the SCZ through the gate access points and there was no speeding in the SCZ. Ferry operator's explanation was accepted.

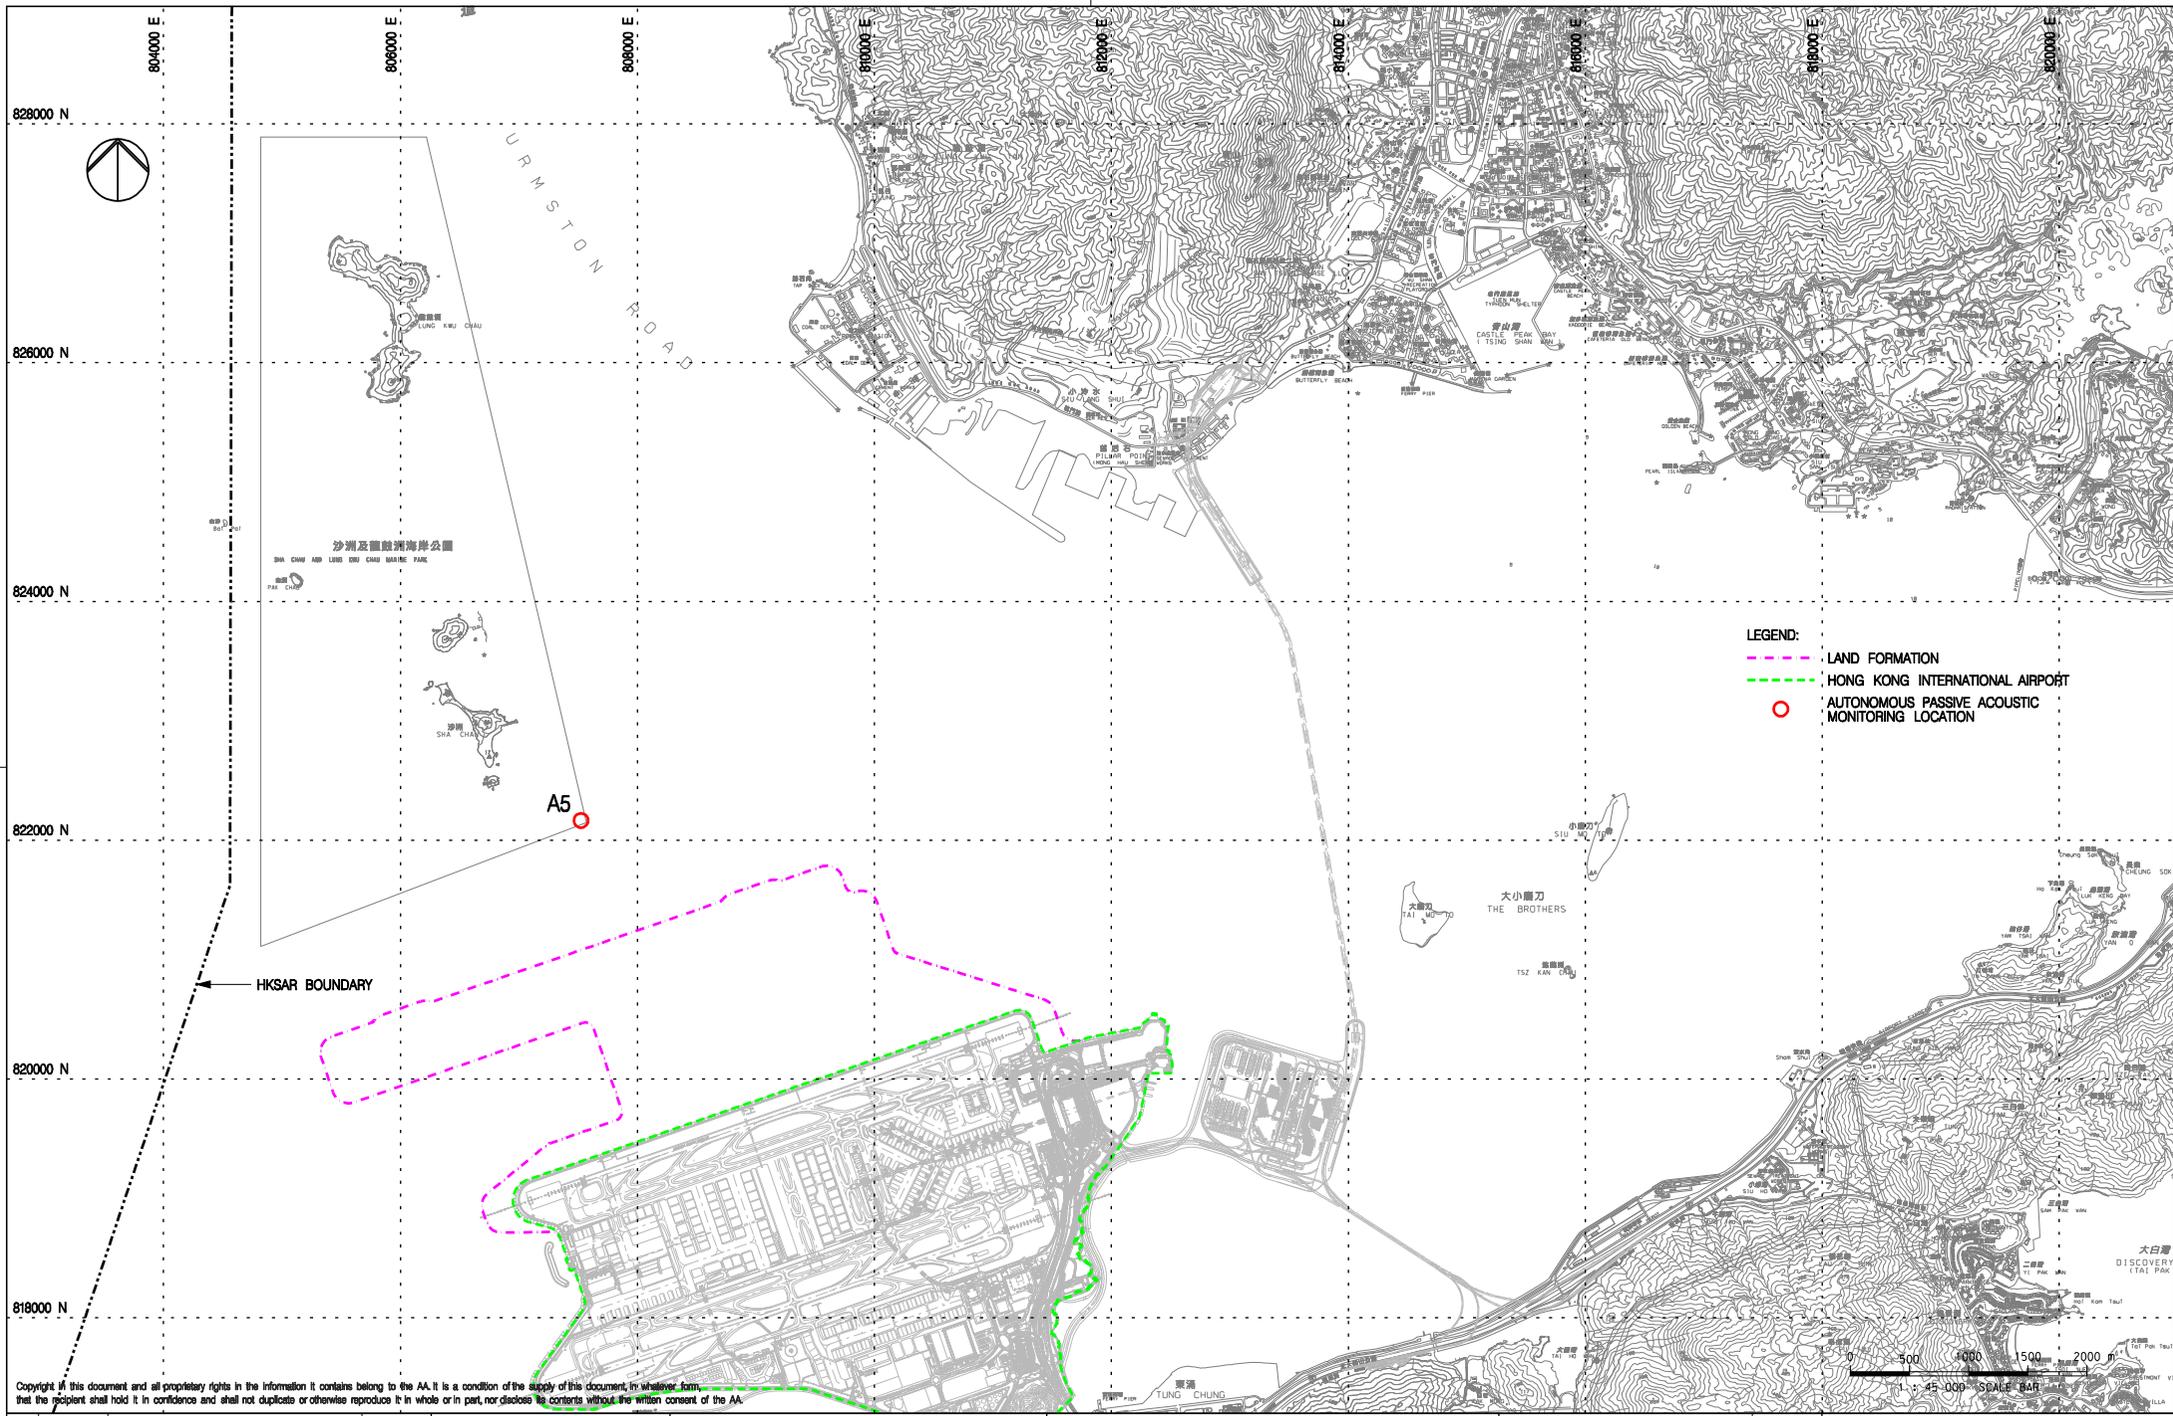
EXPANSION OF HONG KONG INTERNATIONAL AIRPORT INTO A THREE-RUNWAY SYSTEM		Scale at A3
Drawing No.		1:45000
FIGURE 2.10		Rev. C

PAM device has been deployed and positioned to the south of Sha Chau within the SCLKCMP (**Figure 2.10**) to supplement the detection of CWD presence in the south Sha Chau area that are not recorded visually by the land-based theodolite tracking survey and to coincide the theodolite data when there is sighting from the land-based station at Sha Chau. Both C-POD and F-POD are considered as effective PAM devices in detecting CWD occurrence, and F-POD was the main PAM device deployed where feasible. In this reporting period, the F-POD was retrieved on 1 August 2023 for data collection and subsequently re-deployed. As the period of data collection and analysis takes more than four months, PAM results could not be reported in quarterly intervals but report for supplementing the annual CWD monitoring analysis.

- LEGEND:**
- - - LAND FORMATION
 - - - HONG KONG INTERNATIONAL AIRPORT
 - AUTONOMOUS PASSIVE ACOUSTIC MONITORING LOCATION

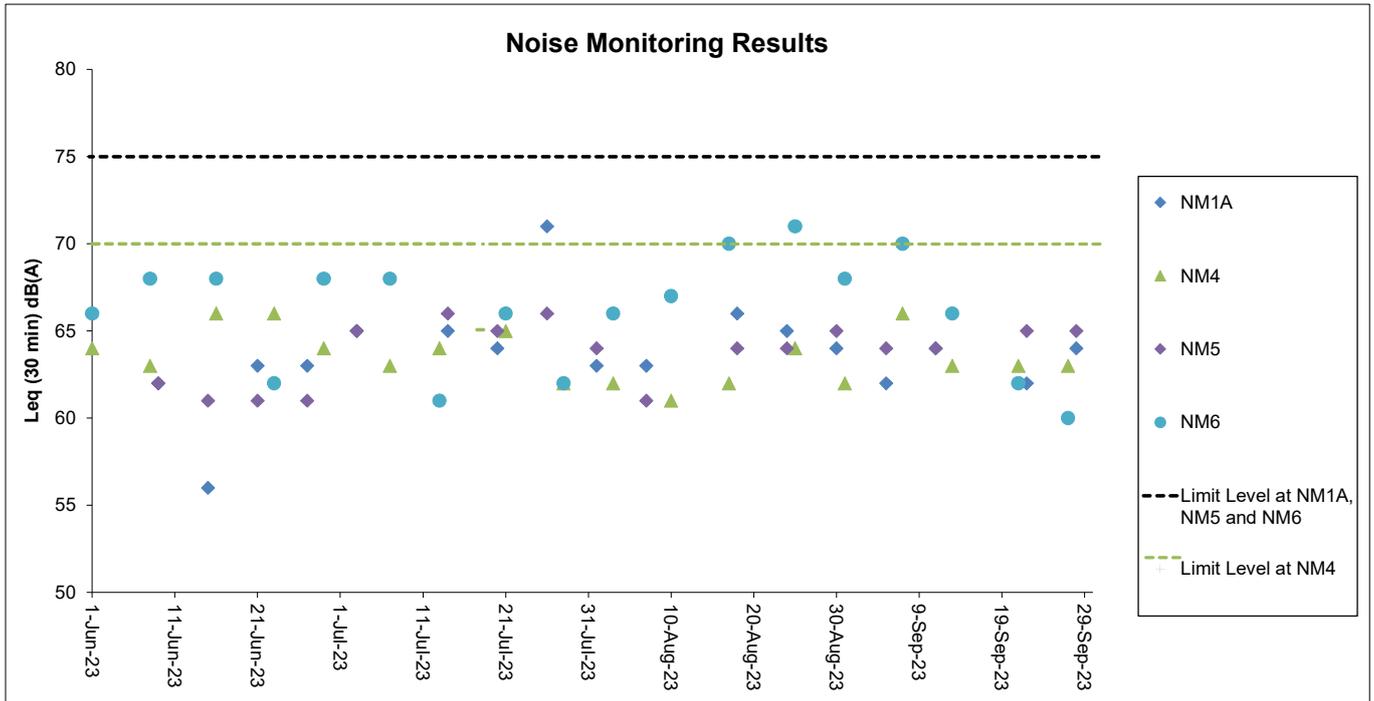
Noise Monitoring Results

1. The Limit Level is reduced to 70dB(A) for school and 65dB(A) during school examination period at NM4. School examination took place on 18 July during this reporting period.
