Expansion of Hong Kong International Airport into a Three-Runway System

Construction Phase Quarterly EM&A Report
No.33 (1 January to 31 March 2024)

May 2024

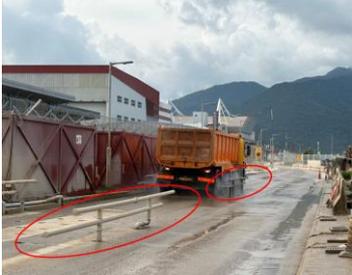
<p>Installed automatic wheel washing facilities in series</p>	<p>Automatic drip irrigation system</p>	<p>Provision of water spray at the stockpiling area</p>

1. Three automatic wheel washing facilities were installed in series by the contractor to ensure the vehicle was washed thoroughly, and all dusty materials from its underneath and wheels were removed before leaving the construction site.
2. Automatic drip irrigation system was provided by the contractor to maintain good health condition of the trees.
3. Water spraying was provided at the stockpiling area for dust suppression purposes.

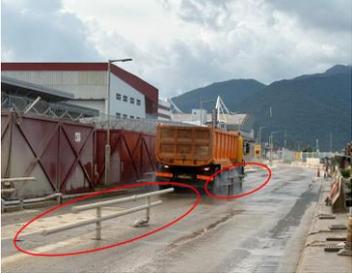
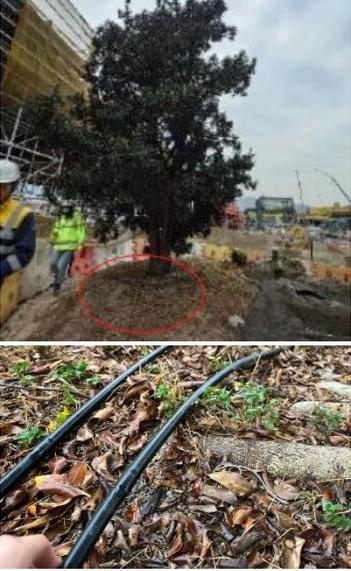
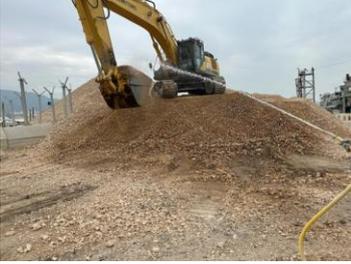
1. Three automatic wheel washing facilities were installed in series by the contractor ensure the vehicle was washed thoroughly, and all dusty materials from its underneath and wheels were removed before leaving the construction site.
2. Automatic drip irrigation system was provided by the contractor to maintain good health condition of the trees.
3. Water spraying was provided at the stockpiling area for dust suppression purposes.

<p>Installed automatic wheel washing facilities in series</p>	<p>Automatic drip irrigation system</p>	<p>Provision of water spray at the stockpiling area</p>

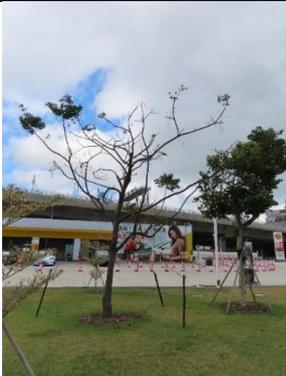
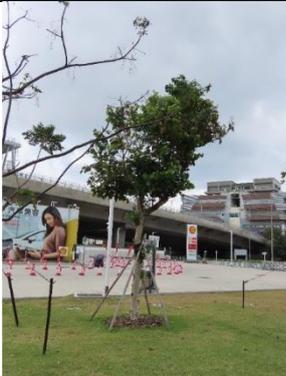
CT276	CT1253

Table 2.15: Photos of the Existing Transplanted Trees Inspected in the Reporting Period
