Expansion of Hong Kong International Airport into a Three-Runway System

Contamination Assessment Report for Terminal 2
Emergency Power Supply Systems No.4

October 2020

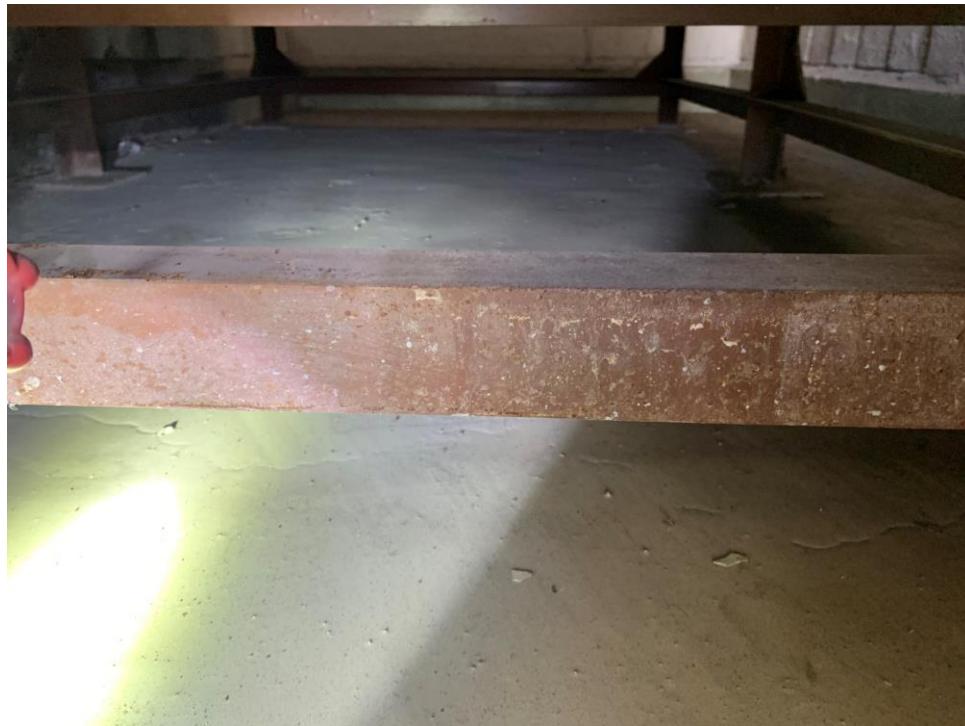
BH10 View 1 – concrete floor condition underneath 1,500L Above-ground Fuel Tank

The above-ground fuel tank (i.e. BH10) and emergency generator (i.e. HS2) of EPSS4 were disconnected in late-May 2020, and the fuel inside the system was removed in mid-June. Final inspection of the BH10 and HS2 was conducted on 18 June 2020. During our final inspection, BH10 and HS2 were at the same locations as for the time of preparation of SCAP in 2018. Both facilities were mounted on intact concrete floor with no oil stain observed, and no oil stain was observed inside the drip tray of the above-ground fuel tank (BH10). In addition, curb by builder was provided in the fuel tank room. Photo records of final inspections are presented in **Appendix H**.
