## Expansion of Hong Kong International Airport into a Three-Runway System

**3<sup>rd</sup> PLG Meeting  
7 September 2016**

Airport Authority Hong Kong

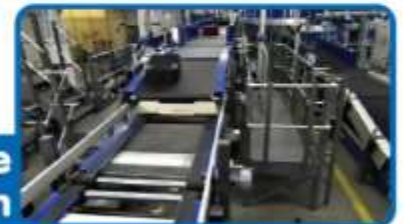
New Baggage  
Handling System

Baggage transport  
speed: **25-36** km/h

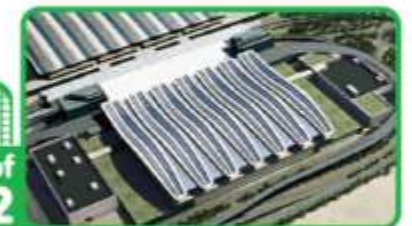
Expansion of  
**Terminal 2**

Providing arrivals, departures and full-fledged  
passenger services

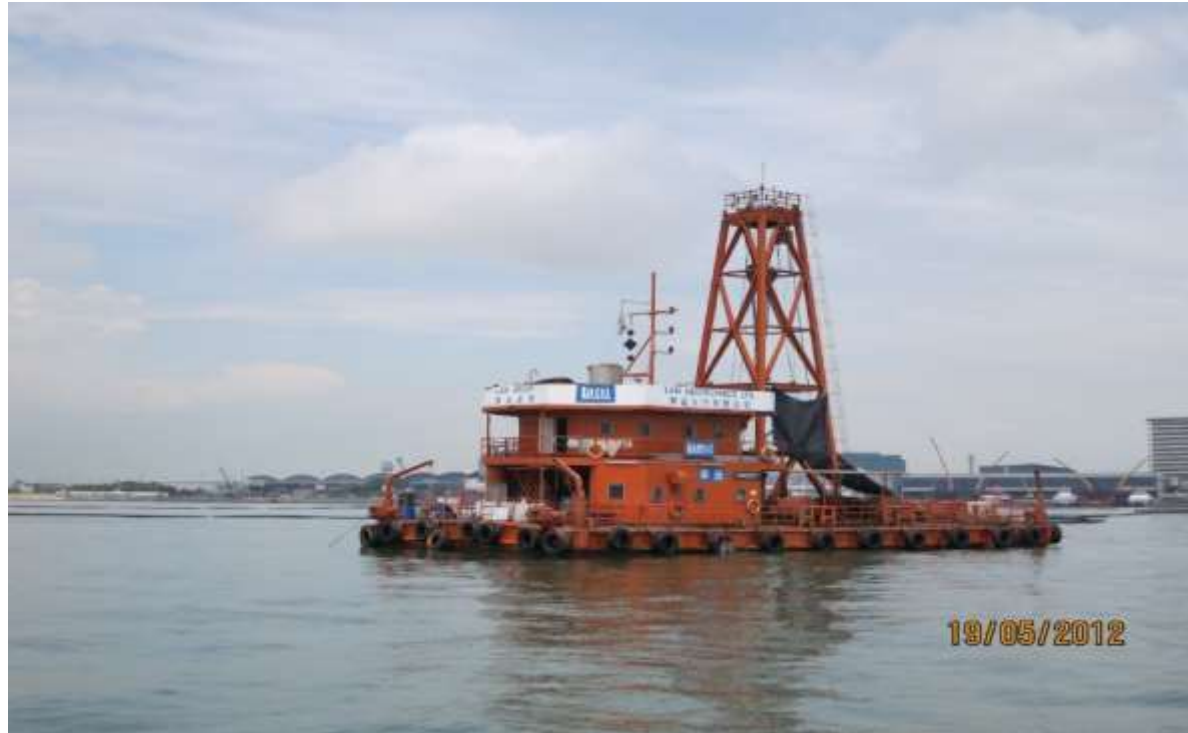
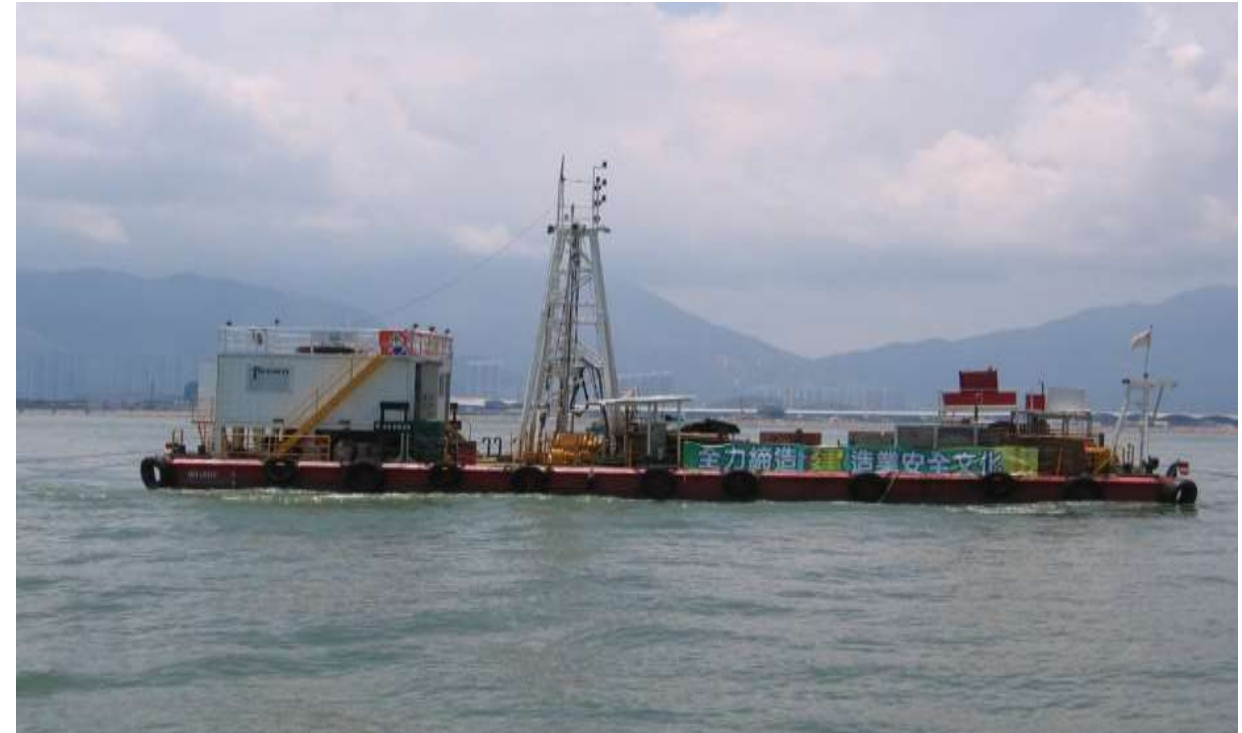
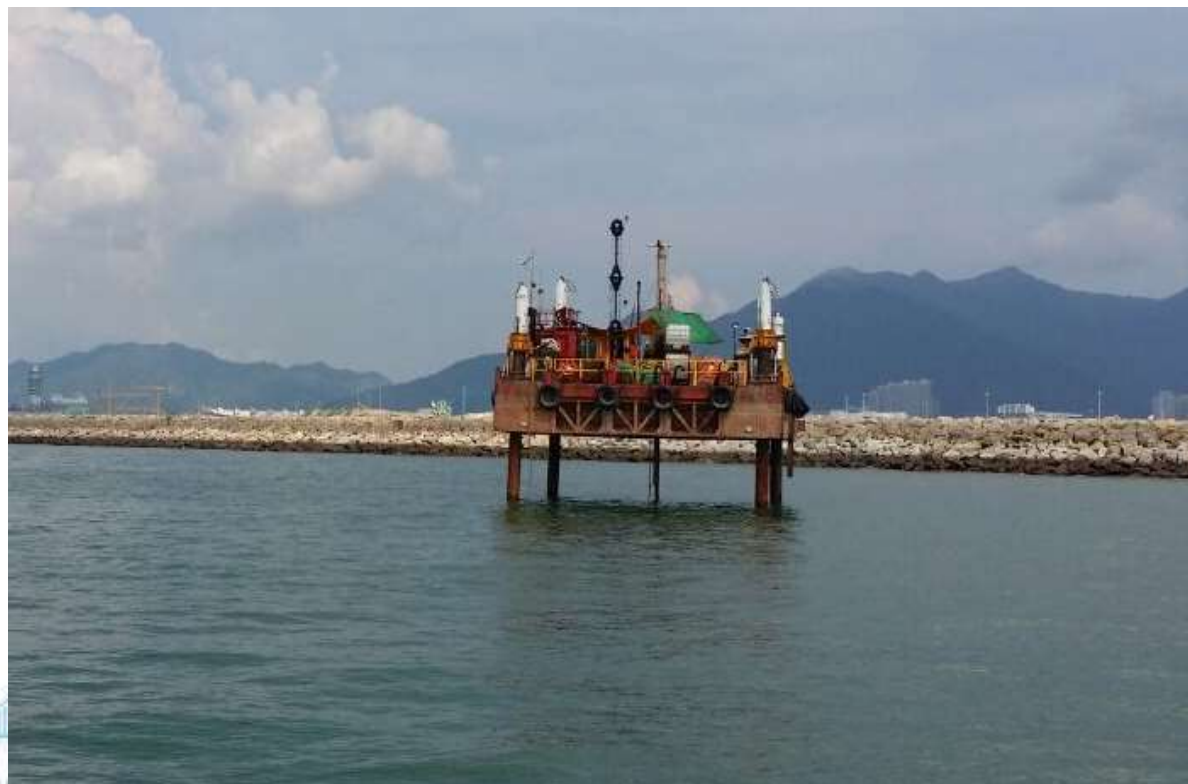
- Site Investigation

# Marine Works Activities (1)

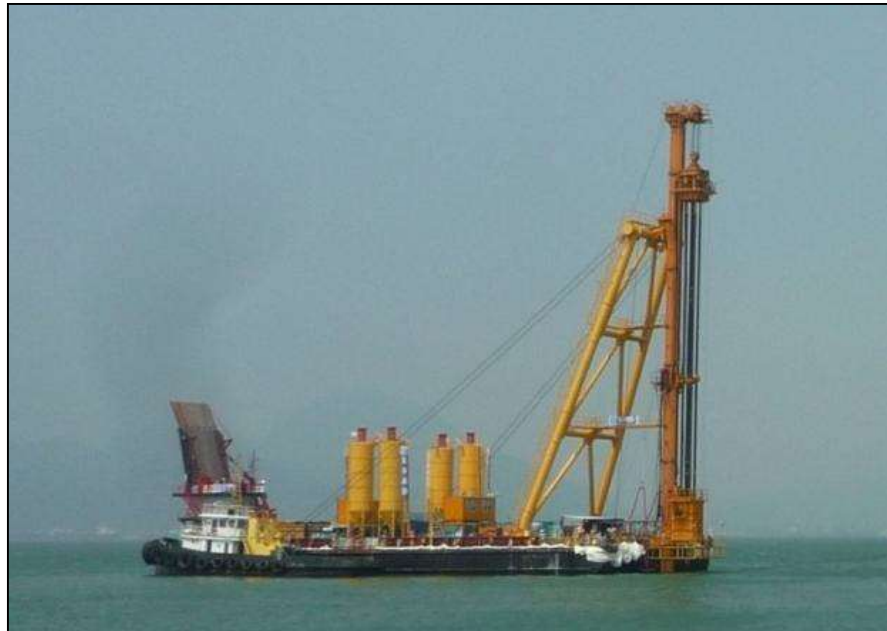
Single Rig

- Ground Improvement Works by Deep Cement Mixing

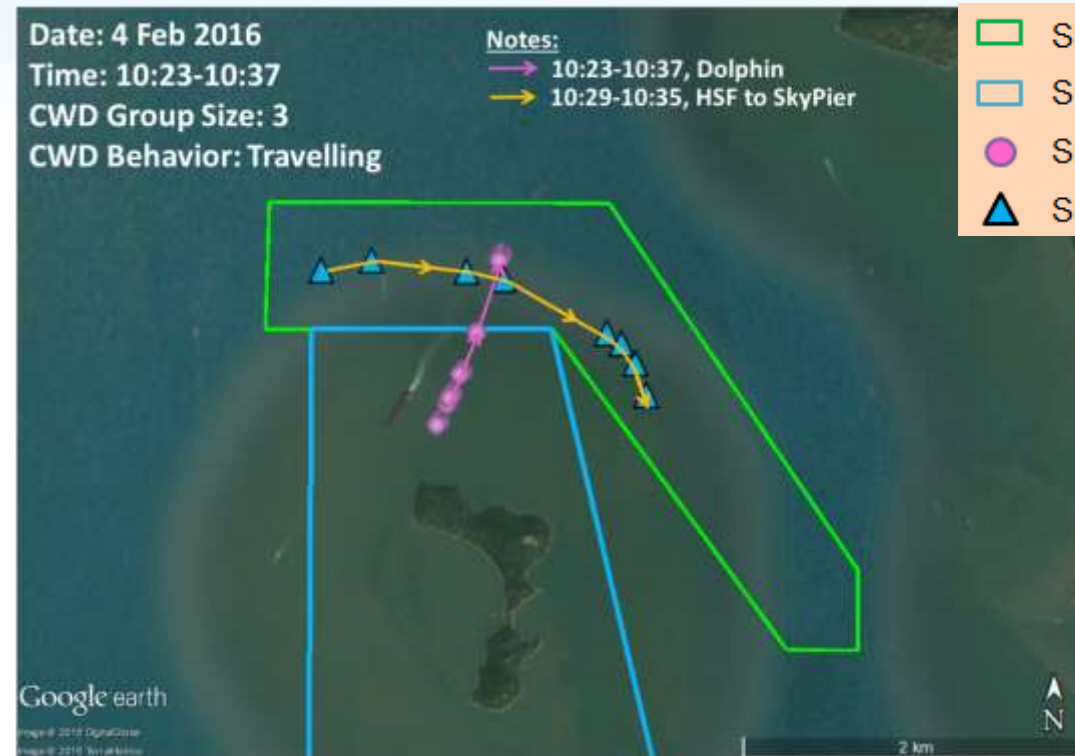
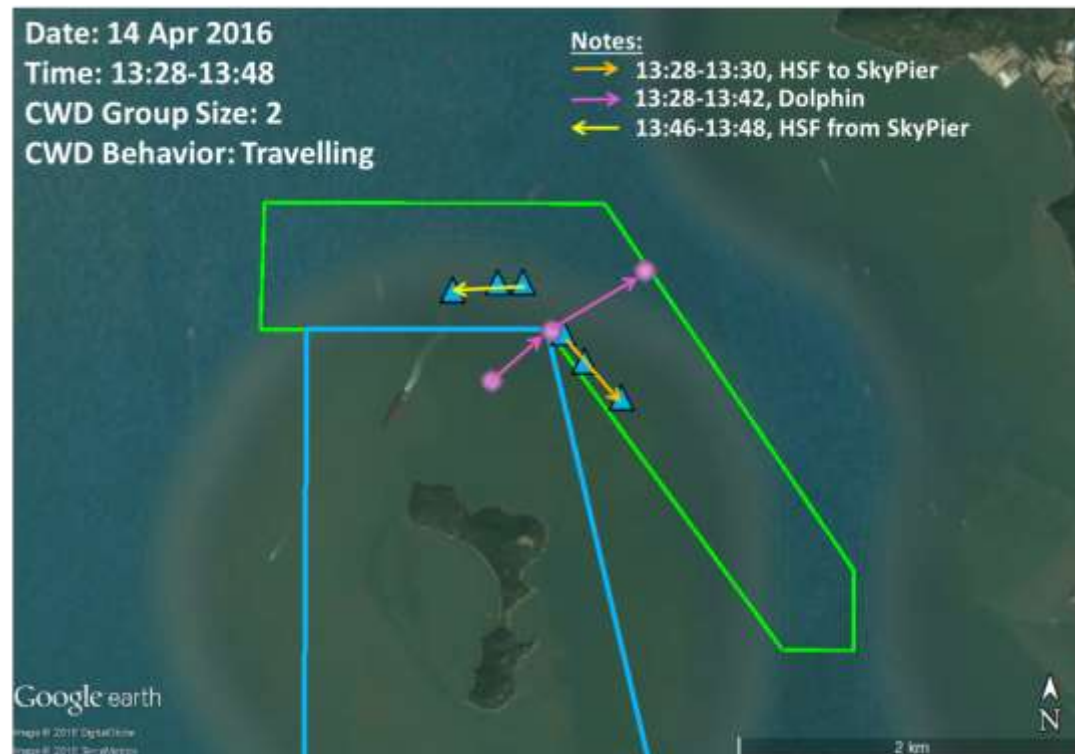
# Co-occurrence of CWDs and Diverted SkyPier HSFs observed within SCZ during Land-based Surveys on different days

- SkyPier HSF Speed Control Zone
- SCLKCMP
- Sighting locations of CWD
- ▲ SkyPier HSF

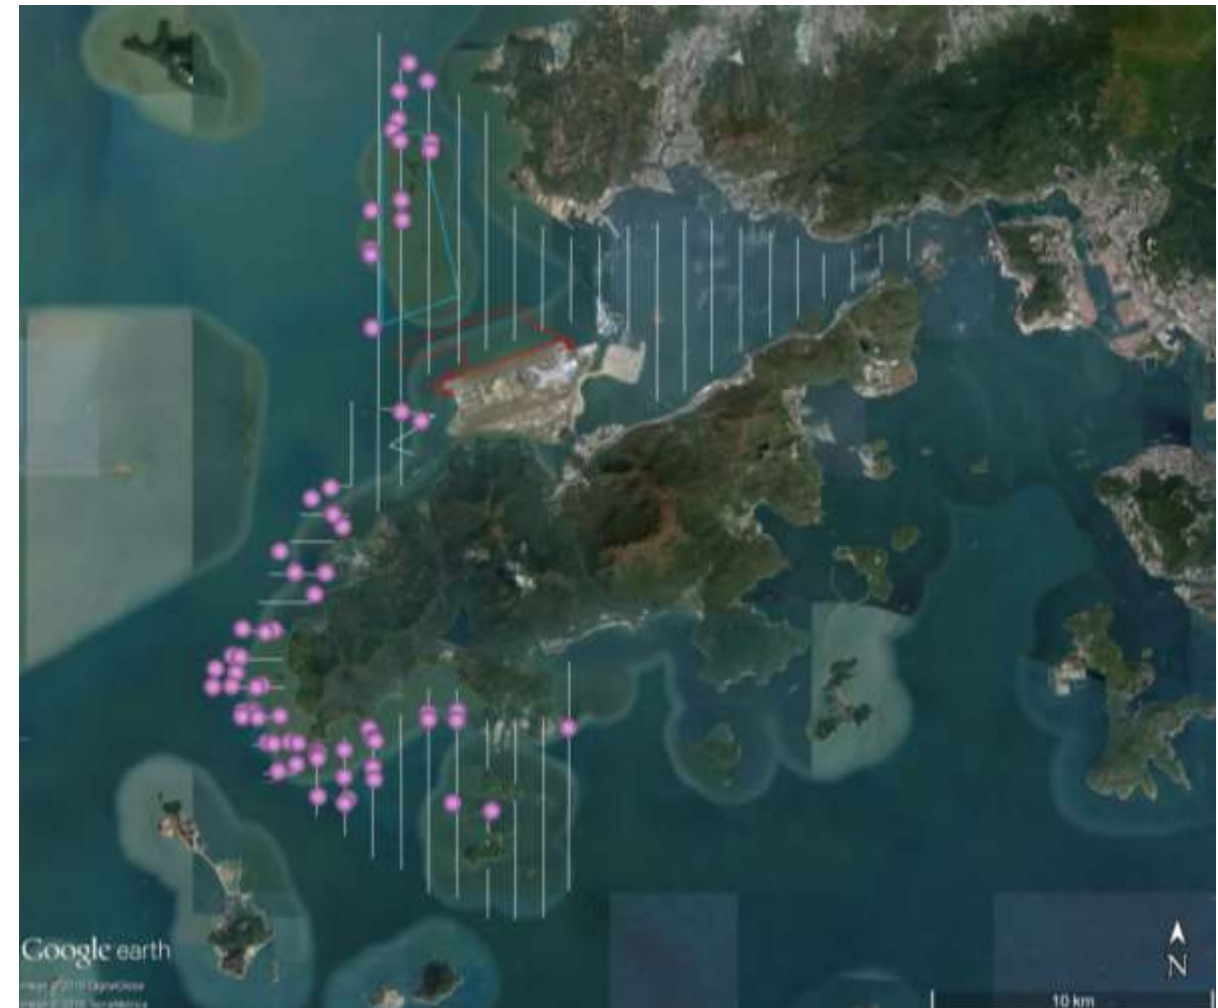
Sightings Distribution of CWDs (during on-effort survey with Beaufort Sea State 3 or below)

- 12 rounds of transect surveys covering NEL, NWL, AW, WL and SWL survey areas completed between 18 Dec 2015 to 17 Jun 2016.
- Over 2,800 km of survey effort collected (with over 90% conducted with Beaufort Sea State 3 or below)
- 71 groups of CWDs with 314 individuals were sighted (during on-effort survey with Beaufort Sea State 3 or below)
- CWD group size average was 4.42, ranged from 1 to 19 individuals
- A total of 96 CWD individuals were identified

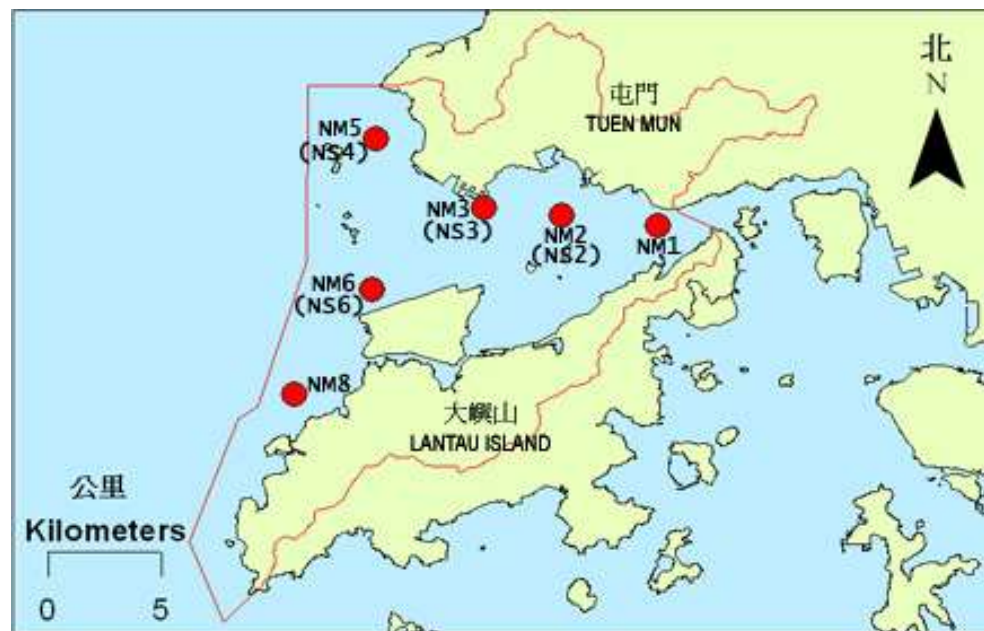
### EPD's 3 years (2013-2015) results range vs 3RS baseline monitoring results range

- 3RS baseline monitoring results are consistent with EPD's 3 years results range

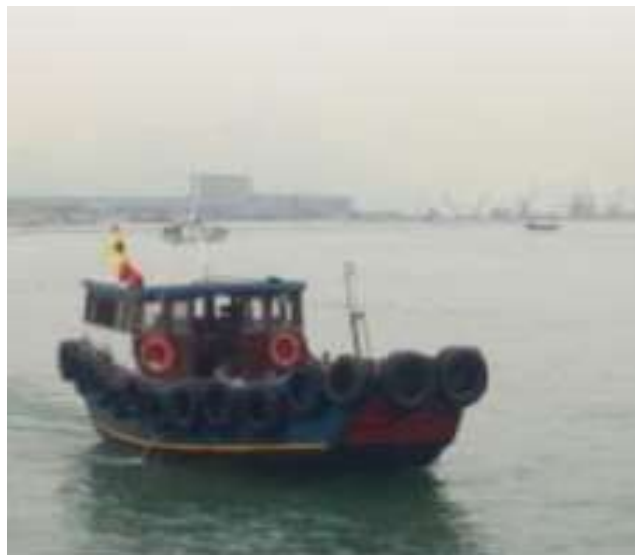
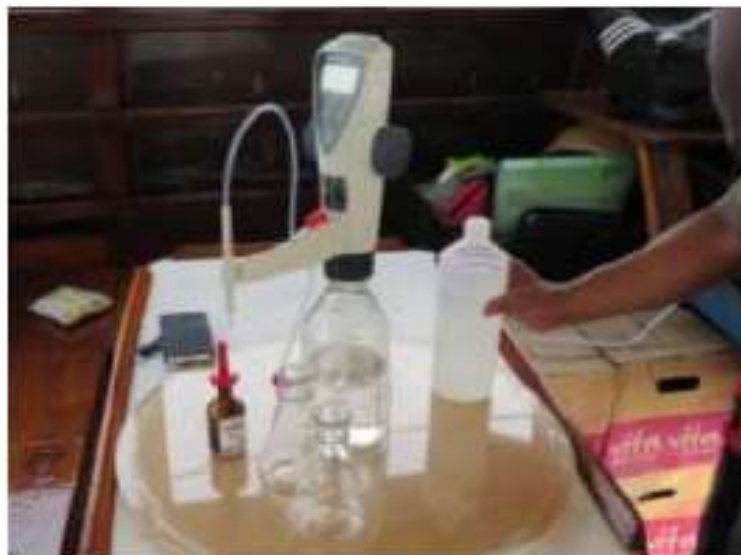
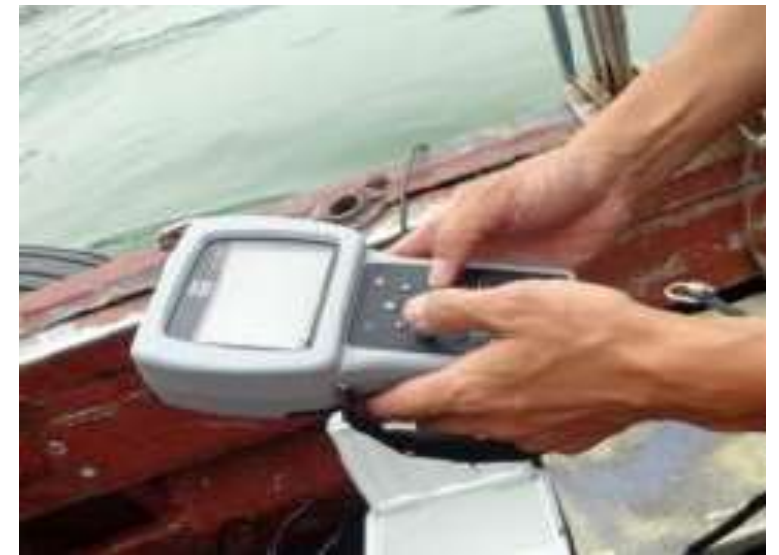
# Water Quality Baseline Monitoring

- Monitoring activities were conducted over 4 weeks in May and July 2016
- Monitoring parameters – Dissolved Oxygen, pH, Temperature, Salinity, Turbidity, Suspended Solid, Alkalinity, Heavy Metals, Nutrients
- Monitoring frequency – three times a week, each covering mid-ebb and mid-flood tides
- 3 Control Stations, 12 Impact Stations and 8 Sensitive Receiver Stations

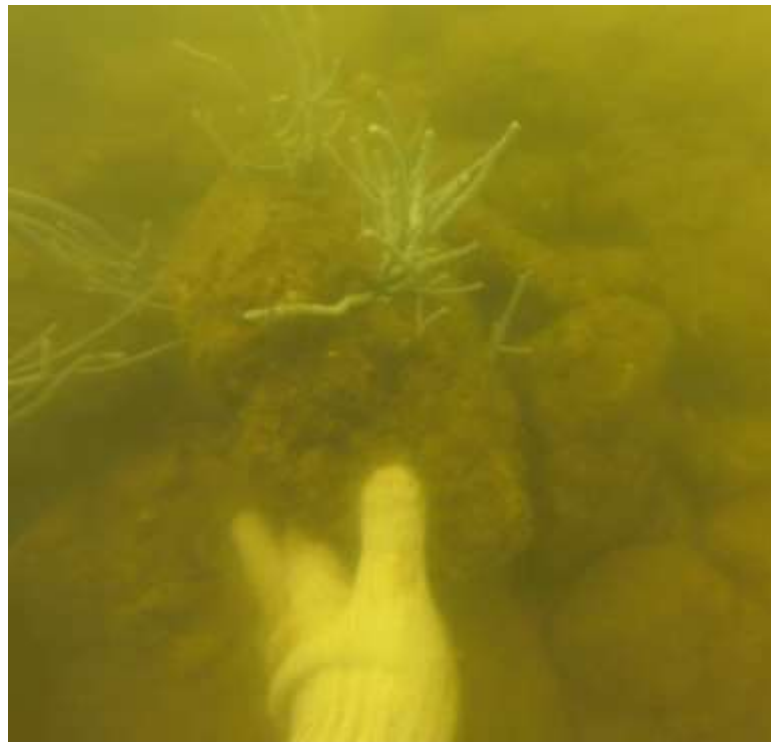
# Translocation Procedure

1. Move those coral colonies together with their attached substratum (movable boulder <50cm) to the recipient site on the same day
2. Keep corals under water in suitable containers during the translocation
3. Tag the translocated coral colonies at the recipient site
4. Post-translocation coral monitoring programme for 15 months

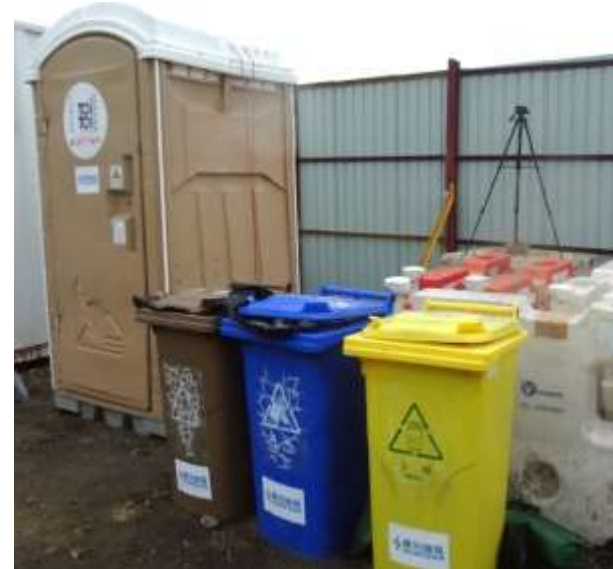
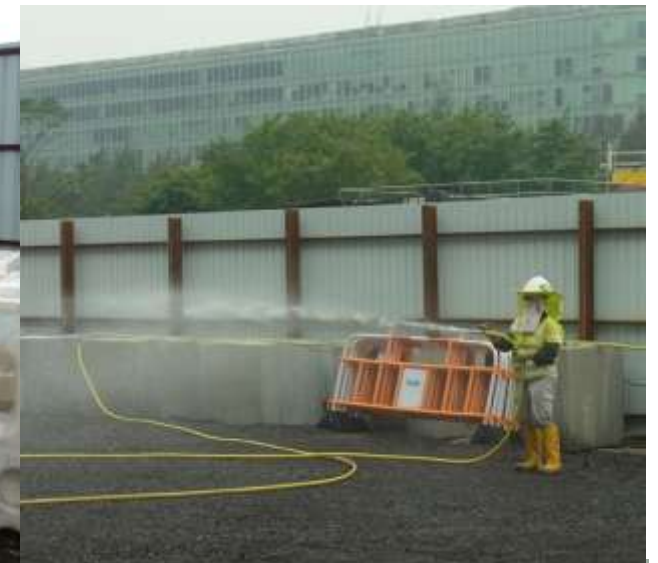
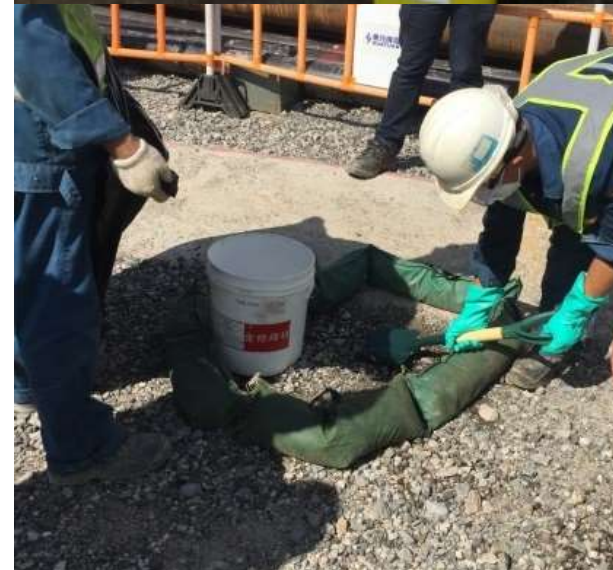
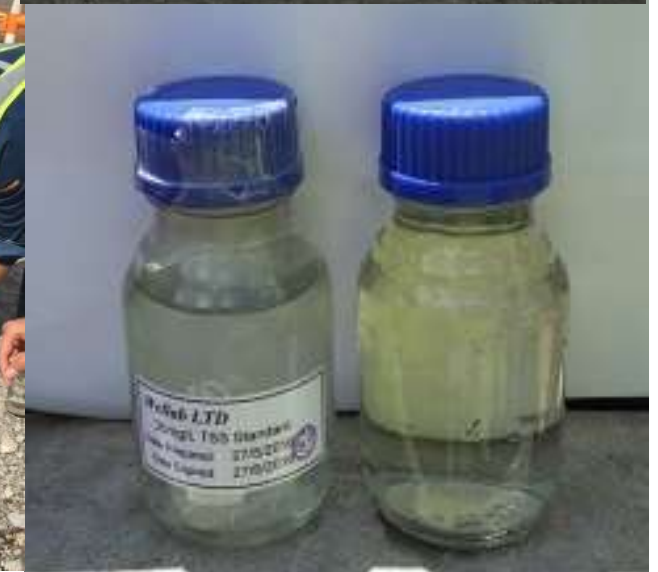
## Weekly Environmental Site Inspection

- Major inspection items:
  - Waste statistics and records
  - Dust suppression measures
  - Improve the efficiency of water treatment facility
  - Proper storage and handling of chemical container
  - Proper handling of waste materials
  - Spill kits
- Other activities:
  - Oil spill drills
  - Instant monitoring of effluent discharge
