Expansion of Hong Kong International Airport into a Three-Runway System

4th PLG Meeting
9 May 2017

Airport Authority Hong Kong

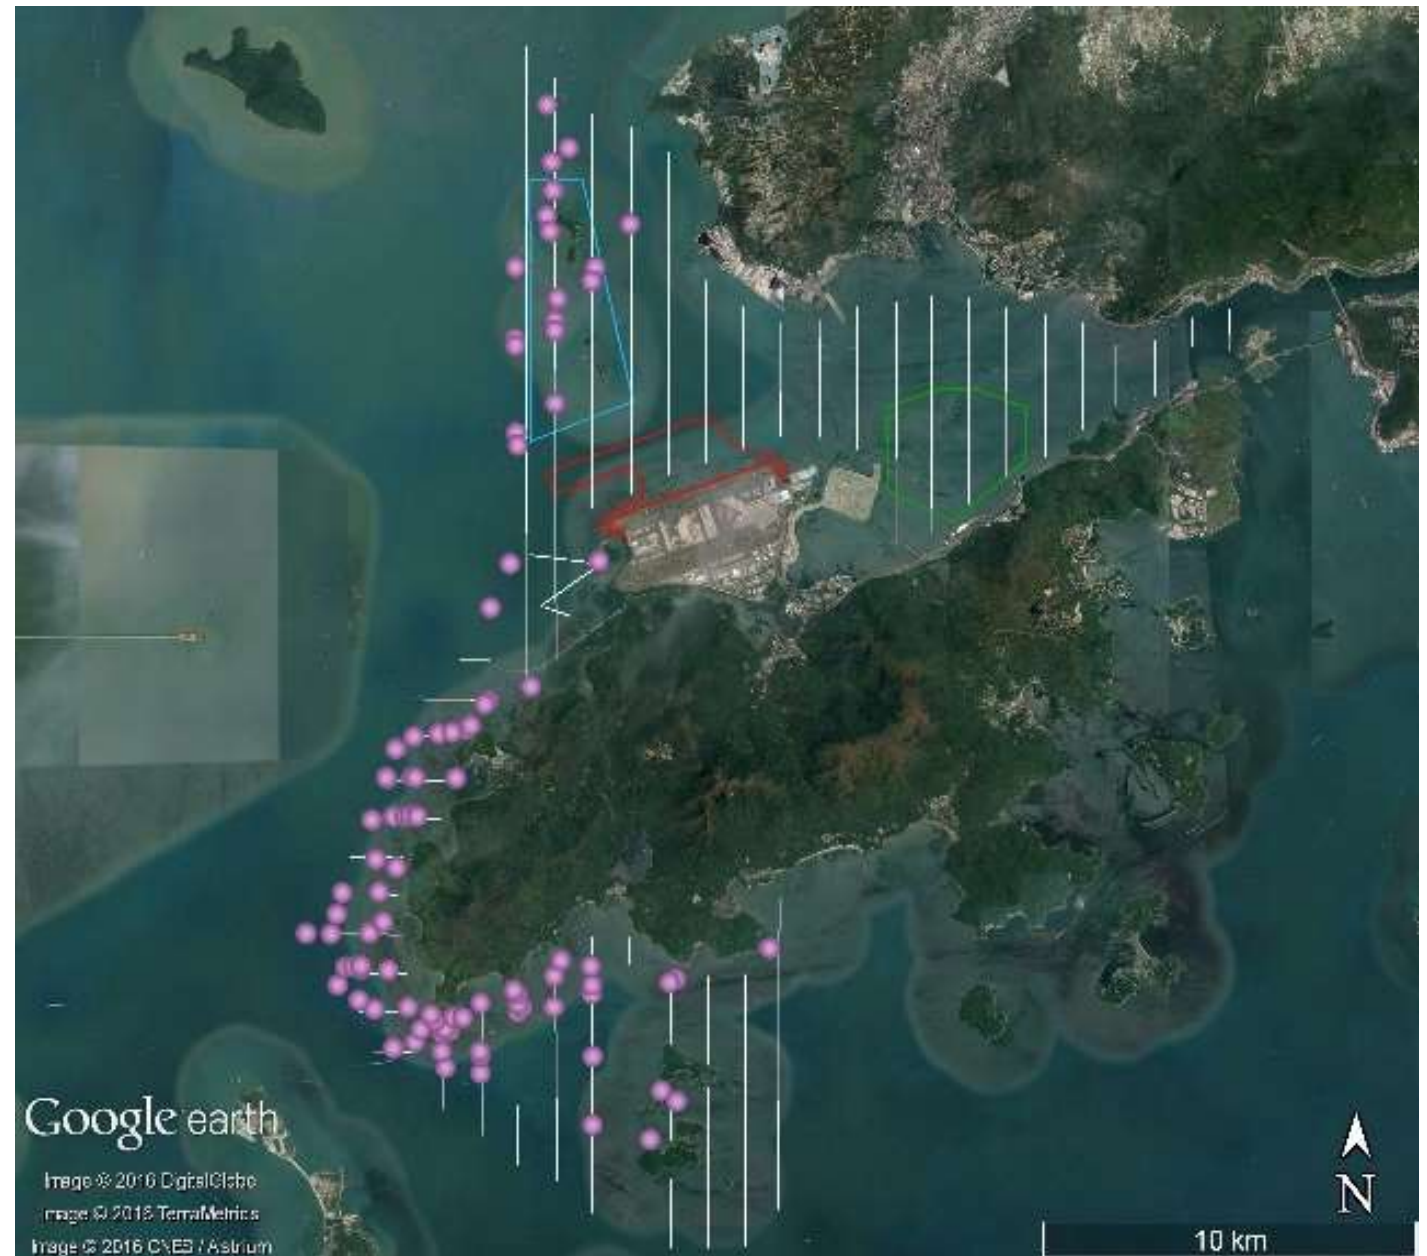
Sightings Distribution of CWDs (during on-effort survey with Beaufort Sea State 3 or below)

- Sightings of CWDs common around the Sha Chau and Lung Kwu Chau Marine Park (SCLKCMP), north of Lung Kwu Chau, including waters close to the diverted SkyPier HSF route
- Observed co-occurrence of CWDs with SkyPier HSFs travelling at <15 knots within SCZ
- Waters north of SCLKCMP including within the SCZ still being used by CWDs as important habitat after SCZ implementation

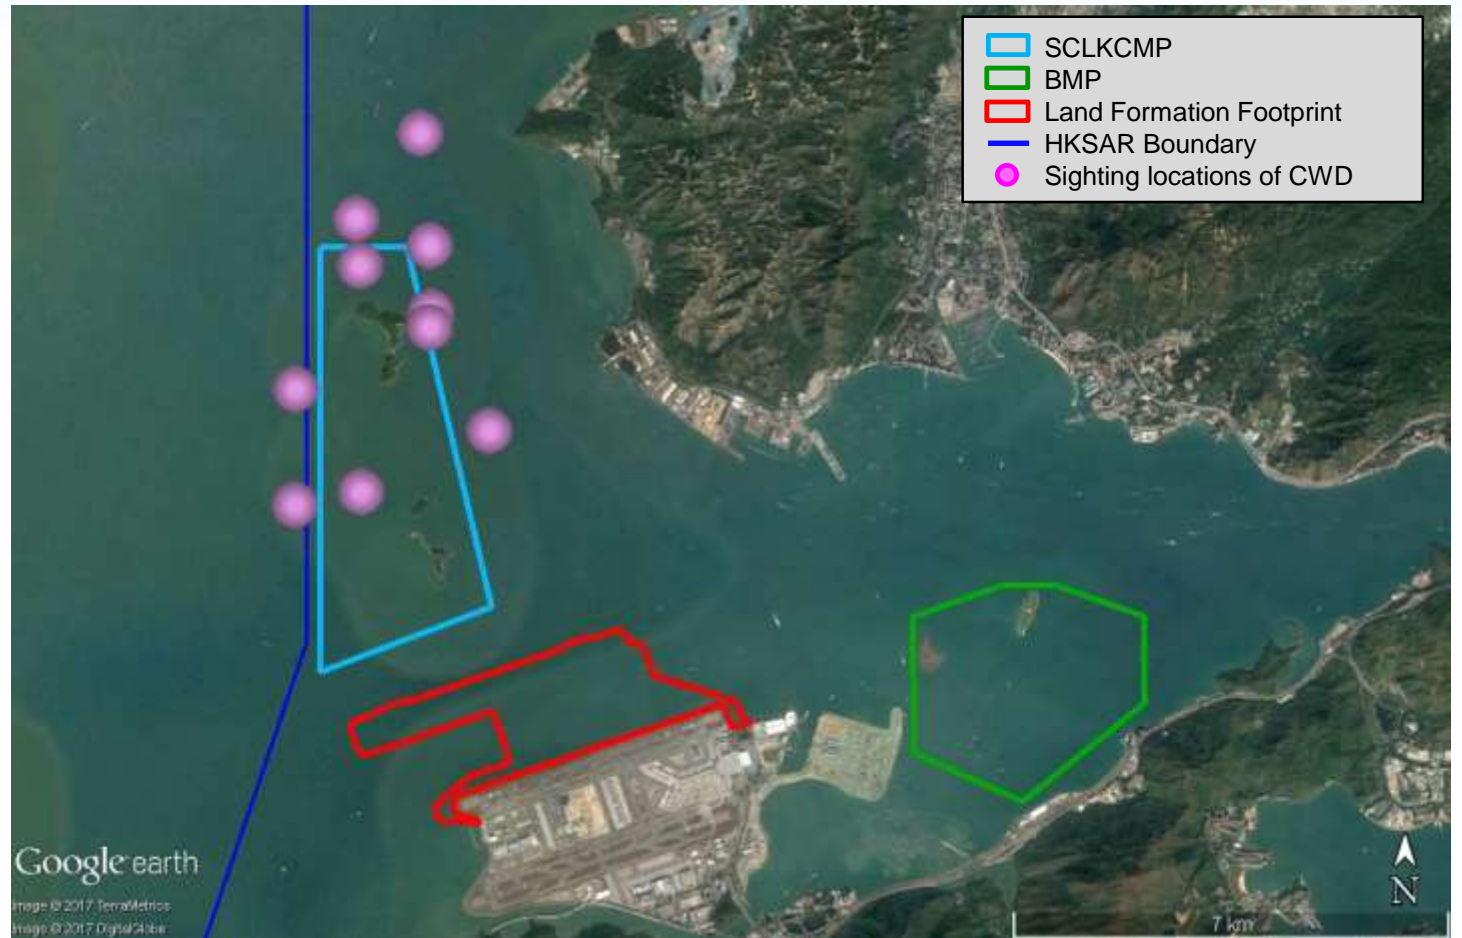
Sighting Locations of NLMM006 and NLMM013 from mid-Dec 2015 to Dec 2016

- A total of 165 CWD individuals were identified by photo identification
- 16 identified individuals were re-sighted within/in close proximity to SCLKCMP
- *Case Study 1*- A mother-and-mottled pair (NLMM006 and NLMM013) used areas around SCLKCMP extensively for foraging, especially around Lung Kwu Chau

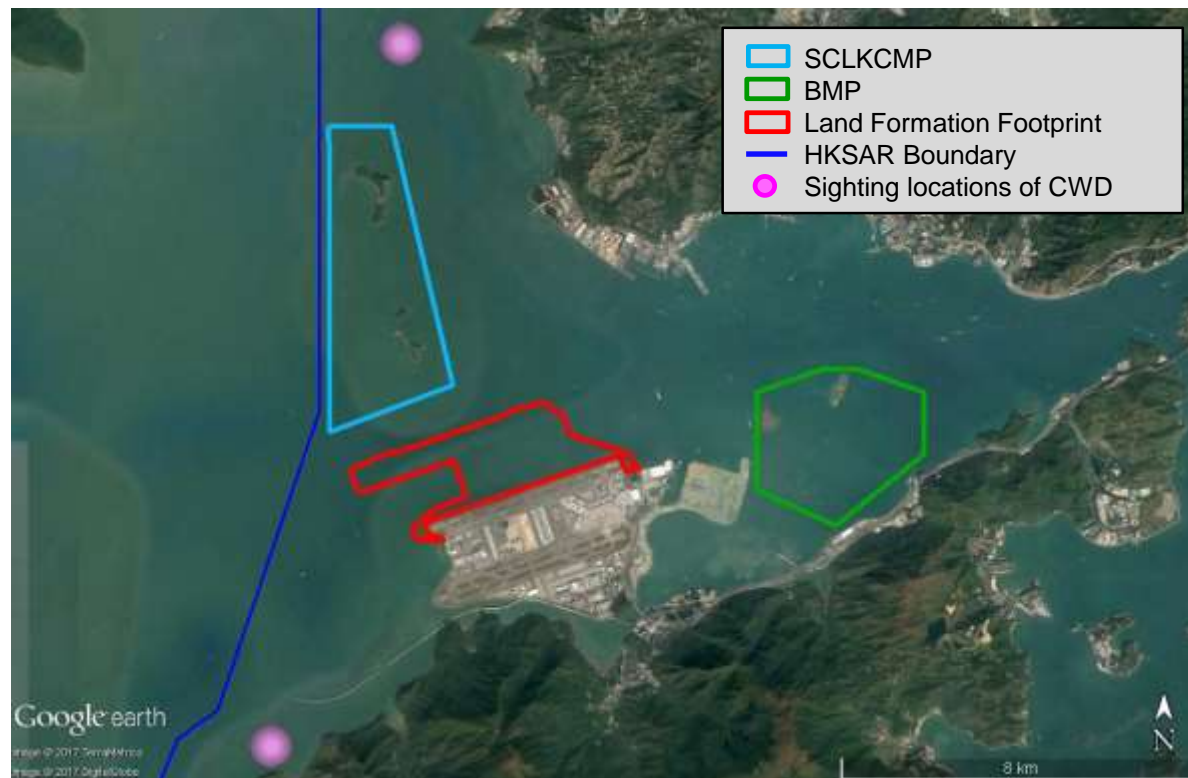
Case Study 2: Sighting Locations of NLMM008

- Some photo-identified CWDs in the Lung Kwu Chau area also sighted in the western Lantau areas
- The results show that some CWDs inhabit NWL move between different transect areas including WL
- This is consistent with what has been determined from long-term AFCD monitoring data.

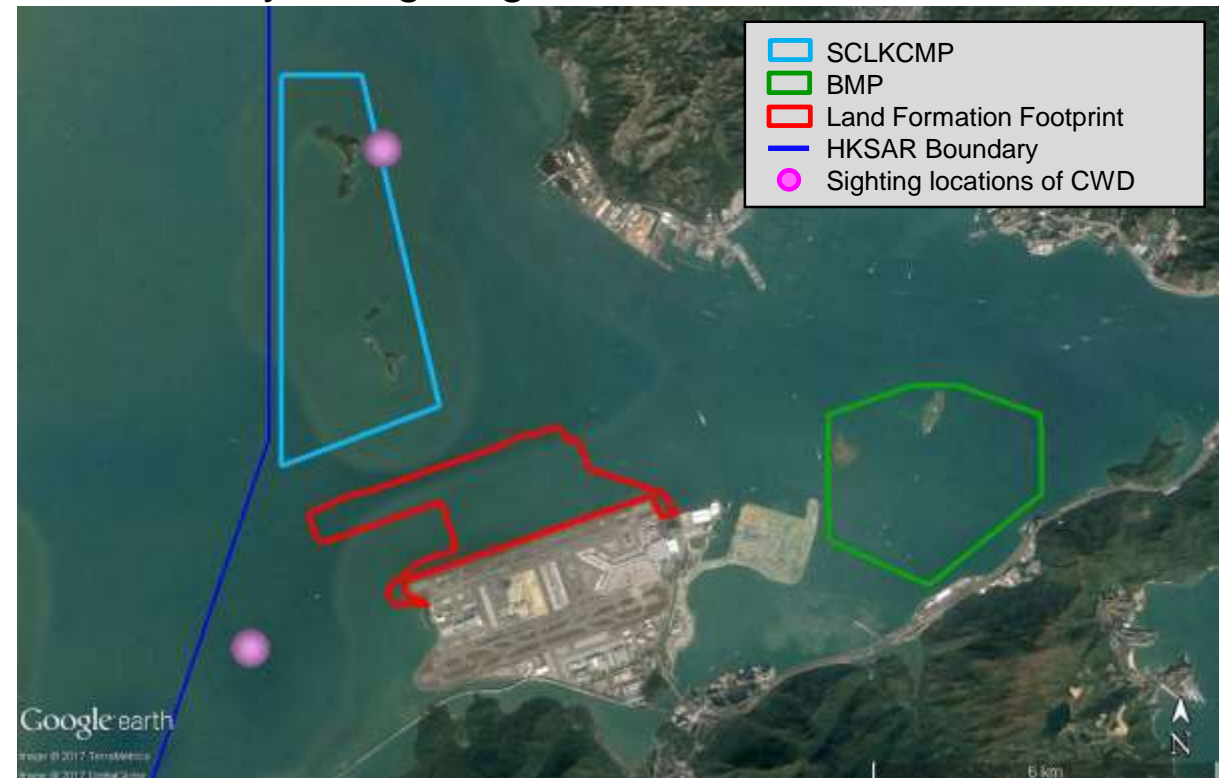
Case Study 3: Sighting Locations of NLMM038

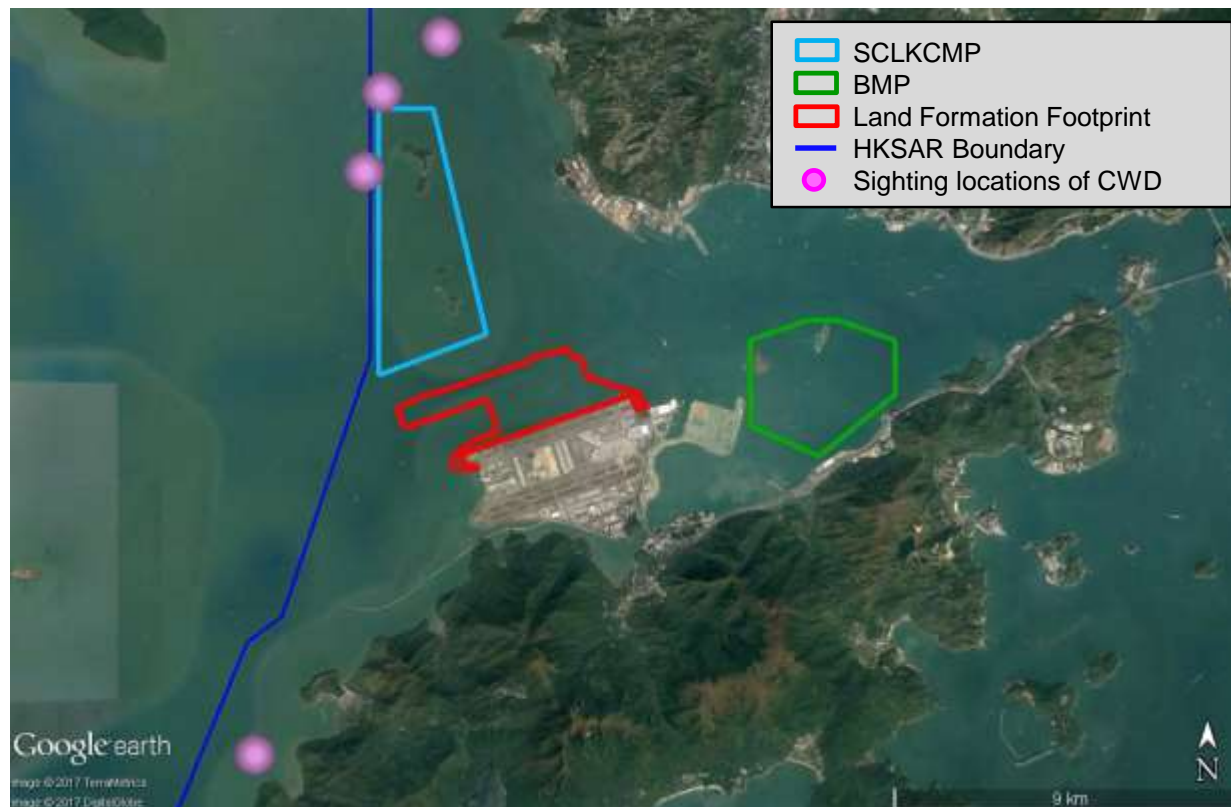
Case Study 4: Sighting Locations of NLMM012

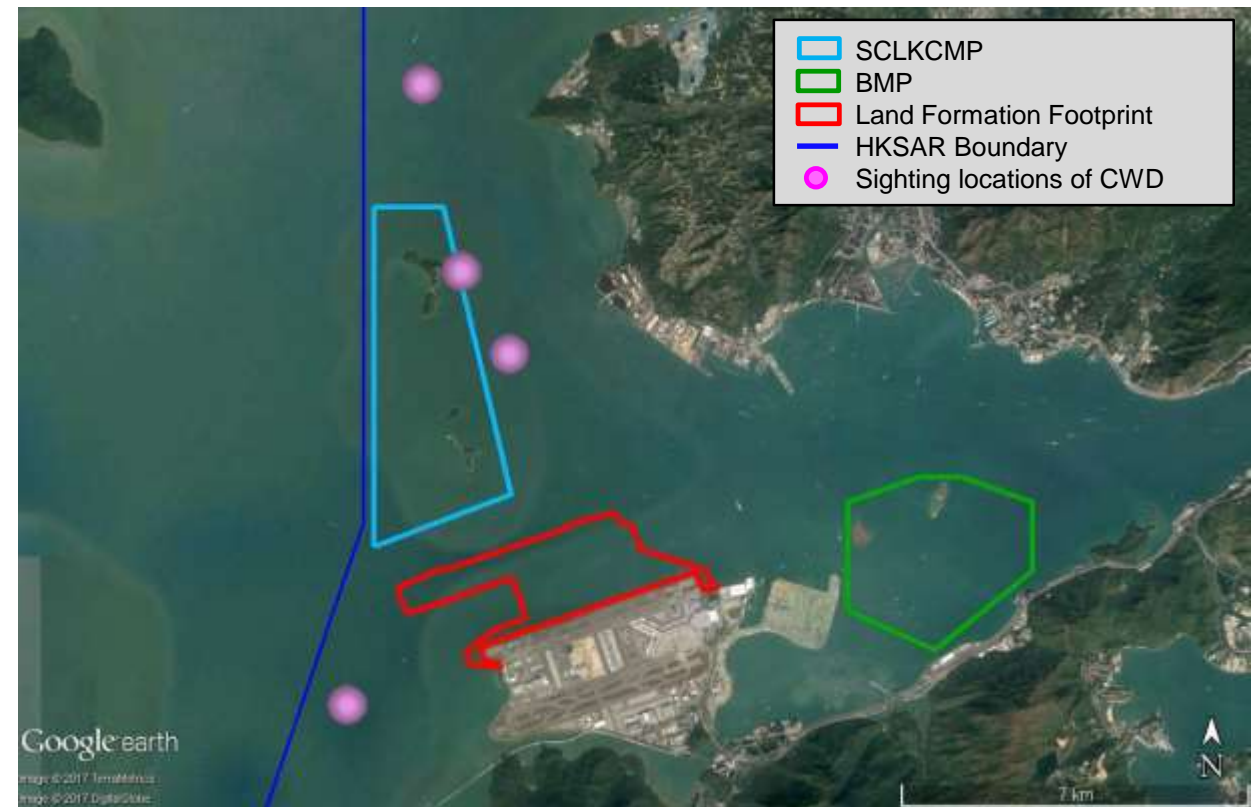
Case Study 5: Sighting Locations of NLMM028

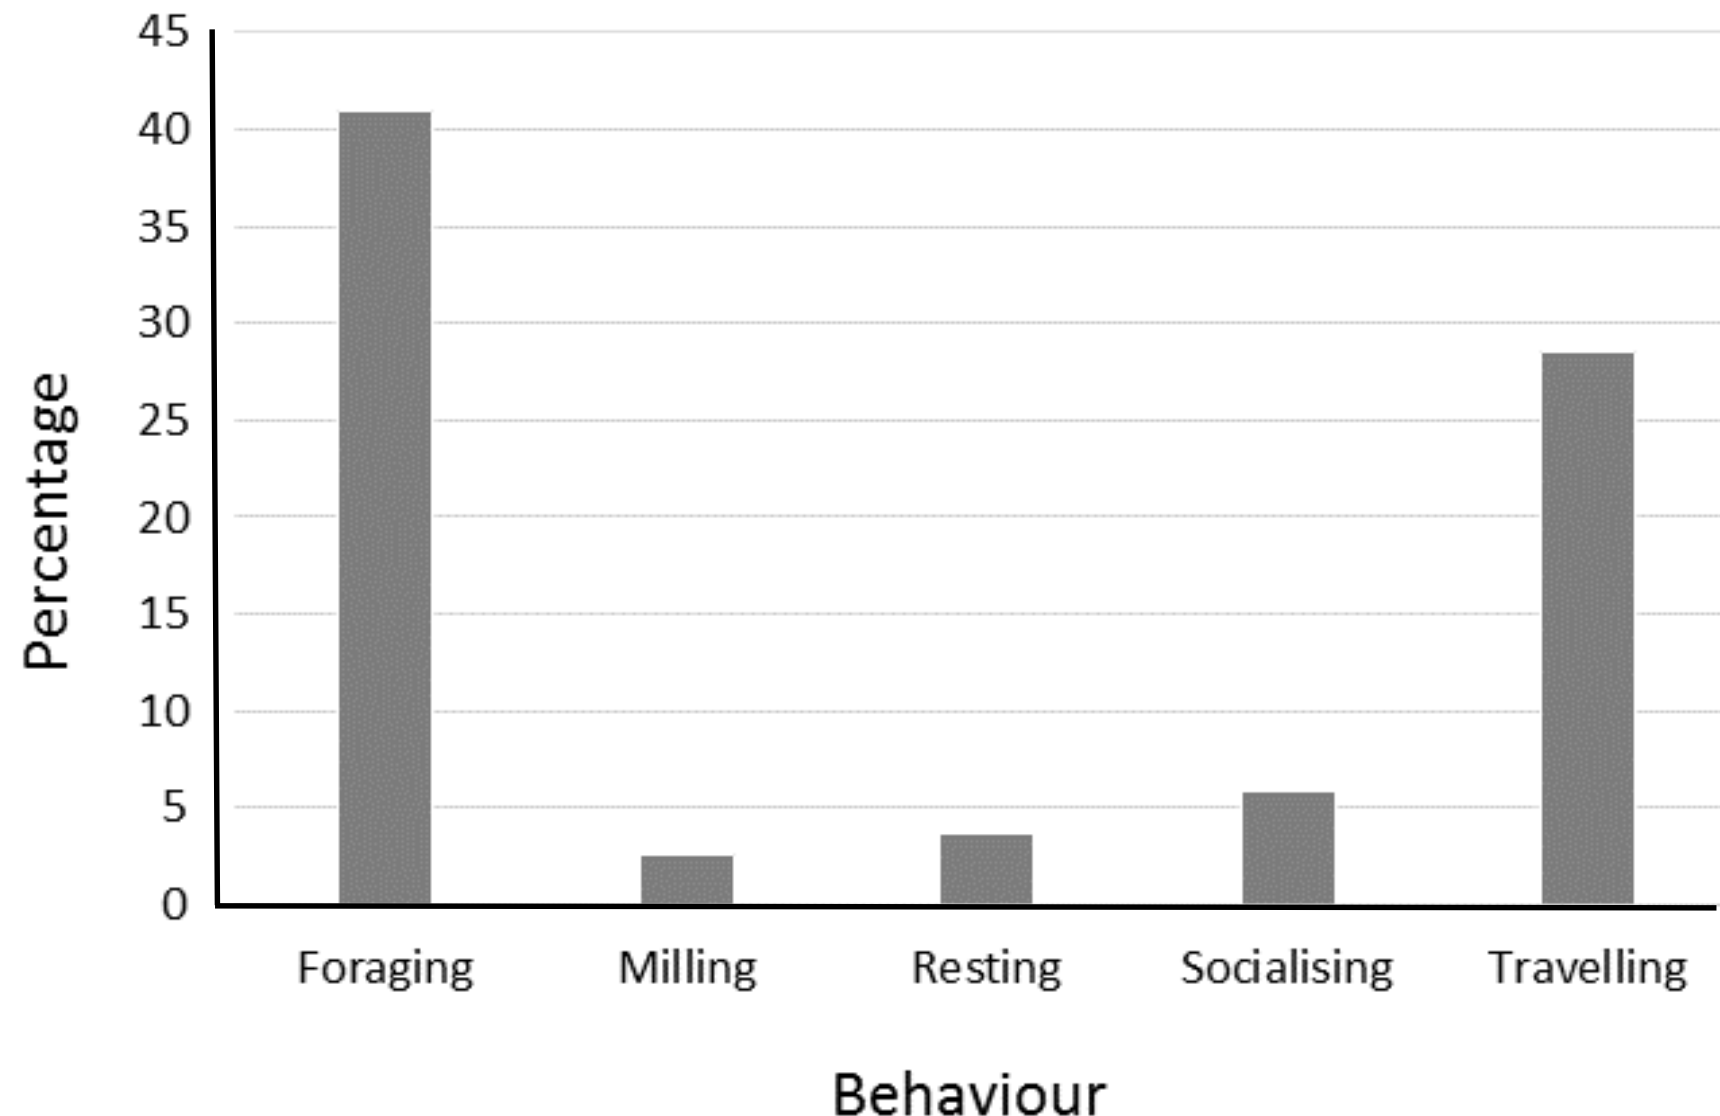
Distribution of CWD's known behavioural states recorded in waters off Lung Kwu Chau

Observations confirm that the waters off Lung Kwu Chau remain an important foraging area for CWDs

Remarks: The total percentage of the five known behaviours does not equal to 100% as some CWD groups were sighted with unidentified behaviours.

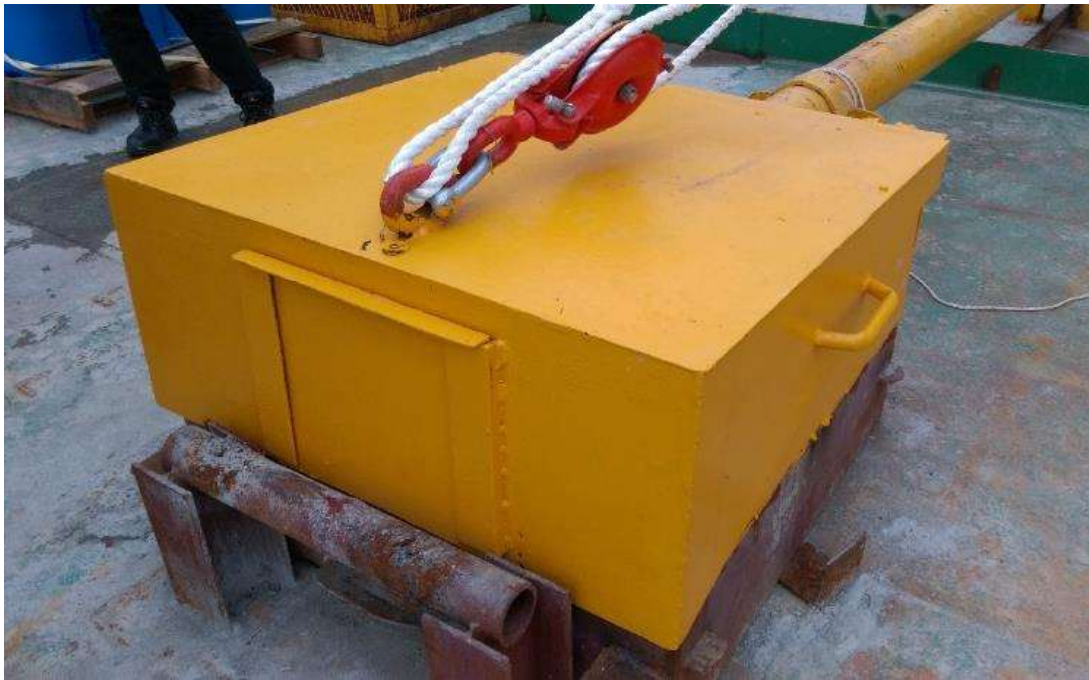
Enclosure at cement connecting pipes to minimise dust dispersion

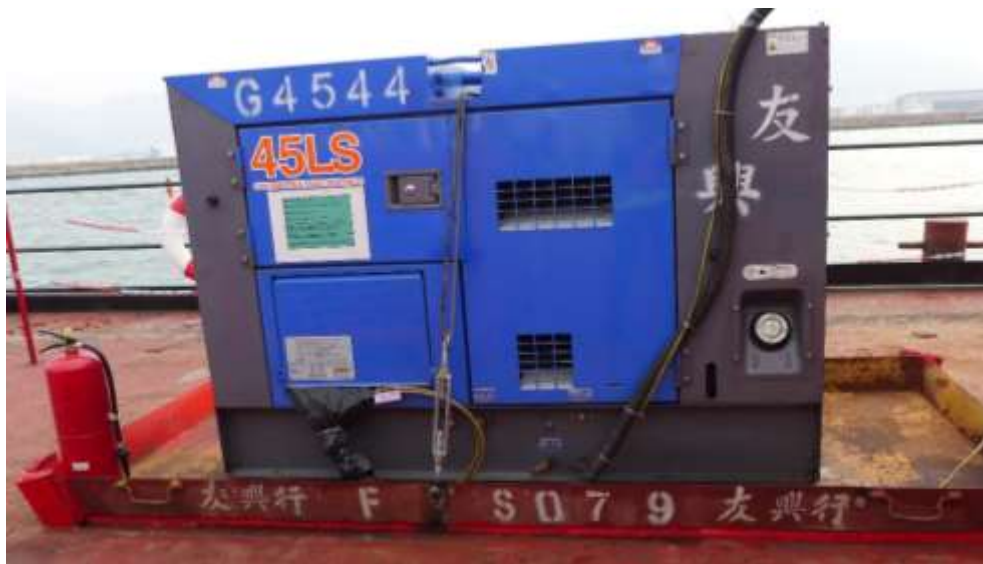
*Full enclosure of generator set/
compressor*

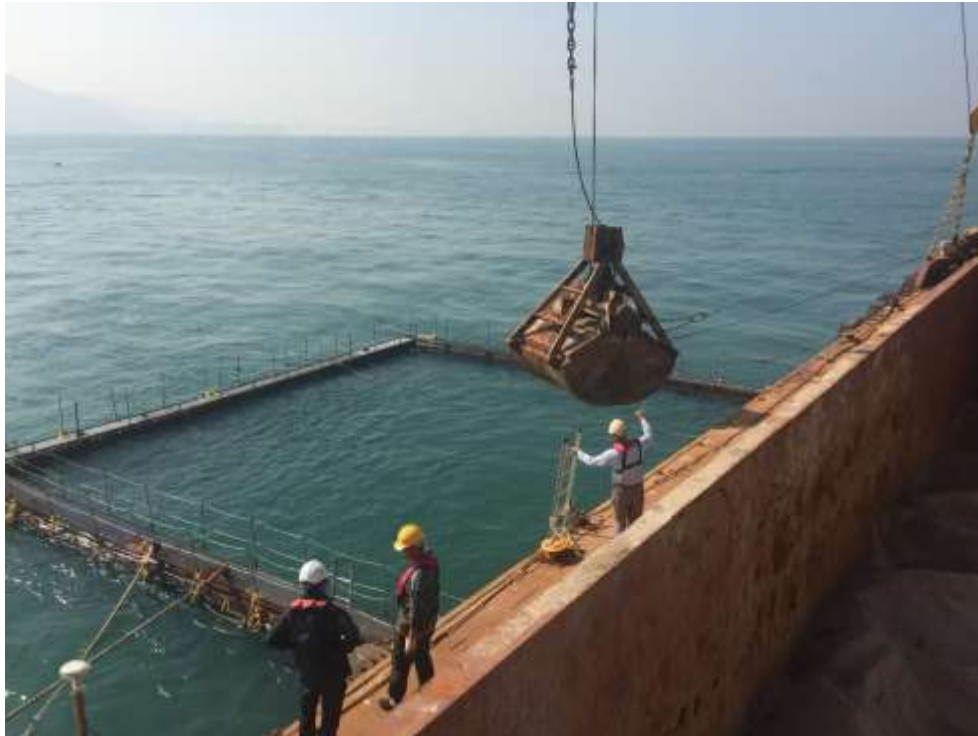
Deployment of silt curtain for sand blanket laying

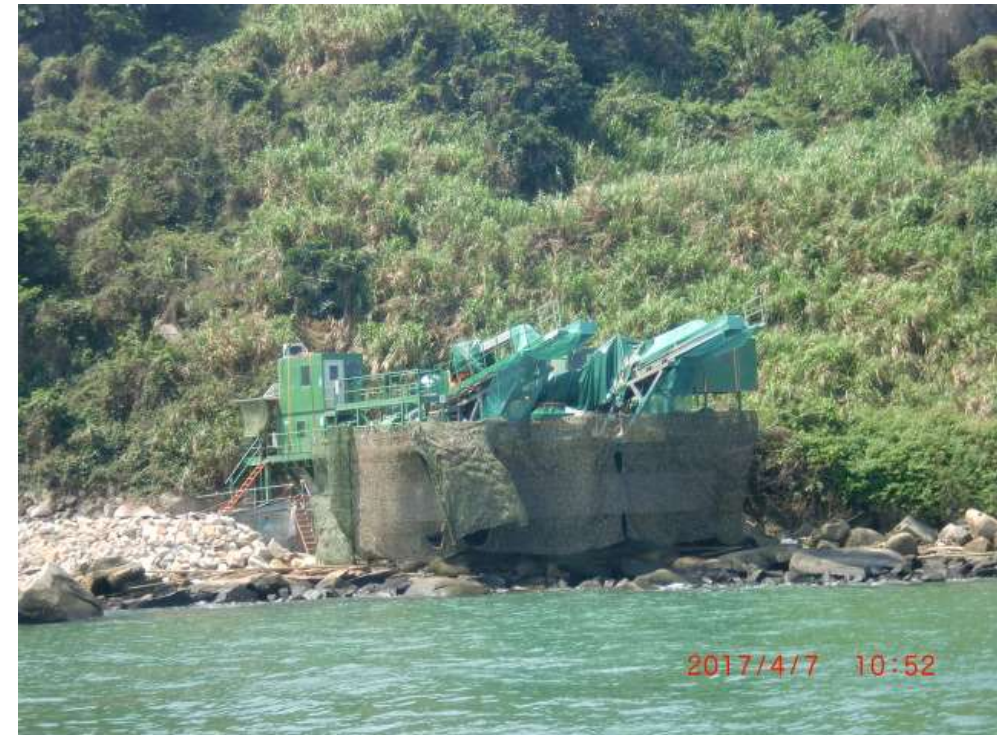
Checking of containment pit on Sheung Sha Chau for prevention of any effluent discharge to surrounding waters

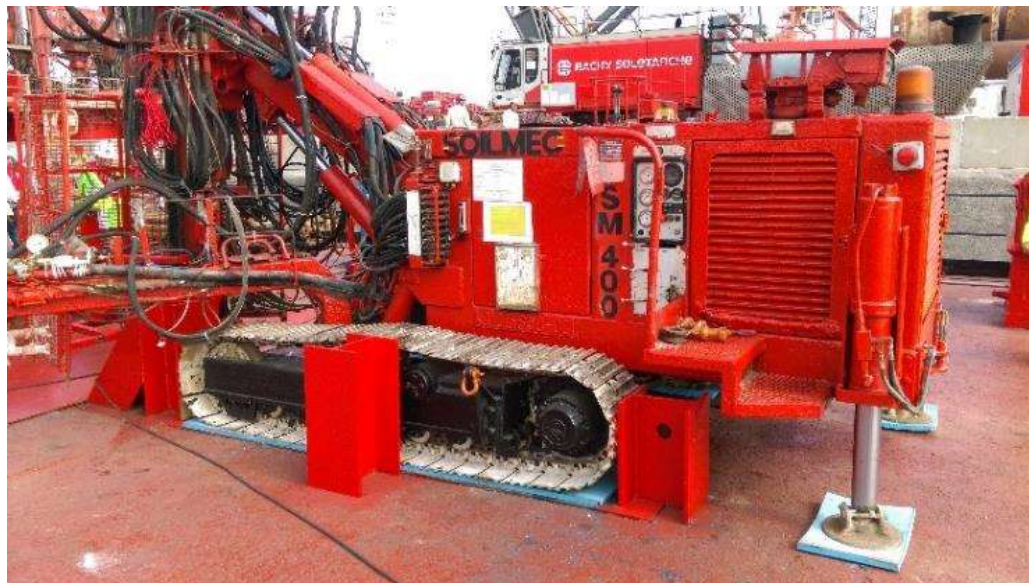
Isolation pads placed under noisy equipment to mitigate ecological impacts

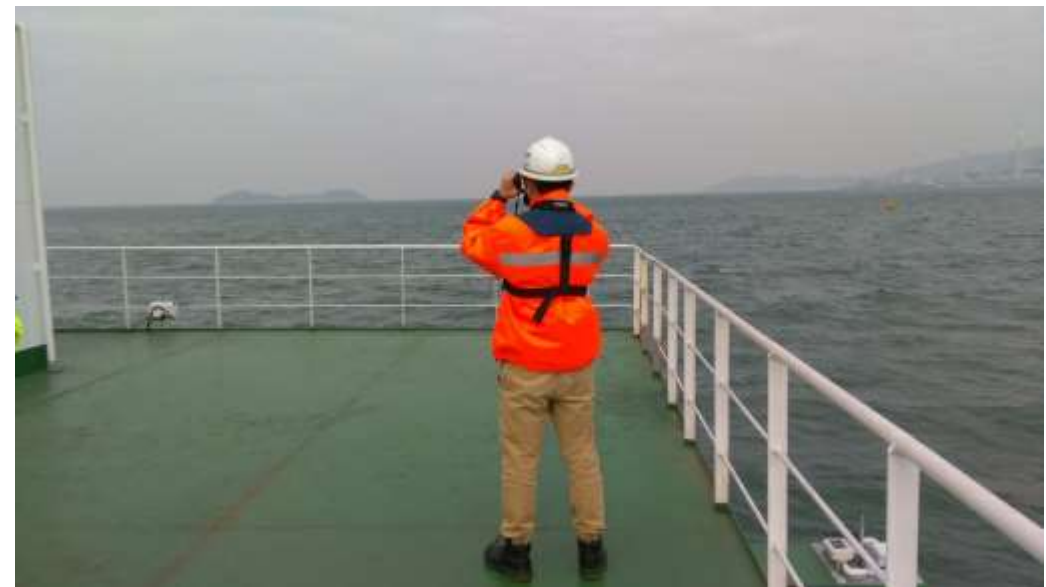
Deployment of DEZ by qualified dolphin observers on DCM barge
