Expansion of Hong Kong International Airport into a Three-Runway System

Construction Phase Monthly EM&A
Report No. 91
(For July 2023)

August 2023

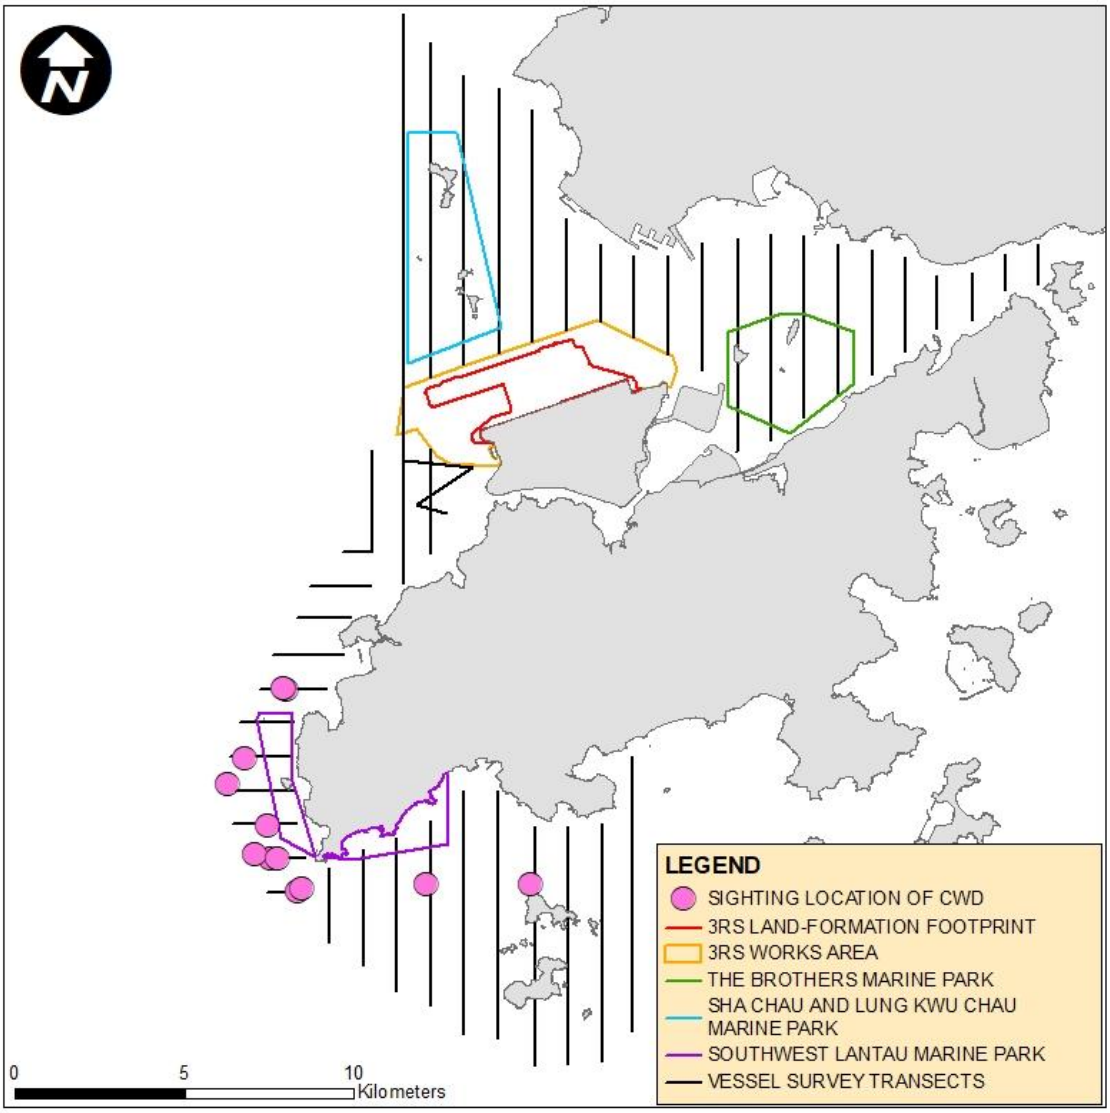
Figure 6.3: Sightings Distribution of Chinese White Dolphins

Distribution of all CWD sightings recorded in the current reporting period is illustrated in **Figure 6.3**. In WL, CWD sightings were scattered at the waters between Yi O and Fan Lau. In SWL, CWD sightings were recorded at the waters north off Siu A Chau and at the water between Fan Lau and Soko Islands respectively. There was no CWD sighting recorded in NWL and NEL survey areas during the reporting period.

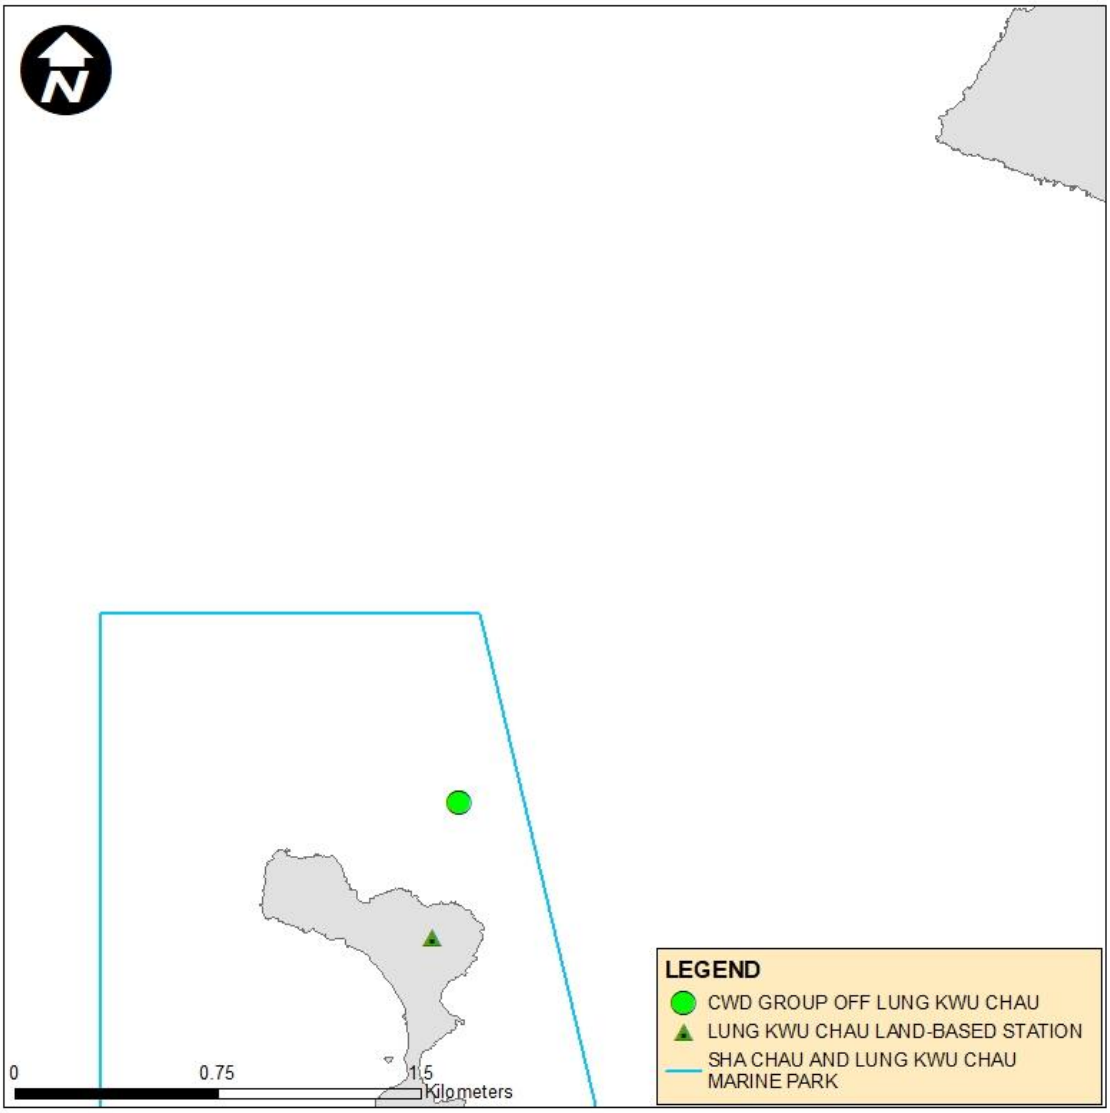
Figure 6.4: : Plots of First Sightings of All CWD Groups obtained from Land-based Stations

Land-based Station	No. of Survey Sessions	Survey Effort (hh:mm)	No. of CWD Groups Sighted	CWD Group Sighting per Survey Hour
Lung Kwu Chau (LKC)	1	6:00	1	0.17
Sha Chau (SC)	1	6:00	0	0
TOTAL	**2**	**12:00**	**1**	**0.08**

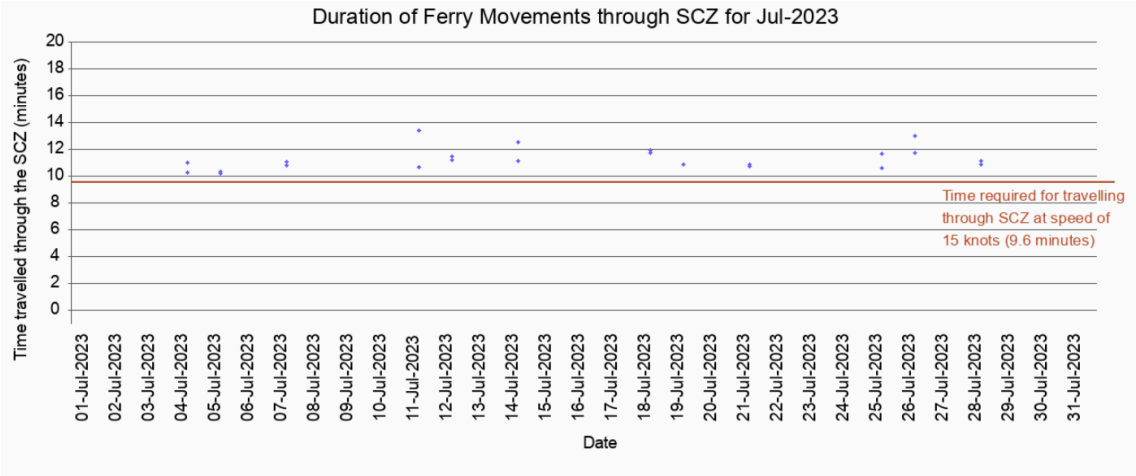
Figure 7.1: Duration of the SkyPier HSFs travelling through the SCZ for July 2023

In total, 22 ferry movements between HKIA SkyPier and Macau were recorded in July 2023 and the data are presented in **Appendix G**. The time spent by the SkyPier HSF travelling through the SCZ in July 2023 was presented in **Figure 7.1.** It will take 9.6 minutes to travel through the SCZ when the SkyPier HSFs adopt the maximum allowable speed of 15 knots within the SCZ. **Figure 7.1** shows that all the SkyPier HSF spent more than 9.6 minutes to travel through the SCZ.

Note: Data above the red line indicated that the time spent by the SkyPier HSFs travelling through the SCZ is more than 9.6 minutes, which is in compliance with the SkyPier Plan.

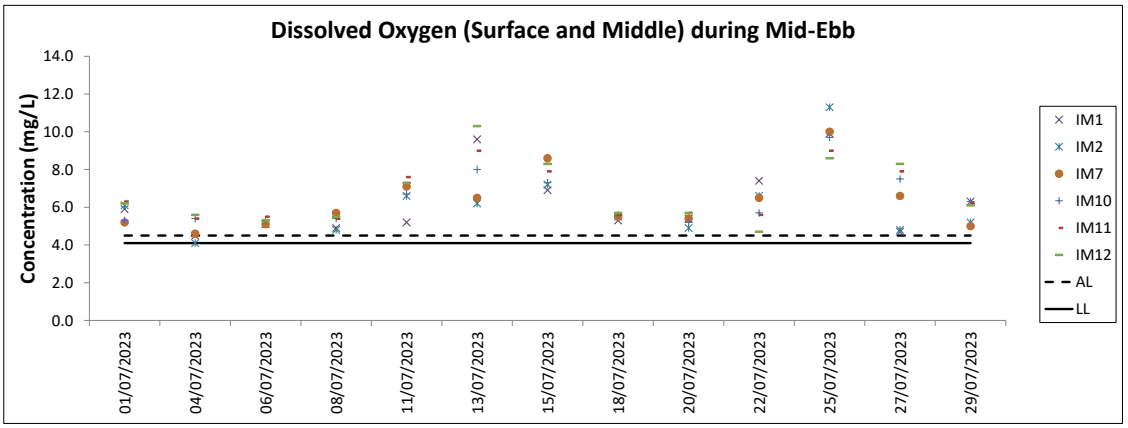
For the DO results recorded at the Surface and Middle water depth during mid-ebb tide (please refer to **Table 4.7**), only one downstream stations, IM2 triggered Action Level on 4 July 2023. It is noted that the monitoring station is located in the western side of the Project, which had similar previous records of widespread low DO level during wet season, implying the cases might be due to presence of external factors out of the project area.

Dissolved Oxygen (Surface and Middle) during Mid-Ebb
Concentration (mg/L)
14.0
12.0
10.0
8.0
6.0
4.0
2.0
0.0
01/07/2023
04/07/2023
06/07/2023
08/07/2023
11/07/2023
13/07/2023
15/07/2023
18/07/2023
20/07/2023
22/07/2023
25/07/2023
27/07/2023
29/07/2023
IM1
IM2
IM7
IM10
IM11
IM12
AL
LL

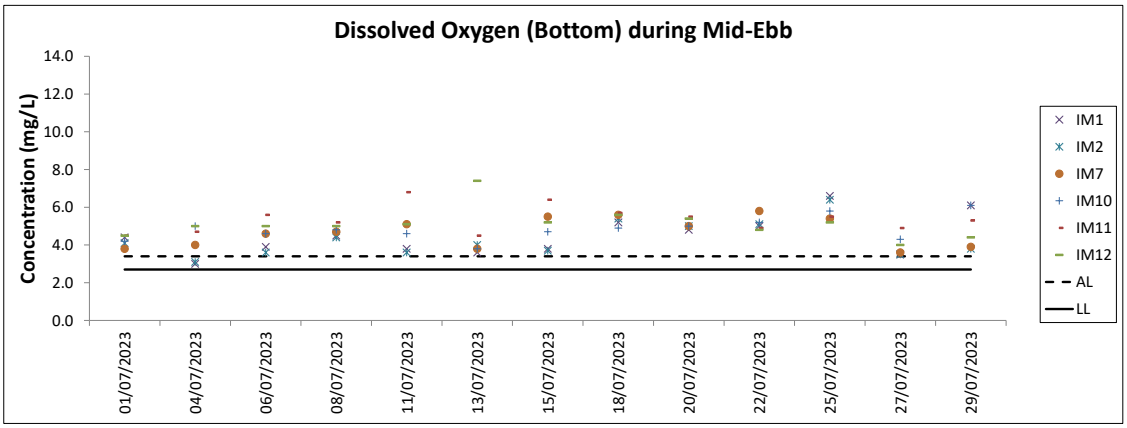
For the DO results recorded at the Bottom water depth during mid-ebb tide (please refer to **Table 4.8**), only downstream stations triggered Action Level on 4 July 2023. For both IM1 and IM2, it is noted that these stations are located in the western side of the Project, which had similar previous records of widespread low DO level during wet season. Similar low DO levels were also recorded at control stations C1 and C2, and the seawall construction works were undertaken more than 1 km away from the monitoring stations, which might possibly suggest the presence of external factors affecting the DO concentration.

Dissolved Oxygen (Bottom) during Mid-Ebb
Concentration (mg/L)
14.0
12.0
10.0
8.0
6.0
4.0
2.0
0.0
01/07/2023
04/07/2023
06/07/2023
08/07/2023
11/07/2023
13/07/2023
15/07/2023
18/07/2023
20/07/2023
22/07/2023
25/07/2023
27/07/2023
29/07/2023
IM1
IM2
IM7
IM10
IM11
IM12
AL
LL
