Expansion of Hong Kong International Airport into a Three-Runway System

Supplementary Contamination Assessment Plan

August 2018

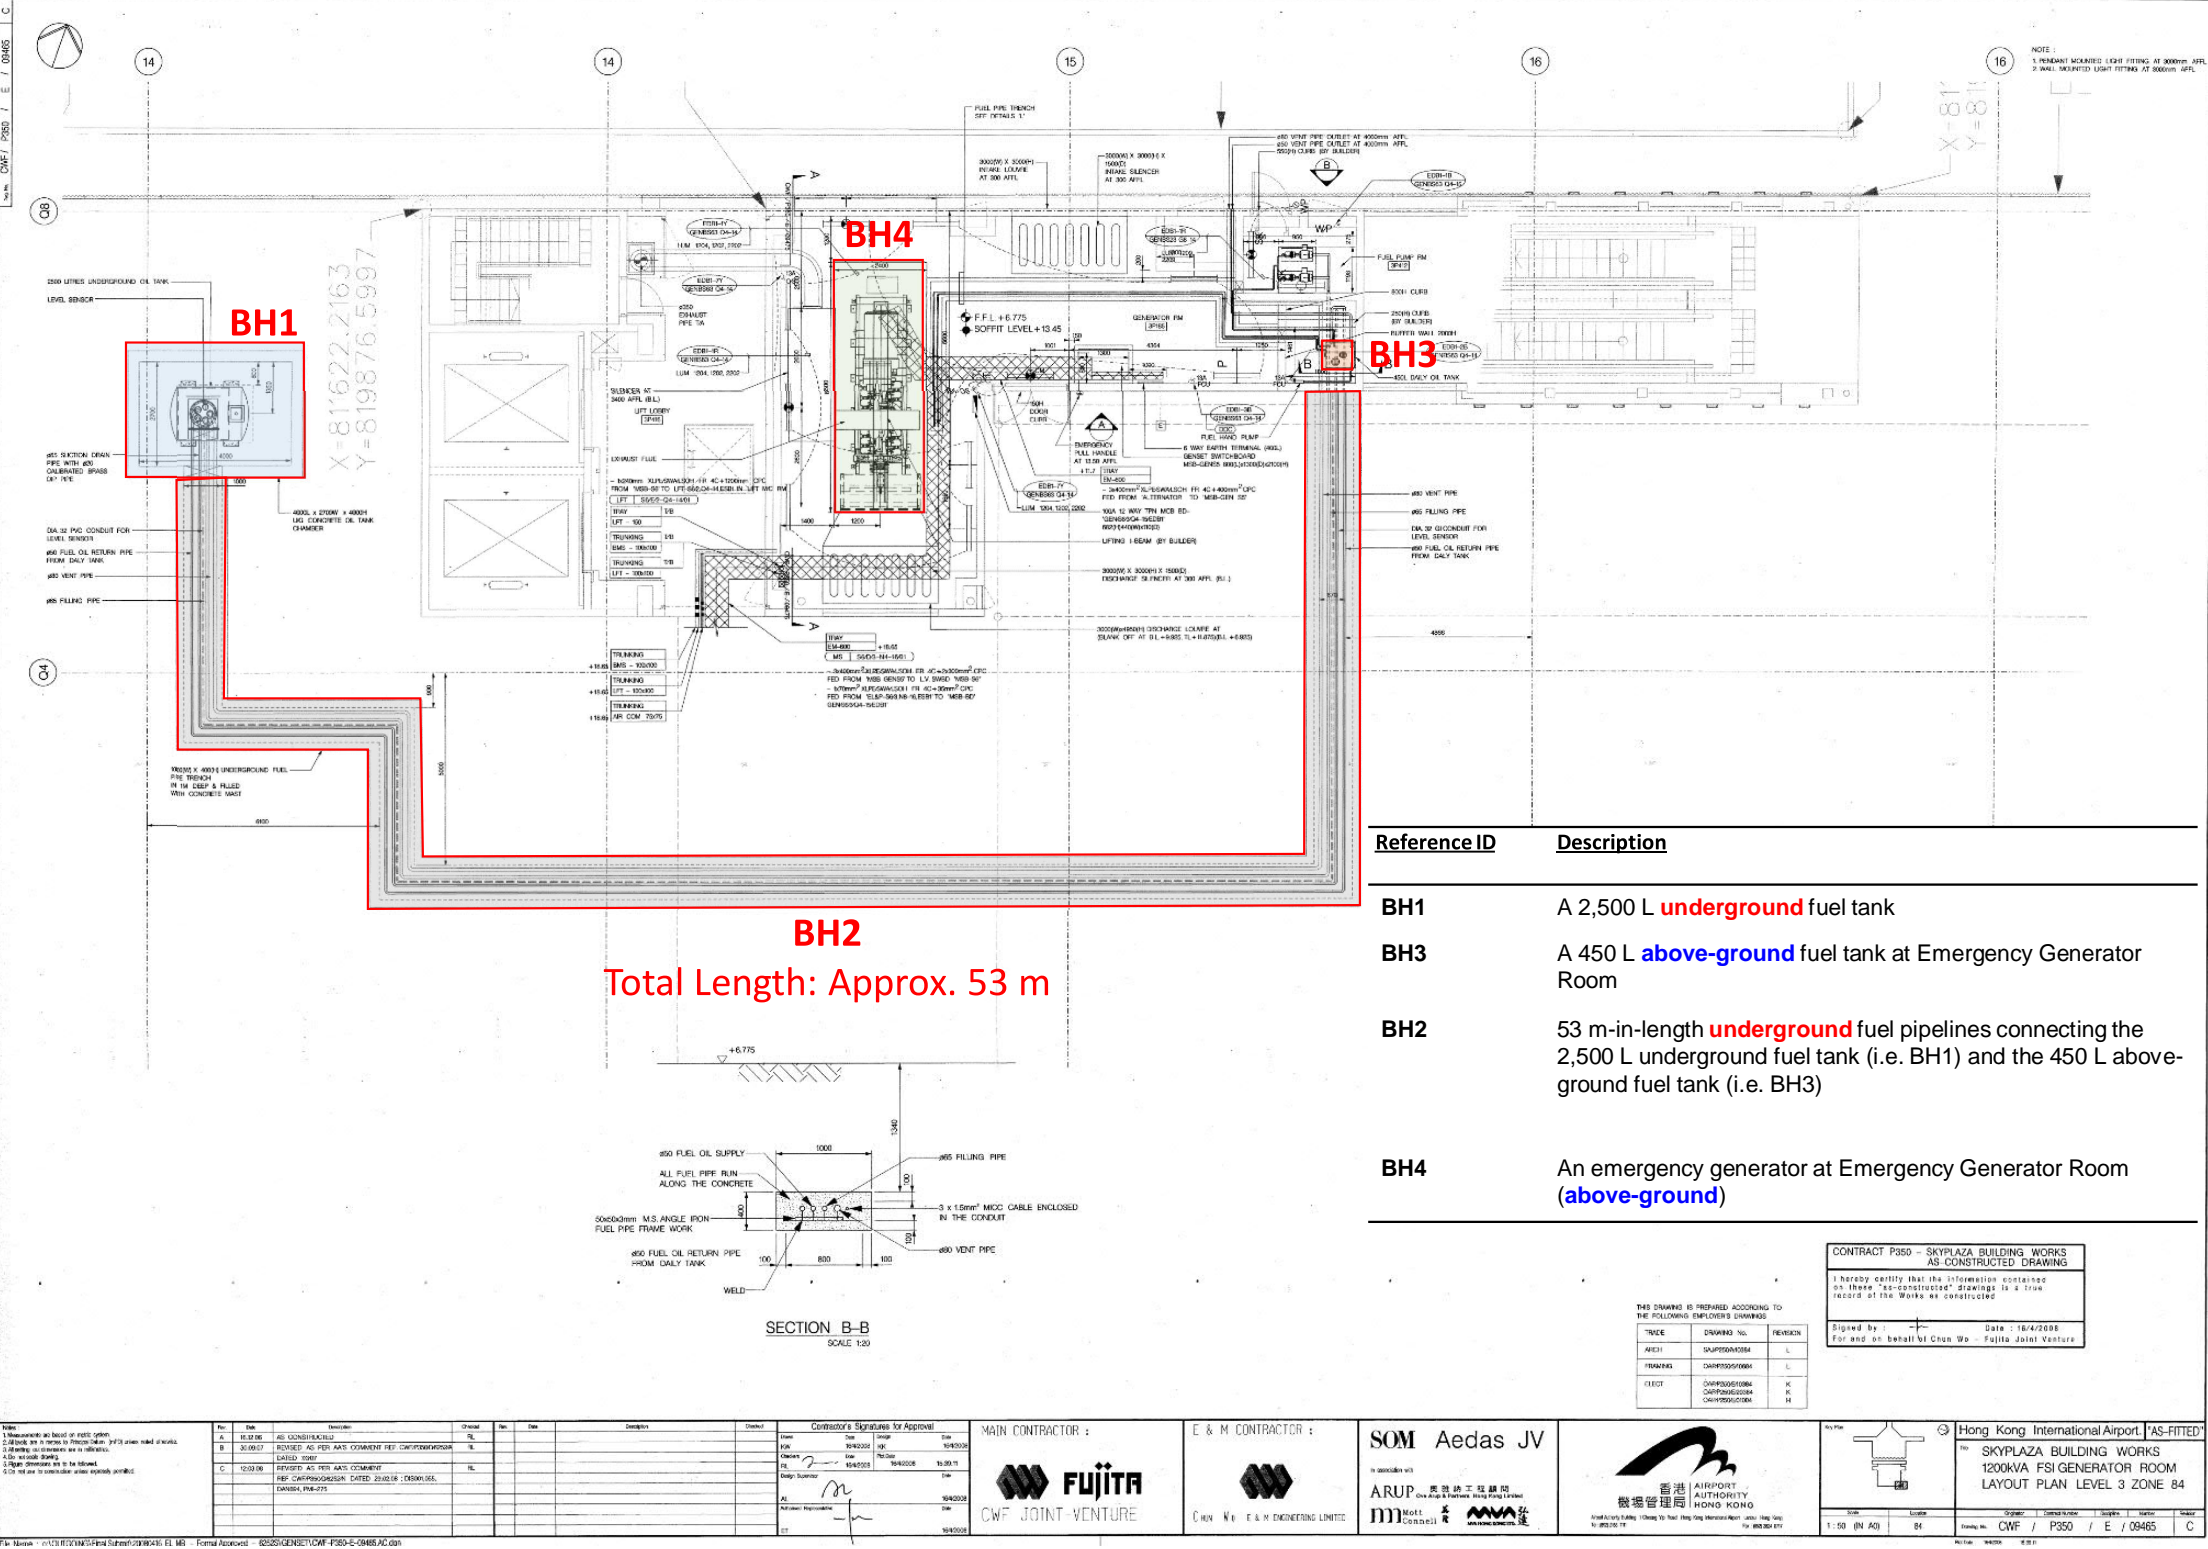
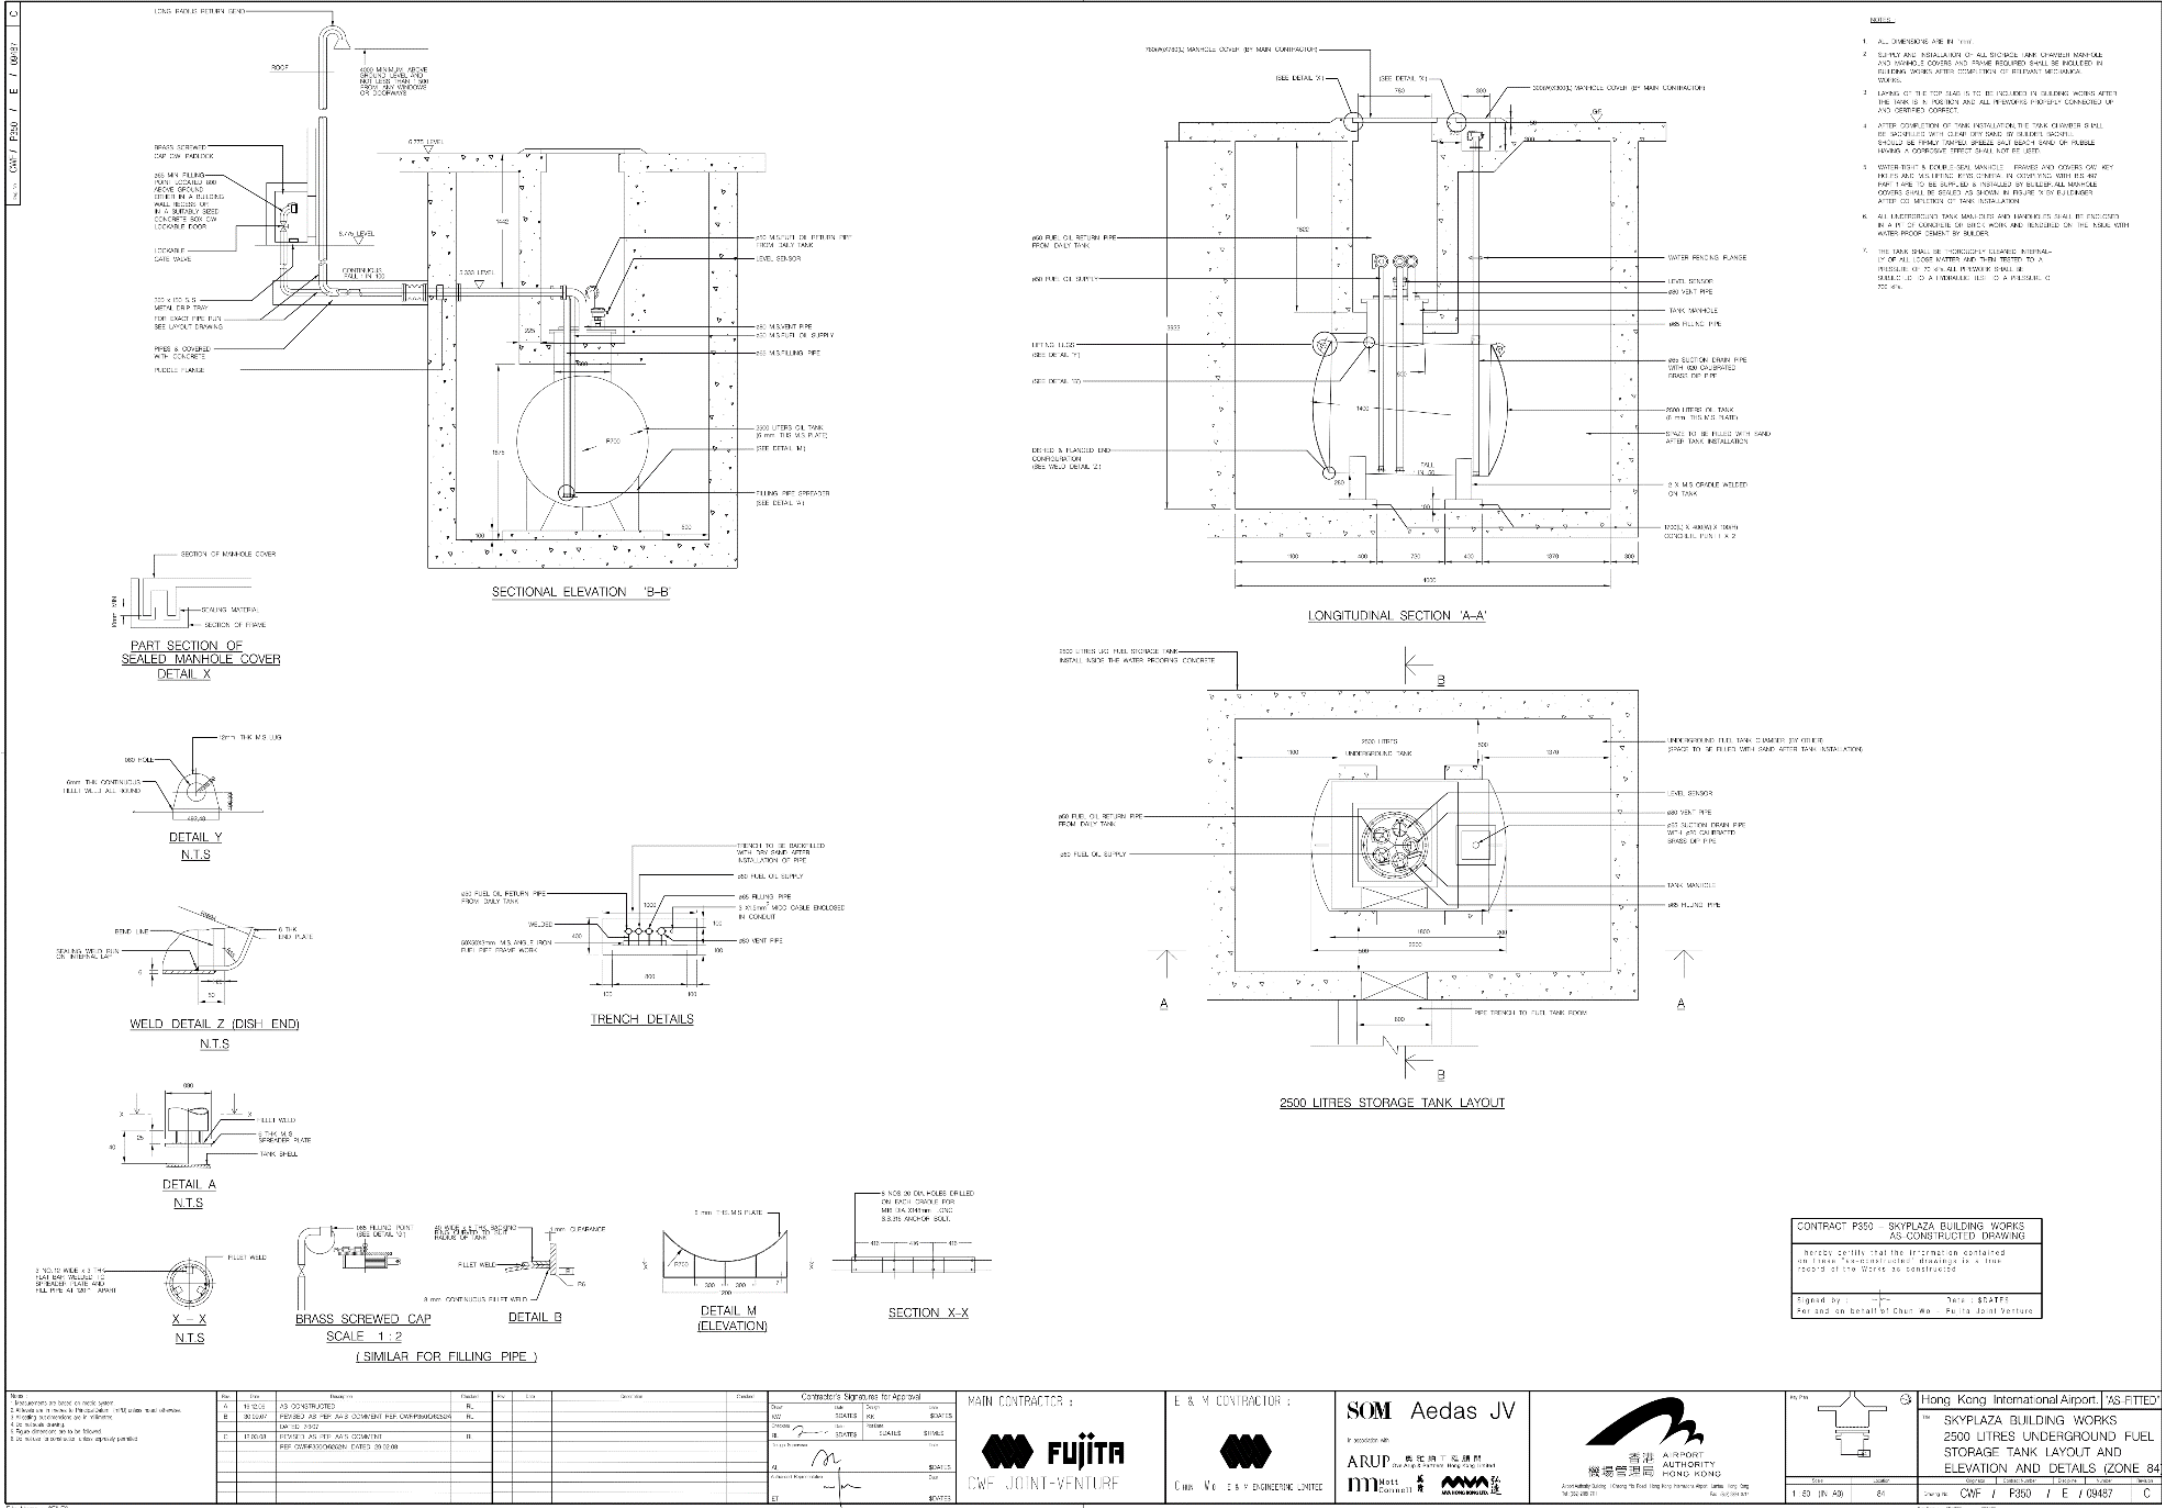
Appendix E.1 Emergency Power Supply System No. 1 (BH1, BH2, BH3 and BH4)

- Underground fuel tank fully encased in 300mm thick concrete chamber
- Space between the tank and the chamber is filled with sand
- Test run of emergency generator conducted monthly (for 30-60 mins)
- Manhole chamber of U/G tank is checked monthly and re-filled approx. every 6 months
- The quantity of fuel inside the tank is automatically monitored by level sensor. No sign of leakage is detected.

- 2500 L underground tank (BH1)
- Underground fuel tank chamber (300mm thickness)

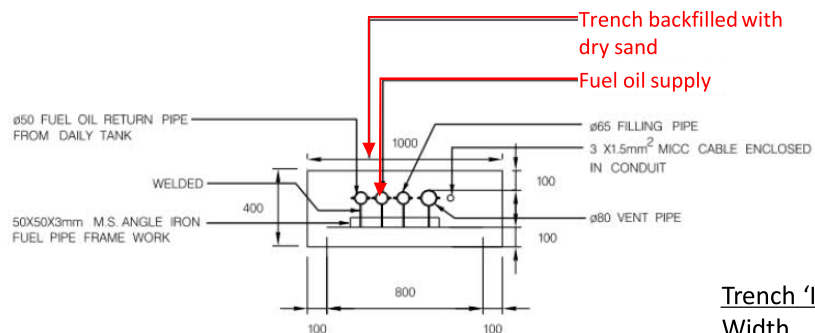
(Underground Pipeline (BH2) – Approx. 1.5m below ground level)

Run inside the sand filled pipe trench (BH2)

<u>Trench 'Inner' Dimensions</u>	
Width	800mm
Depth	300mm
Thickness	100mm

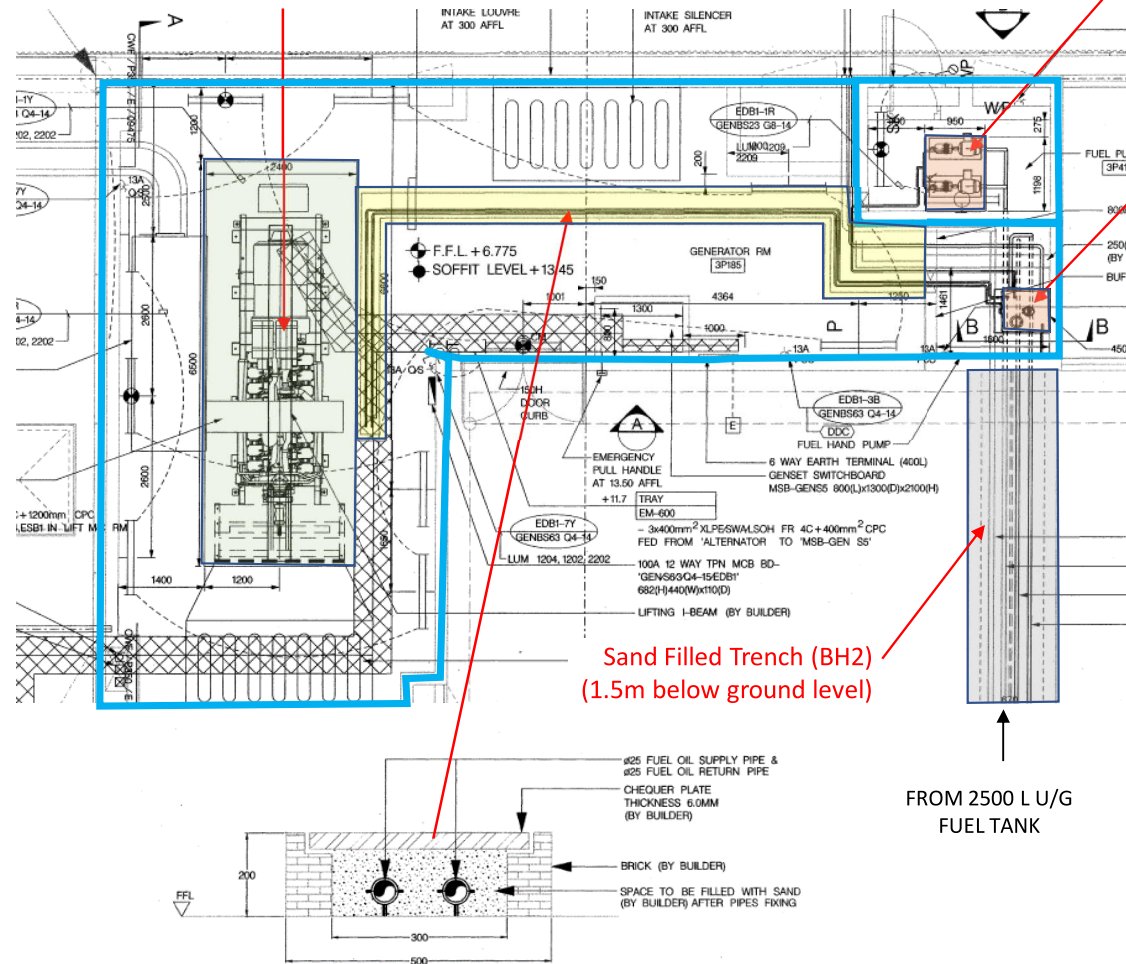
Details of BH3 (450 L Above-ground Fuel Tank) & BH4 (Above-ground Emergency Generator)

Emergency Generator (BH4)
(Mounted on **200mm-thick concrete plinth**)

- Both the fuel tank and generator mounted on intact concrete floor with no any oil stain.
- Fuel tank with metal drip tray and surrounded by concrete curb
- Fuel pipes inside sand filled concrete trench
- Test run of emergency generator conducted monthly (for 30-60 mins)
- Fuel tank is checked monthly and re-filled approx. every 6 months. No fuel leakage was recorded.

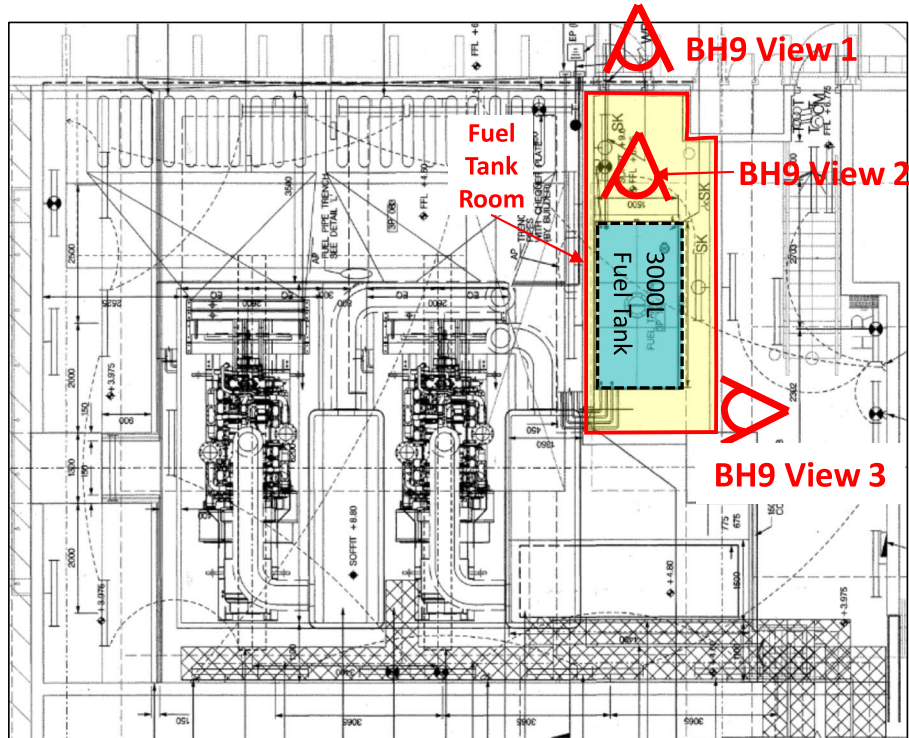
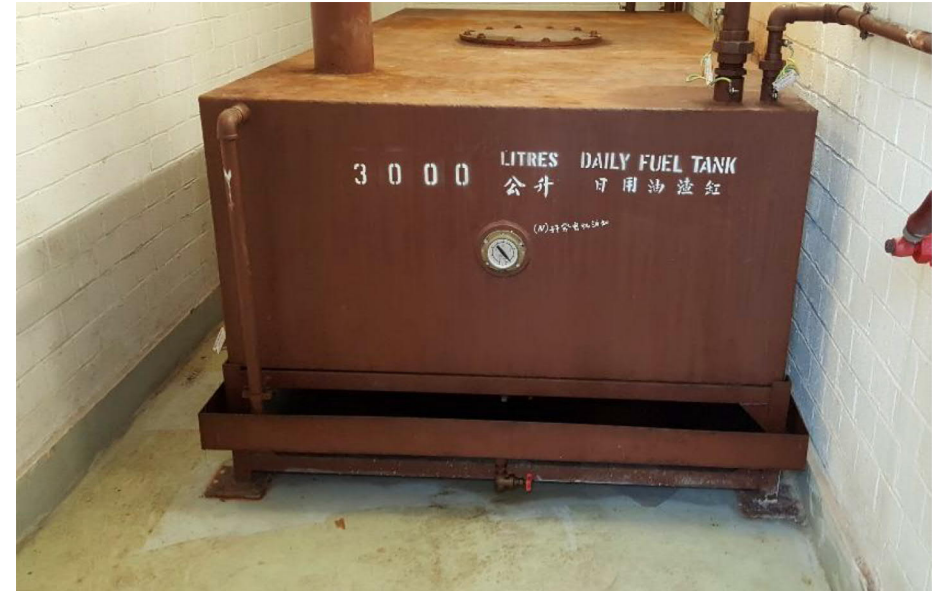
BH9 View 1 - 3000L Above-ground Fuel Tank (BH9)

- Both the fuel tank and generator mounted on intact concrete floor with no any oil stain.
- Test run of emergency generator conducted monthly (for 30-60 mins)
- The fuel tank is checked monthly and re-filled approx. every 6 months
- The quantity of fuel inside the tank is monitored by level sensor. No sign of leakage is detected.

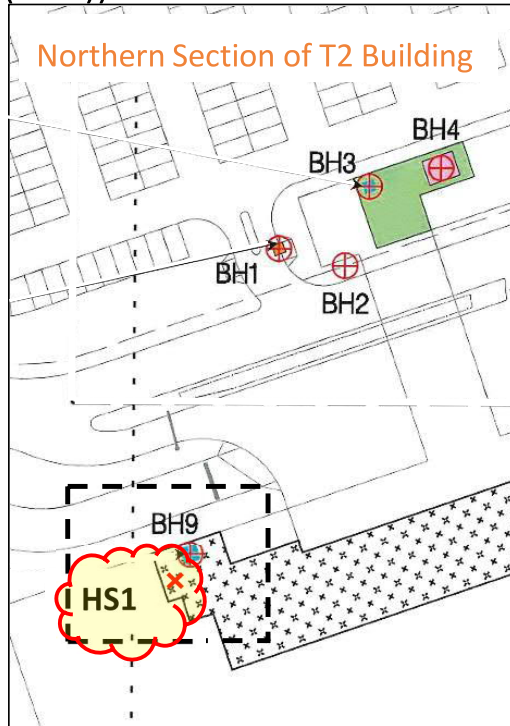
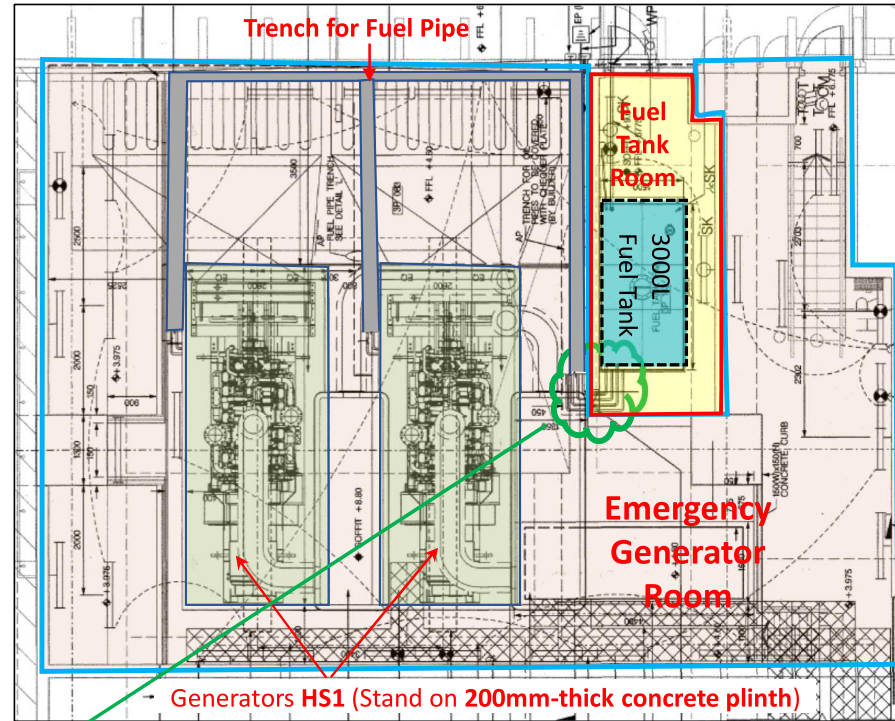
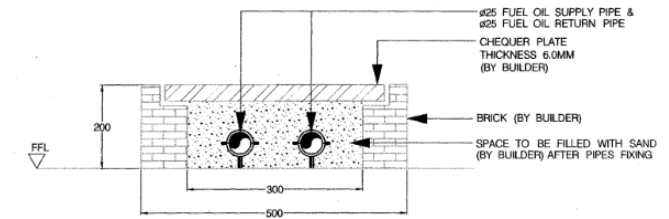
Details of **HS1** (2 Newly identified above-ground Emergency generators connected with 3,000 L **Above-ground** Fuel Tank inside **(BH9)**)

Supply and return pipe from fuel oil tank
(Sand Filled Trench at floor level)

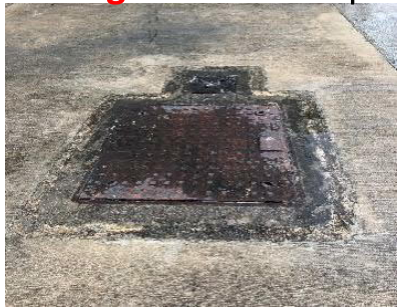
- Underground fuel tank fully encased in 300mm thick concrete chamber
- Space between the tank and the chamber is filled with sand
- Test run of emergency generator conducted monthly (for 30-60 mins)
- Manhole chamber of U/G tank is checked monthly and re-filled approx. every 6 months
- The quantity of fuel inside the tank is automatically monitored by level sensor. No sign of leakage is detected.

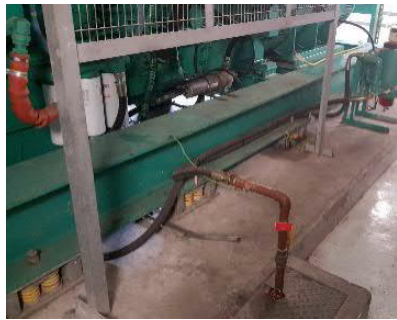
Fuel pipes to/from fuel tank and the generator

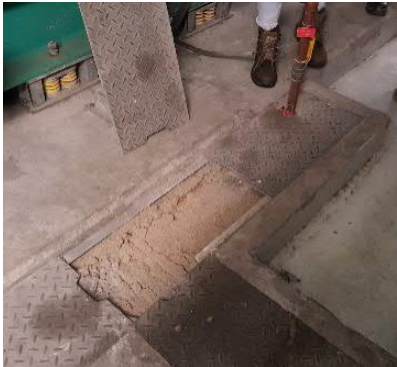
Sand filled trench containing fuel pipes (outside the fuel tank chamber)

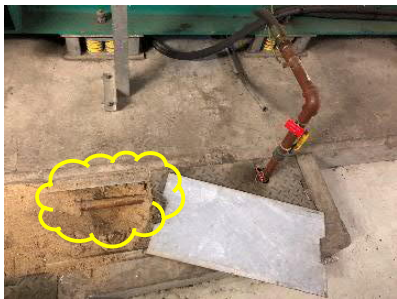
Exposed fuel pipes

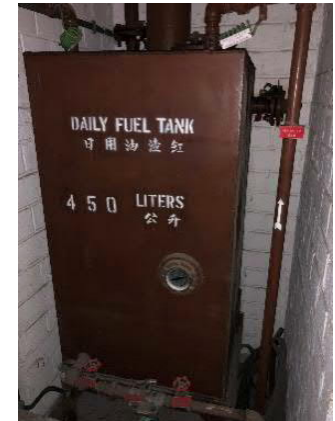
450 L fuel tank (BH7)

- Both the fuel tank and generator mounted on intact concrete floor with no any oil stain.
- Test run of emergency generator conducted monthly (for 30-60 mins)
- Fuel tank is checked monthly and re-filled approx. every 6 months.
- The quantity of fuel inside the tank is monitored by level sensor. No sign of leakage is detected.

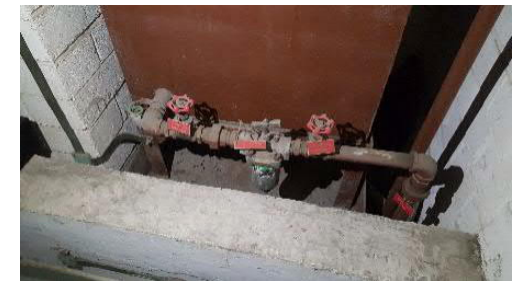
Metal drip tray and concrete curb surrounding fuel tank

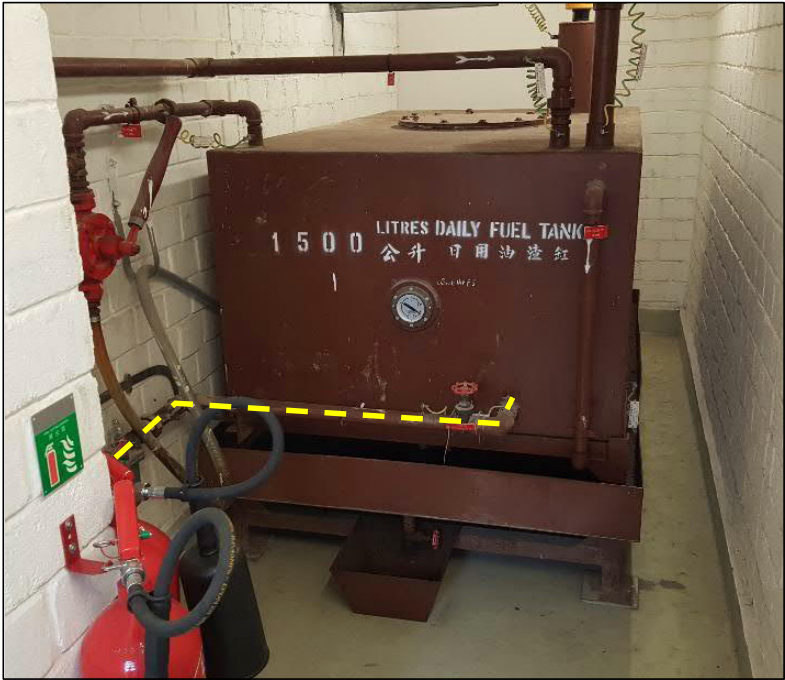
1,500L fuel tank (BH10) with metal drip tray

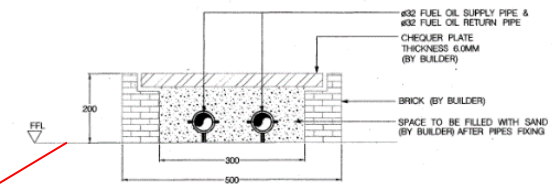
Supply and return pipe from fuel oil tank
(Sand Filled Trench at floor level)

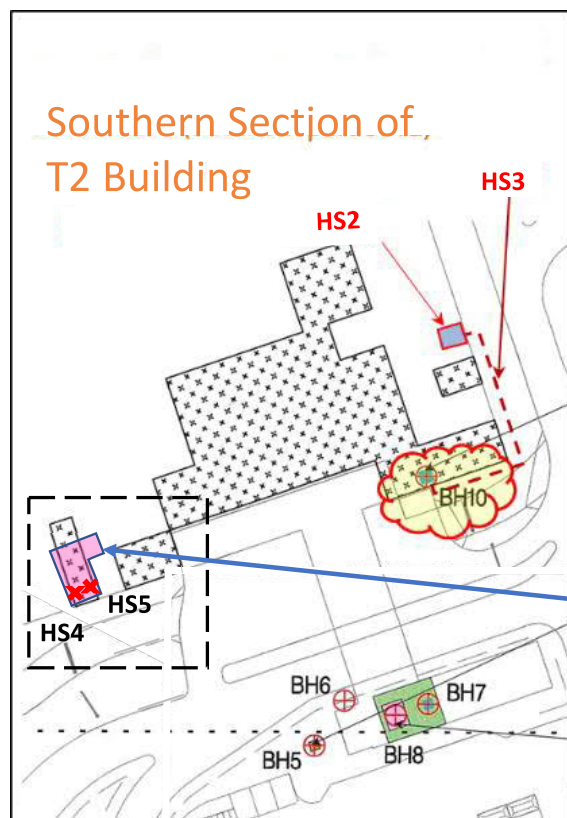
1,500 L Fuel Tank (HS4)

- Both the fuel tank and generator mounted on intact concrete floor with no any oil stain.
- Test run of emergency generator conducted monthly (for 30-60 mins)
- Fuel tank is checked monthly and re-filled approx. every 6 months.
- The quantity of fuel inside the tank is monitored by level sensor. No sign of leakage is detected.

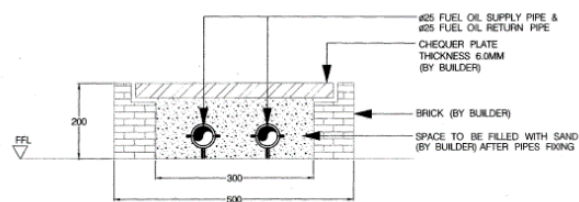
**Supply and return pipe from fuel oil tank
(Sand Filled Trench at floor level)**

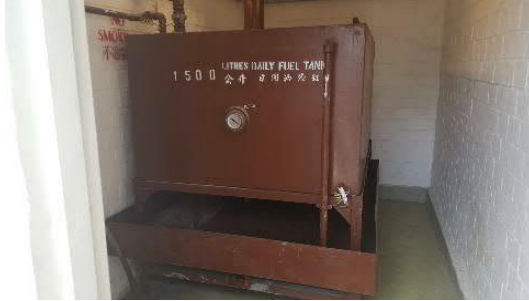
1,500 L fuel tank (HS4) with metal drip tray

- Both the fuel tank and generator mounted on intact concrete floor with no any oil stain.
- Test run of emergency generator conducted monthly (for 30-60 mins)
- Fuel tank is checked monthly and re-filled approx. every 6 months.
- The quantity of fuel inside the tank is monitored by level sensor. No sign of leakage is detected.

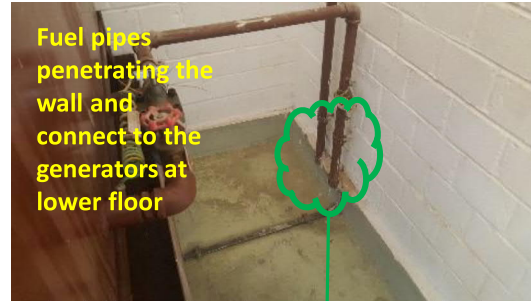
Fuel pipes penetrating the wall and connect to the generators at lower floor

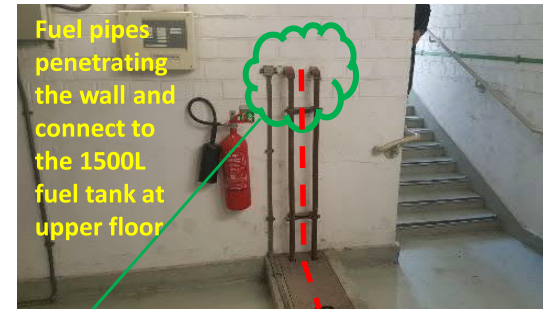
Fuel pipes penetrating the wall and connect to the 1500L fuel tank at upper floor

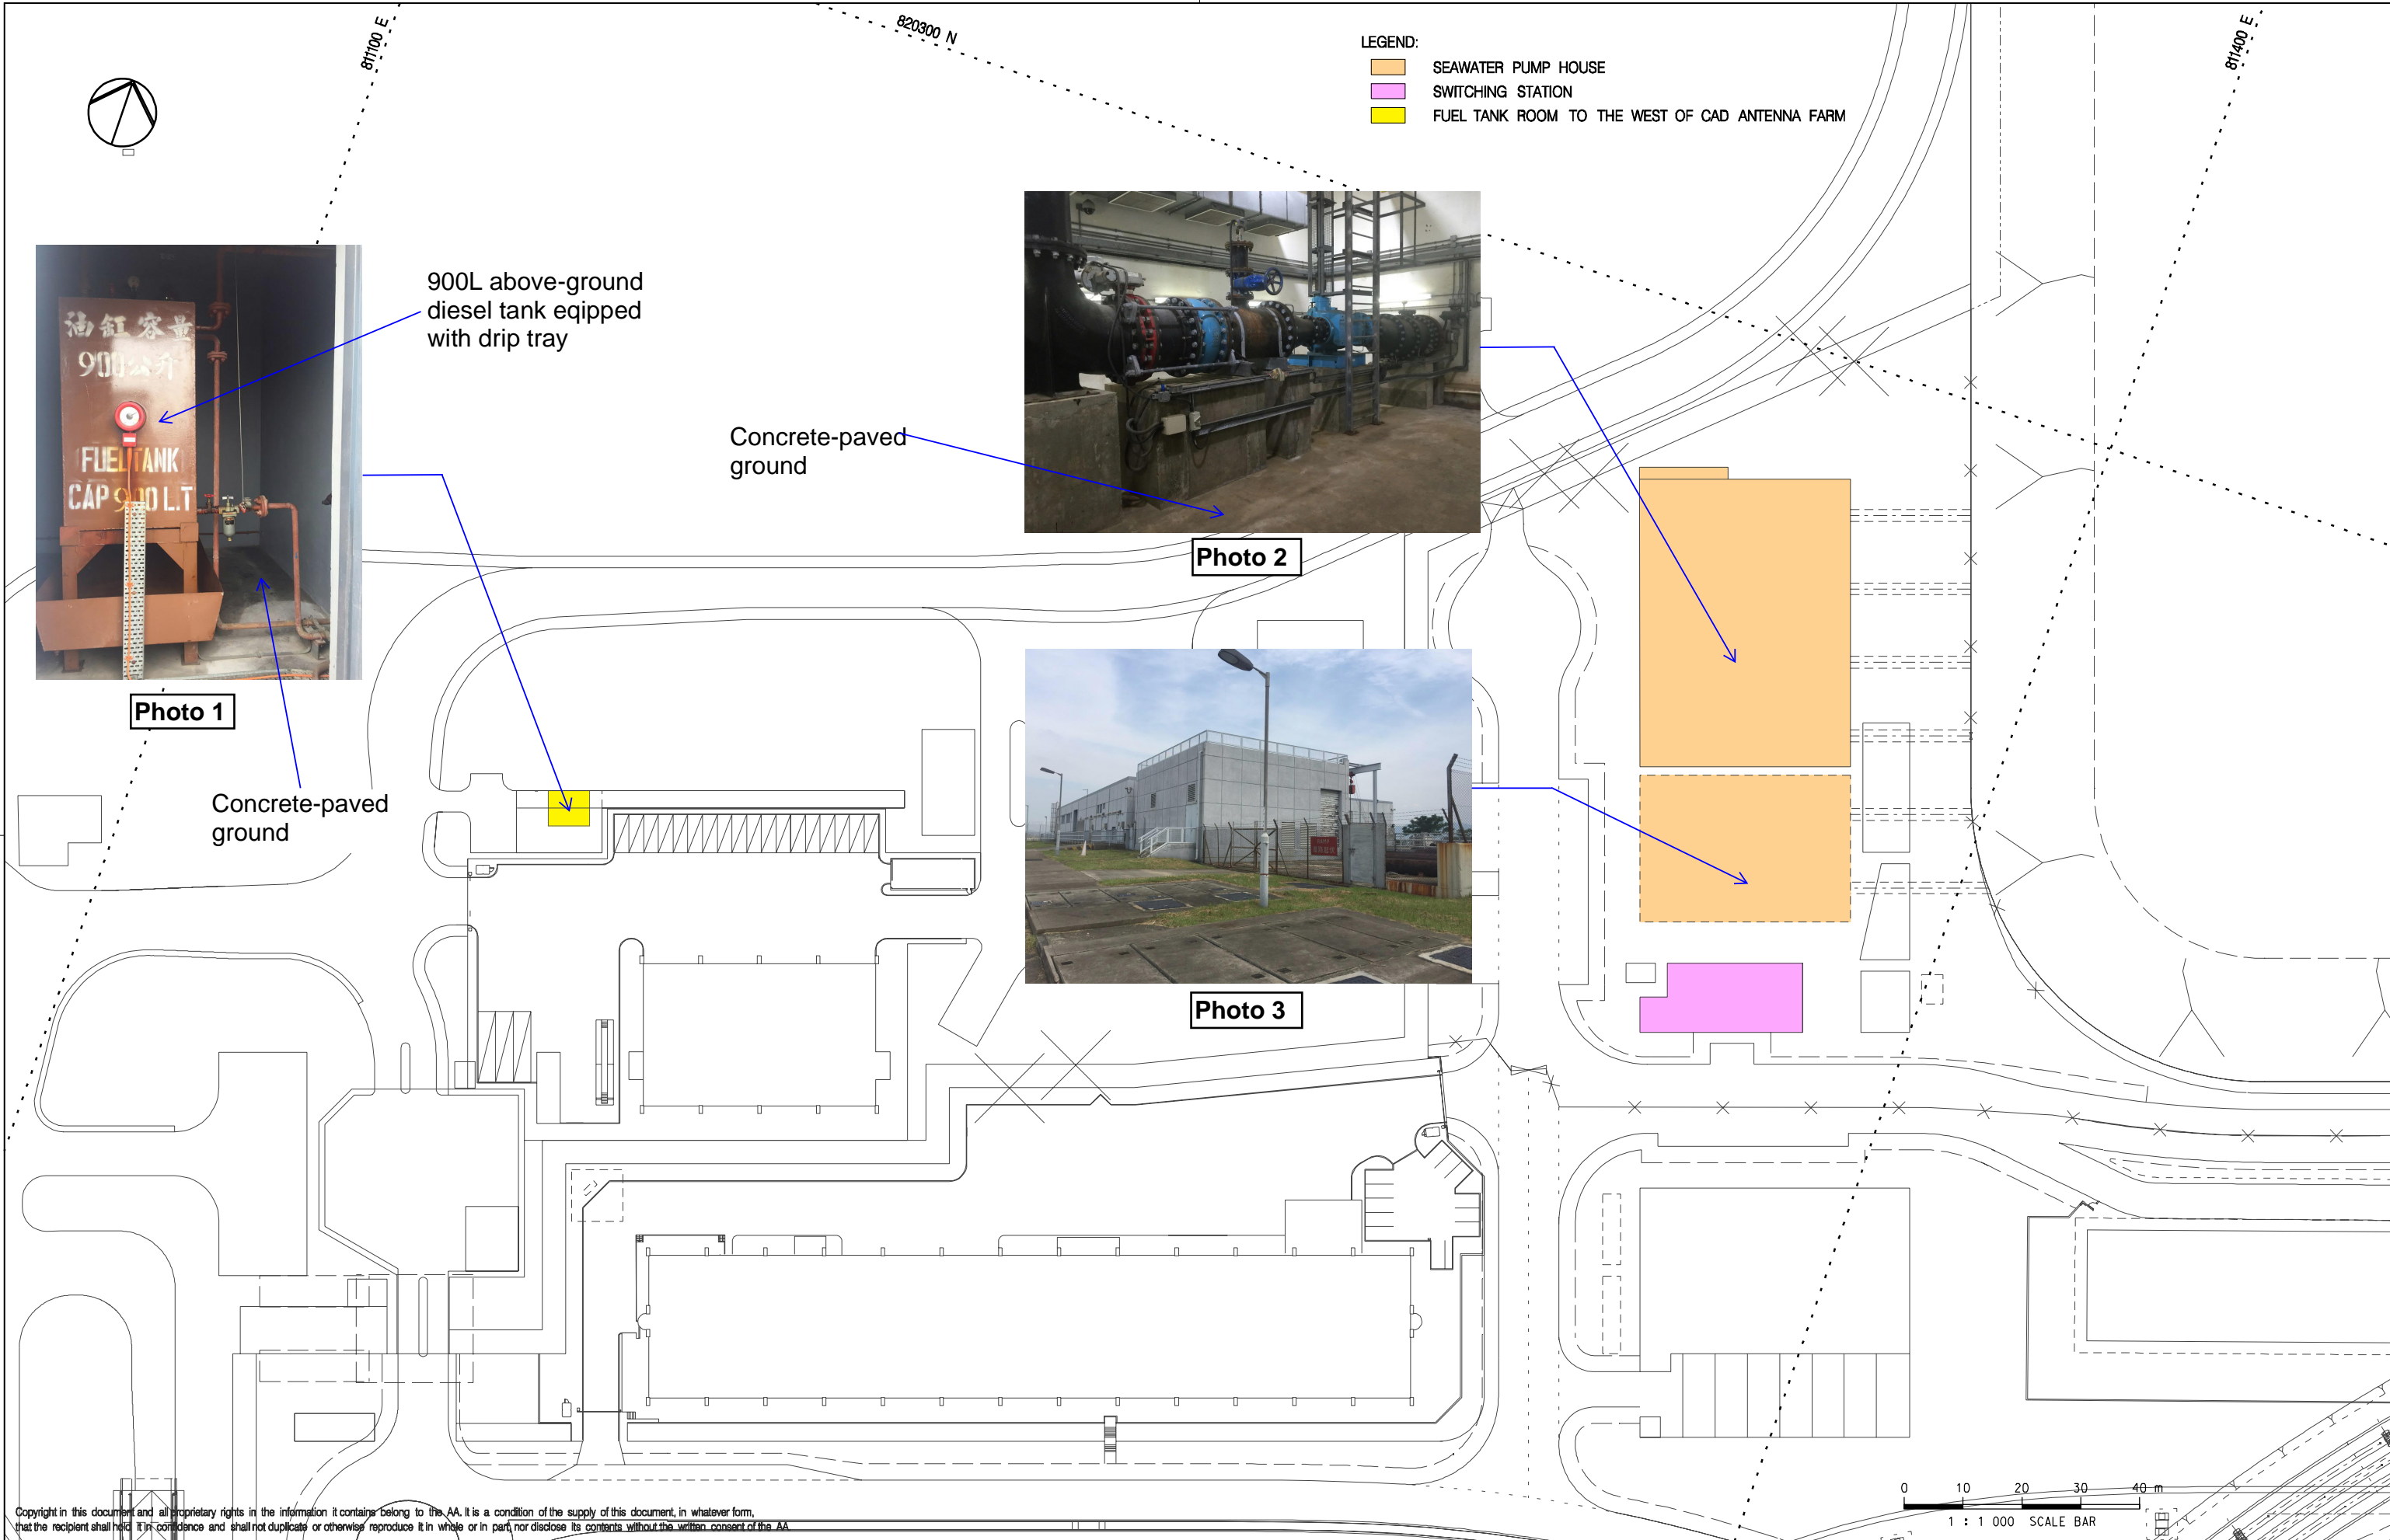
EXPANSION OF HONG KONG INTERNATIONAL AIRPORT INTO A THREE-RUNWAY SYSTEM		Scale at A3 1 : 1000
Drawing No.	FIGURE 3.1	Rev. B

The completed site walkover checklist and the photographic records of the fuel tank room to the west of CAD antenna farm are provided in **Appendix B.1** and **Figure 3.1** respectively.

The completed site walkover checklist and the photographic records of the seawater pump house are provided in **Appendix B.2** and **Figure 3.1** respectively.

Location	Potential Land Contamination Impact	Need for Further Site Investigation	Figure No.
Fuel Tank Room to the West of CAD Antenna Farm	A 900 L above-ground tank containing diesel fuel was found during the site reconnaissance survey. Potential leakage or spillage of fuel may cause land contamination concern.	SI locations have been proposed during EIA stage and are still considered valid. SI will be conducted prior to the commencement of construction works at site. *	Figure 3.1 and EIA drawing MCL/P132/EIA/11-015 as presented in Appendix C.1
Fuel Tank Room within T2 Building	After consolidating latest information, the approach towards this facility is updated. Please refer to Potential Contamination Source Reference ID BH9 in Table 3.3 .		
Seawater Pump House	No contaminative land use types were identified.	No	Figure 3.1
Switching Station	During detailed design of the project, relocation of the switching station is no longer required. Therefore, site appraisal process for land contamination potential is considered not necessary.		Figure 3.1

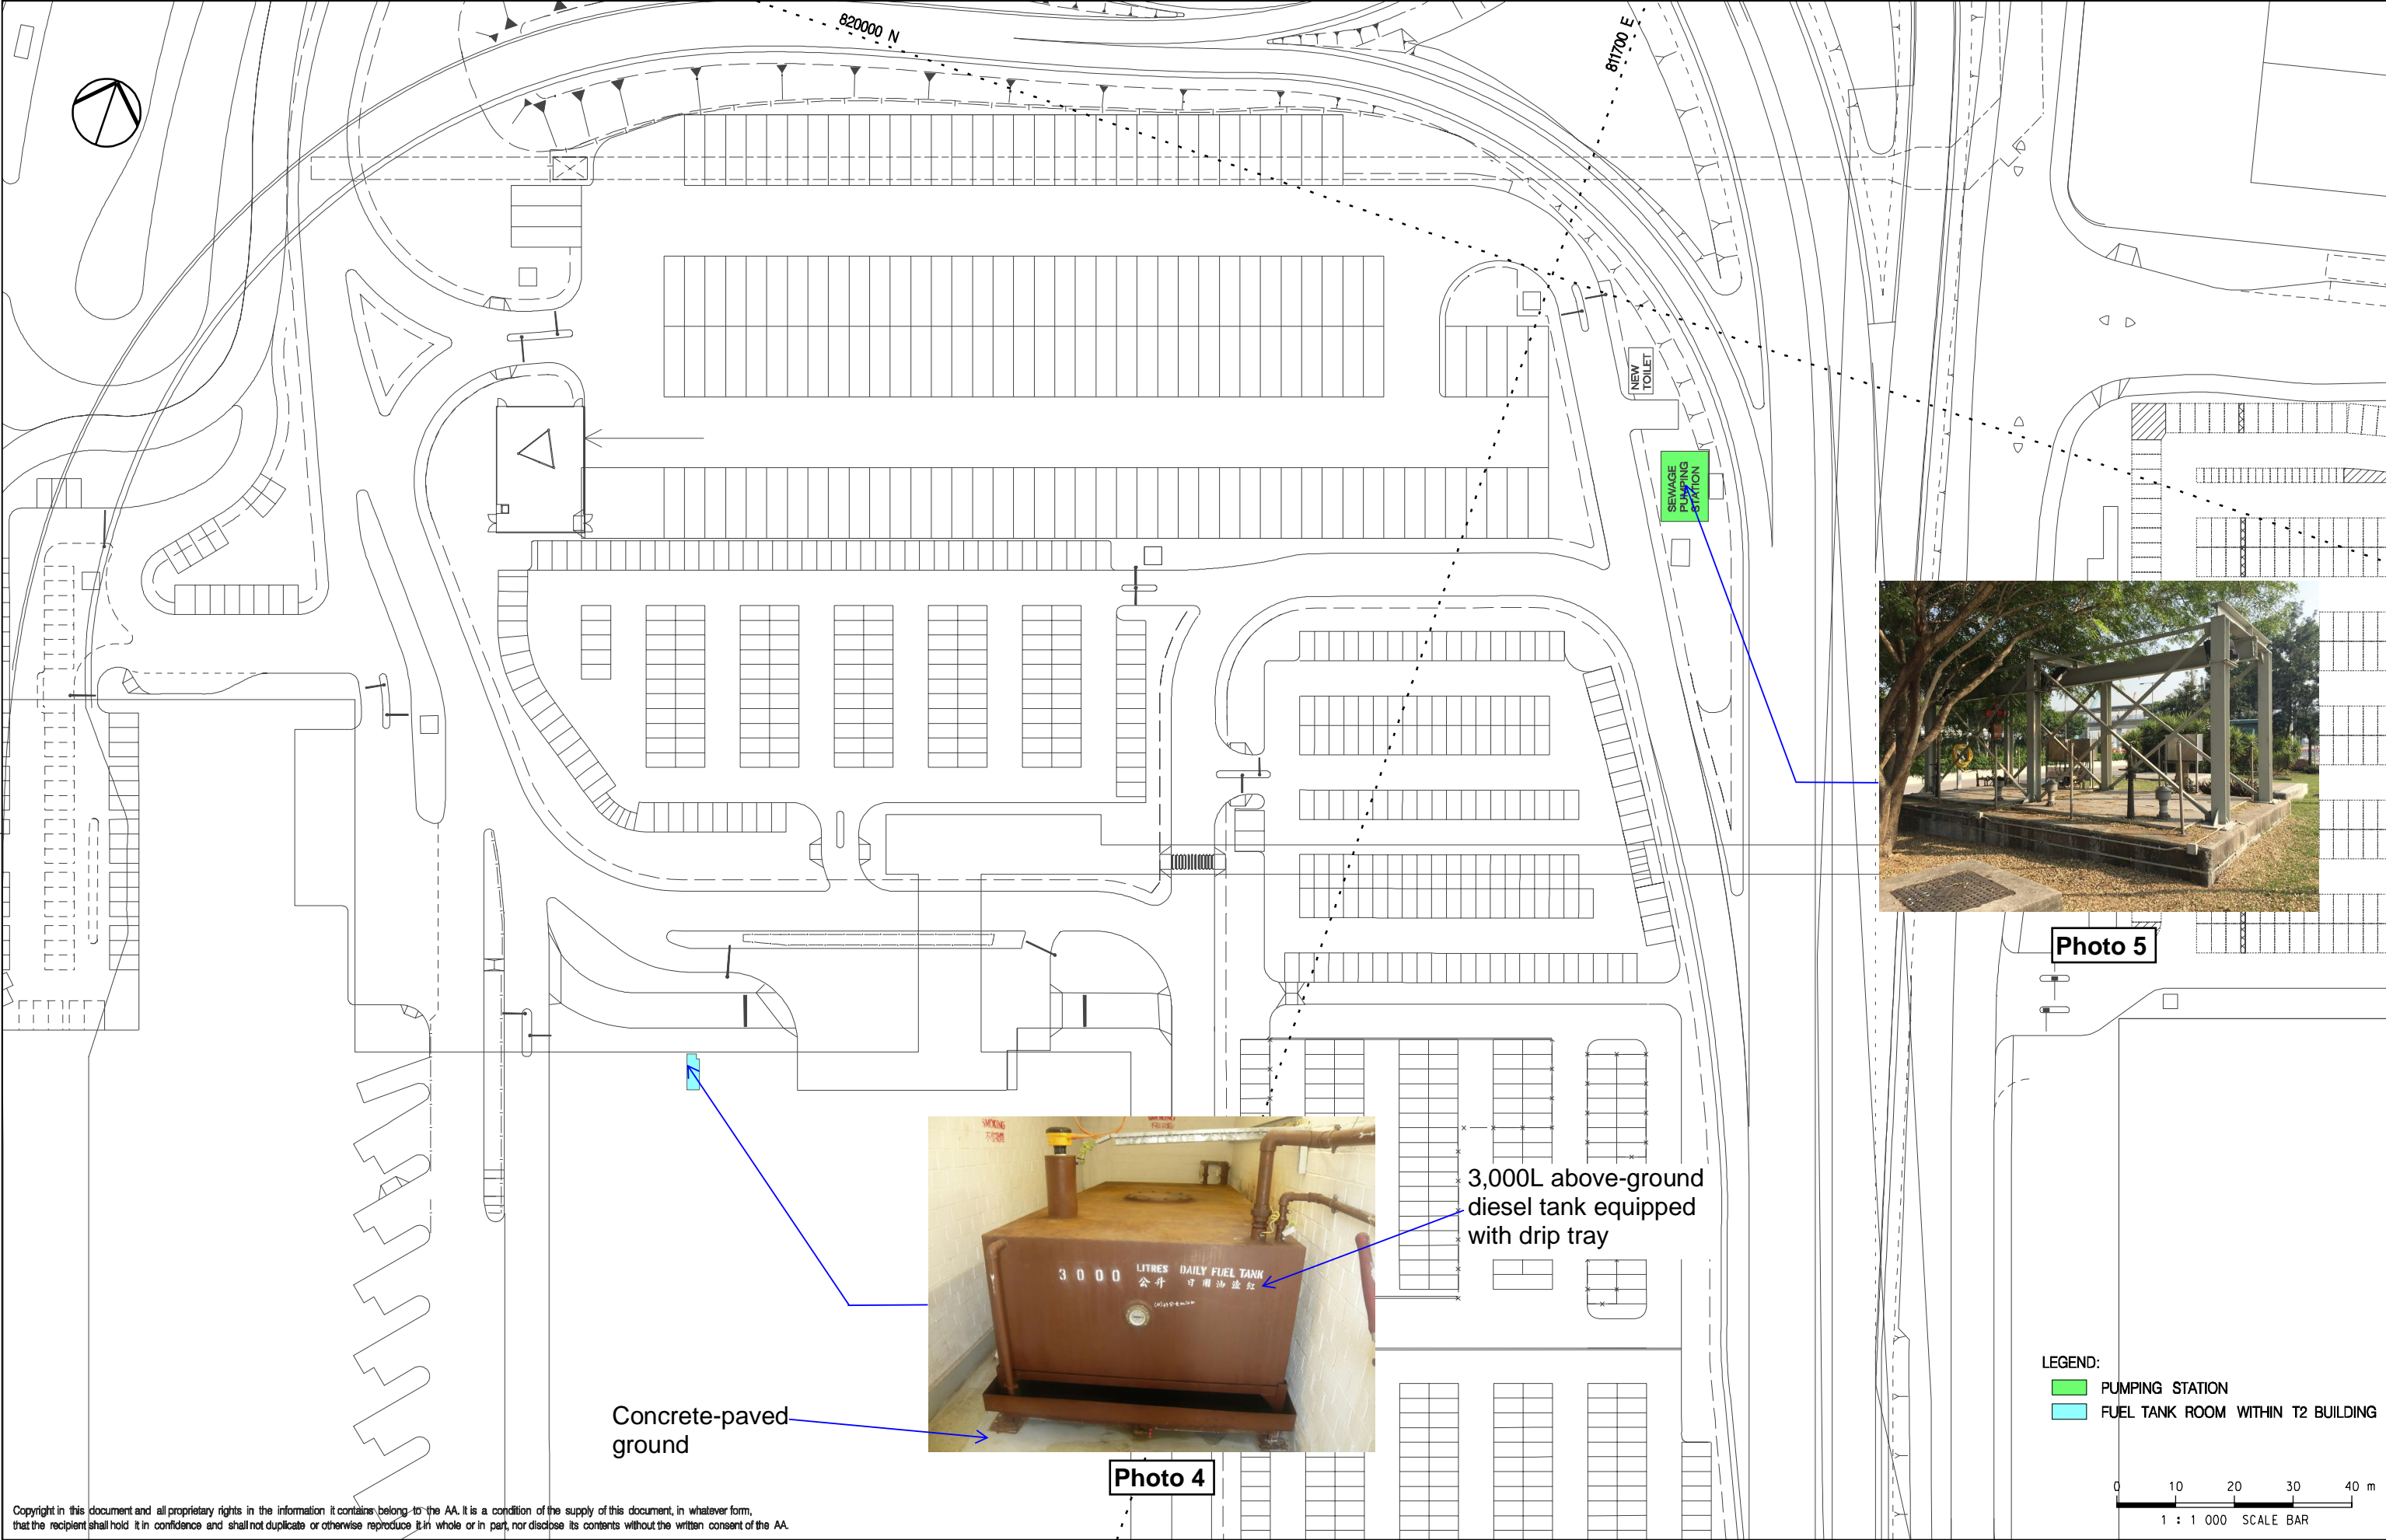
FIGURE 3.2

The completed site walkover checklist and the photographic records of the pumping station are provided in **Appendix B.3** and **Figure 3.2** respectively.

T2 building comprises northern and southern sections, where each section consists of number of Emergency Generator Rooms and Fuel Tank Rooms. A site reconnaissance survey was carried out at one of the Fuel Tank Room within T2 building in May 2017, focusing on the 3,000 L above-ground fuel tank (i.e. BH9). Relevant site walkover checklist and photographic records are presented in **Appendix B.5** and **Figure 3.2** respectively.

Pumping Station	No contaminative land use types were identified.	No	Figure 3.2
