Expansion of Hong Kong International Airport into a Three-Runway System

Supplementary Contamination Assessment Plan

August 2018

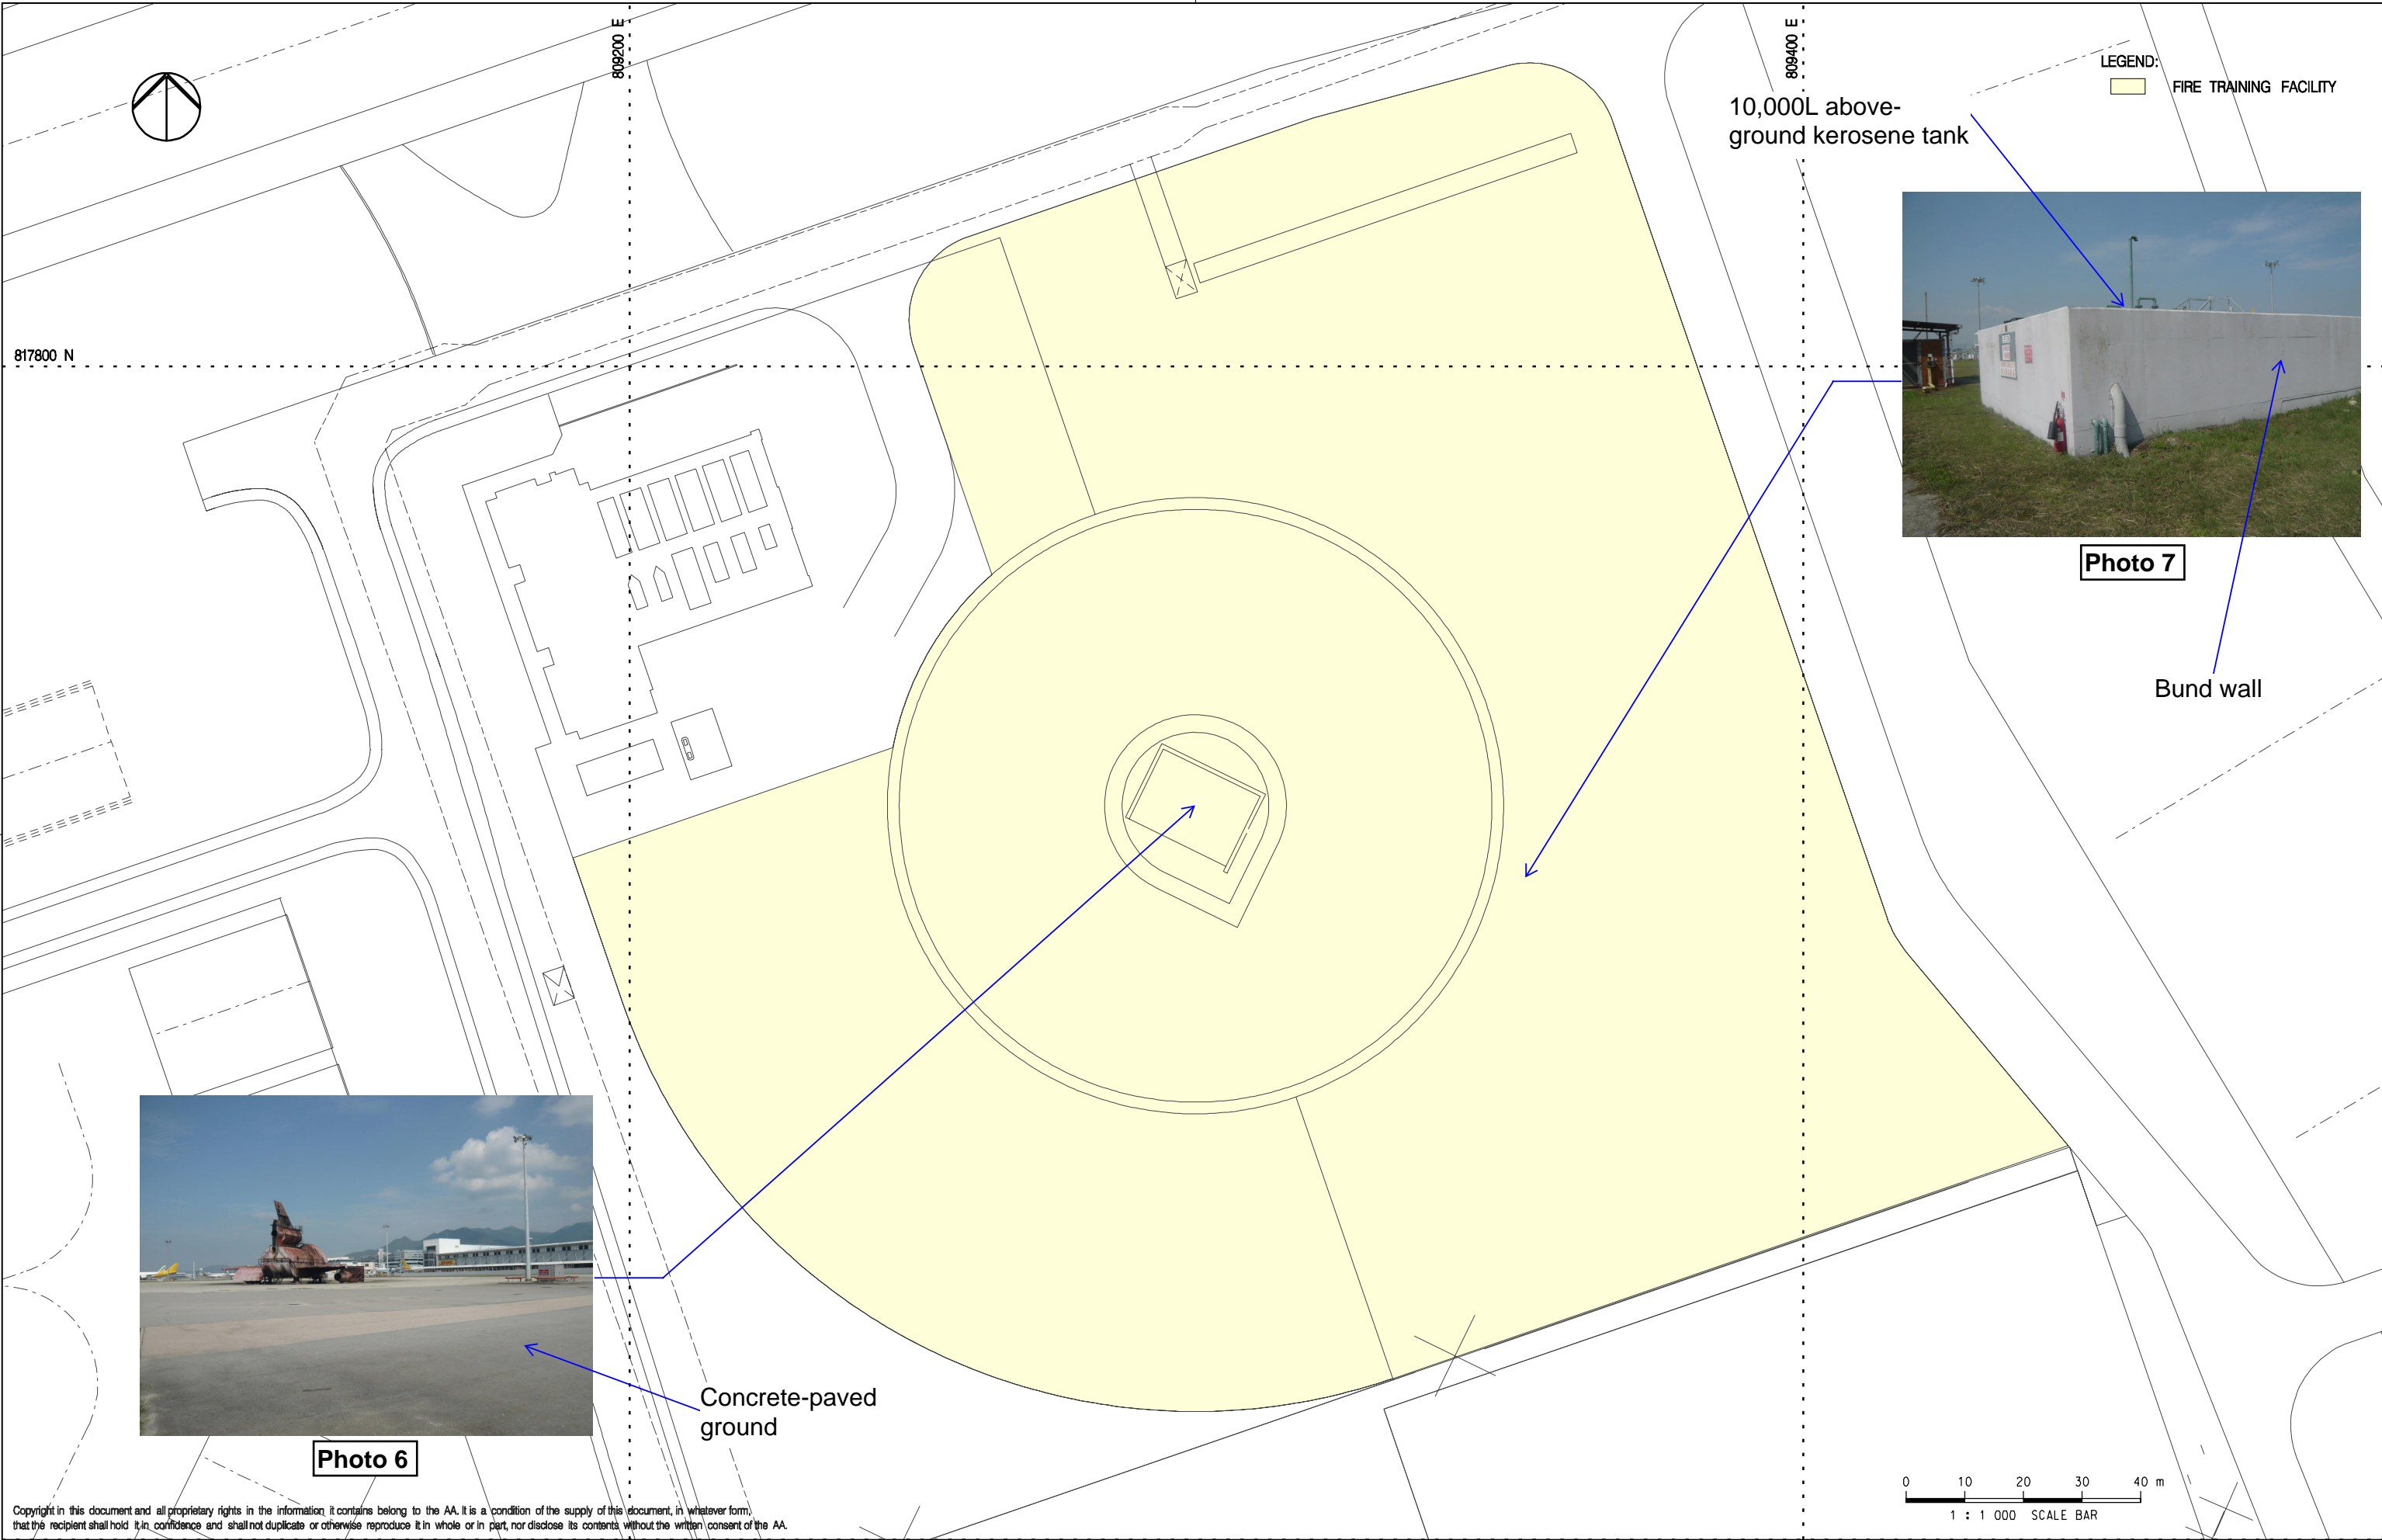
EXPANSION OF HONG KONG INTERNATIONAL AIRPORT INTO A THREE-RUNWAY SYSTEM		Scale at A3 1 : 1000
Drawing No.		Rev.
FIGURE 3.3		A

The completed site walkover checklist and the photographic records of the fire training facility are provided in **Appendix B.4** and **Figure 3.3** respectively.

Location	Potential Land Contamination Impact	Need for Further Site Investigation	Figure No.
Fire Training Facility	A 10,000 L above-ground tank containing kerosene was found during the site reconnaissance survey. Potential leakage or spillage of fuel may cause land contamination concern.	Yes, SI will be conducted prior to the commencement of construction works at site. *	Figure 3.3
