Expansion of Hong Kong International Airport into a Three-Runway System

Site Re-appraisal Summary Report
– Fire Training Facility

November 2023

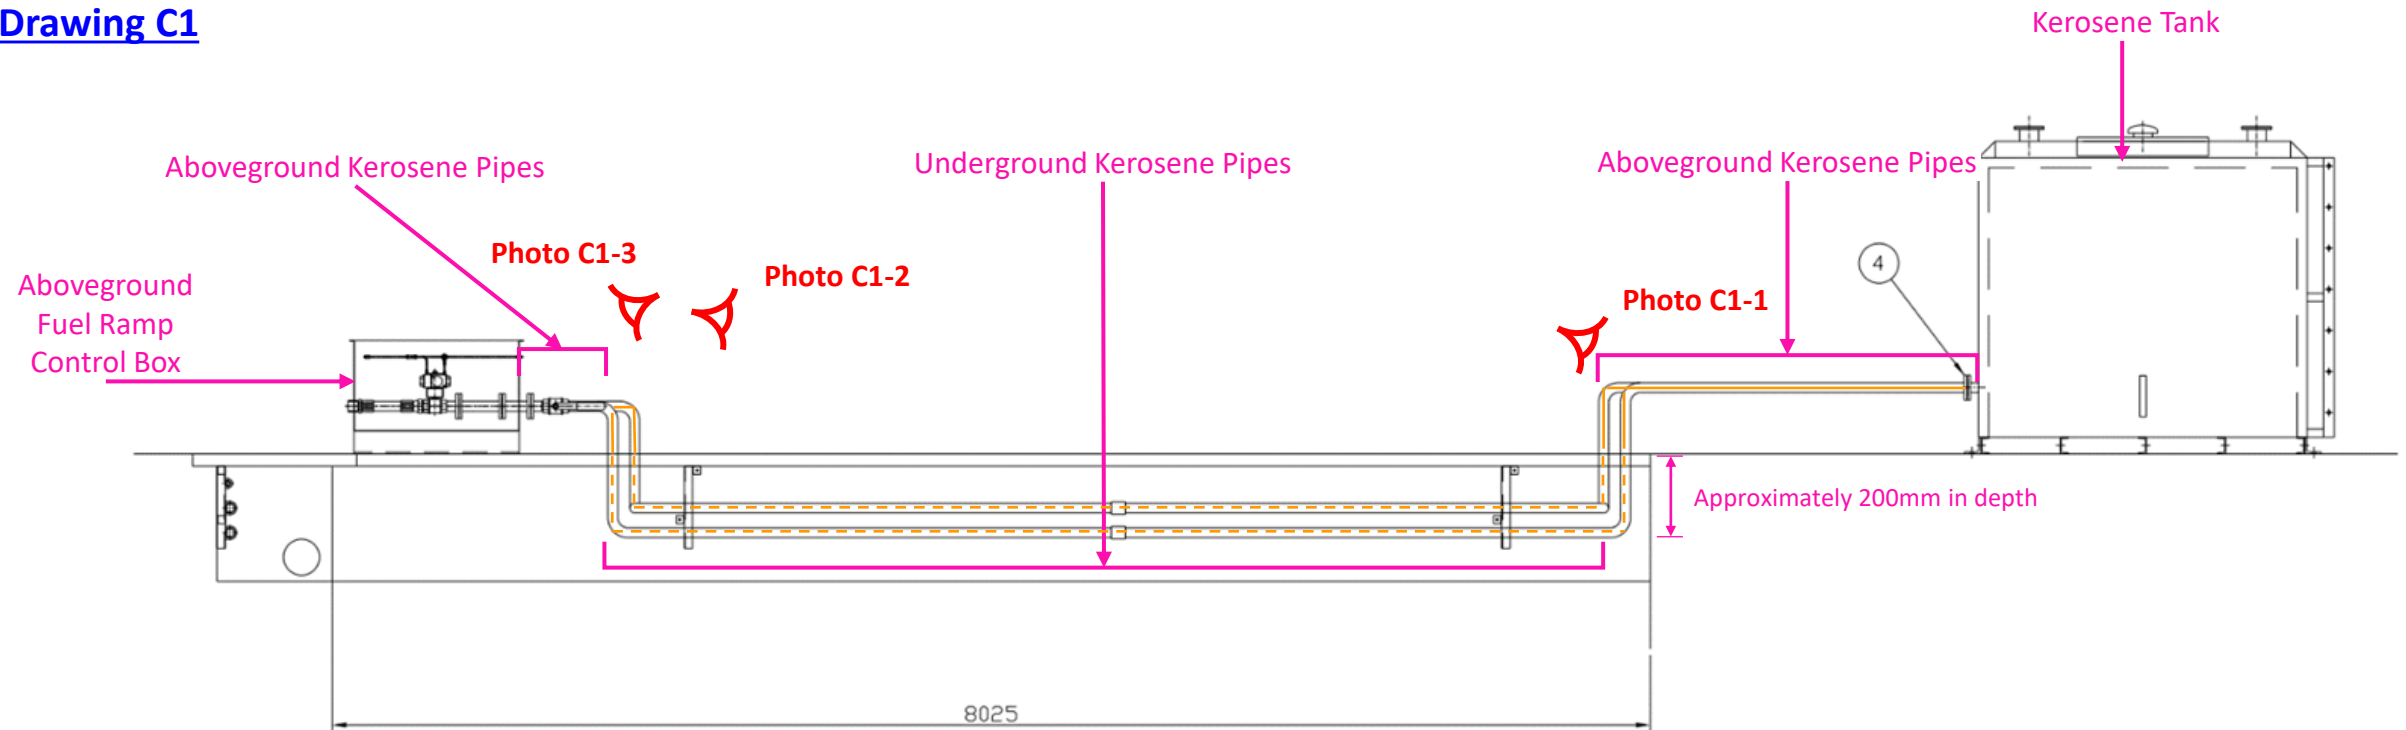
Drawing C1

- Pipes between the concrete bund wall and the fuel ramp control box is located underground.
- The bottom level of this underground pipe section is approximately 200mm below ground level.
- Soil surrounding the bottom of the underground pipes near the bund wall have been taken for inspection.
- No specific odour or visual observations in relation to kerosene leakage / spillage have been identified.

- Section of underground pipes connecting the kerosene tank and fuel ramp control box
- No sign of grass withering

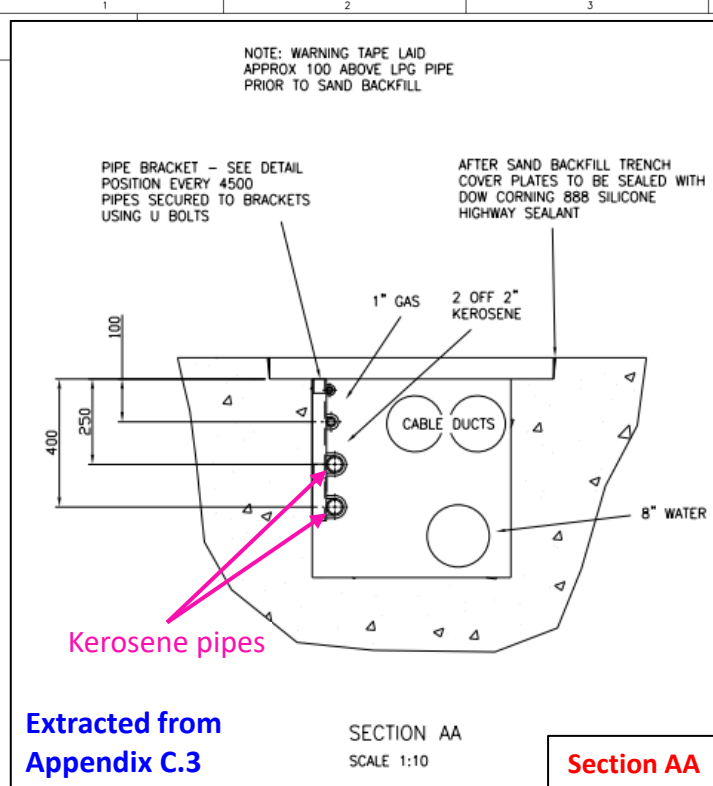
The whole section (marked in light blue box) of underground kerosene pipes is running through the concrete trench and sealed with cover plate.
