Expansion of Hong Kong International Airport into a Three-Runway System

Construction Phase Monthly EM&A
Report No. 80
(For August 2022)

September 2022

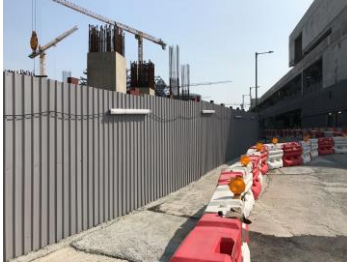
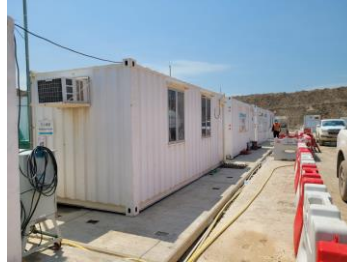
Table 7.2: Examples of Landscape and Visual Mitigation Measures in the Reporting Periods

<p>Erection of site hoardings around works area in unobtrusive colours (CM5)</p>	<p>Avoidance of excessive height and bulk of site buildings (CM6)</p>	<p>Control of night-time lighting using light hooding and minimisation of night working period (CM7)</p>
