Expansion of Hong Kong International Airport into a Three-Runway System

Construction Phase Monthly EM&A
Report No. 106
(For October 2024)

November 2024

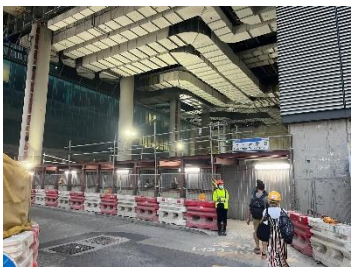
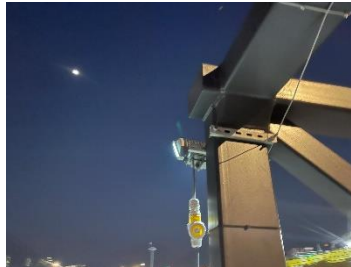
Table 7.2: Examples of Landscape and Visual Mitigation Measures in the Reporting Period

<p>Erection of site hoardings around works area in unobtrusive colours (CM5)</p>	<p>Avoidance of excessive height and bulk of site buildings (CM6)</p>	<p>Control of night-time lighting using light hooding and minimisation of night working period (CM7)</p>

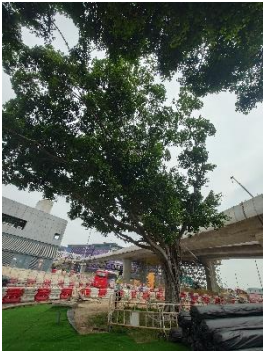
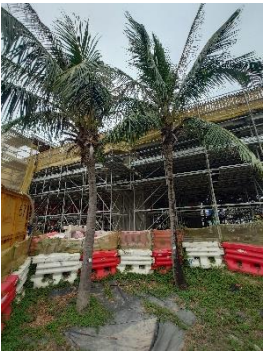
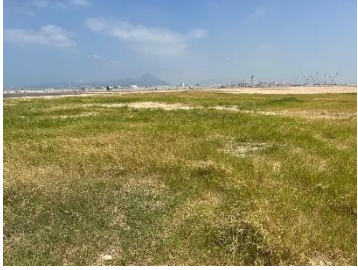
General view of retained tree (CM8)	General view of transplanted trees (CM9)	General view of advanced hydroseeding works (CM10)

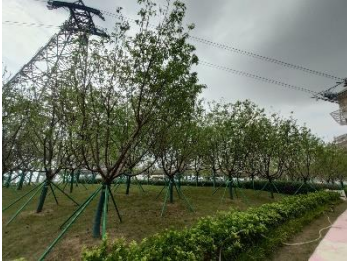
General view of compensatory tree planting (OM7)
