Expansion of Hong Kong International Airport into a Three-Runway System

Construction Phase Monthly EM&A
Report No. 97
(For January 2024)

February 2024

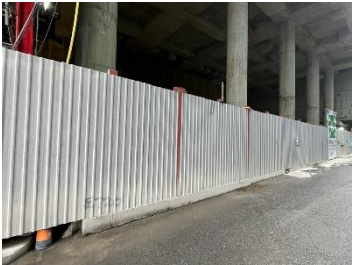
Erection of site hoardings around works area in unobtrusive colours (CM5)	Avoidance of excessive height and bulk of site buildings (CM6)	Control of night-time lighting using light hooding and

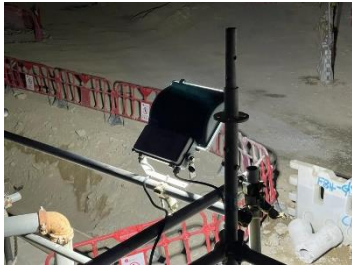
minimisation of night working period (CM7)

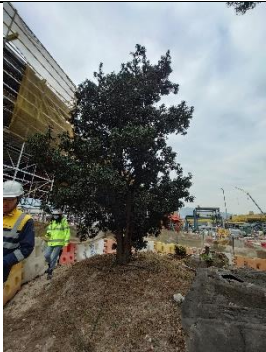
General view of retained tree (CM8)	General view of transplanted trees (CM9)	General view of compensatory tree planting (OM7)
