Expansion of Hong Kong International Airport into a Three-Runway System

Construction Phase Quarterly EM&A Report
No.36 (1 October to 31 December 2024)

February 2025

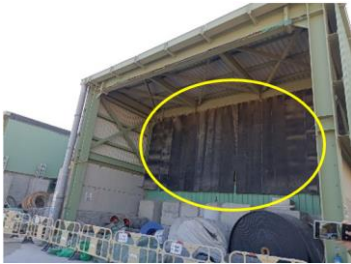
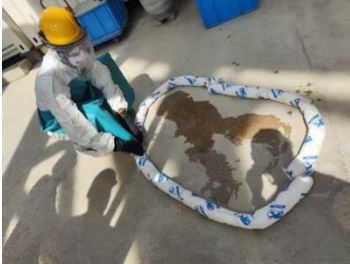
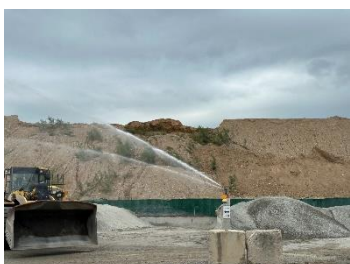
Installation of flexible curtain at aggregate storage area	Provision of chemical spill drill by Contractor	Provision of water spraying at the stockpiling area

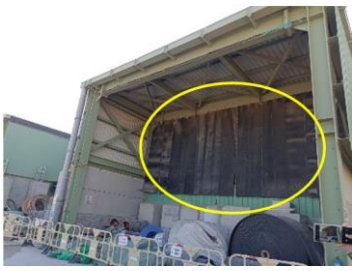
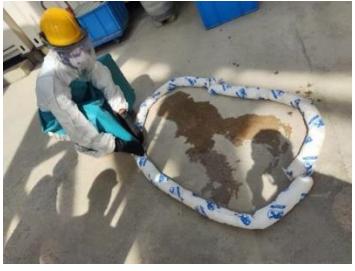
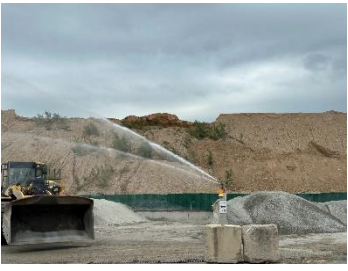
1. Installed flexible curtain at the aggregate storage area to prevent dust nuisance.
2. Conducted a chemical spill drill for the frontline site staff.
3. Provided water spraying for stockpiling area to prevent dust nuisance.

<p>Installation of flexible curtain at the aggregate storage area</p>	<p>Provision of chemical spill drill by Contractor</p>	<p>Provision of water spraying at the stockpiling area</p>
