Expansion of Hong Kong International Airport into a Three-Runway System

Construction Phase Quarterly EM&A Report
No.38 (1 April to 30 June 2025)

August 2025

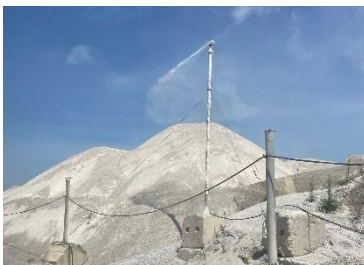
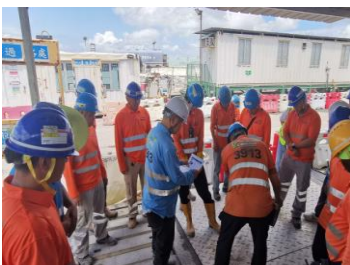
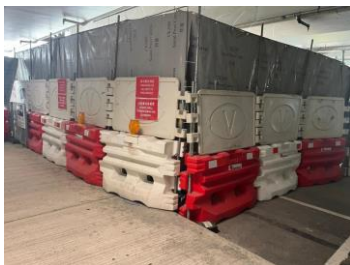
Provision of automated water spraying at the stockpiling area	Provision of oil spillage drill for site personnel	Erection of noise insulation materials
