# **Expansion of Hong Kong International Airport into a Three-Runway System**

Construction Phase Quarterly EM&A Report  
No.40 (1 October to 31 December 2025)

February 2026

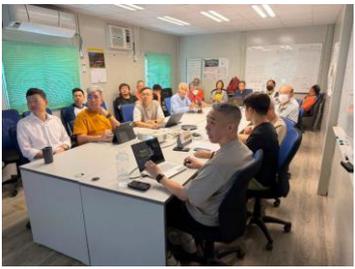
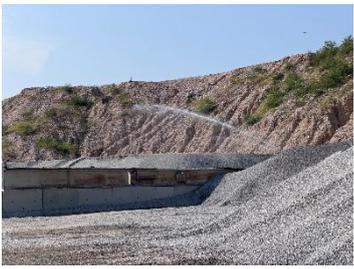
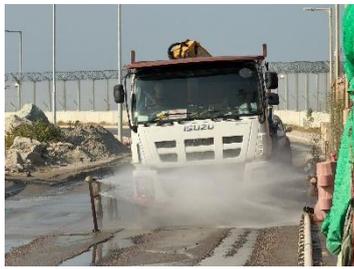
**Snapshots of Good Environmental Practices in the Reporting Period**

Provision of environmental training for site personnel	Provision of water spraying at the stockpiling area	Provision of wheel washing at site exit

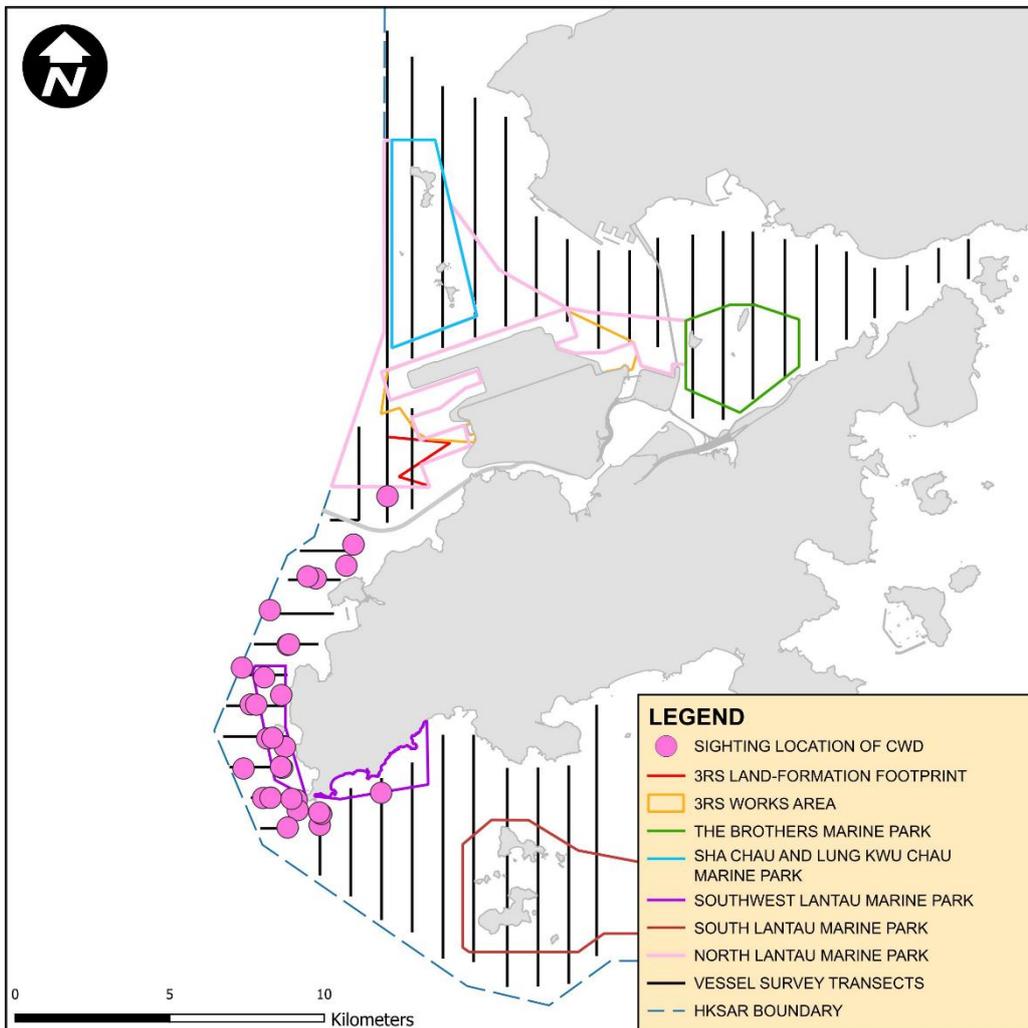
**Figure 2.3: Sightings Distribution of Chinese White Dolphins from October to December 2025**

The distribution of CWD sightings recorded from October to December 2025 is illustrated in **Figure 2.3**. In NWL, the only CWD sighting was recorded at the western waters of the Airport. In WL, CWD sightings were primarily distributed across the waters between Yi O and Fan Lau, with a few sightings scattered near Fu Shan. In SWL, CWD sightings were recorded in western part of the survey area around waters between Fan Lau and Tung Wan. No CWD sighting was recorded in NEL survey area during the reporting period. Details of the sighting data are presented in **Appendix C**.

- (1) Please note that there are 30 pink circles on the map indicating the sighting locations of CWD. Some of them were very close to each other and therefore appear overlapped on this sighting distribution map.
- (2) Marine Park excludes land area and the landward boundary generally follows the high water mark along the coastline.

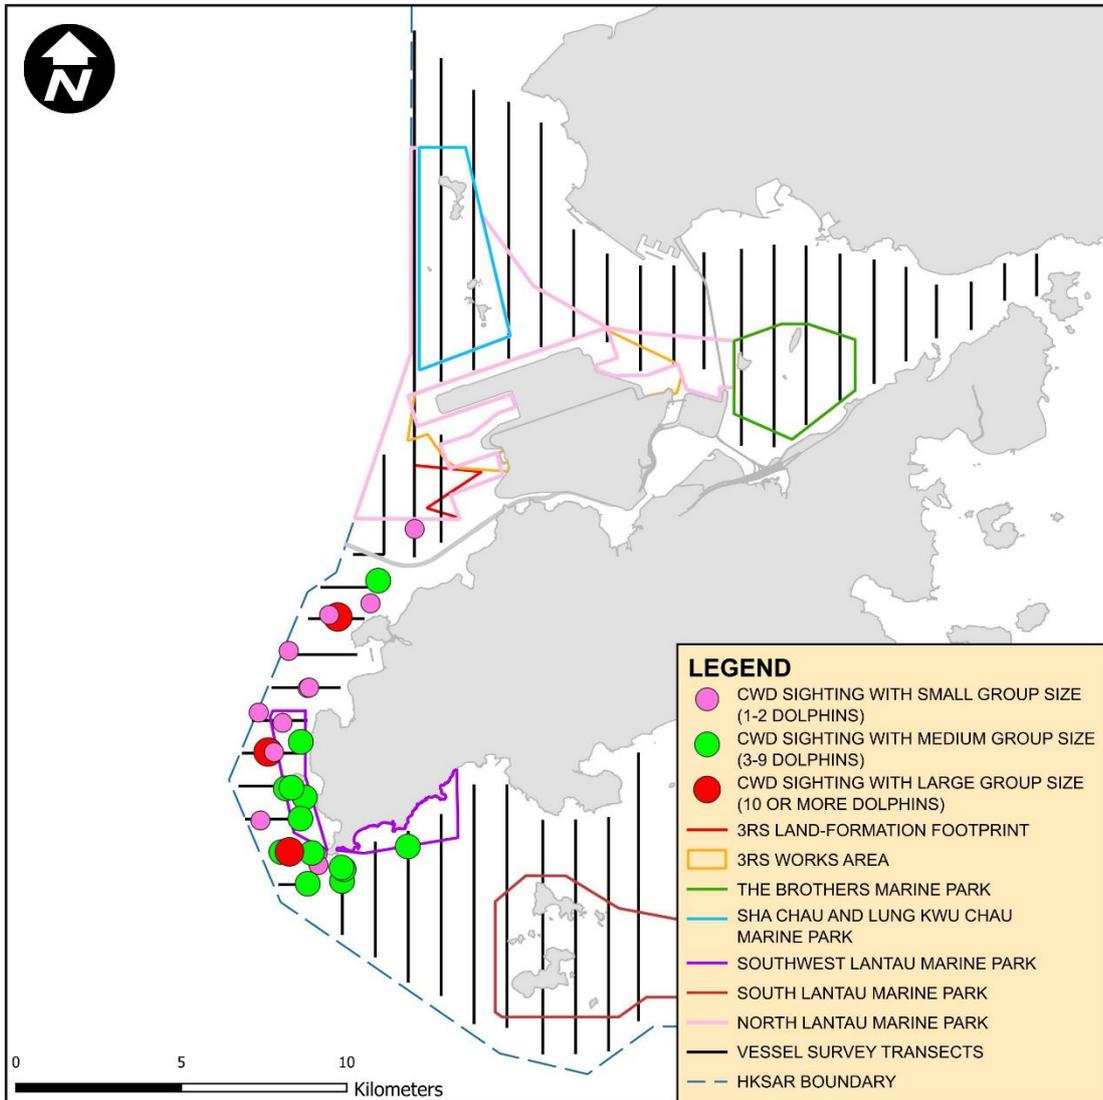
Figure 2.4: Sighting Locations of Chinese White Dolphins with Different Group Sizes

All three large-sized dolphin groups were recorded in WL survey area. There was no apparent pattern in the distribution of small-sized dolphin groups and medium-sized dolphin groups in all survey areas. Sighting locations of CWD groups with different group sizes are depicted in **Figure 2.4**.

- (1) Please note that there are 30 circles on the map indicating the sighting locations of CWD. Some of them were very close to each other and therefore appear overlapped on this sighting distribution map.
- (2) Marine park excludes land area and the landward boundary generally follows the high water mark along the coastline.

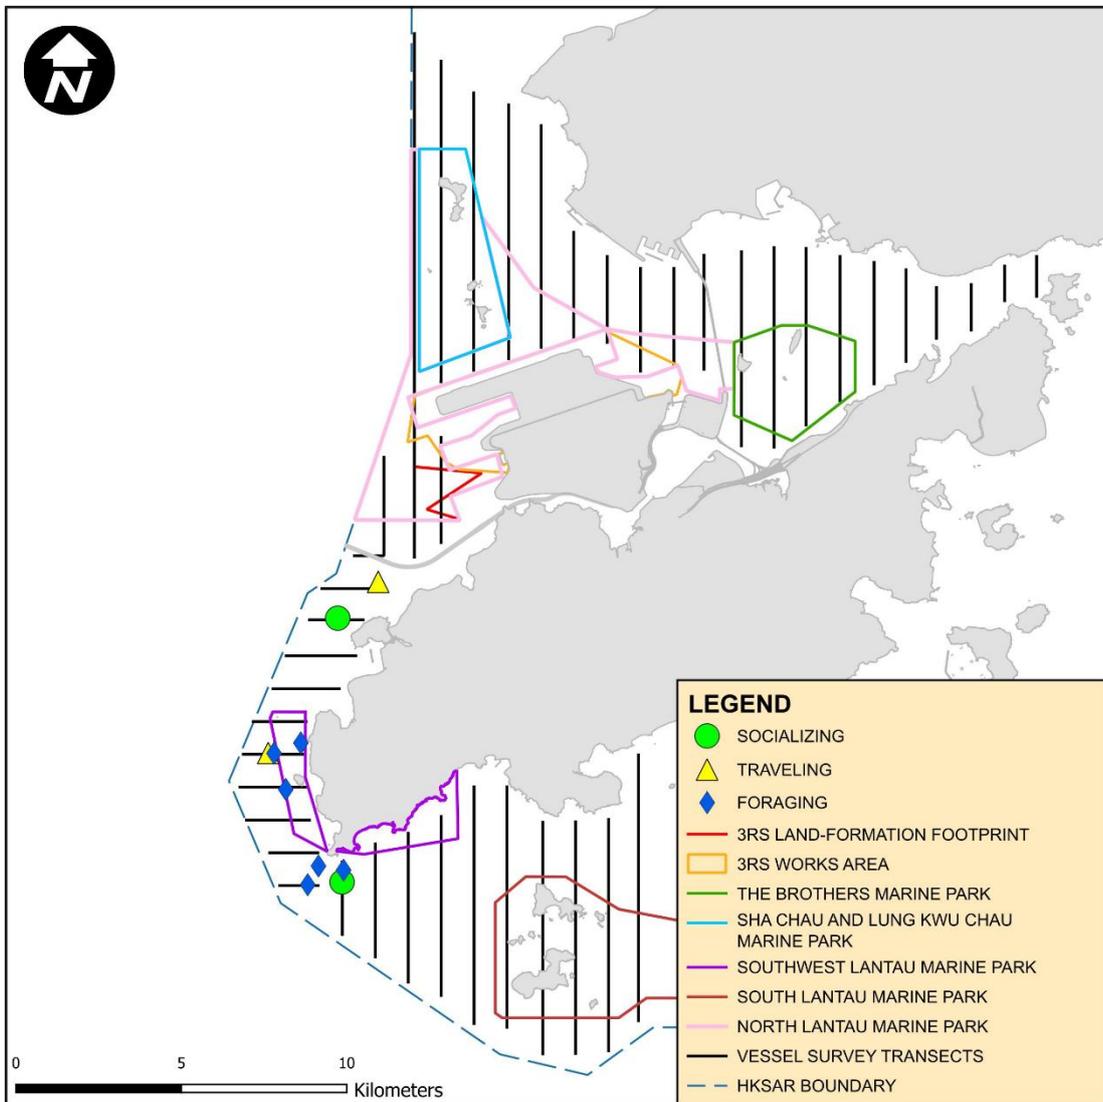
**Figure 2.5: Sighting Locations of Chinese White Dolphins Engaged in Different Behaviours**

From October to December 2025, six sightings of CWD were recorded with foraging activities. Amongst them, two sightings were observed associated with operating purse seiners in SWL and WL survey area while one sighting was observed associated with operating shrimp trawler in WL.

The sighting locations of CWDs engaged in different behaviours during the current reporting period are illustrated in **Figure 2.5**.

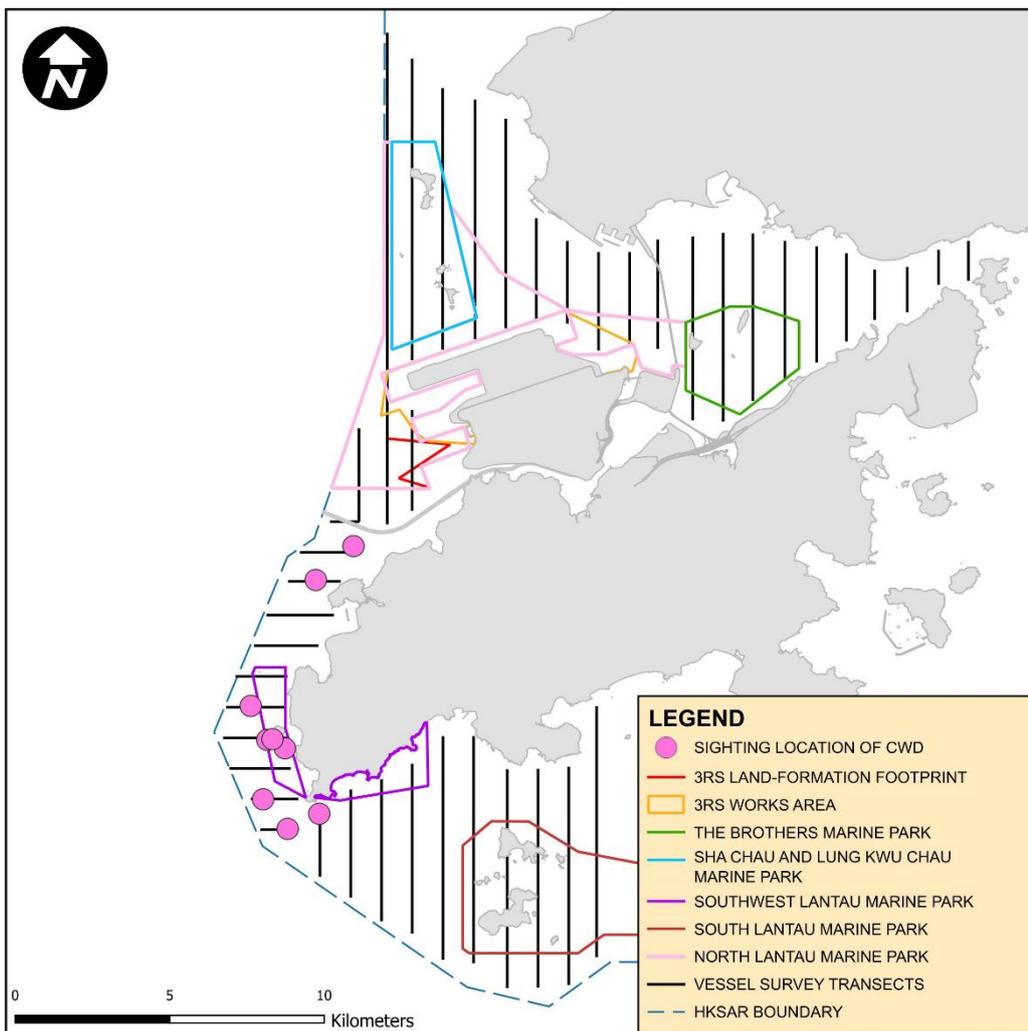
**Figure 2.6: Sighting Locations of Mother-calf Pairs**

These nine sightings with the presence of mother-calf pairs recording during the reporting period were recorded in WL and SWL survey area. The locations of CWD sightings with the presence of mother-calf pairs are shown in **Figure 2.6**.

- (1) Please note that there are nine circles on the map indicating the sighting locations of CWD. Some of them were very close to each other and therefore appear overlapped on this sighting distribution map.
- (2) Marine park excludes land area and the landward boundary generally follows the high water mark along the coastline.

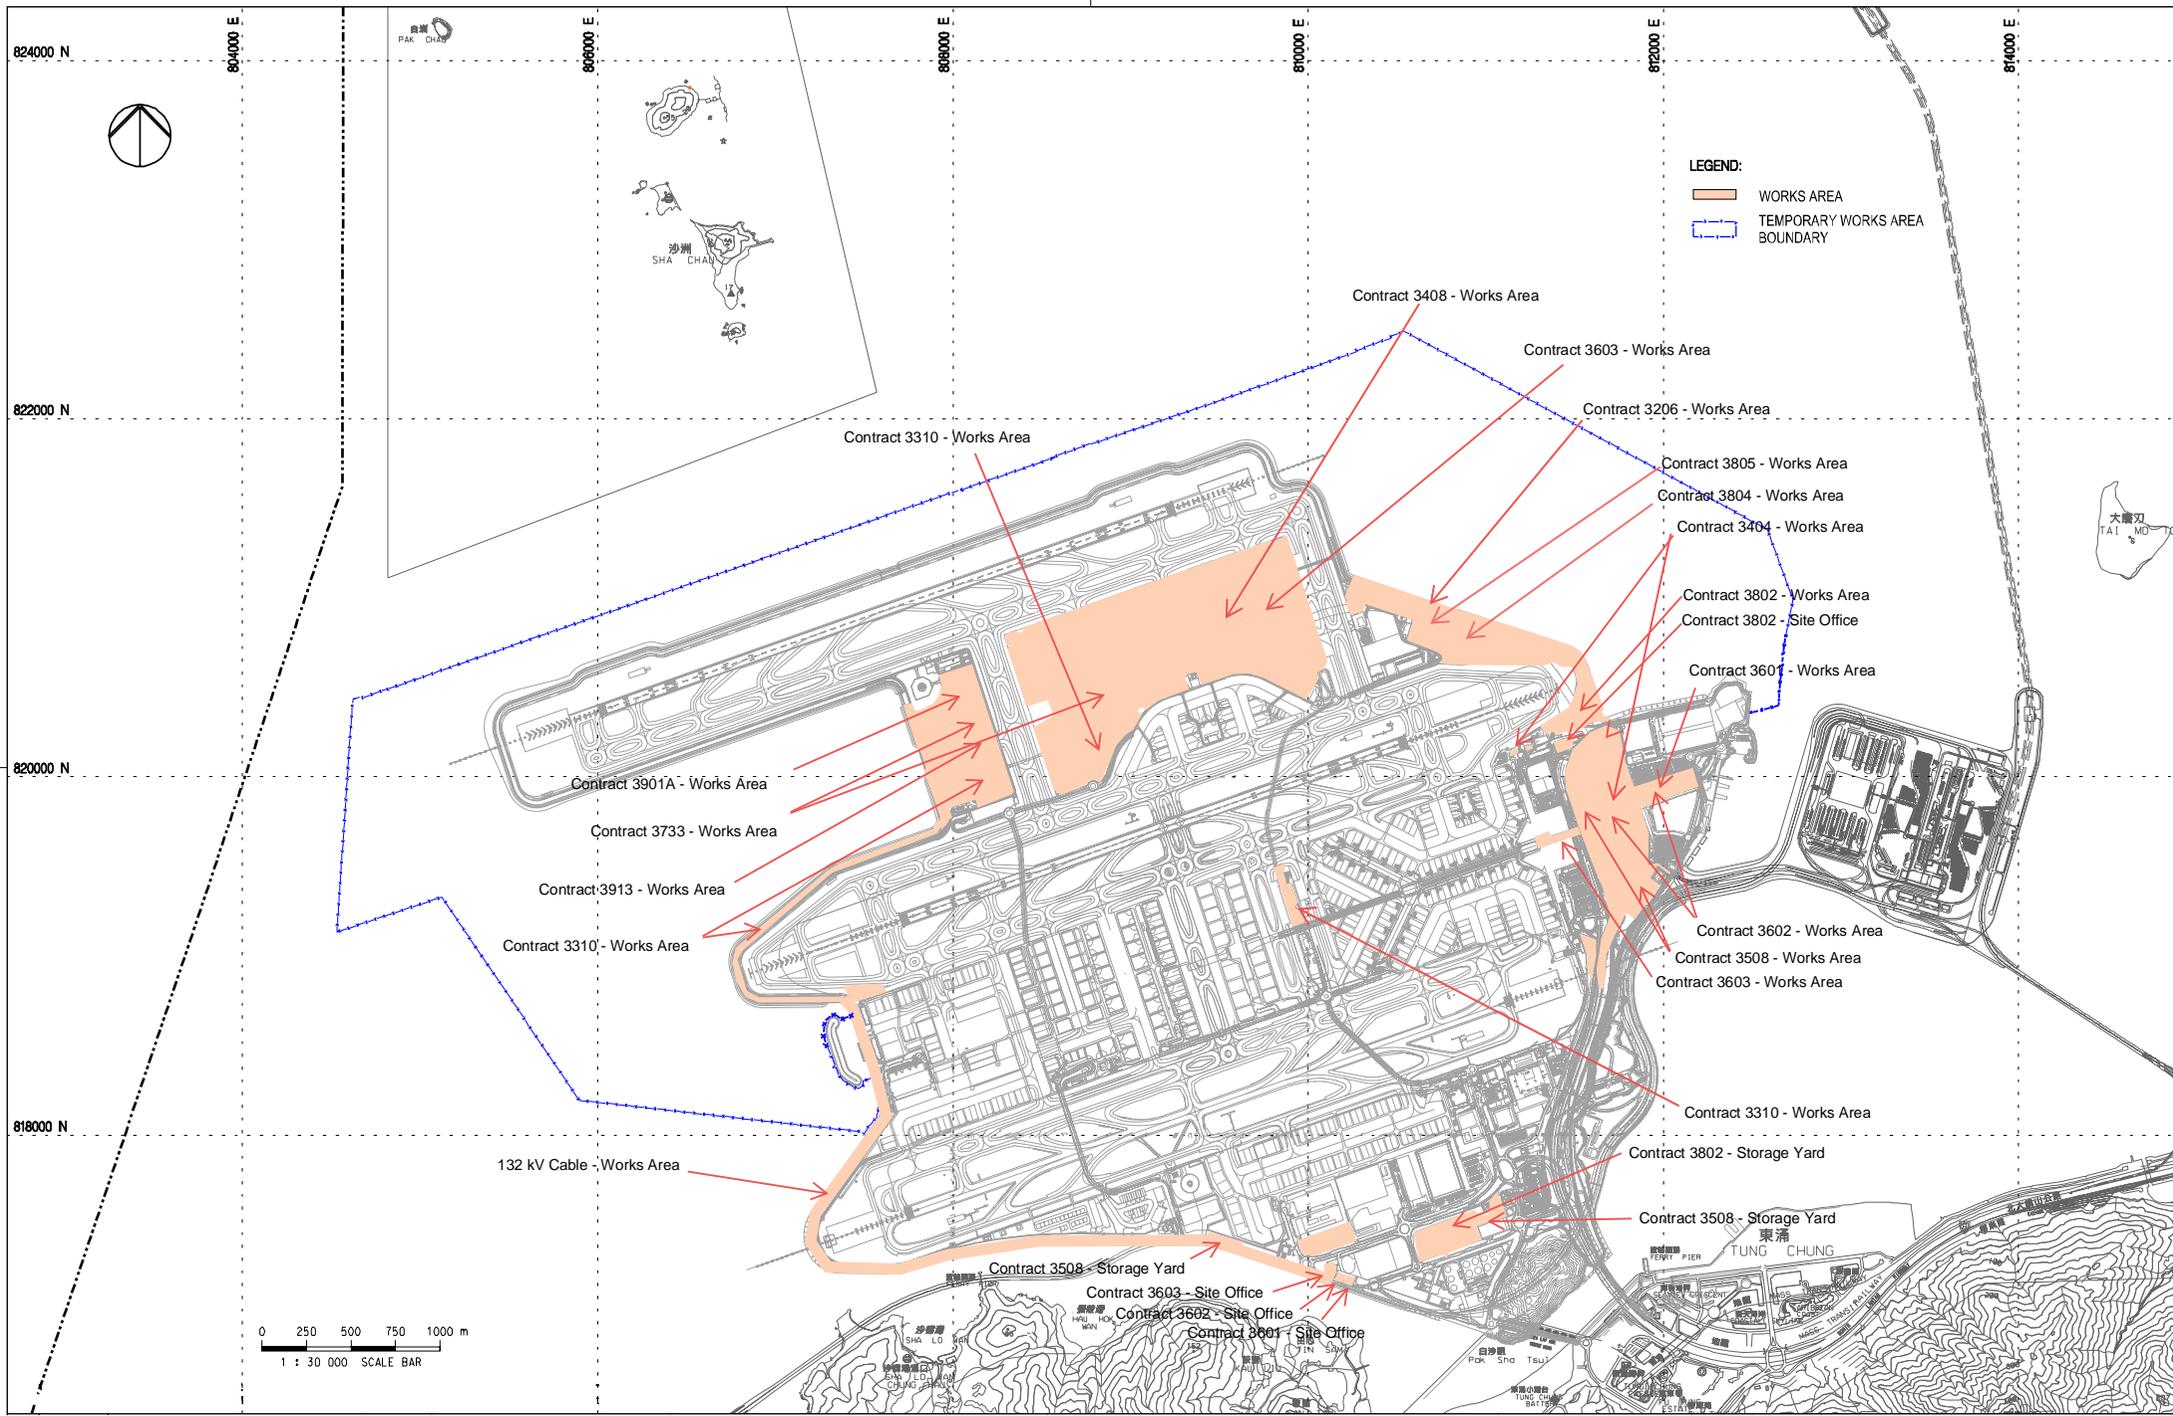
FIGURE 1.1 LOCATIONS OF KEY CONSTRUCTION ACTIVITIES

Note: The locations are for indicative purpose. The actual construction work locations are in accordance with the construction work programme

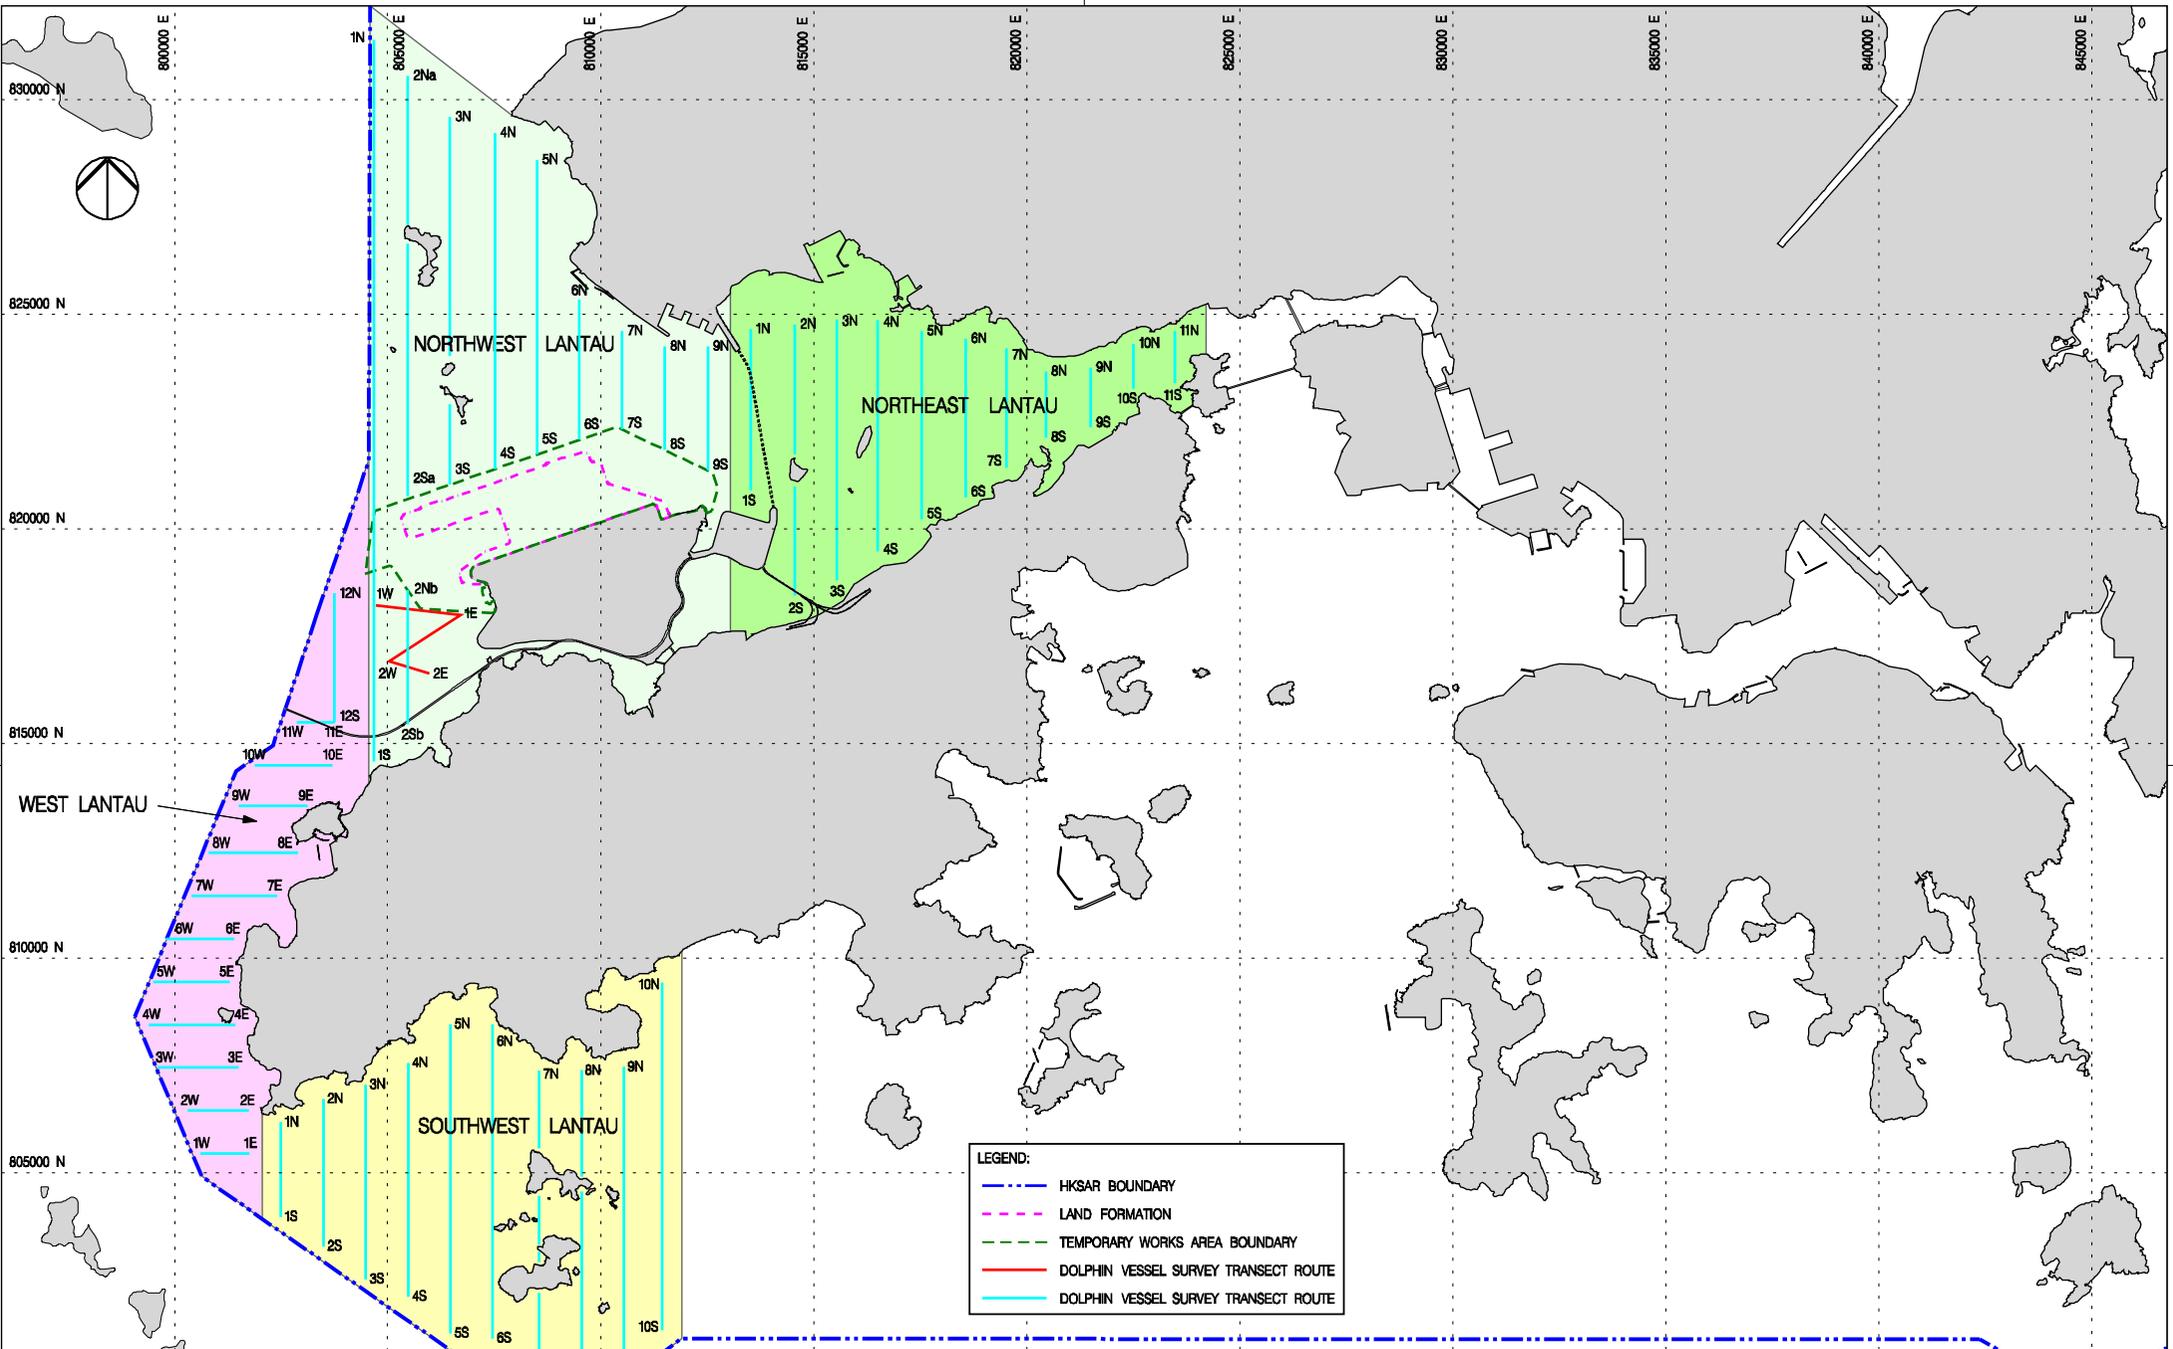
EXPANSION OF HONG KONG INTERNATIONAL AIRPORT INTO A THREE-RUNWAY SYSTEM	
Drawing No.	Scale at A3 1 : 125000
FIGURE 2.2	
Rev.	F

Remarks: Transects for operation phase monitoring subject to refinement based on the actual boundaries for the extension of Hong Kong International Airport Approach Areas (HKIAAA) and 3RS Marine Park

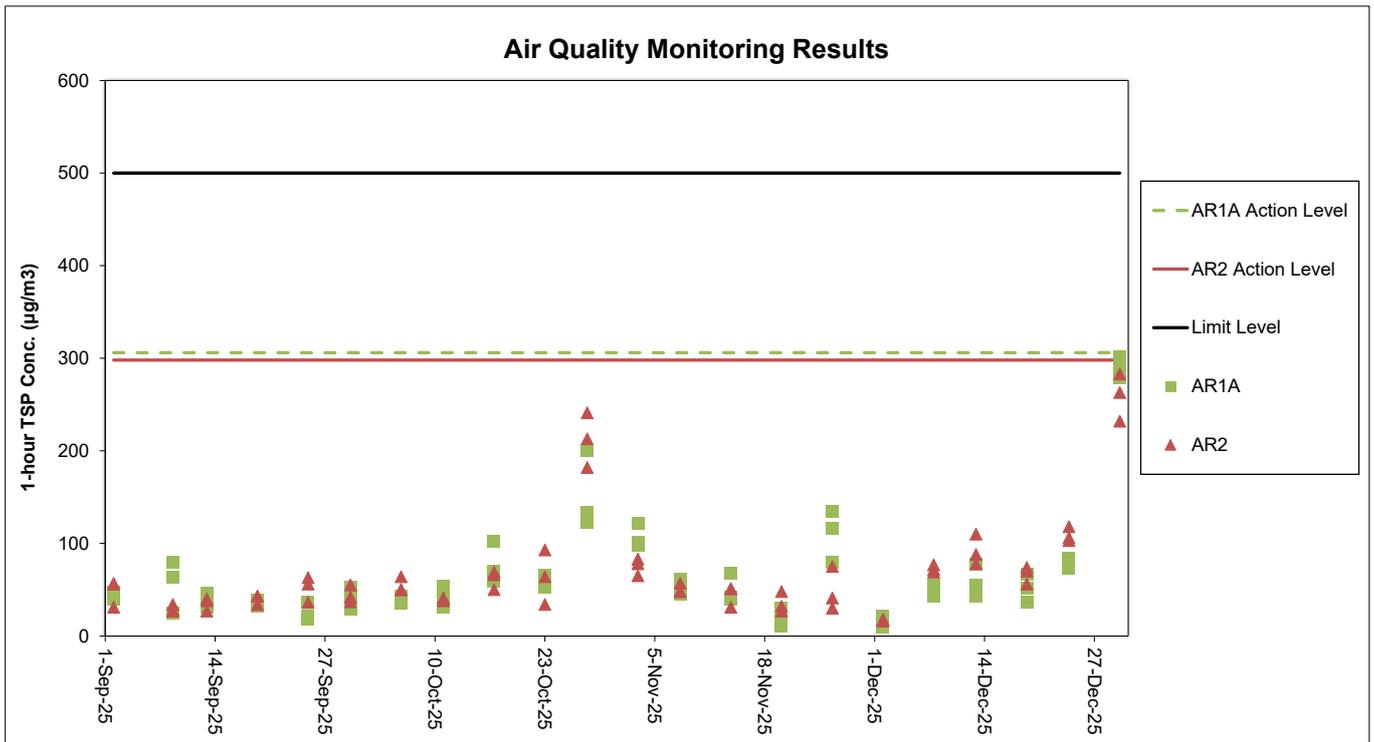
# **Air Quality Monitoring Results**

1. The key activities of the Project carried out in the reporting period are located in reclamation areas and existing airport island respectively. Works in the reclamation areas included concourse superstructure works, pavement works, tunnel works for Automated People Mover (APM) and Baggage Handling System (BHS) and associated works. Meanwhile, works on the existing airport island involved T2 expansion works, modification and tunnel works for APM and BHS, utilities works, road and drainage works, and excavation works.
2. General weather condition during monitoring ranged from sunny to cloudy. Detailed meteorological conditions can be referred to Table 2.3 of this Report and corresponding Monthly EM&A Reports.
3. QA/ QC requirements as stipulated in the EM&A Manual were carried out during measurement.

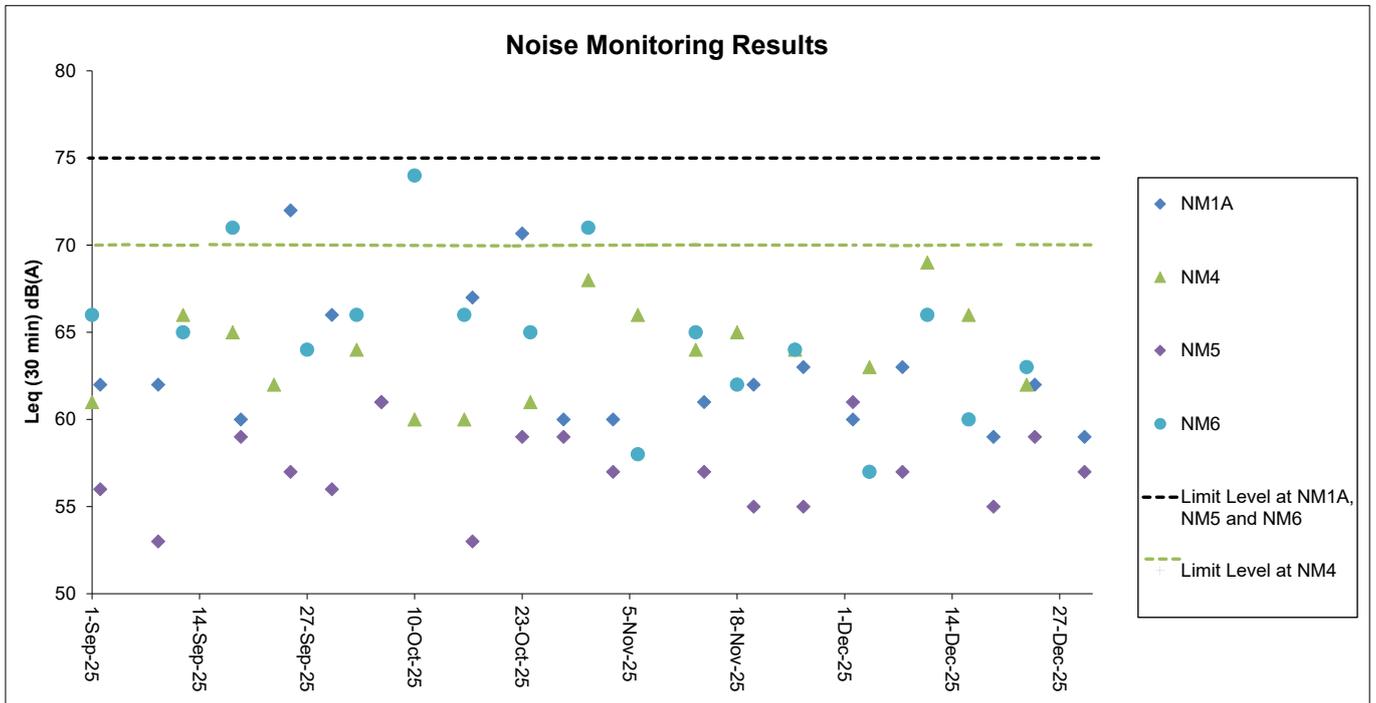
# Noise Monitoring Results

1. The Limit Level is reduced to 70dB(A) for school and 65dB(A) during school examination period at NM4. School examination took place from 20 October 2025 to 24 October 2025 and 3 December 2025 to 10 December 2025 during this reporting period.
