Expansion of Hong Kong International Airport into a Three-Runway System

Construction Phase Monthly EM&A Report No.43
(For July 2019)

August 2019

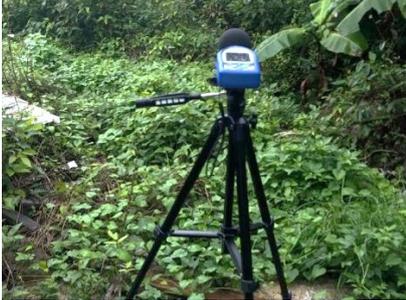
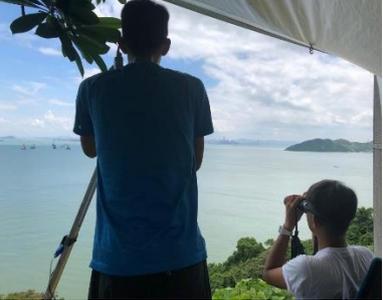
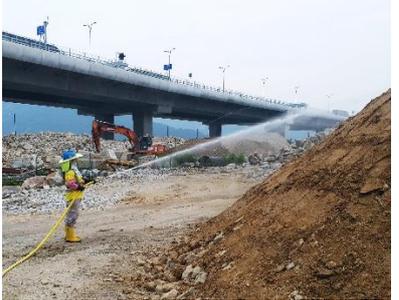
Snapshots of EM&A Activities in the Reporting Period

<p>Noise Monitoring Conducted by ET at Tin Sum</p>	<p>Land-Based CWD Theodolite Tracking Survey Conducted by ET on Lung Kwu Chau</p>	<p>Water Spraying by Contractor for Dust Control</p>

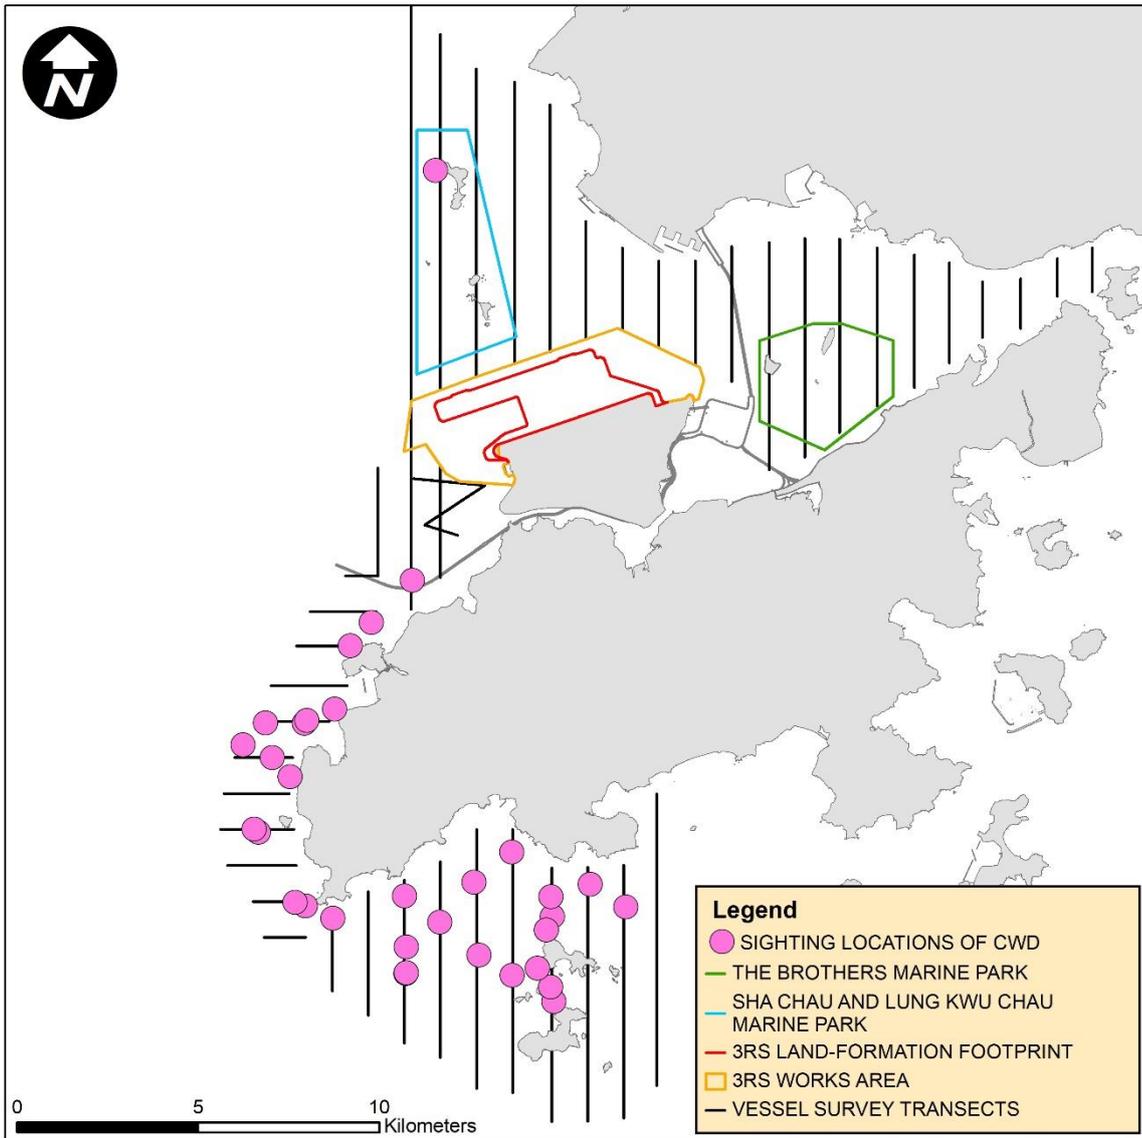
Figure 6.3: Sightings Distribution of Chinese White Dolphins

Distribution of all CWD sightings recorded in July 2019 is illustrated in **Figure 6.3**. In NWL, there were two CWD sightings recorded at the northwestern waters of Lung Kwu Chau and southwestern corner of the survey area respectively. In WL, CWD sightings were recorded from Tai O to Fan Lau with more sightings recorded between Tai O and Peaked Hill. In SWL, there were remarkable increase in CWD sightings compared to previous months. Based on field observation, there were plenty of schools of fish appeared in SWL waters during the surveys in that area. This might be a possible reason for the emerging of a large number of CWDs in SWL in this month. CWD sightings in SWL were scattered among the entire survey area from Fan Lau to the Soko Islands and Lo Kei Wan. No sightings of CWD were recorded in NEL or in close vicinity to 3RS Works Area.

Remarks: Please note that there are 33 pink circles on the map indicating the sighting locations of CWDs. Some of them were very close to each other and therefore may appear overlapped on this distribution map.

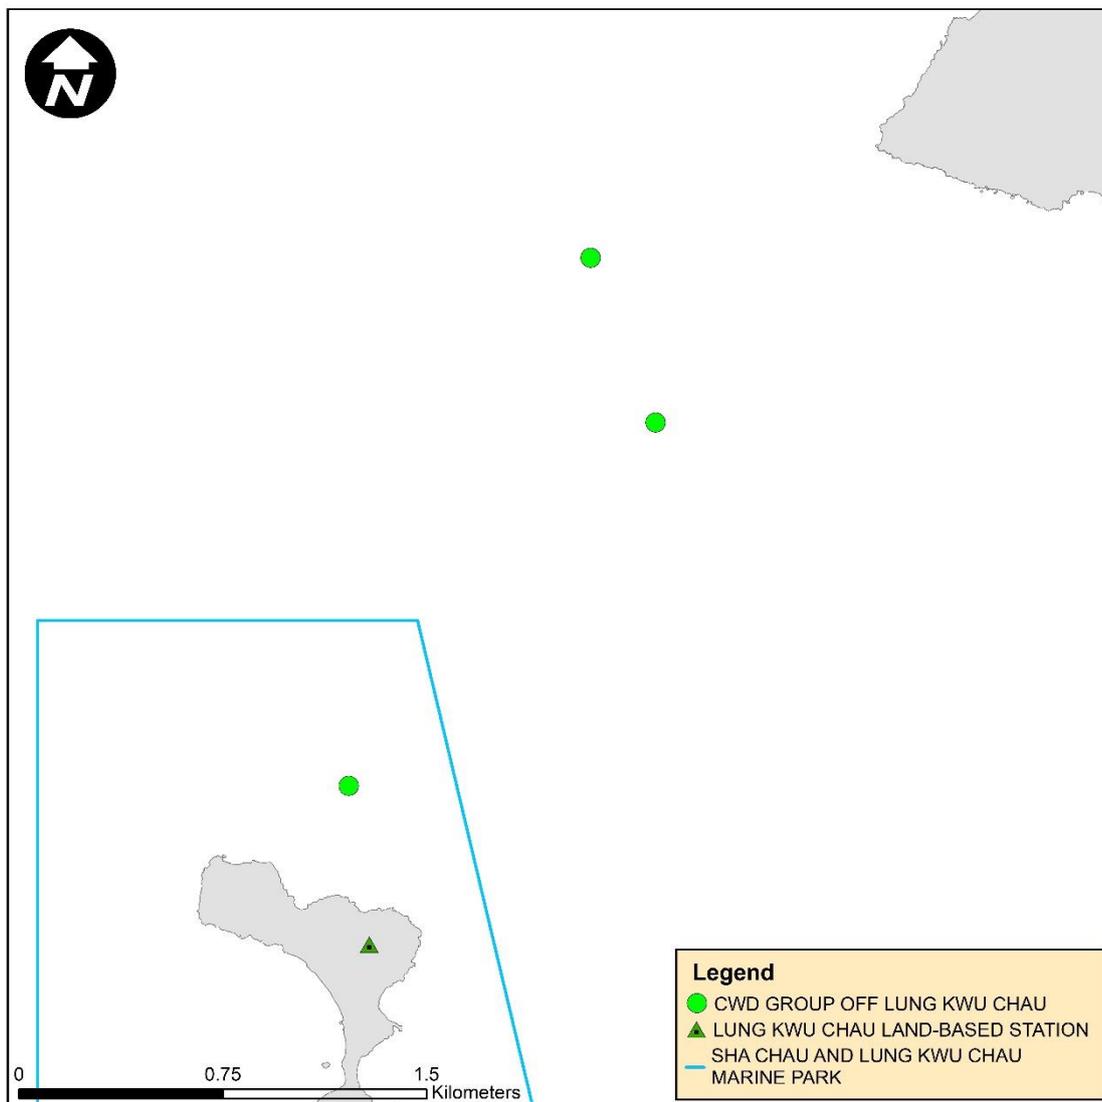
Figure 6.4: Plots of First Sightings of All CWD Groups obtained from Land-based Stations

Land-based Station	No. of Survey Sessions	Survey Effort (hh:mm)	No. of CWD Groups Sighted	CWD Group Sighting per Survey Hour
Lung Kwu Chau	2	12:00	3	0.25
Sha Chau	1	6:00	0	0
TOTAL	3	18:00	3	0.17

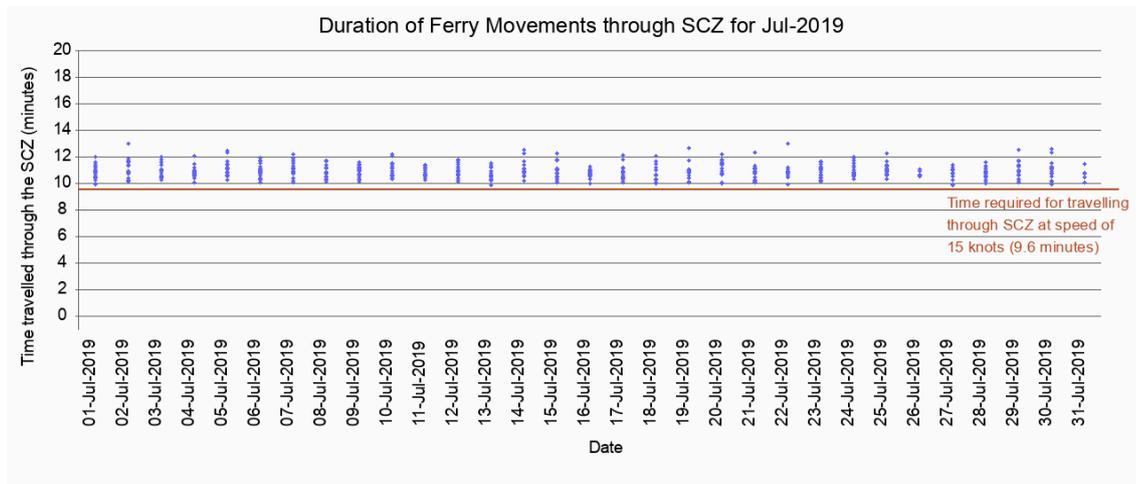
Figure 7.1: Duration of the SkyPier HSFs travelling through the SCZ for July 2019

In total, 640 ferry movements between HKIA SkyPier and Zhuhai / Macau were recorded in July 2019 and the data are presented in **Appendix G**. The time spent by the SkyPier HSFs travelling through the SCZ in July 2019 were presented in **Figure 7.1**. It will take 9.6 minutes to travel through the SCZ when the SkyPier HSFs adopt the maximum allowable speed of 15 knots within the SCZ. **Figure 7.1** shows that all of the SkyPier HSFs spent more than 9.6 minutes to travel through the SCZ.

Note: Data above the red line indicated that the time spent by the SkyPier HSFs travelling through the SCZ is more than 9.6 minutes, which is in compliance with the SkyPier Plan.

A total of one ferry was recorded with minor route deviation on 26 July 2019. Notice was sent to the ferry operator and the case is under investigation by ET.

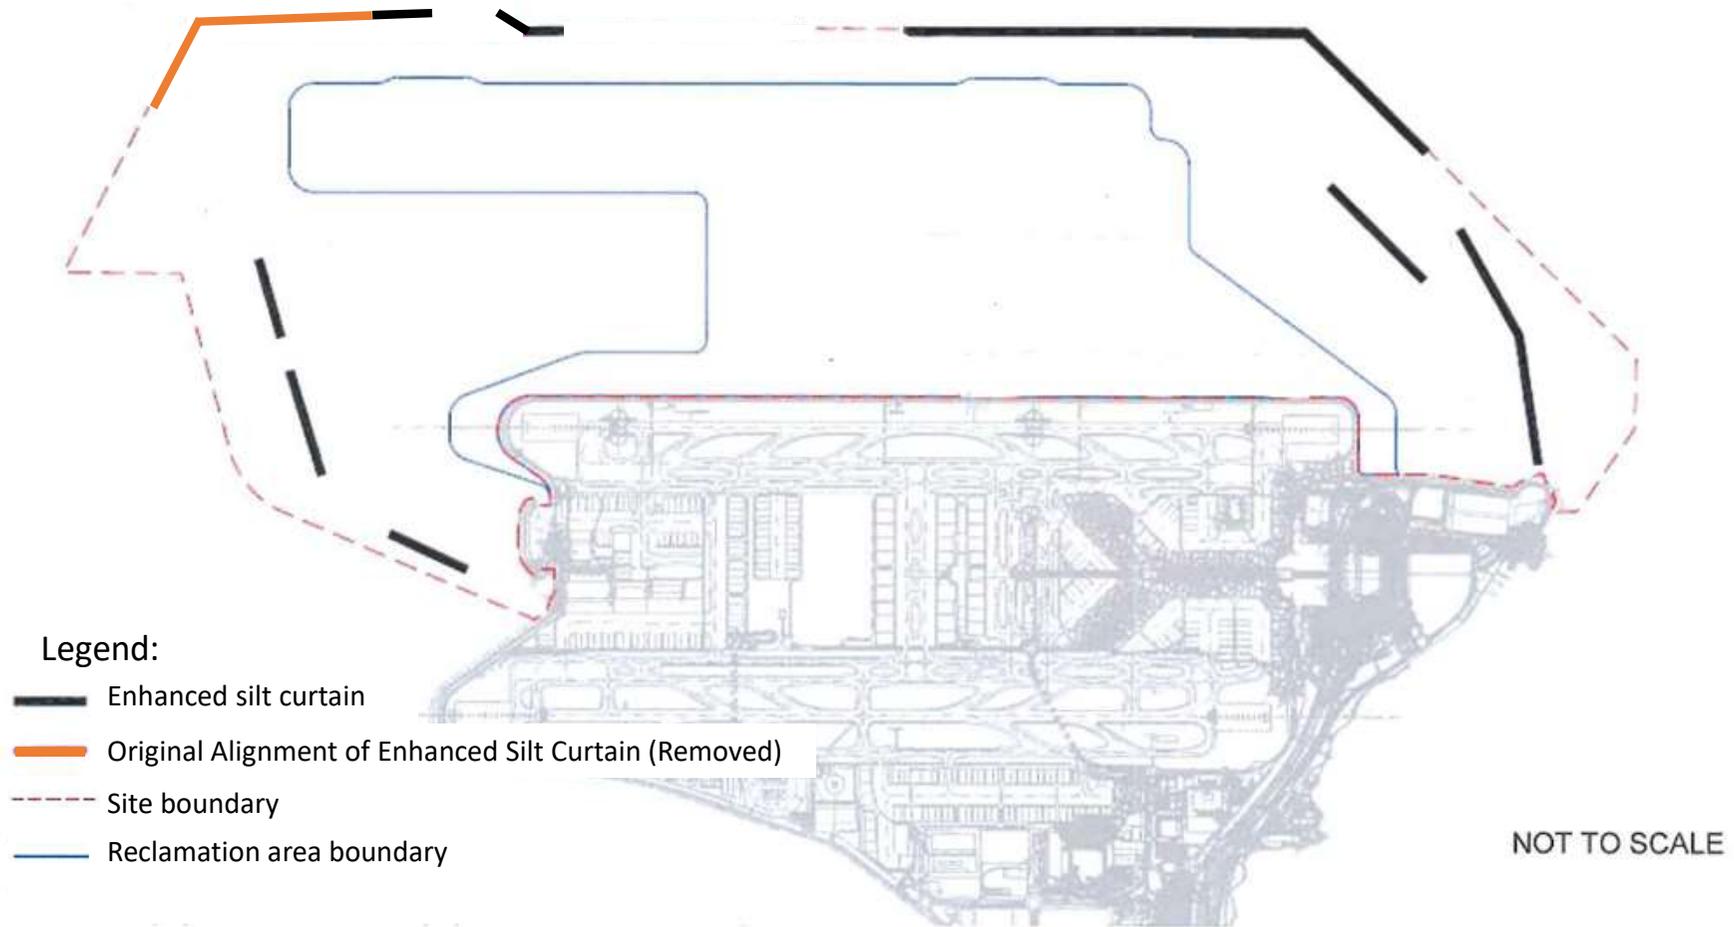
Figure 1.2

Latest Layout of the Enhanced Silt Curtain

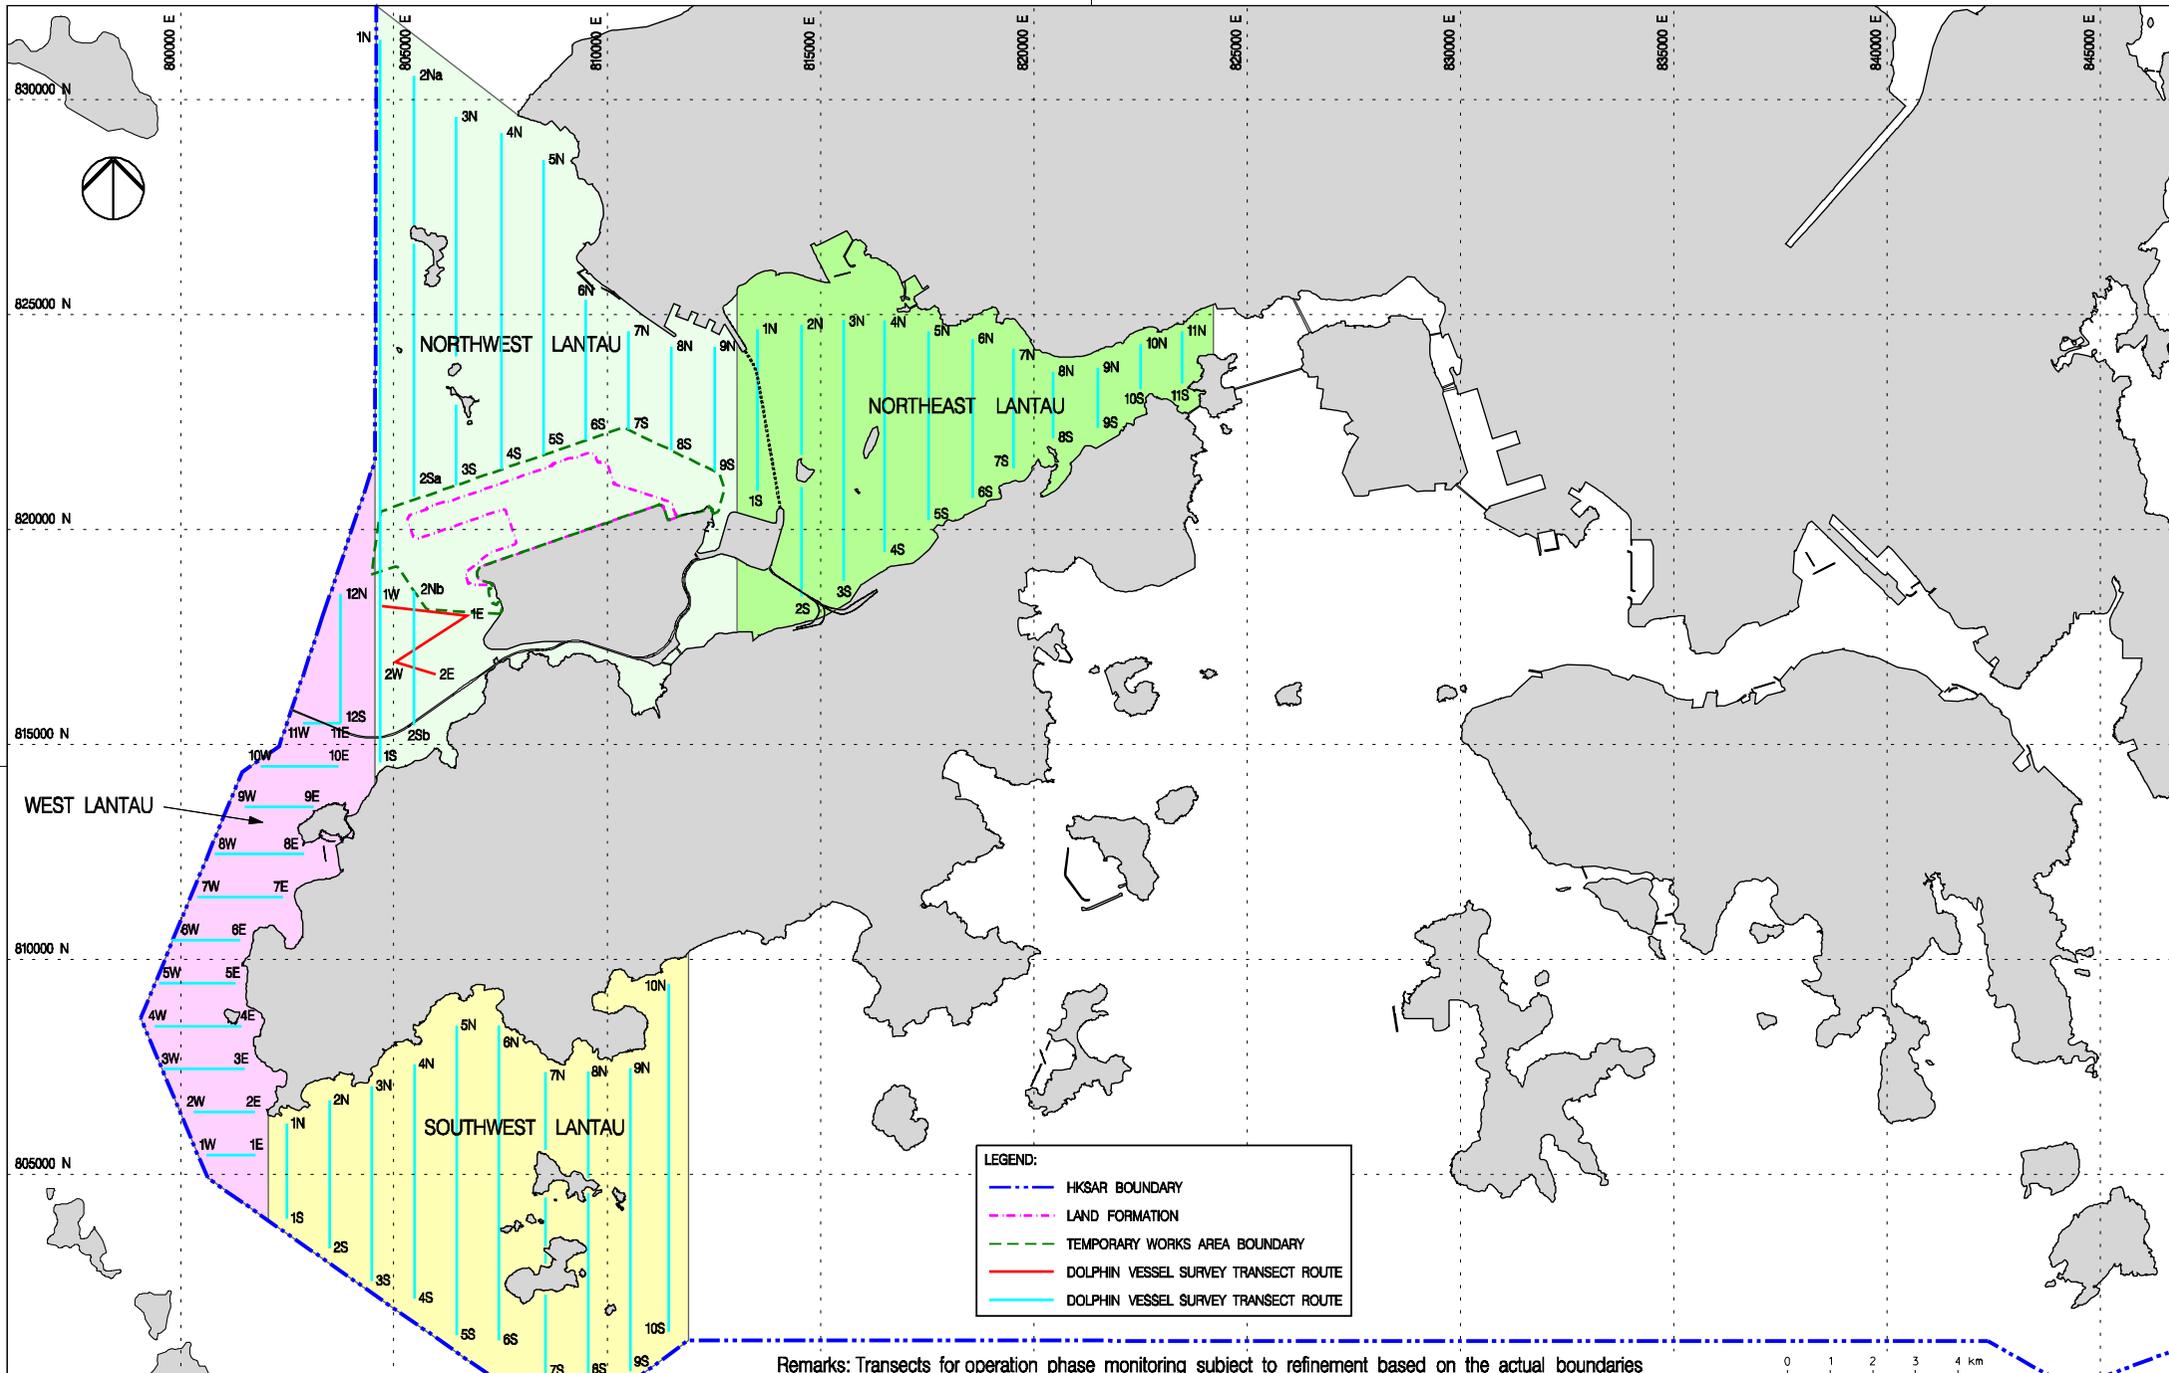
FIGURE 6.1

The planned vessel survey transect lines follow the waypoints set for construction phase monitoring as proposed in the Manual and depicted in **Figure 6.1** with the waypoint coordinates of all transect lines given in **Table 6.2**, which are subject to on-site refinement based on the actual survey conditions and constraints.

Remarks: Transects for operation phase monitoring subject to refinement based on the actual boundaries for the extension of Hong Kong International Airport Approach Areas (HKIAAA) and 3RS Marine Park
