Expansion of Hong Kong International Airport into a Three-Runway System

Supplementary Contamination Assessment Plan

August 2018

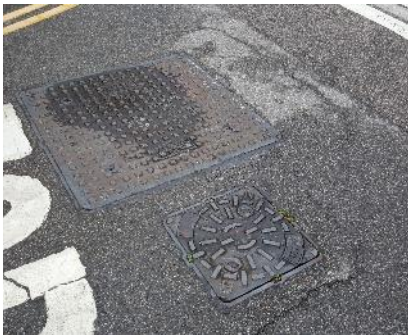
Appendix E.1 Emergency Power Supply System No. 1
Details of **BH1** (2,500 L **Underground** Fuel Tank) & **BH2** (**Underground** Fuel Pipeline)

- Underground fuel tank fully encased in 300mm thick concrete chamber
- Space between the tank and the chamber is filled with sand
- Test run of emergency generator conducted monthly (for 30-60 mins)
- Manhole chamber of U/G tank is checked monthly and re-filled approx. every 6 months
- The quantity of fuel inside the tank is automatically monitored by level sensor. No sign of leakage is detected.

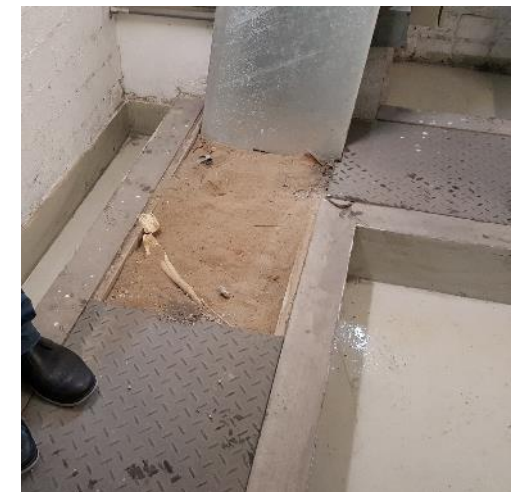
Sand filled trench containing fuel
pipes (outside the fuel tank
chamber)

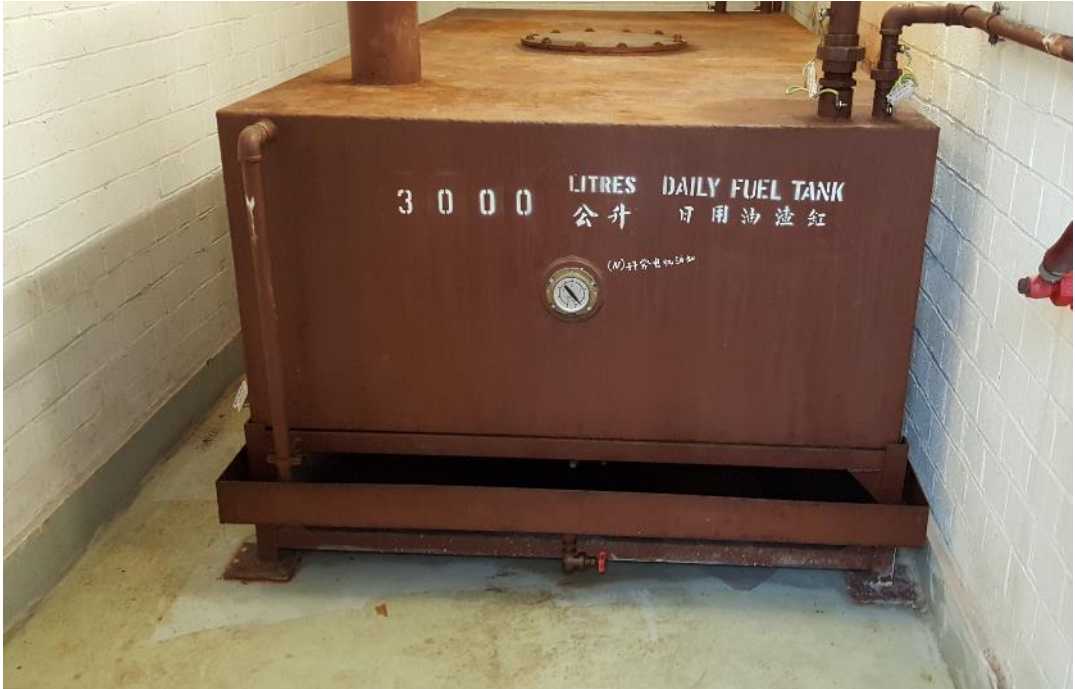
3000 L fuel tank with metal drip tray

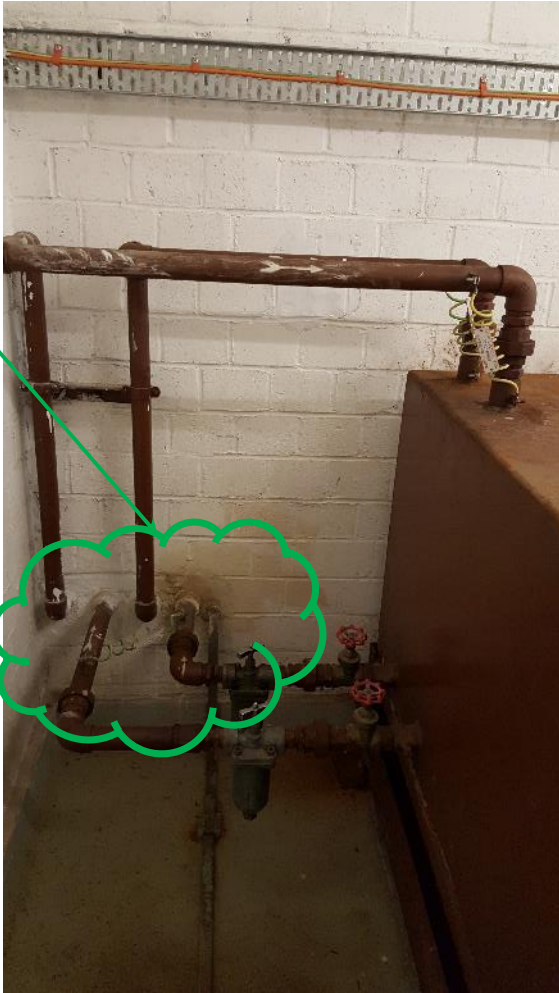
Fuel pipes penetrating the wall and connect to the generators at lower floor

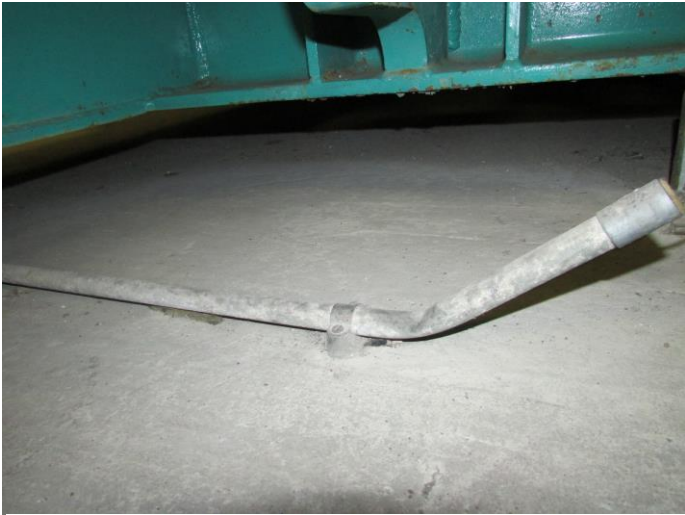
HS1 View 5 - concrete floor condition underneath emergency generators

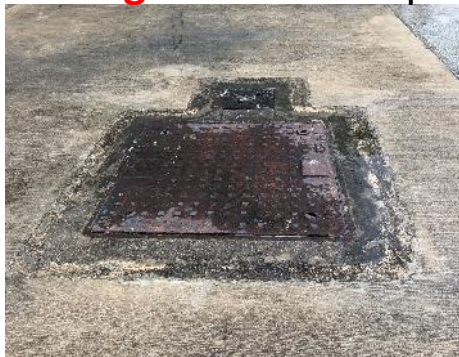
- Notes
- Underground fuel tank fully encased in 300mm thick concrete chamber
 - Space between the tank and the chamber is filled with sand
 - Test run of emergency generator conducted monthly (for 30-60 mins)
 - Manhole chamber of U/G tank is checked monthly and re-filled approx. every 6 months
 - The quantity of fuel inside the tank is automatically monitored by level sensor. No sign of leakage is detected.

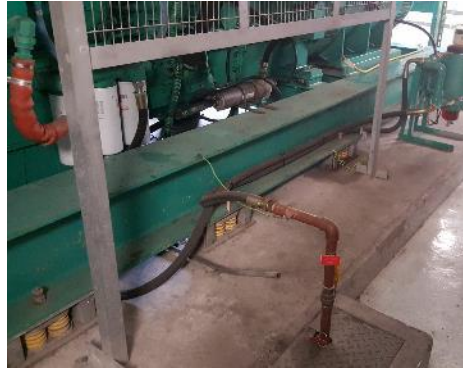
Fuel pipes to/from fuel tank and the generator

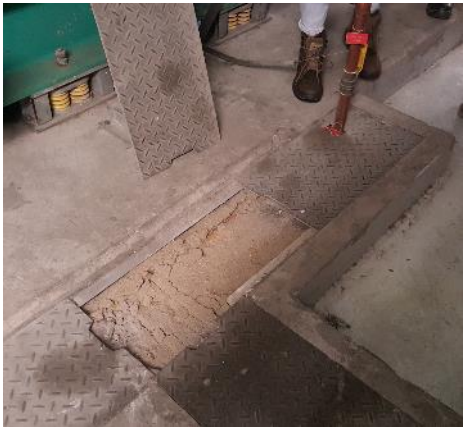
Sand filled trench containing fuel pipes (outside the fuel tank chamber)

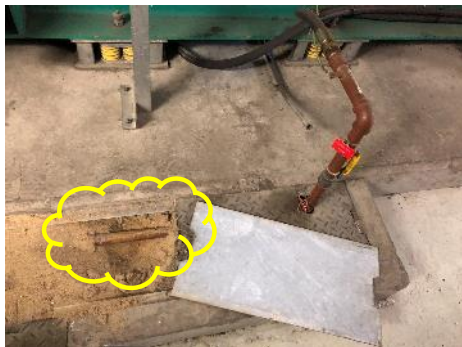
Exposed fuel pipes

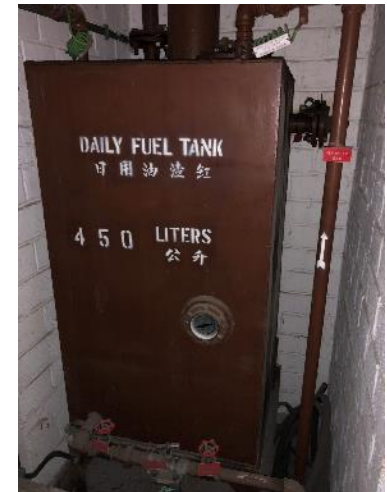
450 L fuel tank (BH7)

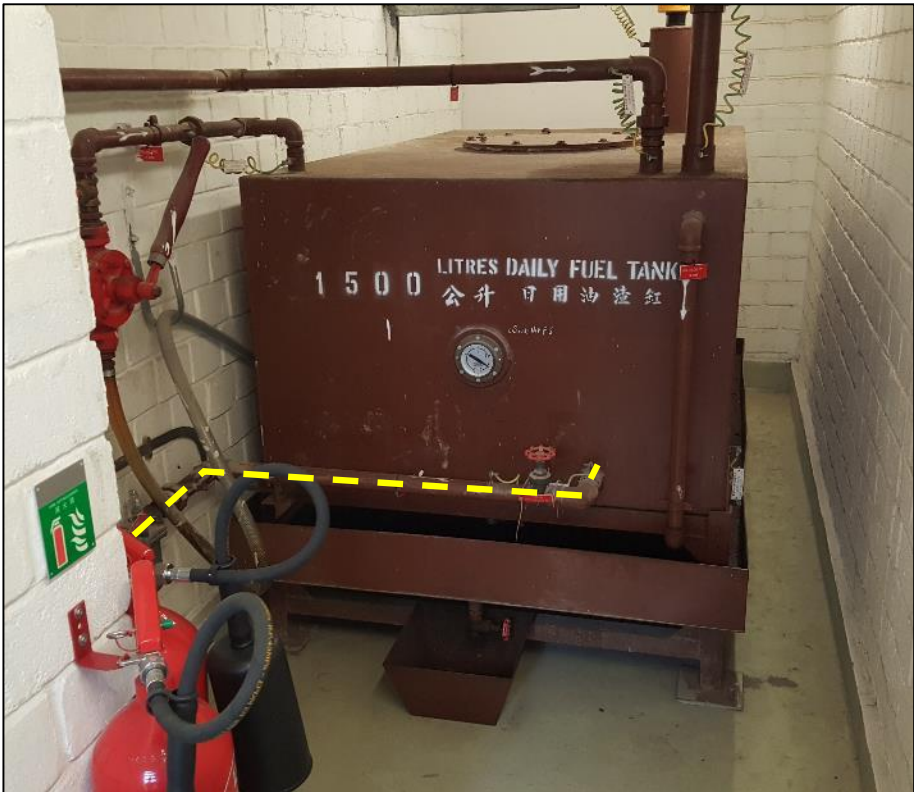
1,500L fuel tank (BH10) with metal drip tray

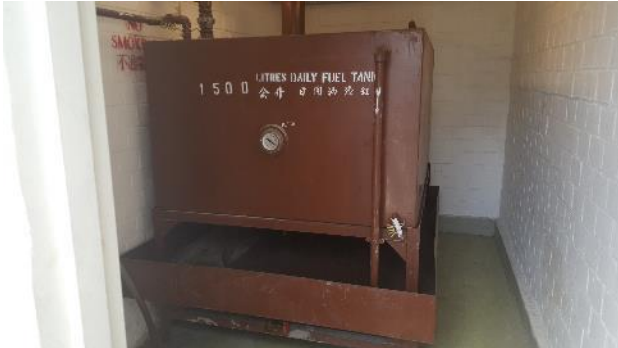
1,500 L fuel tank (HS4) with metal drip tray

- Notes
- Both the fuel tank and generator mounted on intact concrete floor with no any oil stain.
 - Test run of emergency generator conducted monthly (for 30-60 mins)
 - Fuel tank is checked monthly and re-filled approx. every 6 months.
 - The quantity of fuel inside the tank is monitored by level sensor. No sign of leakage is detected.
